MOUNTAIN MAPLE GARDEN & TREE SERVICE LTD.
#200, 8208 SWENSON WAY
DELTA, BC V4G 1J6
PHONE: 604 - 499 - 6568
MOUNTAIN.MAPLE@HOTMAIL.COM

RE: Arborist Report for Metric Architecture - For property located at 1805 Larch St., Vancouver, BC

Applicant: Metric Architecture
C/o: Scott Mitchell
Phone: 604 - 786 - 2868
Email: scott@metricarchitects.com

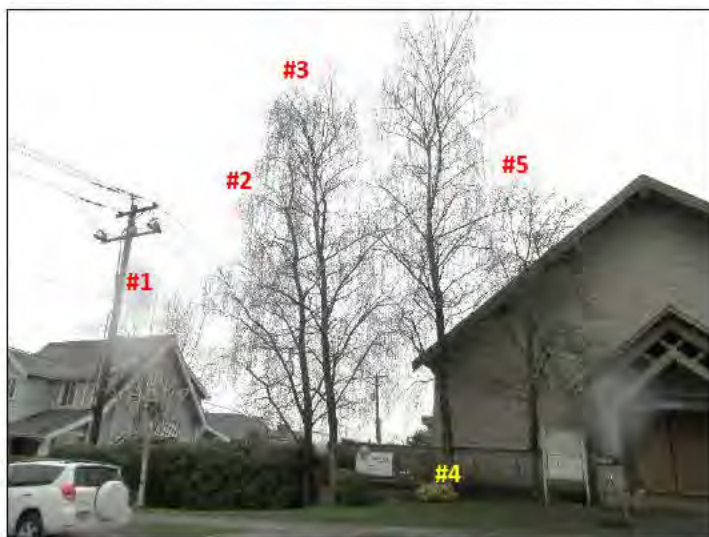
Trees #1 - #5 – East side

<u>TREE</u>	<u>SPECIES</u>	<u>DBH</u>	<u>HEIGHT</u>	<u>CRZ</u>	<u>Condition</u>	<u>OBSERVATIONS & RECOMMENDATIONS</u>
#		(cm)	(m) est.	radius (ft.)		
1	Birch (<i>Betula sp.</i>)	16	7	3.3'	Fair	<p>This tree may be slightly shared ownership with the City. The south side of the canopy has been cut back to provide clearance to the communication cables, Hydro power pole, guywire and laneway. There is branch and twig dieback and fungal activity within the upper canopy; several limbs have already failed. This tree is on a slight slope; the grade slopes upward north of the stem and downward southwest of the stem.</p> <p>RECOMMENDATIONS: RETAIN. Install Tree Protection Zone fencing 5ft from the base of the stem on the north and west sides, adjacent to the laneway on the south side and adjacent to the City sidewalk on the east side. This tree should be monitored and reassessed in two years or sooner if signs of stress or decline are observed, and if any significant changes are noted.</p>

2	Birch (<i>Betula sp.</i>)	34	12	7'	Fair	<p>This tree somewhat forms part of a group. It is tall and spindly. It has a slight lean to the south. It lacks adequate trunk taper and basal flare, which is indicative of a grade change. The crown is asymmetrical and is heavily weighted to the south; due to the proximity of Tree #3, the canopies of these trees form one crown. The south side of the canopy has been cut back to provide clearance to the three-phase Hydro lines, communication cables and guy wire. The crown has been raised to provide clearance to the City sidewalk on the east side and the existing raised concrete patio and wood fence, which are 2.5ft from the north side of the stem; there is a 2.5ft grade difference. It has been reported this patio may be an addition to the existing building. There is also an existing concrete retaining wall 3.5ft from the west side of the stem; the grade on the west side of the wall is 7ft lower. There is an existing parking area at lower grade. Due to the proximity of the existing retaining wall and patio this tree lacks any supportive structural roots on the north and west sides of the stem; it is unknown if any roots were cut or damaged during the installation of the patio. This tree has exceeded the height of the surrounding and existing buildings, which will put it at risk of windthrow due to inadequate structural and supportive rooting. There is branch and twig dieback throughout the canopy. This tree is on a slight slope; the grade slopes downward south of the stem. The Critical Root Zone radius is 7ft. This tree is within the footprint of the proposed underground parkade.</p> <p>RECOMMENDATIONS: REMOVE. Removal of this tree is necessary to enable the proposed underground parkade. Demolition and removal of the existing adjacent retaining wall and patio will cause extensive Critical Root damage and soil disturbance causing instability. This tree also forms part of a group, which is proposed for removal.</p>

<u>TREE</u>	<u>SPECIES</u>	<u>DBH</u>	<u>HEIGHT</u>	<u>CRZ</u>	<u>Condition</u>	<u>OBSERVATIONS & RECOMMENDATIONS</u>
#		(cm)	(m) est.	radius (ft.)		
3	Birch (<i>Betula sp.</i>)	29	14	6'	Fair	<p>This tree somewhat forms part of a group. It is tall and spindly. It has a slight lean to the southeast. It lacks adequate trunk taper and basal flare, which is indicative of a grade change. The crown is asymmetrical and is heavily weighted to the north; due to the proximity of Tree #2, the canopies of these trees form one crown. The northwest side of the canopy has been cut back to provide clearance to the existing building. The crown has been raised and cut back on the east side to provide clearance to the City sidewalk and on the west side to provide clearance to the existing raised concrete patio and wood fence, which are 1.5ft away; there is a 2.5ft grade difference. It has been reported this patio may be an addition to the existing building. Due to the proximity of the existing patio this tree lacks any supportive structural roots on the west side of the stem; it is unknown if any roots were cut or damaged during the installation of the patio. This tree has exceeded the height of the surrounding and existing buildings, which will put it at risk of windthrow due to inadequate structural and supportive rooting. There is branch and twig dieback throughout the canopy. This tree is on a slight slope; the grade slopes downward south and southeast of the stem. The Critical Root Zone radius is 6ft. This tree is within the footprint of the proposed underground parkade.</p> <p>RECOMMENDATIONS: REMOVE. Removal of this tree is necessary to enable the proposed underground parkade. Demolition and removal of the existing adjacent patio will cause extensive Critical Root damage and soil disturbance causing instability. This tree also forms part of a group, which is proposed for removal.</p>

4	Birch (<i>Betula sp.</i>)	31	16	6.4'	Fair	<p>This tree somewhat forms part of a group. It is tall and spindly. It has a slight lean to the southeast. It lacks adequate trunk taper and basal flare, which is indicative of a grade change. The west side of the canopy has been raised and cut back to provide clearance to the existing building, which is 6ft away and the existing raised concrete patio, walkway and wood fence, which are 1ft away. There is a 1.5ft grade difference between the base of the stem and the existing walkway; the grade difference increases to the south. It has been reported this patio and walkway may be an addition to the existing building. Due to the proximity of the existing patio and walkway this tree lacks any supportive structural roots on the west side of the stem; it is unknown if any roots were cut or damaged during the installation of the patio and walkway. This tree has exceeded the height of the surrounding and existing buildings, which will put it at risk of windthrow due to inadequate structural and supportive rooting. There is branch and twig dieback throughout the canopy. This tree is on a slight slope; the grade slopes downward south and southeast of the stem. The Critical Root Zone</p>

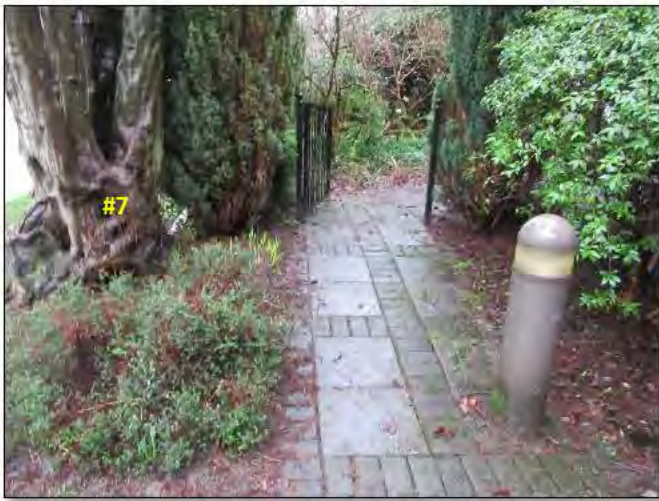
Tree #7 – Existing site conditions

7	Dogwood (<i>Cornus sp.</i>)	95 combined (34+33+28)	14	19.6'	Fair	<p>This tree belongs to the City; although, it does not appear to be something that would be planted and maintained by them. It has four stems commencing at 3ft; these stems divide further up. There is an accumulation of soil and some decay within the union; the bark is cracked and has begun to slough. The crown has been raised to provide clearance to the City roadway and sidewalk on the north side, the existing concrete walkway, which is 5ft from the west side and the existing paver walkway, which is 3ft from the south side of the stem. This tree is on a slight slope; the grade slopes downward west of the stem. The Critical Root Zone radius is 19.6ft; this is somewhat skewed based on the combined diameter of the stems. The corner of the elevated concrete staircase, which has been supported by a concrete retaining wall is 9ft from the south side and 5ft from the west side of the stem. This retaining wall must remain intact; otherwise, the removal of this wall will result in extensive Critical Root damage and soil disturbance causing instability of the adjacent retained tree. This wall may need to be reduced in height and structurally upgraded. The grade on the south side of the wall is about 6ft lower; the grade difference decreases to the west. The existing wood fence is 11.5ft away and the existing gravel play area is 12ft from the west side of the stem. There is an existing metal gate entry adjacent to the southeast side of the stem and landscaping within the Critical Root Zone.</p> <p>RECOMMENDATIONS:</p> <p>RETAIN. One large Zone shall Protect Tree #7 and Shrub #34. Install Tree Protection Zone fencing 16ft from the base of the stem on the east side of Tree #7, adjacent to the existing staircase on</p>

<u>TREE</u>	<u>SPECIES</u>	<u>DBH</u>	<u>HEIGHT</u>	<u>CRZ</u>	<u>Condition</u>	<u>OBSERVATIONS & RECOMMENDATIONS</u>
#		(cm)	(m) est.	radius (ft.)		
						<p>the south side of Tree #7 and on the west side of Shrub #34, adjacent to the existing play area on the west side of Tree #7, adjacent to the existing retaining wall on the south side of Shrub #34 and adjacent to the City sidewalk on the north side of Tree #7. Demolition and removal of the existing staircase, wood retaining wall, walkways, patio and gate entry that is adjacent to and within this Zone must be supervised by a Certified Arborist. Removal of the existing vegetation within the TPZ must be performed manually; no further excavation can occur.</p> <p>Shrub #34 must be pruned back on all sides to contain prior to any construction; this must be performed by a Certified Arborist.</p>
						<p>This tree has two stems commencing at 25ft; the west stem has been suppressed. This tree has a slight corrected lean to the south. It lacks adequate trunk taper and basal flare, which is indicative of a grade change. The crown has been raised rather high to provide clearance to the existing building on the south side, and the existing adjacent concrete staircase and elevated wood deck that have been supported by an existing concrete retaining wall, which is 4ft from the east side of the stem. This retaining wall must remain intact; otherwise, the removal of this wall will result in extensive Critical Root damage and soil disturbance causing instability of this tree. This wall may need to be reduced in height and structurally upgraded. The grade on the south side of the wall is about 6ft lower; the grade difference decreases to the west. Several limbs have shed throughout the upper canopy. There is also evidence of boring insect activity. This tree is on a slight slope; the grade slopes upward north and east of the stem and downward west of the stem. There is an existing rock retaining wall immediately adjacent to the south side of the stem; this wall is proposed to remain. The grade on the south side of the wall is about 5.5ft lower. The roots have been deflected and have grown downward extending beyond this wall at lower grade. The existing north foundation wall of the building is about 8.5ft away and the existing asphalt walkway is 2ft from the south side of the stem; these are at lower grade. This walkway is cracked and has shifted due to the roots from this tree; it is proposed to be removed and replaced. There is another existing retaining wall 7ft from the east side of the stem; the grade on the east side of the wall is about 6.5ft higher. There is an existing wood fence 9.5ft away and a gravel play area within the Critical Root Zone on the north side of the stem at higher grade. The Critical Root Zone radius is 10.1ft. The footprint of the proposed underground parkade is 8ft away and the new retaining wall is 3.5ft from the south side of the stem, not including the excavation required; this is tolerable due to the location of the existing</p>

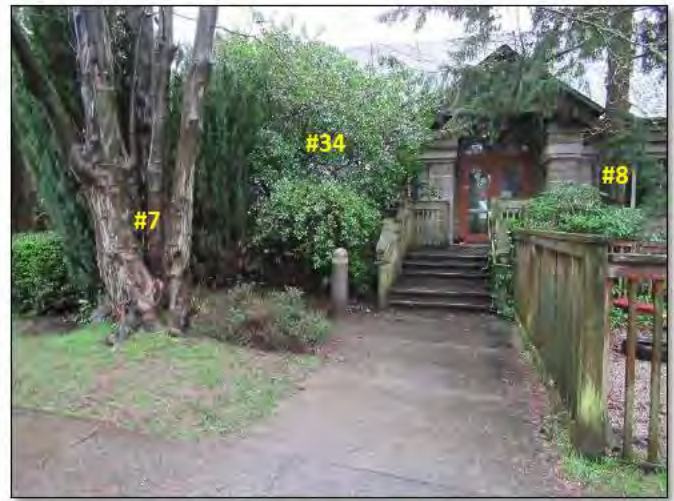
Trees #7 & #8 and Shrub #34 – Existing site conditions

8	Douglas Fir (<i>Pseudotsuga menziesii</i>)	49	16	10.1'	Fair	<p>City of Vancouver - FOI File # 2018-527</p> <p>Page 417 of 494</p>

34	Pieris (<i>Pieris japonica</i>)	34 combined (13+11+10)	2.5	7'	Good	
						RECOMMENDATIONS: RETAIN. See recommendations for Tree #7. One large Zone shall protect Tree #7 and Shrub #34.

RETAIN. One large Zone shall protect Trees #8 - #12. Install Tree Protection Zone fencing 12ft from the base of the stem on the north side of Tree #8, 12ft from the base of the stem on the east side of Tree #11, 12ft from the base of the stem on the west and northwest sides of Tree #12, adjacent to the existing building on the south side of Trees #8 - #12, adjacent to the existing wood deck and retaining wall on the east side of Tree #8, and adjacent to the City sidewalk on the north side of Trees #8 - #12. Demolition and removal of the existing foundation, retaining wall, staircase, wood deck, driveway and walkway, adjacent to and within this Zone must be supervised by a Certified Arborist. Removal of the existing fences, gravel play area, wood tie border and play equipment within the TPZ must be performed manually.

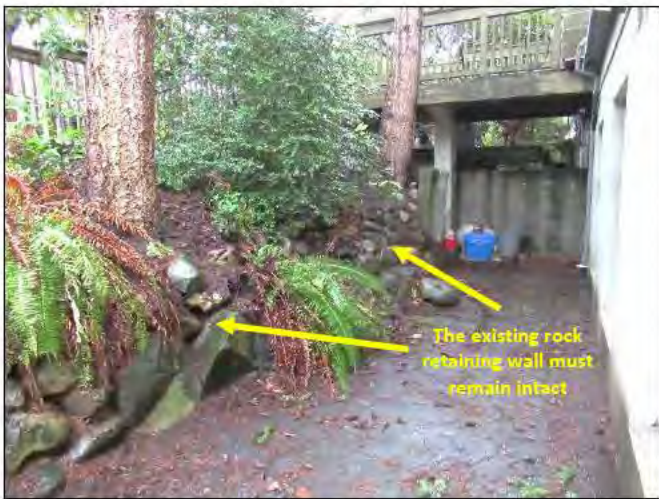
Trees #9 & #8 – South side

foundation. Also, a reduced line of excavation and shoring (vertical cut excavation and shotcrete) has been proposed for the portion of the north foundation wall of the proposed underground parkade to reduce the excavation required into the Critical Root Zone of this tree.

<u>TREE</u>	<u>SPECIES</u>	<u>DBH</u>	<u>HEIGHT</u>	<u>CRZ</u>	<u>Condition</u>	<u>OBSERVATIONS & RECOMMENDATIONS</u>
#		(cm)	(m) est.	radius (ft.)		
9	Douglas Fir (<i>Pseudotsuga menziesii</i>)	40	16	8.3'	Fair	<p>This tree has a dogleg bend in the stem at 10ft. It lacks adequate trunk taper and basal flare, which is indicative of a grade change. The crown has been raised rather high to provide clearance to the existing building on the south side of the stem. Several limbs have failed within the upper canopy. A limb from an adjacent tree is in contact with the northeast side of the stem at 15ft causing minor surface bark damage due to friction. This tree is on a slight slope; the grade slopes upward north and east of the stem and downward west of the stem. There is an existing rock retaining wall immediately adjacent to the south side of the stem; this wall is proposed to remain. The grade on the south side of the wall is 3.5ft lower. The roots have been deflected and have grown downward extending beyond this wall at lower grade. The existing north foundation wall of the building is about 9ft away and the existing asphalt walkway is 2ft from the south side of the stem; these are at lower grade. This walkway is cracked and has shifted due to the roots from this tree; this walkway is proposed to be removed and replaced. There is an existing wood fence 4.5ft and 9ft away and an existing gravel play area within the Critical Root Zone on the north side of the stem. The Critical Root Zone radius is 8.3ft. The footprint of the proposed underground parkade is 8ft away and the proposed retaining wall is 3.5ft from the south side of the stem, not including the excavation required; this is tolerable due to the location of the existing foundation. Also, a reduced line of excavation and shoring (vertical cut excavation and shotcrete) has been proposed for the portion of the north foundation wall of the proposed underground parkade to reduce the excavation required into the Critical Root Zone of this tree.</p> <p>RECOMMENDATIONS: RETAIN. See recommendations for Tree #8. One large Zone shall protect Trees #8 - #12.</p>

Any excavation for the proposed parkade and sunken patio that encroaches into the TPZ requires the supervision of a Certified Arborist. All exposed roots will be properly pruned, then they must be covered with burlap and poly plastic in an effort to prevent desiccation of exposed roots; poly plastic must be removed before shotcrete is applied.

The proposed staircase that encroaches into the TPZ must be supported by Sonotube footings. Any excavation for the footings must be performed manually; no further excavation can occur. If large roots (1.5" diameter and larger) are encountered, then the footings must be shifted to accommodate. The portion of the new walkway and the proposed walkway that encroach into the TPZ must be installed above existing grade; no excavation can occur.

The proposed retaining wall that encroaches into the TPZ cannot have a continuous footing; it must be installed adjacent to the existing retaining wall and supported by a grade beam that spans between posts. The entire grade beam must be above existing grade; no excavation can occur. Any excavation for the posts must be performed manually. Installation of the new wall must be supervised by a Certified Arborist.

The canopies of Trees #8, #9 and #12 must be pruned back to provide clearance for construction activities and the new structure and to balance the remaining crown; all pruning must be performed by a Certified Arborist using spurless climbing and prior to any construction.

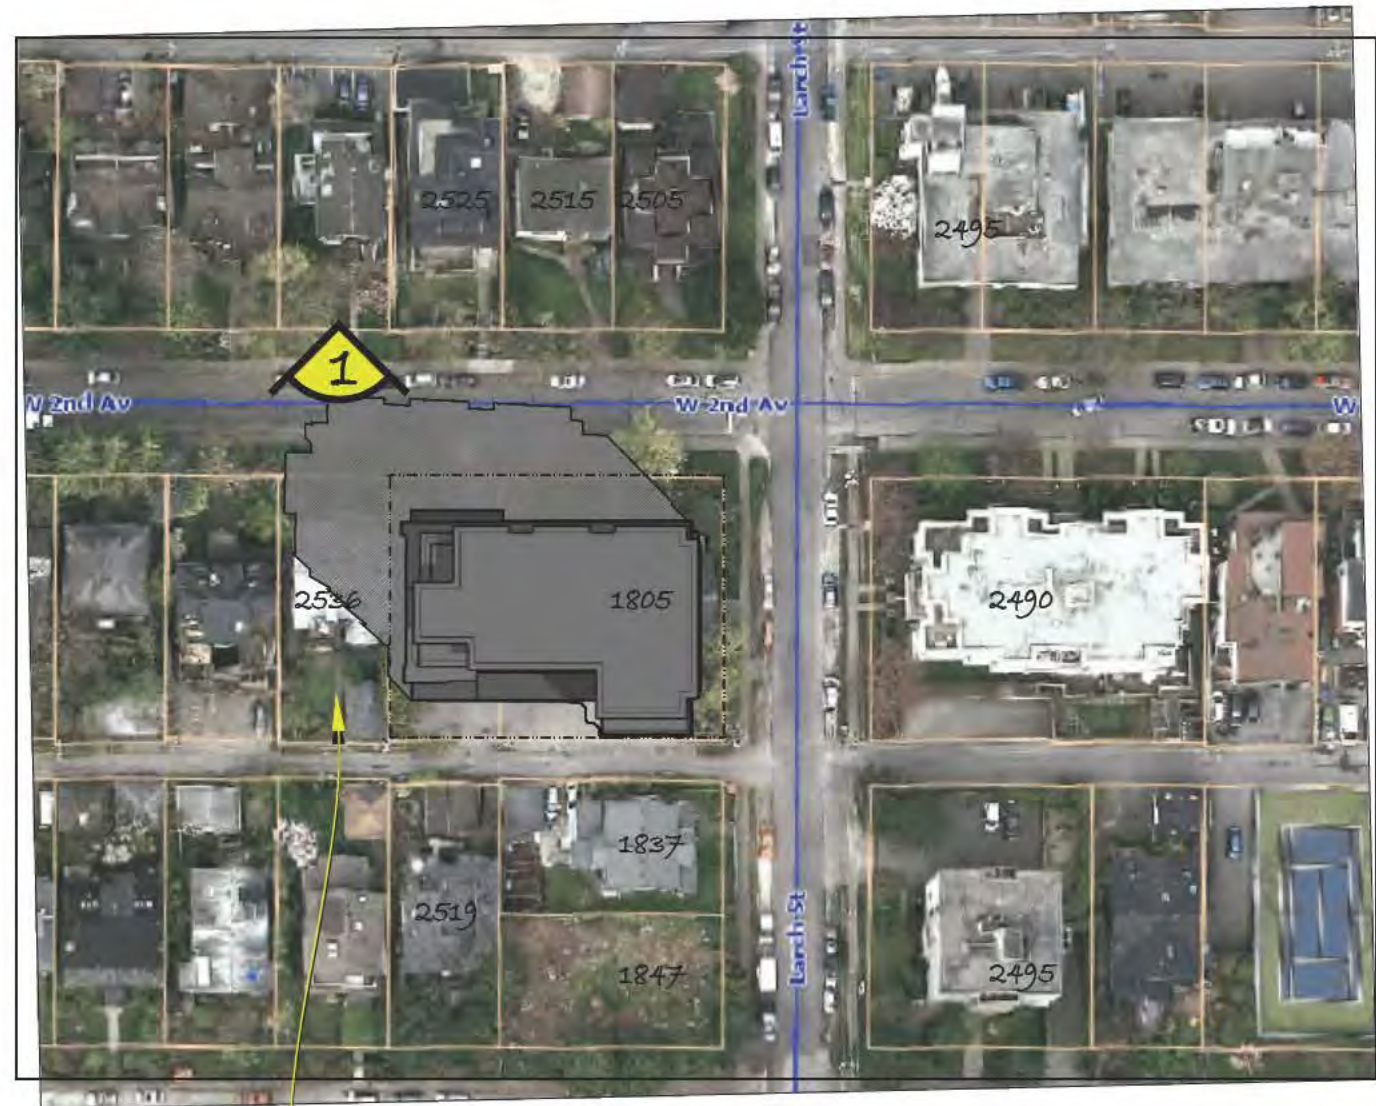
MARCH 21 @ 10 AM

NO SHADOW TO REAR YARD
OF 2536 W2ND AVE.

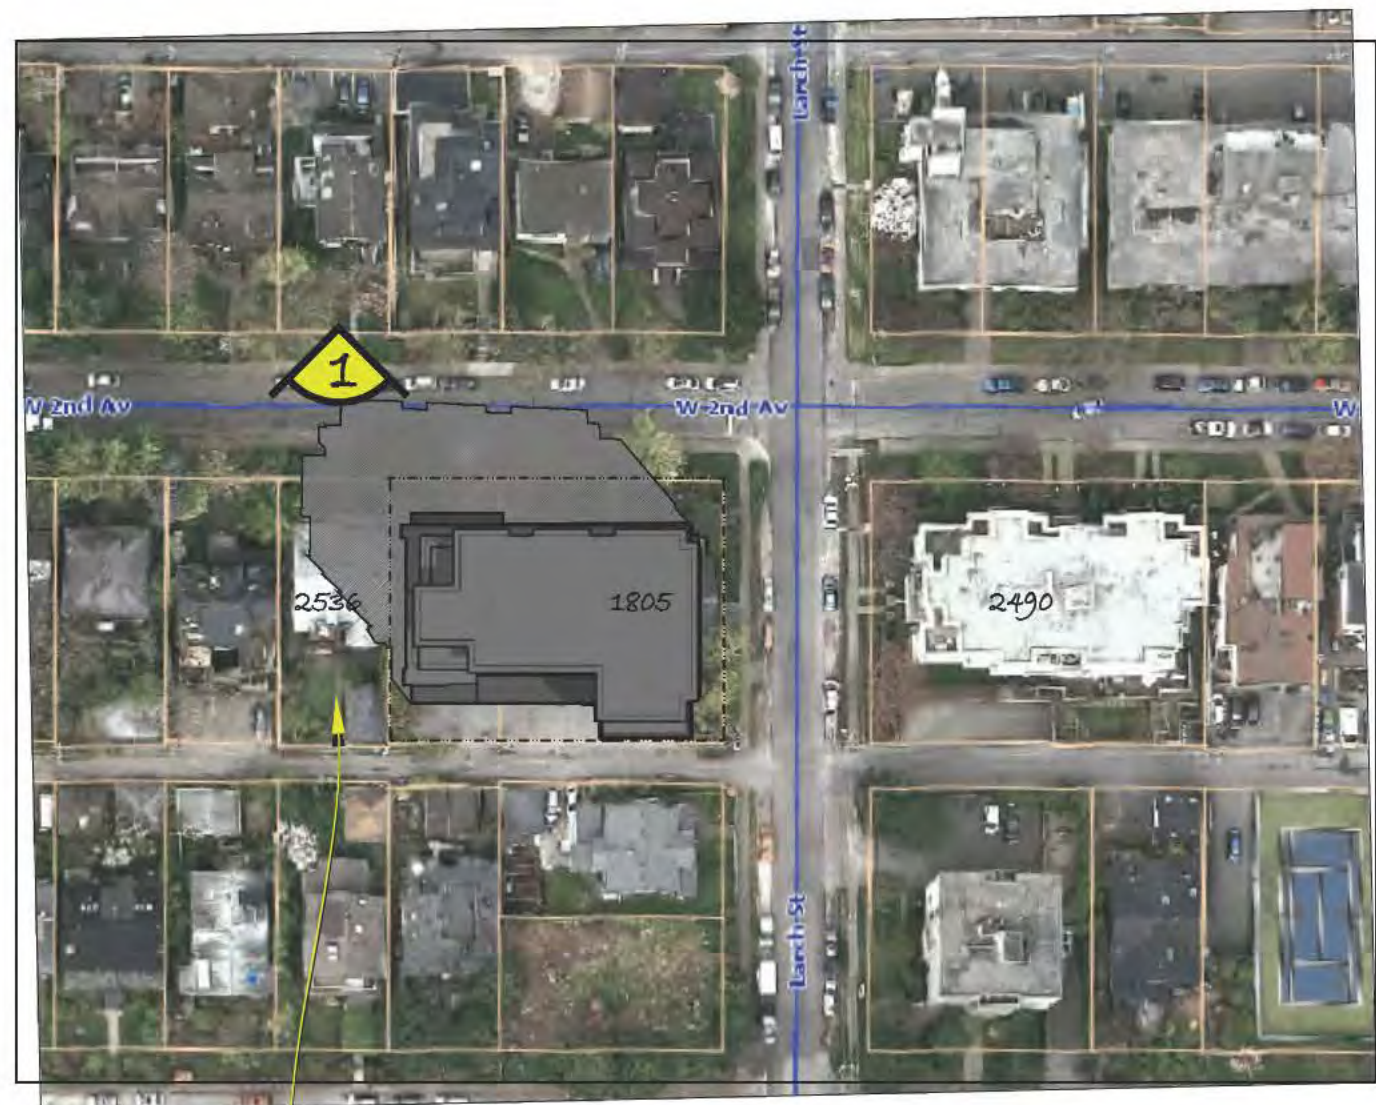
SEPTEMBER 21 @ 10 AM

NO SHADOW TO REAR YARD
OF 2536 W2ND AVE.

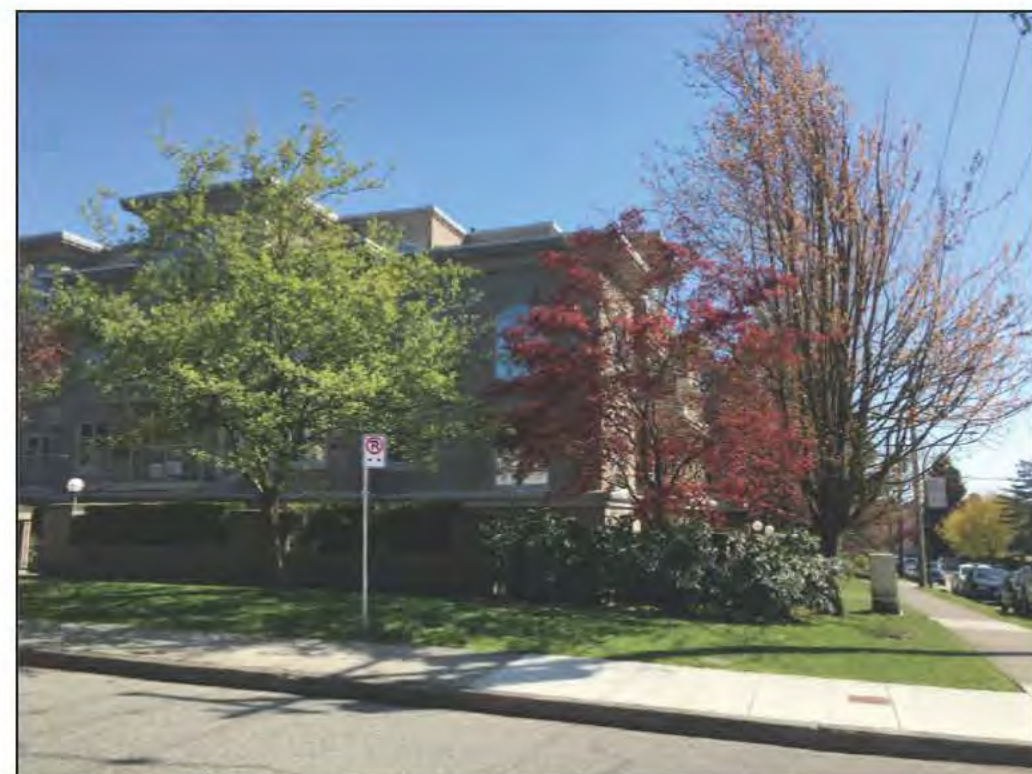
PHOTO 2

EXISTING CONDITION
Photo taken on April 23 @ 3:30 pm
approximates
MARCH 21 and SEPT 21 @ 4 pm
