REPORT ON CONTAMINATED SOIL REMEDIATION Undertaken by an independent operator

PROJECT ADDRESS: 1239 WEST 40TH AVENUE, VANCOUVER, BC

UNDERGROUND STORAGE TANK REMOVAL REPORT

1239 West 40th Avenue Vancouver, BC Fire Permit # FI 406736

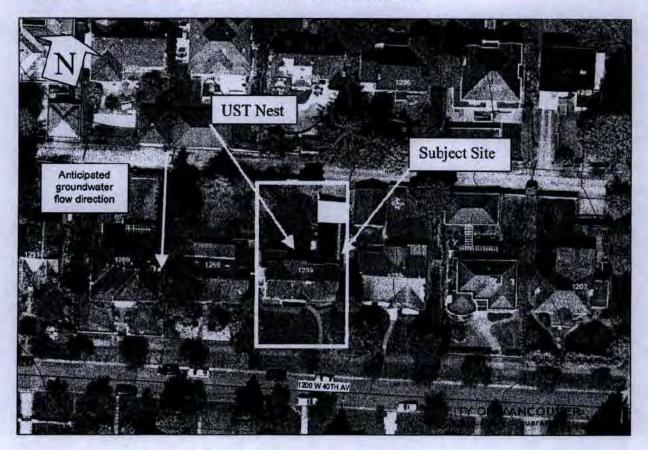
Figure 1 - Site Map

The property is rectangular in shape. A site plan is shown in Figure 1. The subject site lies on the North side of West 40th Avenue in Vancouver, BC.

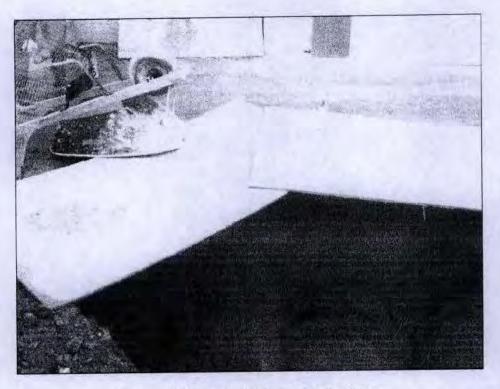
Soil analytical results indicated that the soils on the South and East walls of the UST nest have EPH levels still above the Ministry of Environment (MoE) Residential and "All Sites" Standards, however further excavation was not possible due to the proximity to the building's foundation.

Excavation's proximity to the building

A bioremediation strategy was followed by adding bacterial nutrient into the backfilled material at the level of the contamination.

Soils were investigated using visual, olfactory means, and chemical analysis. Sample results were compared to the BC Ministry of Environment (MoE) Residential and "All Sites" Standards. Soil samples were collected and analysed on site and confirmed that further hydrocarbon contamination exists on the South and East sides of the pit. The lateral movement of the contaminated soil is expected to be very limited. Soil contamination was left in place at the building's foundation, as its removal would compromise the structure's foundation.

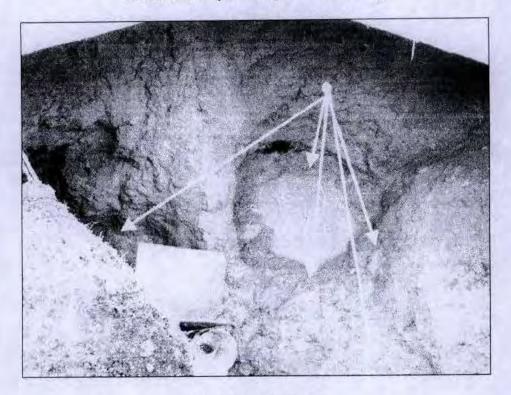
In total, five samples were taken by ALARA Environmental from within the tank nest to characterize soils. Samples were taken from the sides of the tank nest and the bottom of the pit. Approximately 2147 litres of oily water was pumped out of the UST's interior and nest area. The tank was described as being a single walled cylindrical ductile iron vessel having a diameter of 48" and being 8 feet long.

Sampling locations
