2019 ANNUAL REPORT FOR THE VANCOUVER LANDFILL

BC MINISTRY OF ENVIRONMENT AND CLIMATE
CHANGE STRATEGY

CITY OF VANCOUVER
Engineering Services
Transfer and Landfill Operations
320 - 507 West Broadway
Vancouver, BC
V5Z 0B4

March 31, 2020
Version: Final

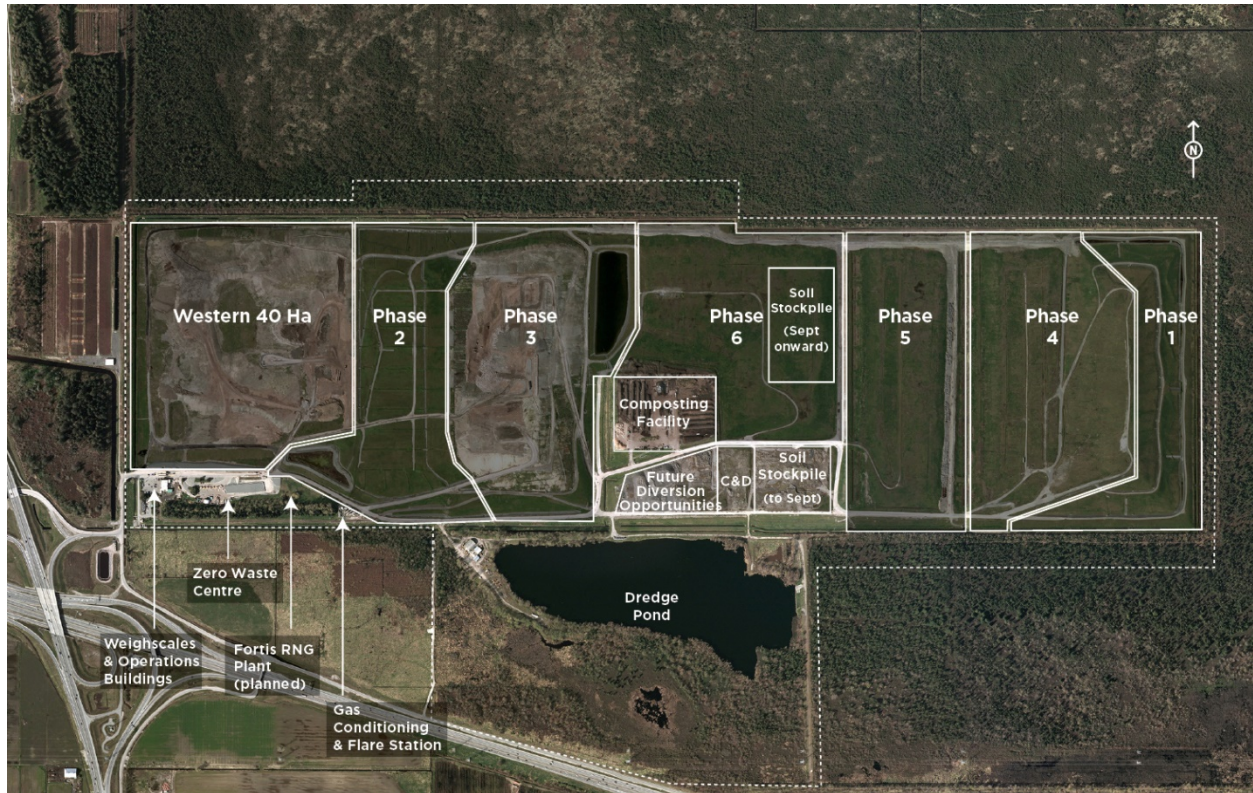
Figure 2: 2019 Vancouver Landfill Site Plan

The locations of the Landfill phases and operations areas are shown in the site plan in Figure 2.

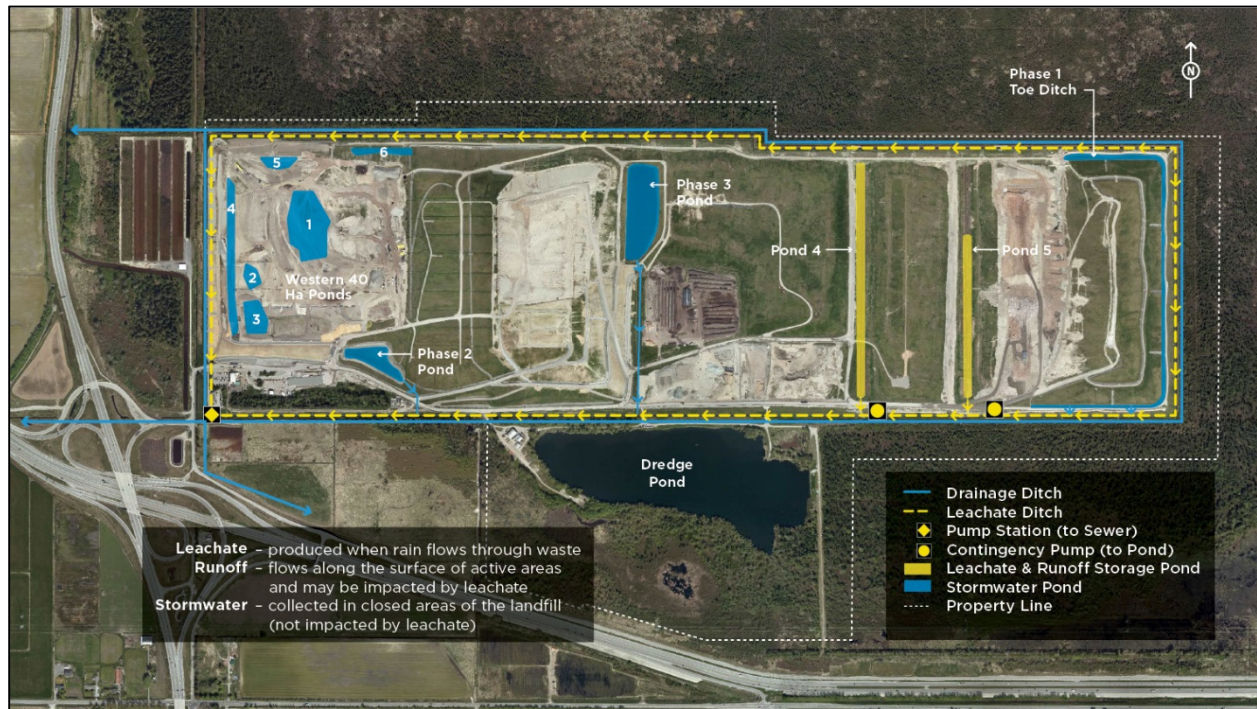
Figure 5: Leachate, Surface Runoff and Stormwater Management

In addition to leachate, surface runoff and stormwater from closed areas are routed to the inner ditch. To reduce peak discharge to the sewer system, approximately 103,000 m³ of leachate and surface runoff retention capacity was created at the end of 2013 through the expansion of two internal storage ponds running south to north between the Compost Facility and Phase 1. The Phase 2 and Phase 3 closure areas each have a dedicated pond for stormwater retention, which had a combined capacity of 100,000 m³ at the time of installation. Six ponds for clean stormwater were constructed in the Western 40 Hectares closure area in 2018 that have a combined storage capacity of approximately 87,700 m³. An additional detention pond will be constructed in 2020 as part of the Phase 4 Closure and Landfill Gas Upgrades Project.

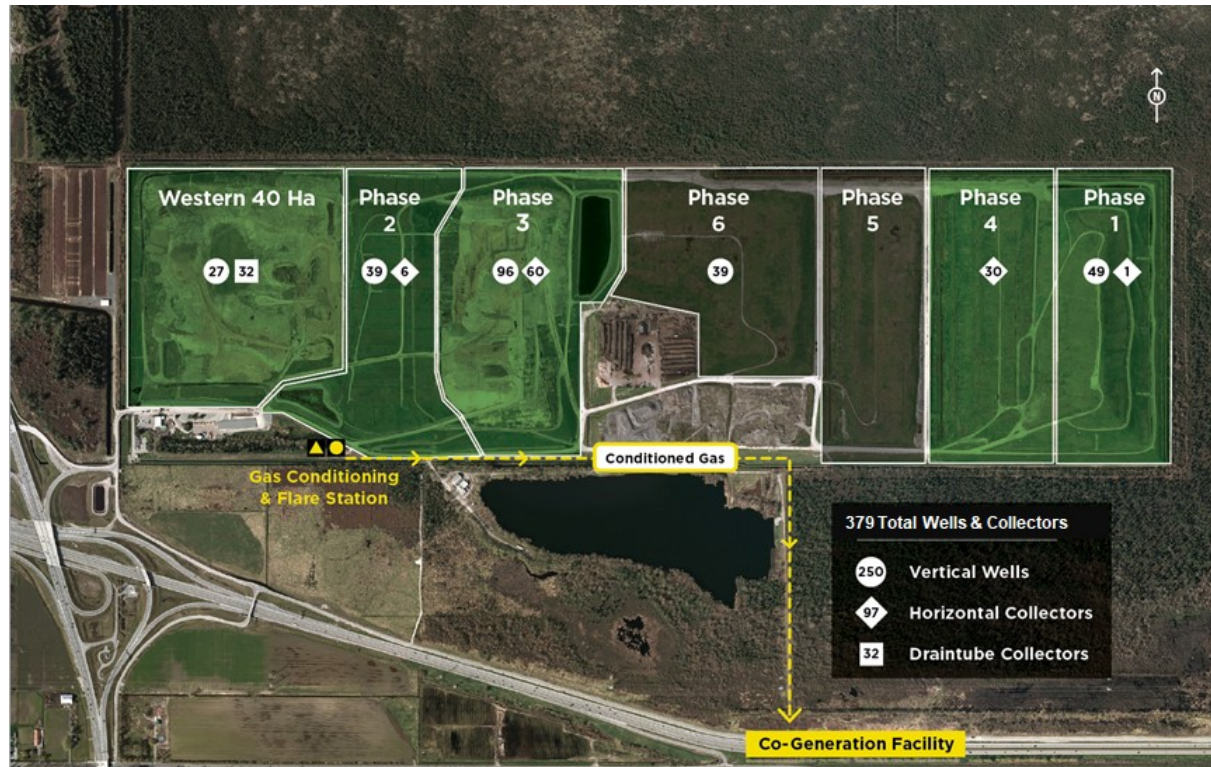
Figure 9: 2019 Landfill Gas Collection System

³ DRAINTUBE is a geocomposite mat consisting of small diameter plastic pipes (<25mm in diameter) between layers of geocomposite material that is used for collecting landfill gas under the geomembrane cover.

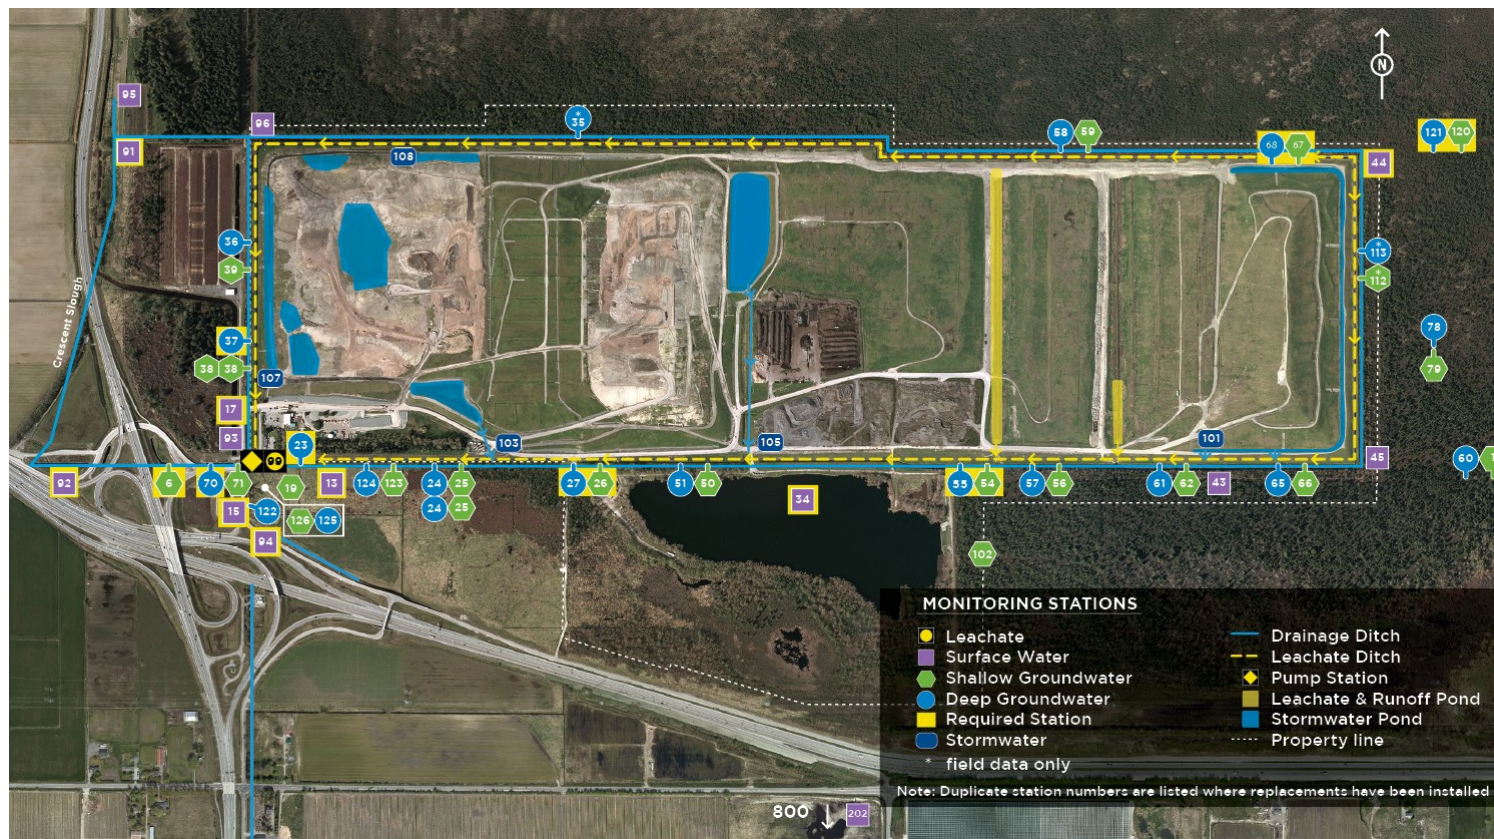
Appendix 3: 2019 Water Quality Monitoring Location Plan

- Routine monitoring at Stations 101, 103, 105, 107 and 108 and 202 started in Q4 2019 as part of the stormwater monitoring program.
- Station 19 was removed from the monitoring program in Q4 2019 (replaced by station 126).
- Duplicate stations 24, 25, and 38 were installed in Q4 2019 and the originals decommissioned.
- Stations 56, 57, 61 and 62 were added to the monitoring program in Q4 2019.
- Required station 27-2013 was damaged in Q4 2019 and was not sampled. A replacement will be installed in early 2020.
- Station 71 is not an OC compliance location and was last sampled in 2014.
