# 2020 ANNUAL REPORT FOR THE VANCOUVER LANDFILL

BC MINISTRY OF ENVIRONMENT AND CLIMATE CHANGE STRATEGY

CITY OF VANCOUVER Engineering Services Transfer and Landfill Operations 320 - 507 West Broadway Vancouver, BC V5Z 0B4

March 31, 2021 Version: Final

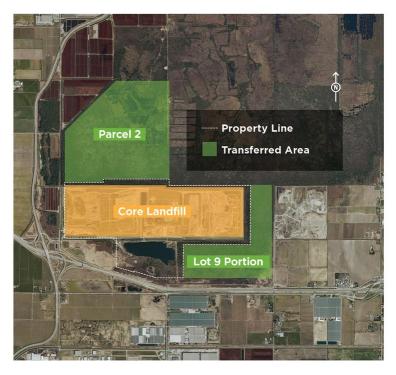
Figure 1: 2020 Vancouver Landfill Property and Footprint

The Landfill property is 320 hectares in size, which contains the footprint (area filled with garbage) at 225 hectares and a 16.7 hectare (ha) pond historically used for dredging cover material. Approximately 320 ha of undeveloped land that were part of the original Landfill property were transferred back to Delta as shown in Figure 1. The site plan for the Landfill property is shown in Figure 2.

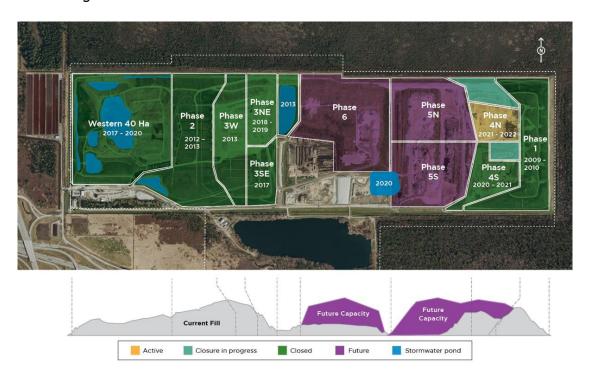
Figure 3: 2020 Landfill Fill and Progressive Closure Plan

Plan and profile views of the engineered fill plan, including projected phase closure dates, are shown in Figure 3.

A full time GPS Technician and one of the Landfill Engineers work closely with Superintendents and Operations staff in the active areas to ensure filling proceeds according to the intent of the engineered fill plan for each lift and phase.

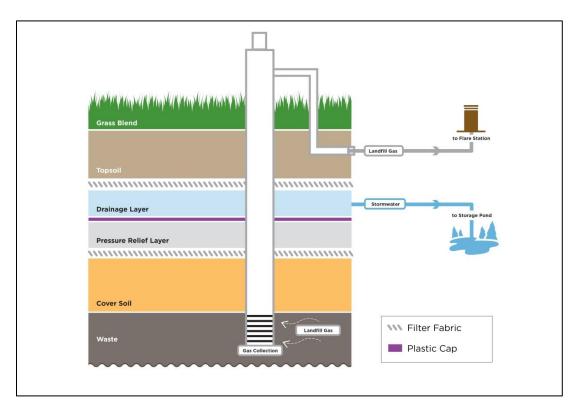
Figure 7: Final Cover System Cross-Section

- Progressive closure of completed phases, with an impermeable geomembrane cover system installed to minimize infiltration and leachate generation. Hydroseeding reduces erosion and increases evapotranspiration. See Figure 7 for the cross-section of the typical final cover system.
- Dedicated linear ponds for leachate and surface runoff to control flows to the leachate pump station as well as stormwater retention ponds to reduce flows from closed areas to the pump station or Dredge Pond during significant precipitation events. See Figure 5 for pond locations.
- Use of daily and intermediate cover at the active face and keeping the active face as small as possible to minimize infiltration from precipitation.
- Erosion control measures on side slopes, such as swales and downchutes, to convey water to internal ditches.

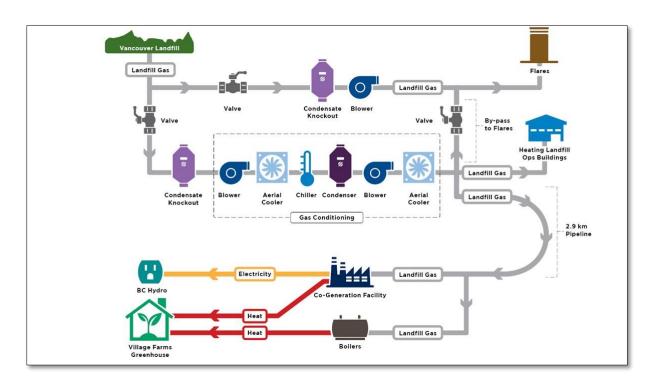
Figure 8: Landfill Gas Collection & Beneficial Use System

The City of Vancouver has operated an active landfill gas collection and flare system since 1991. The system was initially installed to control odour and had the added benefit of reducing greenhouse gas emissions. In December 2002, the City entered into a 20-year agreement with Maxim Power (Maxim) for LFG utilization and the following year Maxim commissioned a gas conditioning facility at the Landfill. In 2014, Maxim sold their conditioning equipment (located at the Landfill Gas Flare Station) and co-generation facility (located off site) to Village Farms International, owner and operator of the greenhouse site that hosts the co-generation facility. Village Farms also uses conditioned LFG as a natural gas replacement fuel in two of their six direct-fired boilers. A small portion of the gas is directed to the Landfill Administration and Engineering Buildings (Ops Buildings) where it is used to provide space heat.

An overview of the LFG management system is shown in Figure 8, with the distribution of the vertical gas wells, horizontal collectors and Draintube<sup>3</sup> collectors across the Landfill footprint shown in Figure 9.

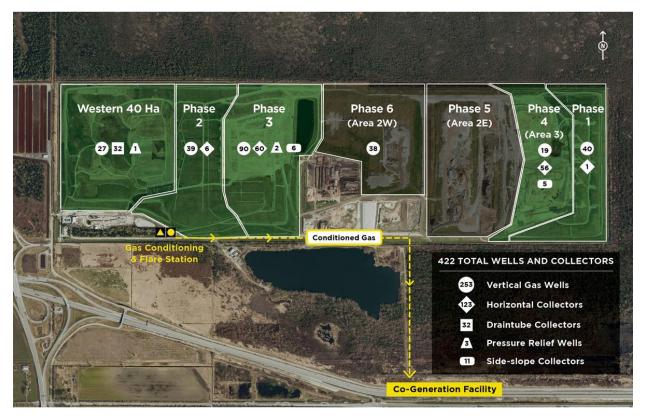
Figure 9: 2020 Landfill Gas Collection System

<sup>&</sup>lt;sup>3</sup> Draintube is a geocomposite mat consisting of small diameter plastic pipes (<25mm in diameter) between layers of geocomposite material that is used for collecting landfill gas under the geomembrane cover.

Vertical gas wells were drilled as part of Phase 4S closure, horizontal collectors were installed as filling progressed in Phase 4S and 4N, side-slope collectors were installed in Phase 4N and replacement (re-drilled) vertical gas wells were installed in Phases 1, 2 and 3.

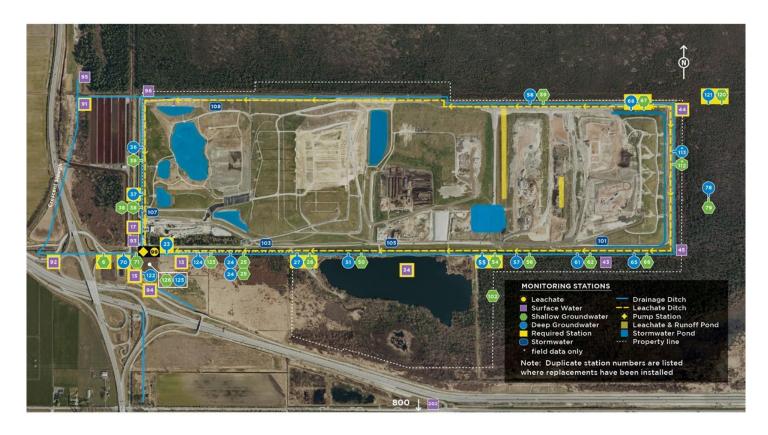
Appendix 3: 2020 Water Quality Monitoring Location Plan

- Routine monitoring at Stations 101, 103, 105, 107, 108 and 202 continued in 2020 as part of the stormwater monitoring program.
- Required station 27-2013 was damaged in Q4 2019 and replaced in 2020 with 27-2020.
- Station 71 is not an OC compliance location and was last sampled in 2014.
