Re: **Request for Access to Records under the Freedom of Information and Protection of Privacy Act (the "Act")**

All records relating to steps the City of Vancouver took when it determined that the crosswalk located at the intersection West 11th Avenue and Hemlock Street did not pose a danger to pedestrians and its decision not to install warning lights at the crosswalk or carry out further investigations about installing warning lights. Date Range: January 1, 2019 to July 27, 2019.

PEDESTRIAN SIGNAL WARRANT

LOCATION:HEMLOCK ST & W 11TH AV

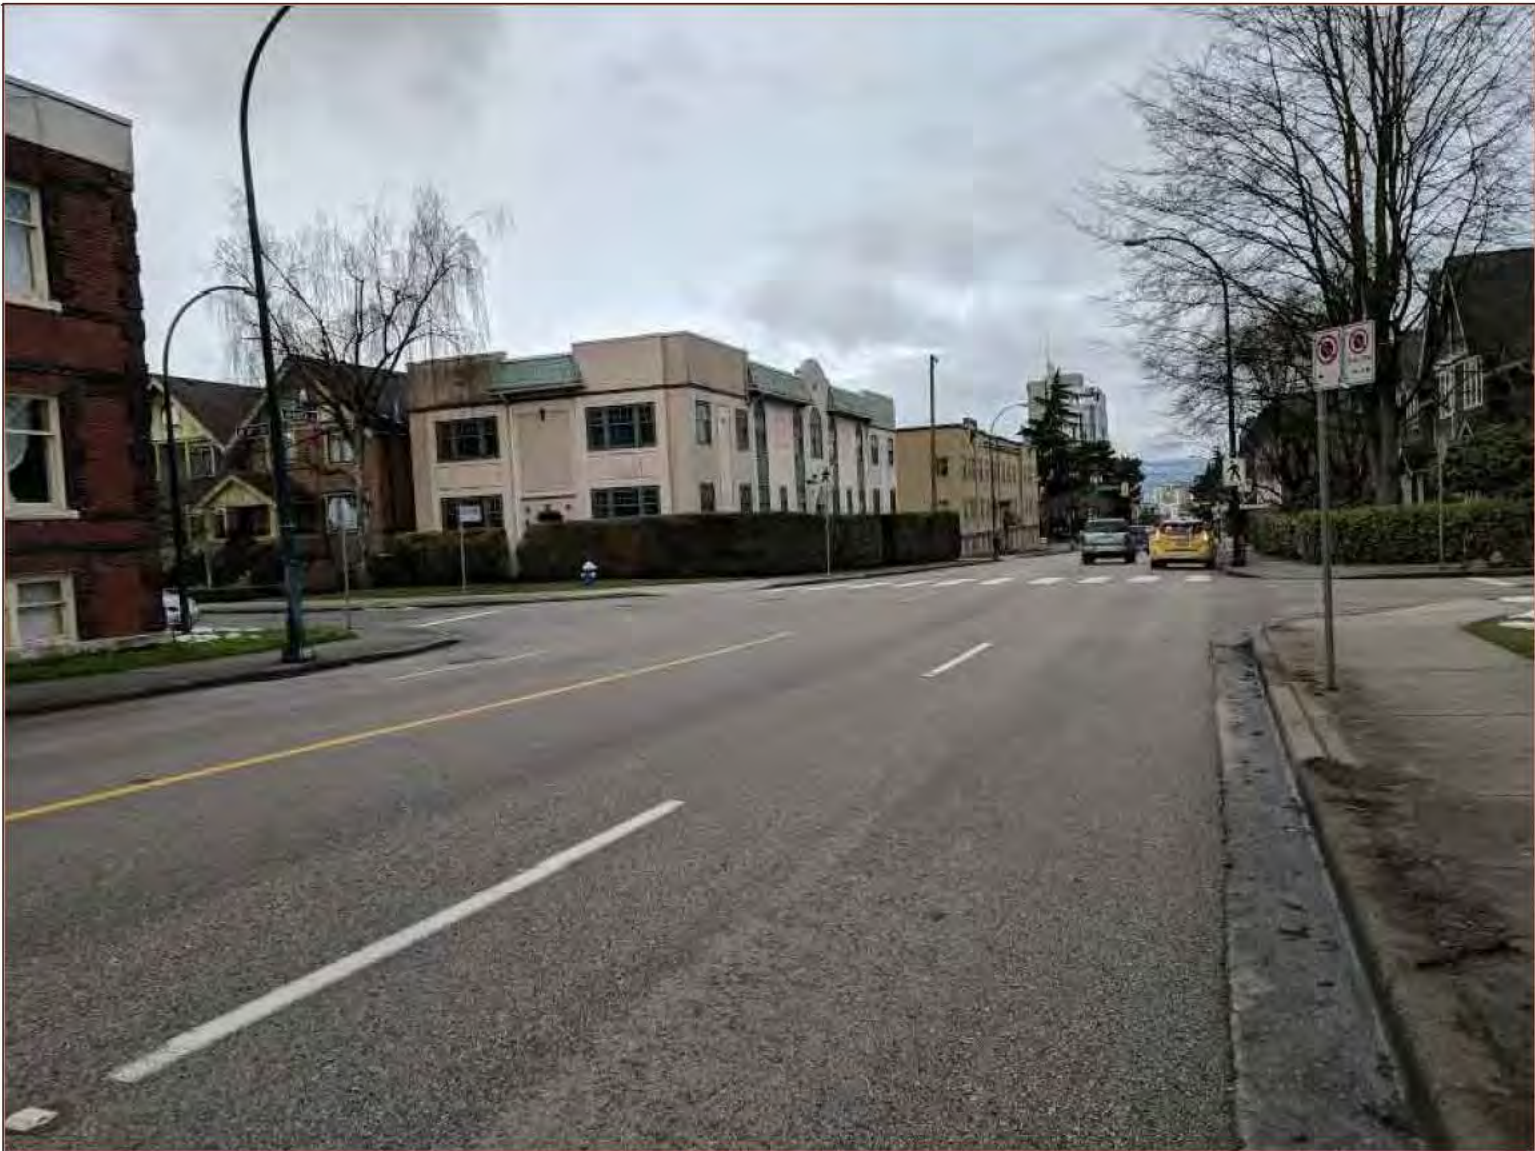
NORTHBOUND

Pedestrian Study with no Radar Gap Gun	
Location: HEMLOCK ST & W 11TH AV	
Date: 2/27/2018	
Time: 1600-1730	Observer: MP

North								
Pedestrians				Cyclists Riding			Cyclists Walking Bikes	Bus
Seniors	Adults	Disabled	Children	Adult Cyclists	Senior Cyclists	Children Cyclists		
30	19							
60	14							
90	20

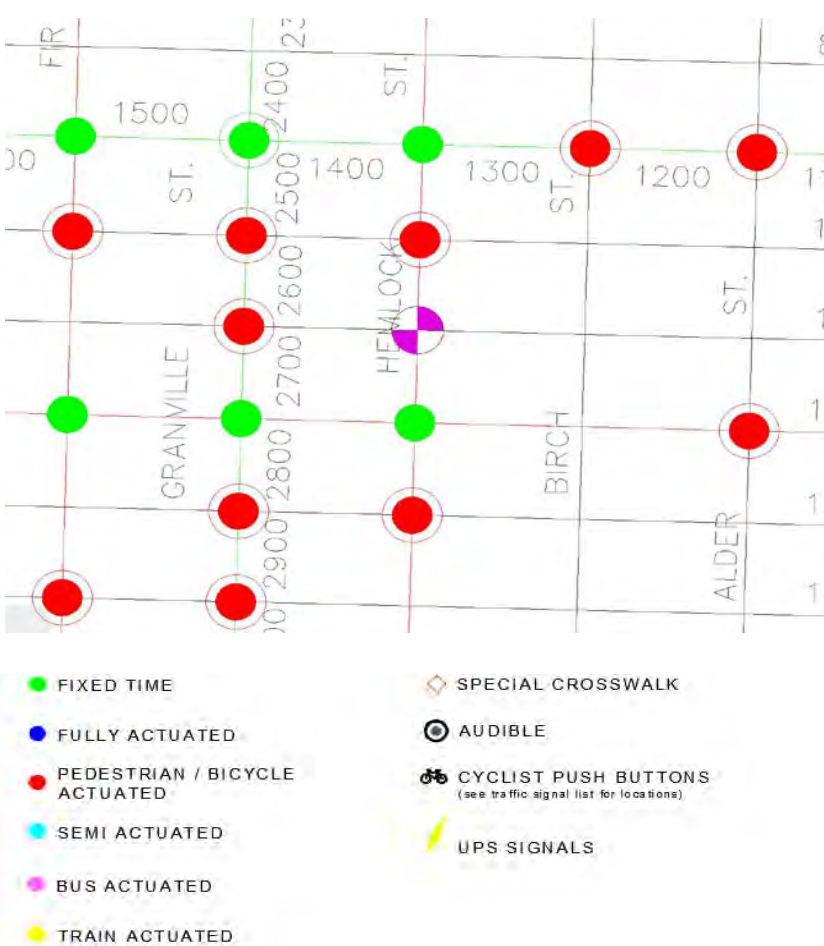
ADJACENT SIGNAL MAP

S U M M A R Y		
Pedestrian Total		63
Cyclist Total		0
Number of Crossings		63
Number of Adequate Gaps		120
COV Signal Warrant		Ip= N/A
		Ip(with EAUs)= N/A
		Ix= N/A
Signal Warranted?		N/A
TAC Warrant		ADT 18000
		No. lanes per direction 2
		Speed limit (km/hr) 50
Recomended Treatment		
Overhead Flashing Beacon Systems (special crosswalk)		
BC PCCM Warrant		
Crossing opportunities per hour		80
EAUs per hour		44
Recommended Treatment		
Special Crosswalk		
Crossing Difficulty Index		N/A
P Max		N/A
X Max		N/A
T Max		N/A
6 yr Ped Int. Accidents		1
6 yr Cyclist Int Accident		0
6 yr Vehicle Int Accident		26
	YES	NO
School(s) Nearby		X
Signal(s) Nearby	X	
Marked Crosswalk	X

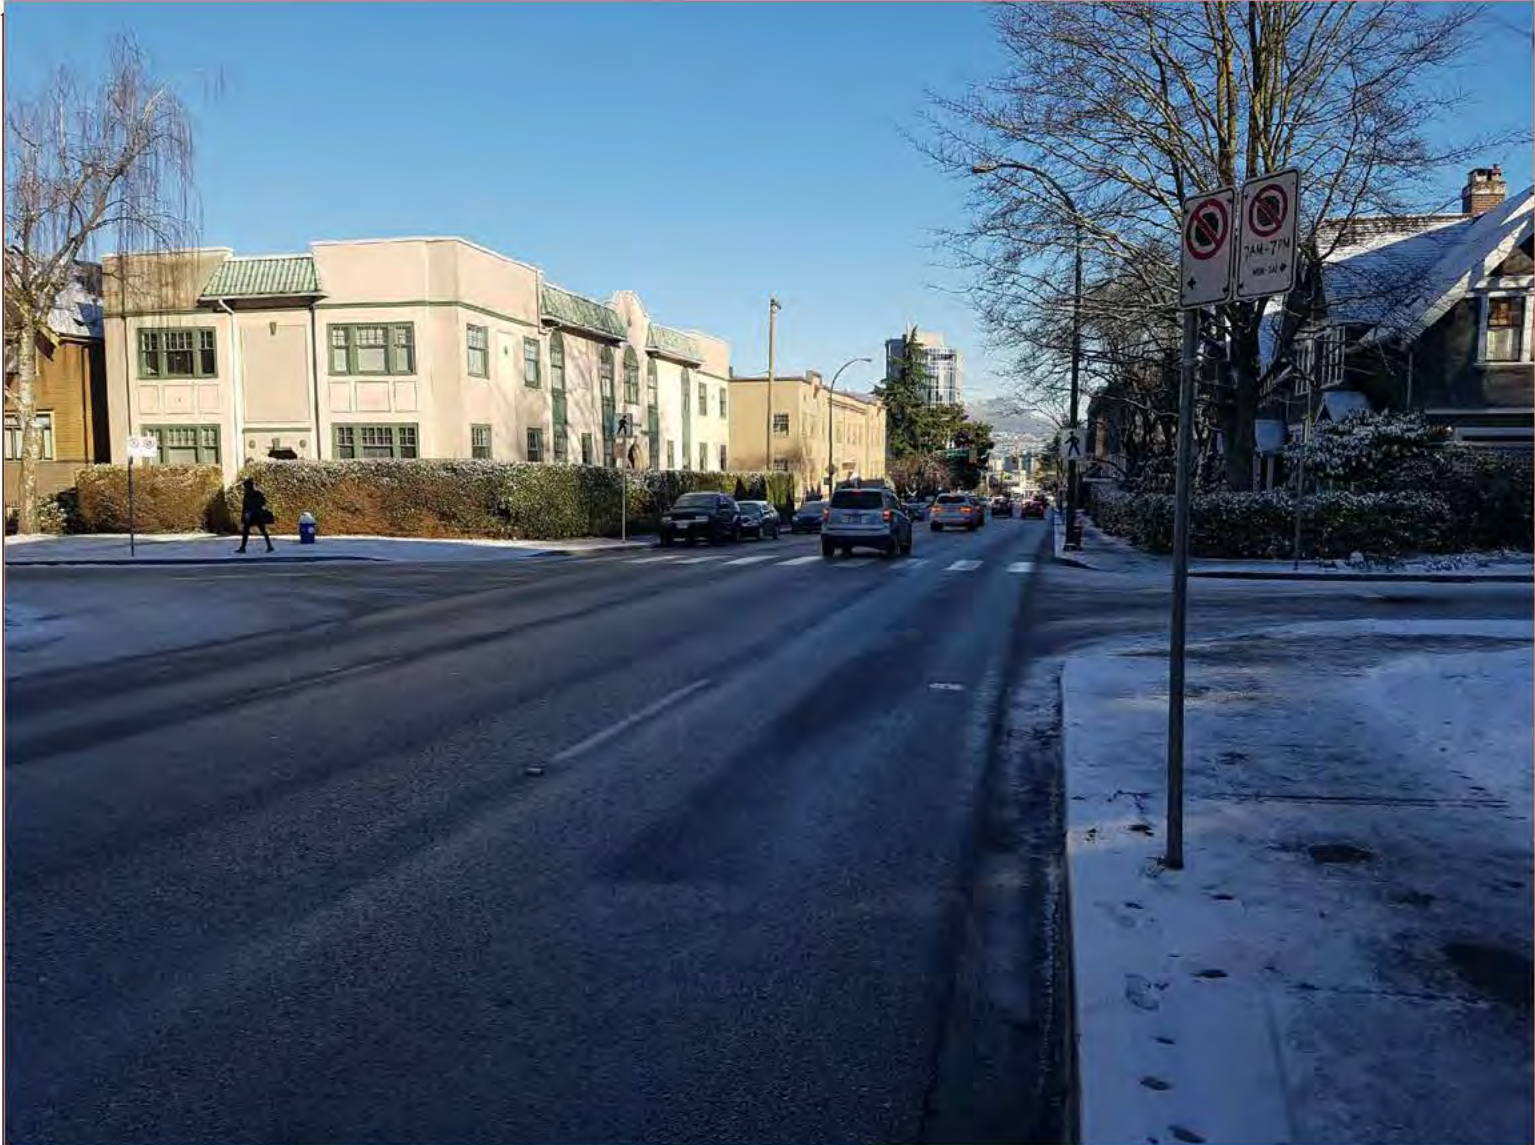
NORTHBOUND

Pedestrian Study with no Radar Gap Gun	
Location: Hemlock St & W 11th Av	
Date: 2018-02-22	
Time: 7:30am - 9:00am	Observer: Jay Prieur

North								
Pedestrians				Cyclists Riding			Cyclists Walking Bikes	Bus
Seniors	Adults	Disabled	Children	Adult Cyclists	Senior Cyclists	Children Cyclists		
	56		3

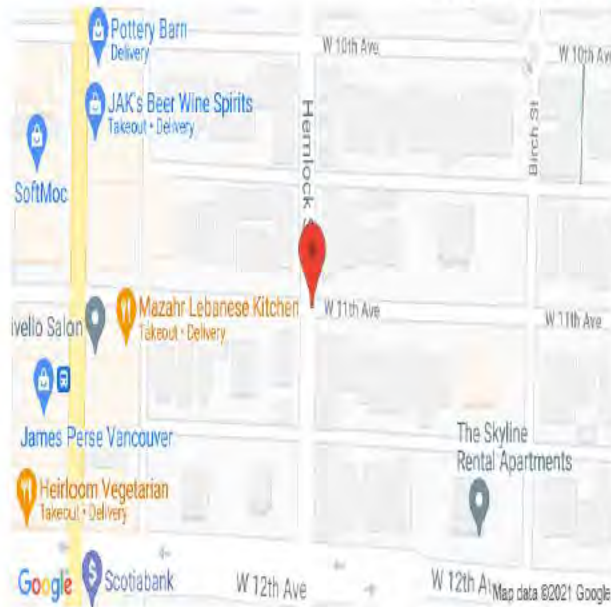
PS Description: There is an existing pedestrian crossing at the intersection of Hemlock and 11th Avenue. I use this 4 times a day and each time have difficulty crossing as cars speed by without stopping. Often one car stops and the second one speeds by. Having a visual signal, I believe, would greatly increase the safety of pedestrians at this intersection.

A pedestrian study had recently been completed at this location. The study included a field visit to the site to determine the number of pedestrians/cyclists crossing by age, number of adequate gaps in traffic to cross safely, driver courtesy observations, nearest alternative pedestrian/cycling crossings, speed limit, traffic volumes, among others. Additionally, as part of the study we reviewed safety statistics (ICBC claims data, VPD traffic related fatality data & VCH injury data from hospitals) and assessed flashing beacons/pedestrian

signal warrants to determine the need for a crossing upgrade. Since the city receives hundreds of requests per year, it is necessary for us to follow the warrants and rank the results. The program only receives enough budget for 3 pedestrian signals a year and unfortunately, Hemlock St & W 11th Ave did not rank higher than other intersections in the city for a pedestrian signal. Thus, the City cannot install a pedestrian activated signal at this location at this time. With that being said, the City will continue to keep the record in our database. In the meantime, if dangerous driving or speeding is observed, citizen is encouraged to call the non-emergency VPD number at 604-717-3321 and request traffic enforcement.
