Re: **Request for Access to Records under the Freedom of Information and Protection of Privacy Act (the "Act")**

Project Name	SMT-5000 Salvage	Project Number	3-22-527
Owner	Sentry Marine Towing Ltd.	Status Report Date	Friday, April 15, 2022
Project Manager	Ian Purvis	Project Director / Sponsor	Jesse Percy
Superintendent / GF	TBD	Project Engineer	N/A

HAZARDOUS MATERIALS SURVEY REPORT

SMT-5000 BARGE SALVAGE MARINE HABITAT ASSESSMENT REPORT

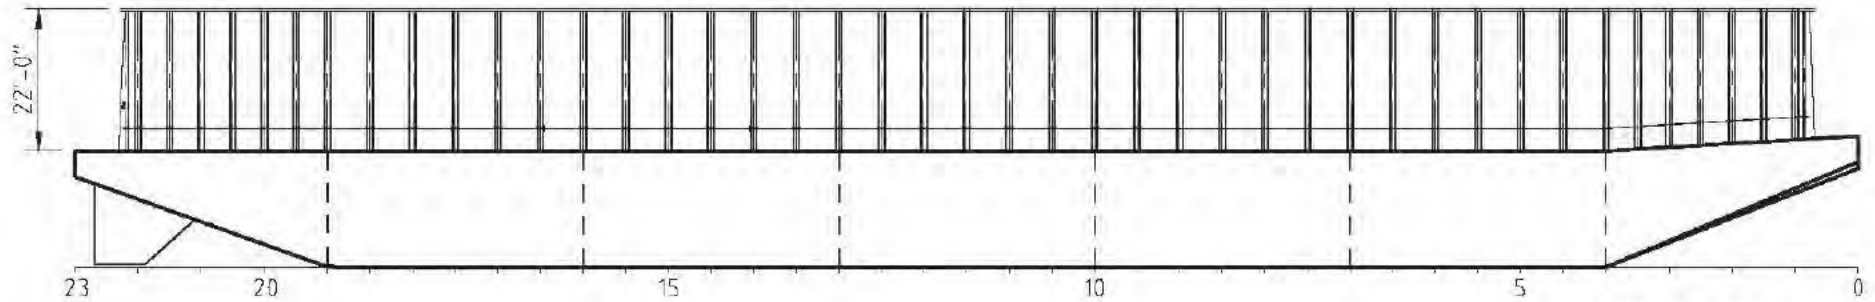
PROFILE VIEW

VESSEL DESCRIPTION	
VESSEL TYPE	Chip Barge
SERVICE	Columbia/Snake River, Coastwise
CARGO TYPE	Chips
CALL SIGN	N/A
HAIL PORT	Portland, OR
OLD NAMES	Foss 275
DATE BUILT	Feb 1968
REBUILT	1987
BUILDER	Zidell Explorations, Inc., Portland, OR

DIMENSIONS	
REG. GT.	2,406
REG. NT.	2,406
ITC GR TONS	
ITC NT TONS	
REGULAT. GT	
REGULAT. NT	
DRAFT MIN	3.7'
DRAFT MAX	11.5'
REG. LENGTH	276'
REG. BREADTH	60'
REG. DEPTH	17'
LOA	276'
MAX BREADTH	
MAX HEIGHT	
DISPLACEMENT	5,140 ST
DIEADWEIGHT	3,770 ST

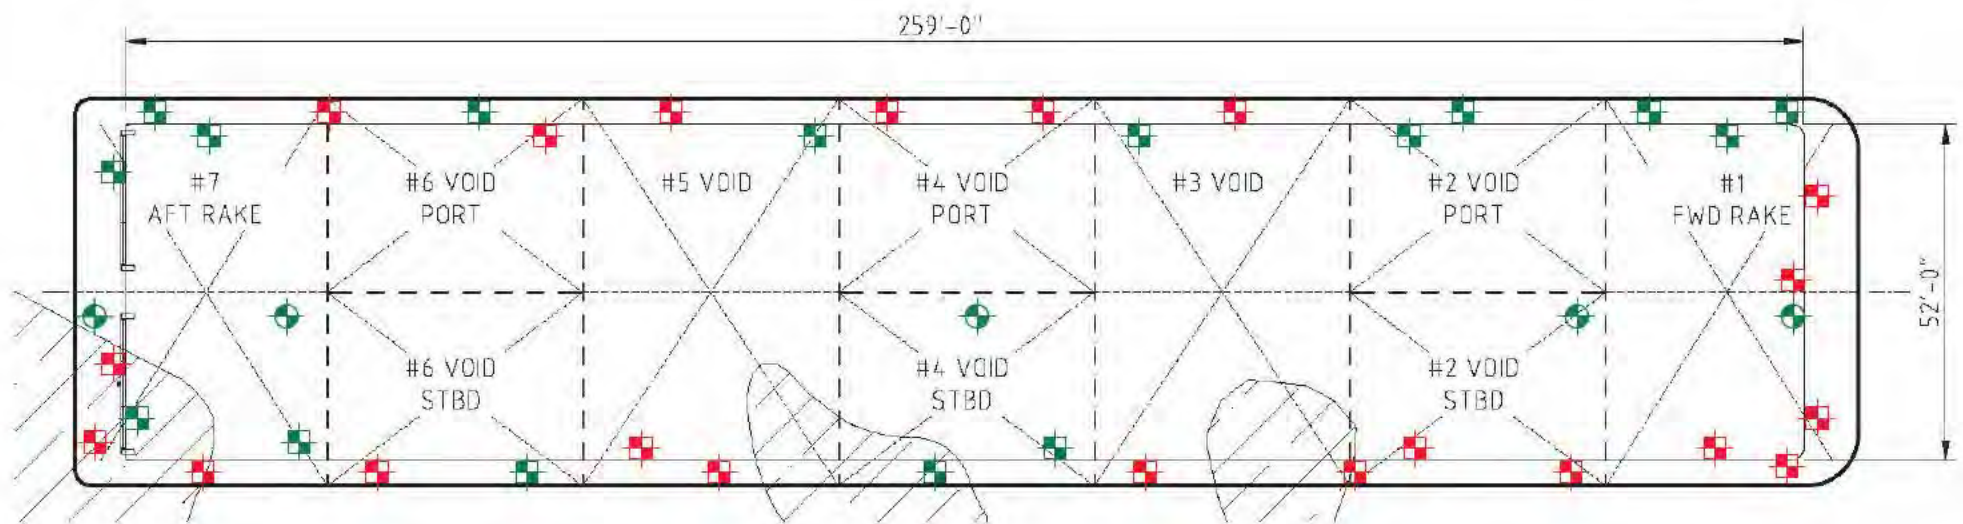
Nanaimo, B. C. Canada	
TITLE BARGE STM5000 (ENGLISH BAY STRANDING)			
PROJECT NO. 1230.2	DWG NO 1230.2 -1	DATE 2022-02-11	REV 0
SCALE NTS	DRAWN WPJ	SHEET 1 OF 1

ASBESTOS SAMPLE POSITIVE		LEAD SAMPLE POSITIVE
	ASBESTOS SAMPLE NEGATIVE		LEAD SAMPLE NEGATIVE

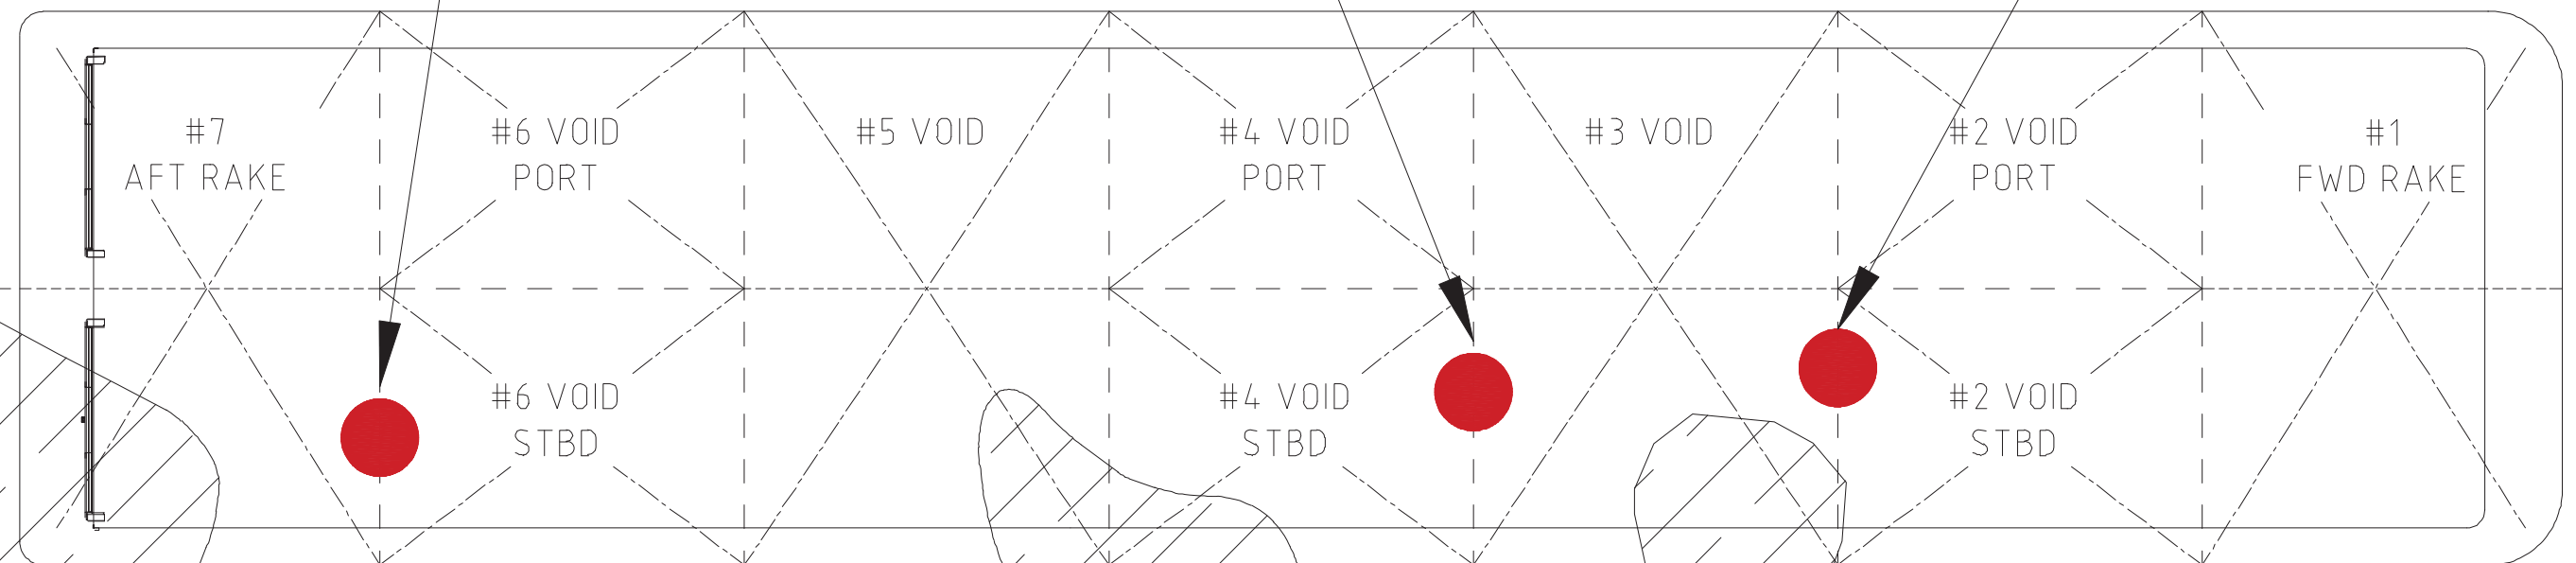
STARBOARD #4:
HOLED ON BULKHEAD
AND BOTTOM AT #8-10
BL.

STARBOARD #3:
HOLED ON BULKHEAD
AND BOTTOM AT #11-12
BL.AND BOTTOM PLATE

SMT-5000	
VOID #1 COMMON	WATER FROM STARBOARD #7 BL TO PORT SIDE SHELL 6'
VOID #2 PORT	6-8' AT MANHOLE, NOT ENTERED
VOID #2 STBD.	WATER FROM STARBOARD #7 BL TO PORT SIDE SHELL 6'
VOID #3 COMMON	SIGHTED FROM PORT SIDE 8-10' WATER
VOID #4 PORT	6-8' AT MANHOLE, NOT ENTERED
VOID #4 STBD	WATERTIGHT BULKHEAD WATER INGRESS AT #8 BL, 8' WATER AT CL BULKHEAD
VOID #5 COMMON	SIGHTED FROM PORT SIDE 8-10' WATER
VOID #6 PORT	6-8' AT MANHOLE, NOT ENTERED
VOID #6 STBD	WATER ENTERING AT AFT BULKHEAD AT #5-6 BL
VOID #7 COMMON	WATER ENTERING AT AFT BULKHEAD AT #5-6 BL

NOTES:
VOIDS TO BE CONFIRMED AREAS WHEN WATER REMOVED
SURVEY OF BOTTOM CONDUCTED OUTBOARD OF SMT-5000
VANPILE DERRICK ON-SITE WEDNESDAY, PORT OUTBOARD.

Exterior and accessible internal areas were visually inspected. At the time of our inspection the ship was stranded off Vanier Park (English Bay) in North Vancouver, and in poor condition, with the hull reported as breached in at least three areas. The underwater hull and internal voids were not accessible and not inspected. The above waterline hull, deck and bulwarks were inspected and sampled. As such, our inspection can be characterized as 'semi-intrusive' in nature.

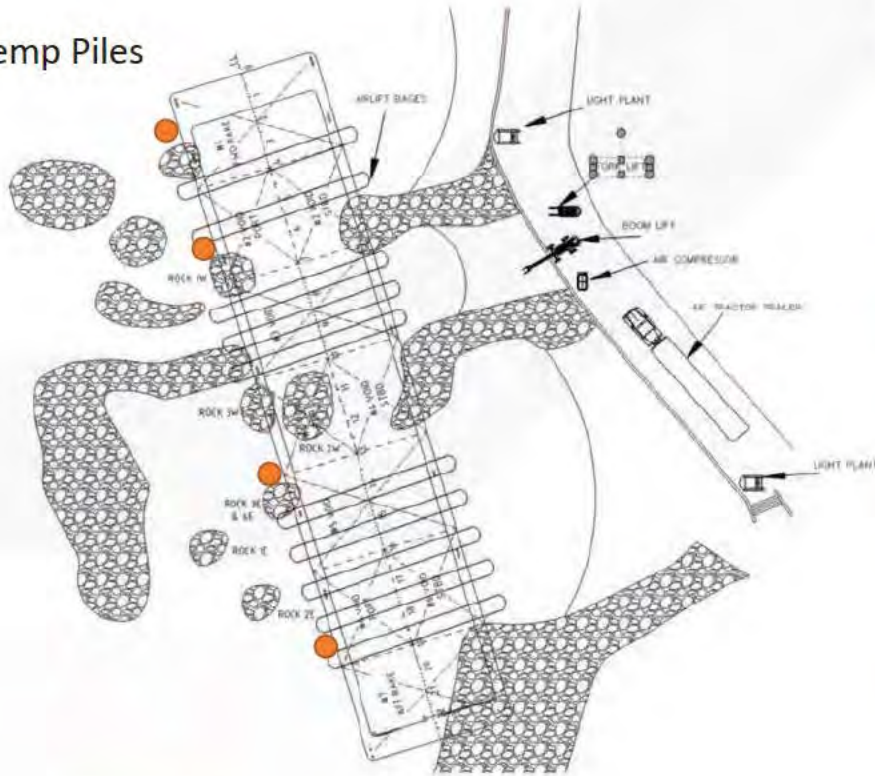
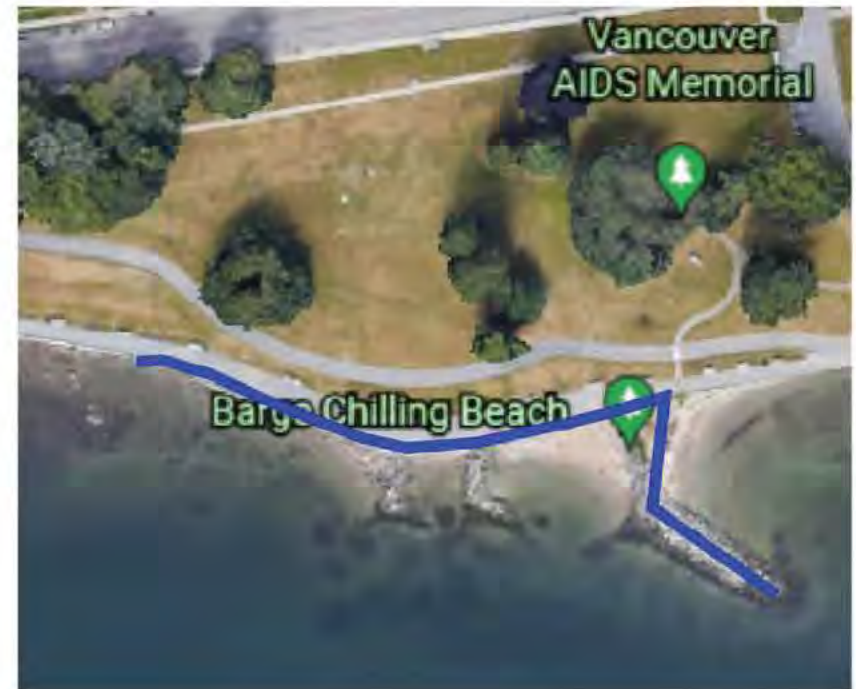
Install Temp Piles

- Install Temporary Piles
- Install cribbing under front rake
- Install airbags to level barge (TBD)
- Remove wood chips & debris from Deck
- Use Excavator with Shear to remove bin walls to 4' above deck to provide safety railing.
- Load bin walls onto support barge for transport

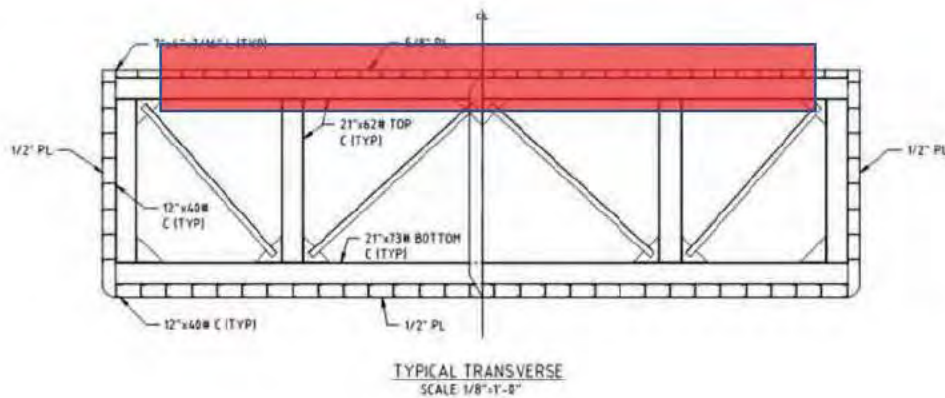
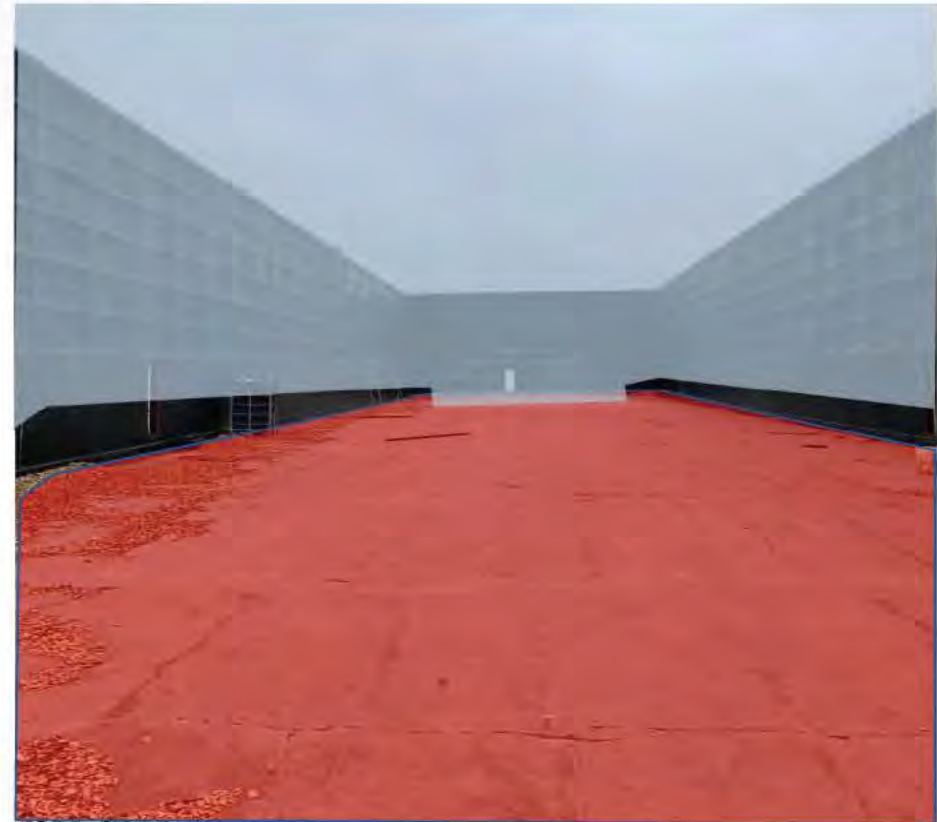
REMOVING FORWARD & AFT RAKES

- Install cribbing under forward rake
- Remove Forward and Aft Rakes in 4 or 8 pieces (TBC by Lift Calculations)
- Load Large Sections onto barge for transport

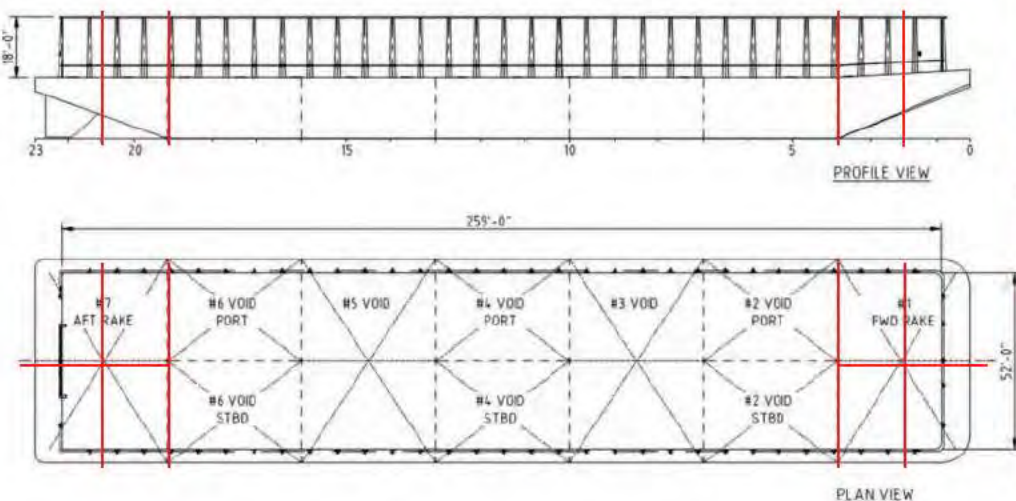
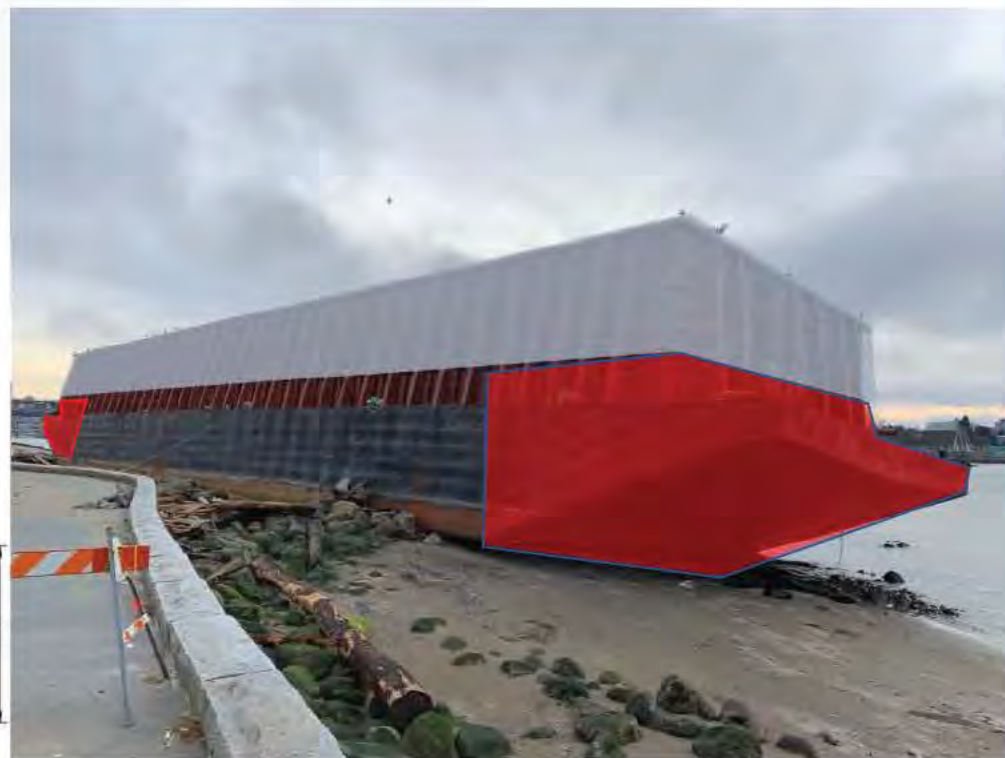
REMOVING PILLARS & SHELL WALLS

Staging TBC through lift analysis

- Remove Starboard Shell Wall, Pillars & Bracing
- Remove Port Shell Wall & Bracing

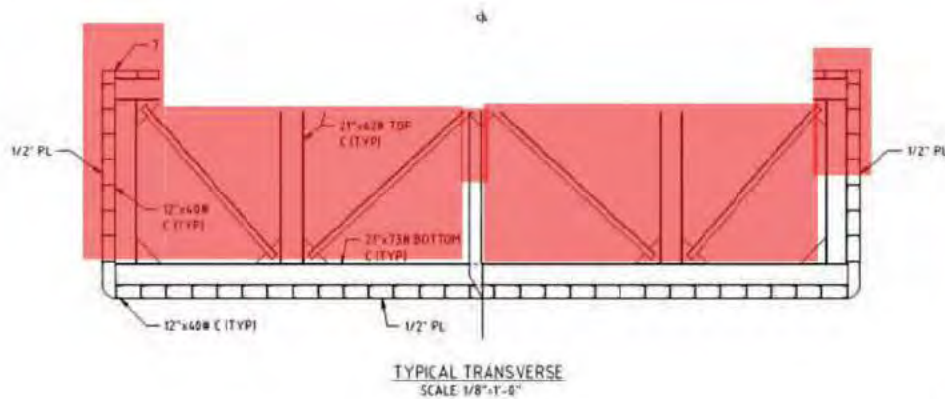
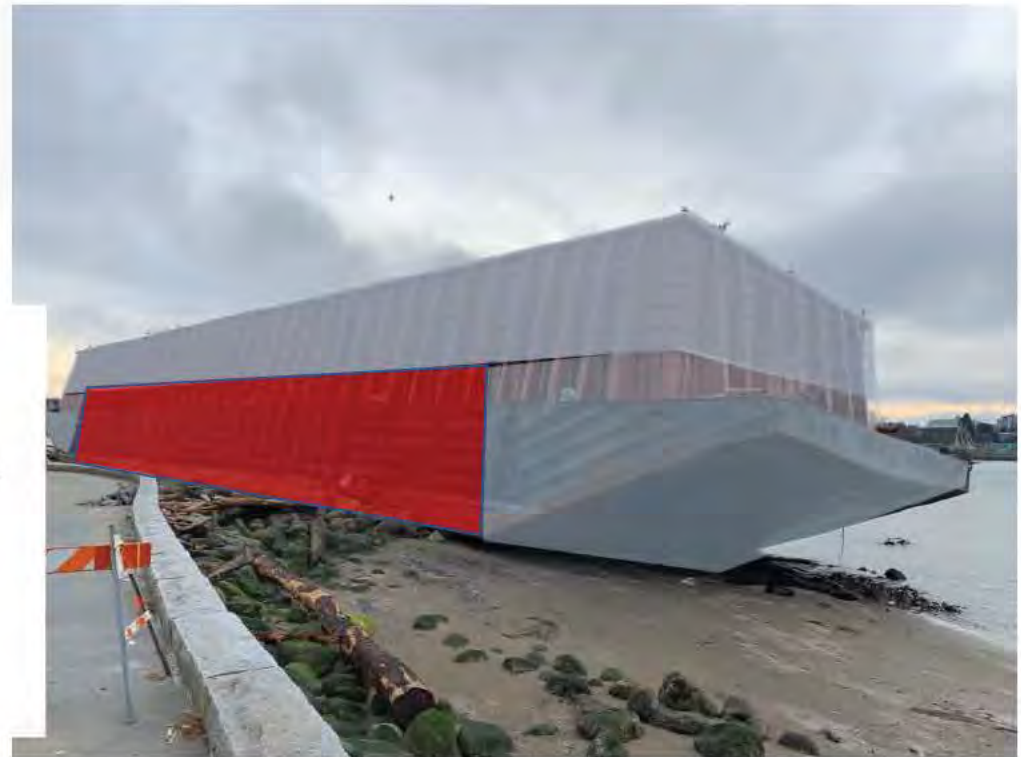
REMOVING SHELL BOTTOM

Staging & Number of Sections TBC by lift analysis:

1. Remove Starboard Shell Bottom
2. Remove Port Shell Bottom
3. Site Clean Up & Restoration

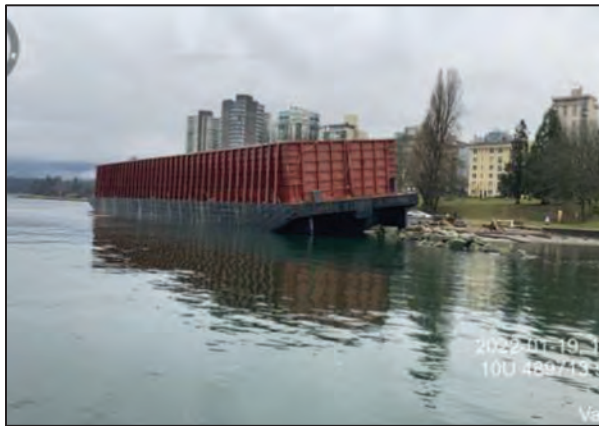
A) Seaward port side at high tide.

The Study Area is bounded to the north by the seawall in English Bay. The Barge is grounded on boulders in the intertidal zone approximately 24 m from the seawall (Figure 5A). On the shoreward side of the Barge, boulders and woody debris lie over sandy substrate, as seen in Figure 5B taken at a low tide of +1.8 m CD. The substrate in the subtidal zone consists mostly of sand, with clusters of cobble, gravel, and boulder in varying proportions, as well as shell hash, algal wrack, and wood debris (Figure 6). Within the Study Area, riparian, intertidal, and subtidal habitats were assessed, and the elevation ranged from approximately + 4.0 m Chart Datum (CD), to approximately - 1.5 m CD.
