3.2 Tree Risk Assessment

Hastings Park Traffic, Parking, and Access Study Draft Rev. 1

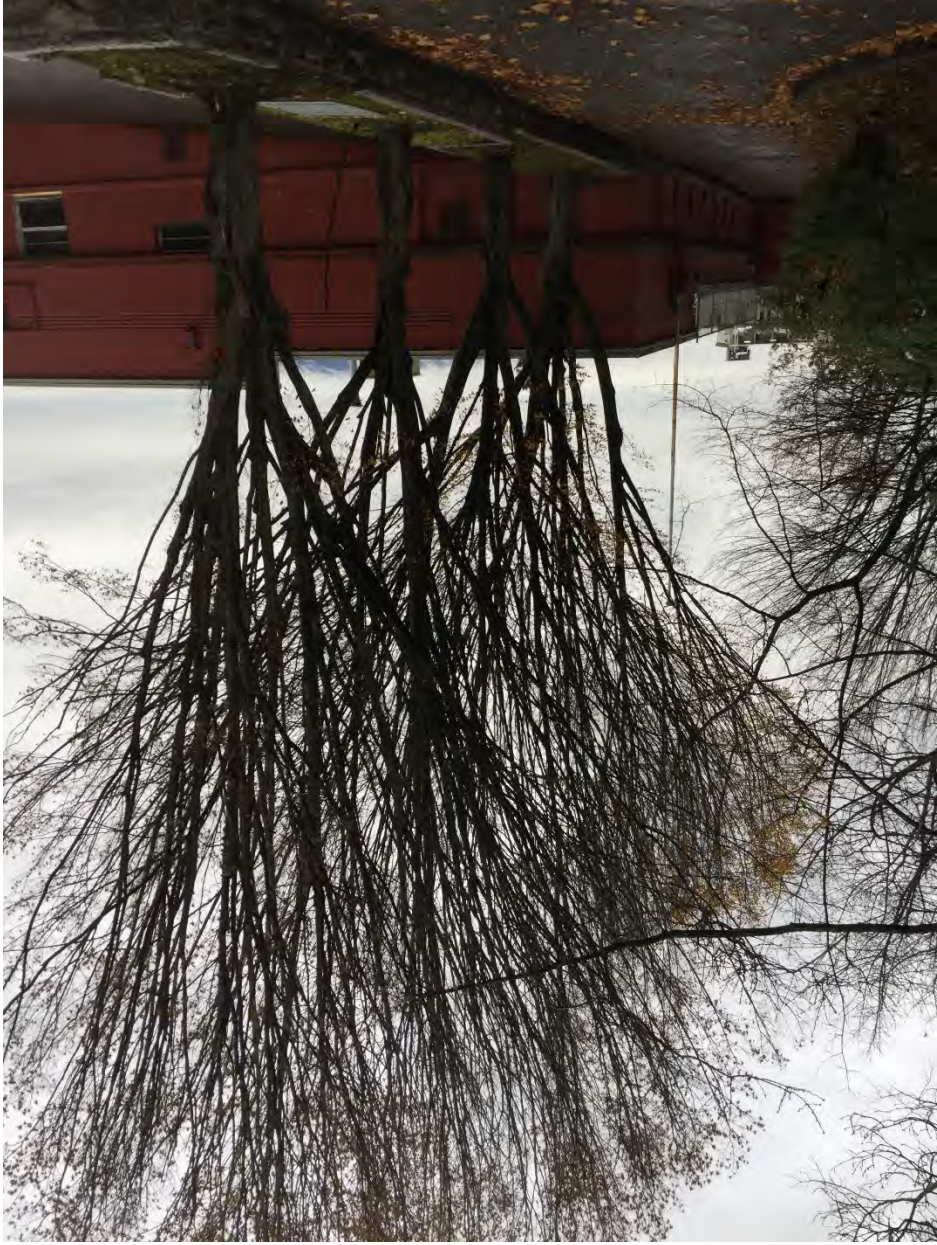
Photo 1. Row 12 Decay on main trunks.

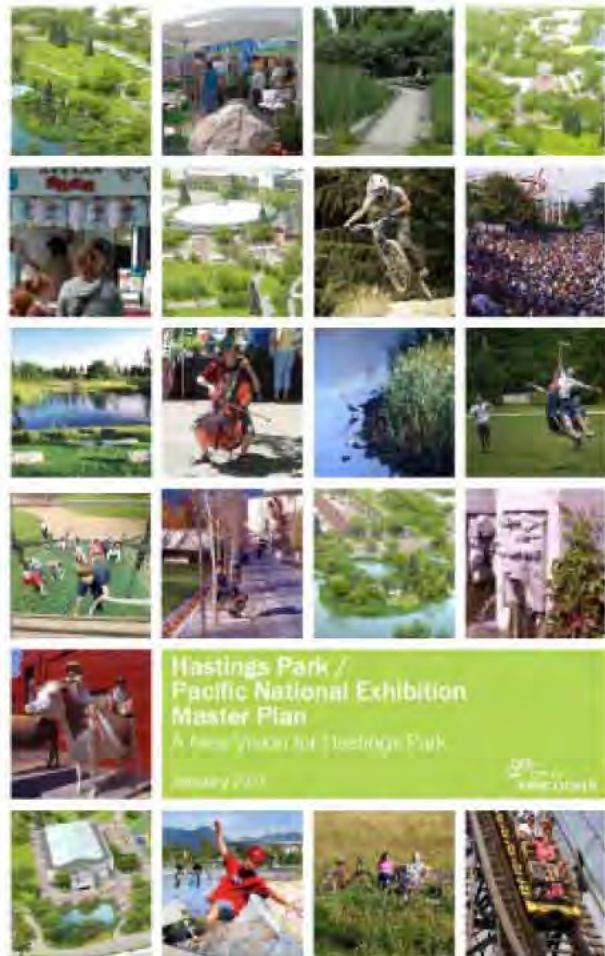
Figure 1-2: Hastings Park / PNE Master Plan

- **Expand Park Space and Habitat** by consolidating parking, road, and back-of-house uses to the northern portion of the site
- **Build in Flexibility** by creating spaces that can transform and adapt to future park needs

- **Create a Hastings Park Identity** so the Park is recognized as an active, public park destination.

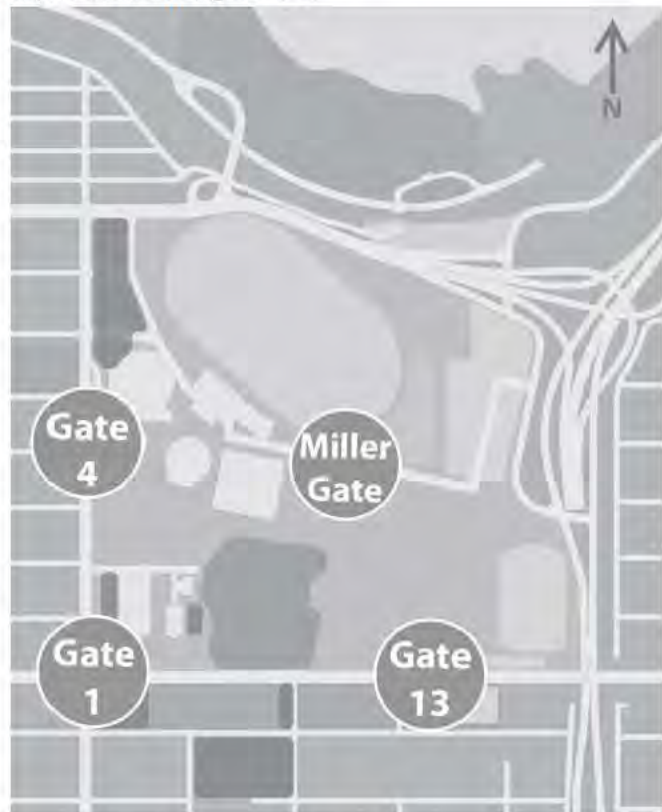
Figure 1-7: Hastings Park Pedestrian Gates

Visitor arrival and departure information is based on one-day pedestrian access counts conducted by TransTech during the Fair on August 26, 2017 and during Playland's regular season on July 15, 2018. The gates where pedestrians were counted are shown in **Figure 1-7**. Data collected by TransTech during the access counts can be found in **Appendix C: Access Count and Parking Data from TransTech** while methodology and findings from both surveys are summarized in the following subsections.

During the Fair, pedestrian access counts were conducted at Gate 1, Gate 4, Gate 13 and the Miller Drive Gate. Findings from the one-day pedestrian access count, indicate that generally peak arrival time for the Fair is 11:00 AM. A spike in arrivals at 2:00 PM was likely a result of the programming on site during the day of data collection. During data collection, departures had a minor peak at around 5:30 PM, with the greatest peak in pedestrian departures occurring at 8:30 PM.

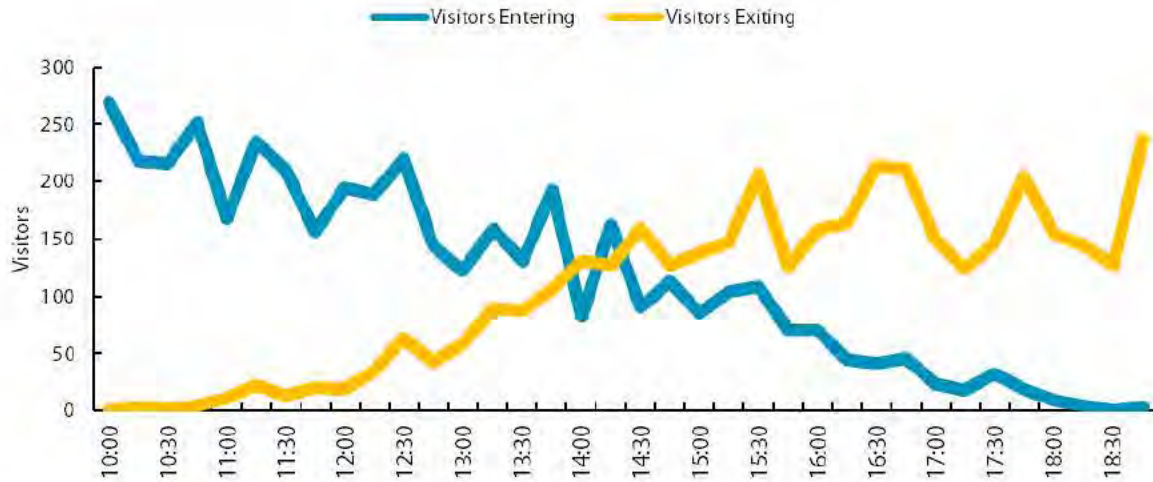
Figure 1-8: Playland Arrivals and Departures by Time of Day on July 15, 2018 (TransTech)

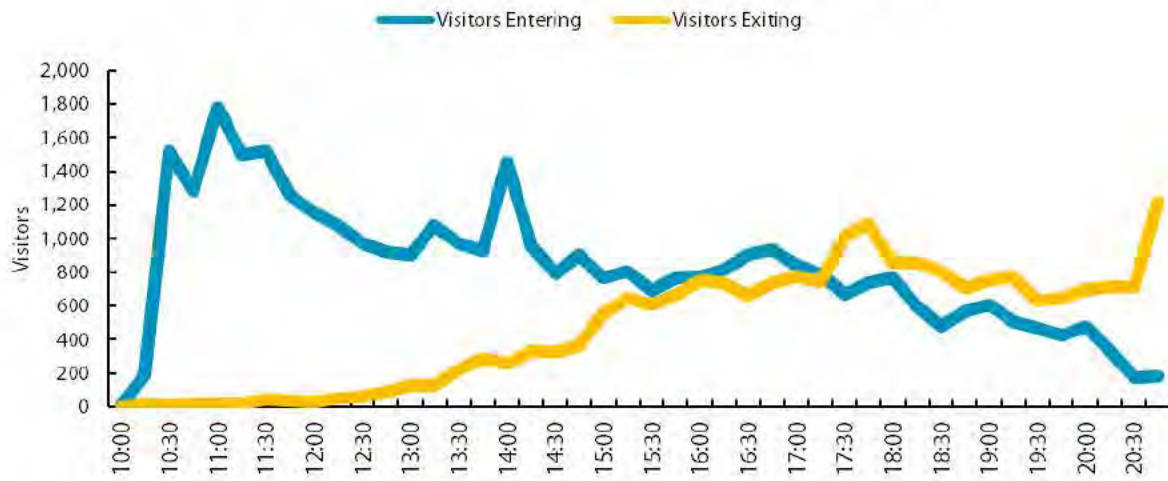
Figure 1-9: Fair Arrivals and Departures by Time of Day on August 26, 2017 (TransTech)

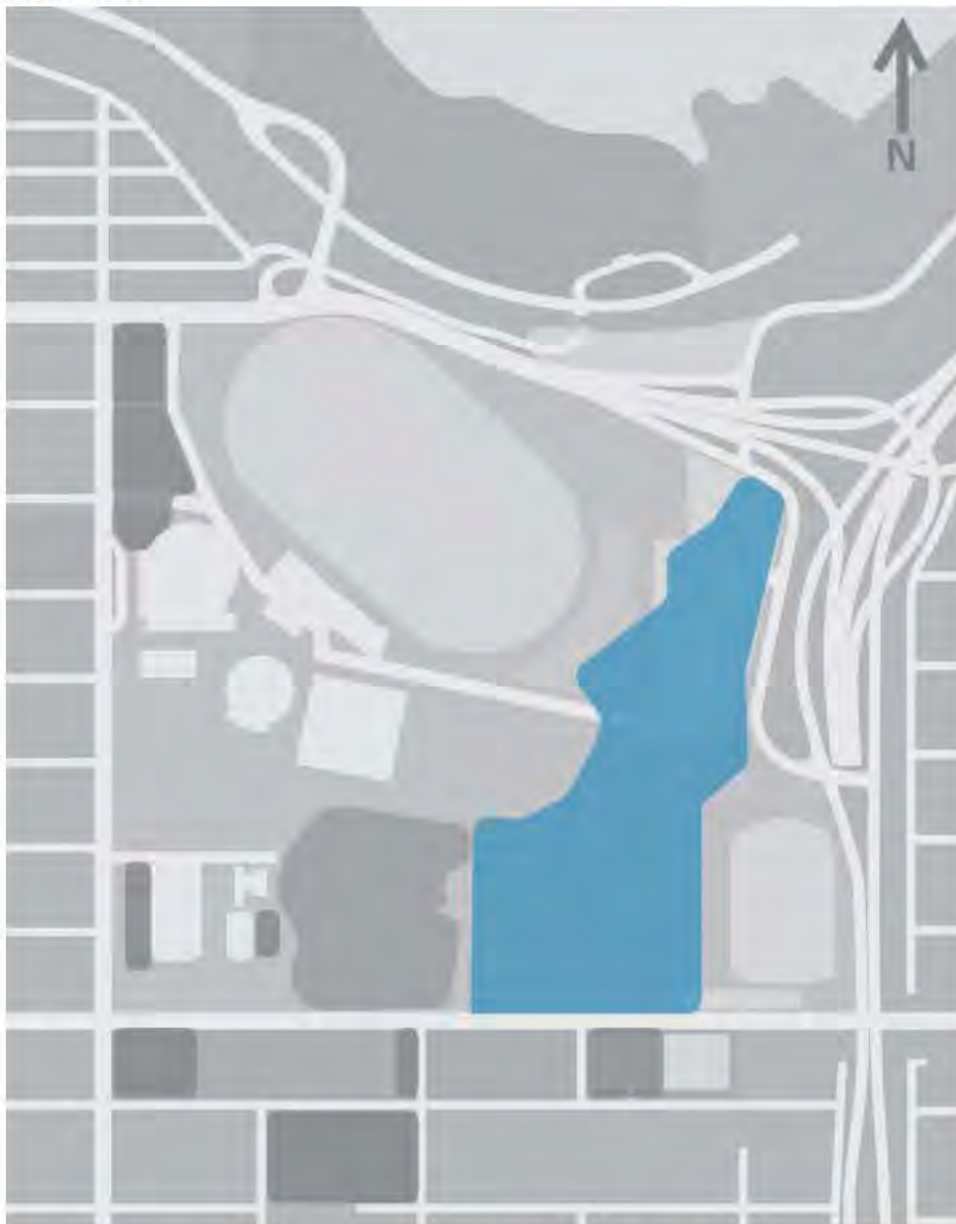
Figure 1-14: Planned Playland Expansion Area (Source: Hastings Park - PNE Master Plan)

The Playland expansion scenario that was ultimately selected for this study is expected to expand the current Playland site from 5.8 to 9.5 hectares and is estimated to increase attendance from 537,547 in 2017 to **749,500 visitors annually in 2029**. The planned Playland expansion area is illustrated in **Figure 1-14**. A summary of the four expansion scenarios evaluated can be found in **Appendix A: Playland and Fair Attendance Records and Projections**.

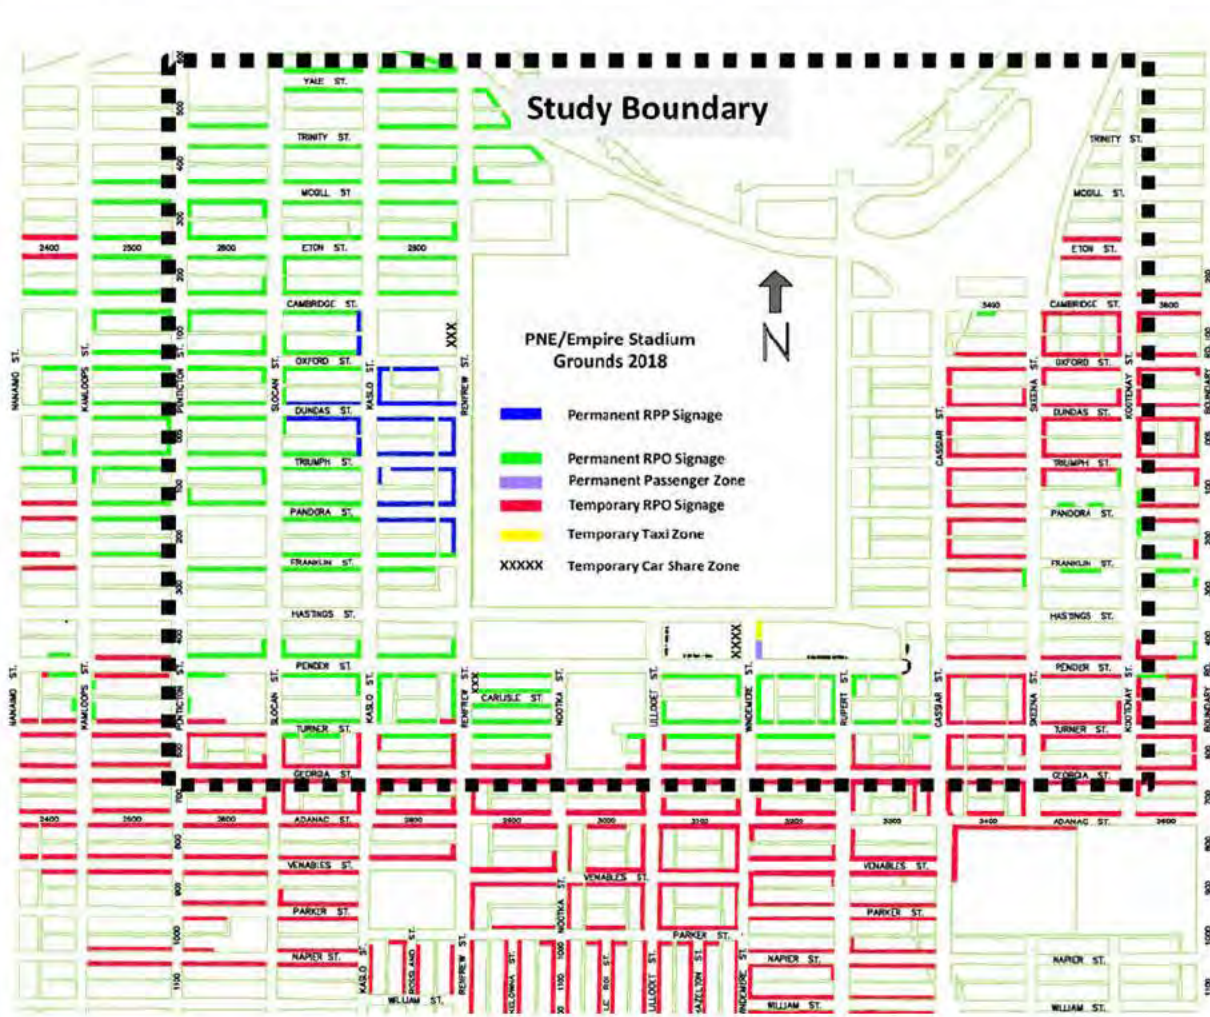
Figure 2-1: On-Street Parking Survey Study Area Boundary and Parking Restrictions. (Source: City)

- There were 143 move vehicles parking in the study area during the day, when the Fair was taking place, than at night;
- For all street segments *without residential parking restrictions*, there were 391 more vehicles parked in the study area during the day than at night (residential parking restrictions shown in **Figure 2-1**);
- The street segment with the highest on-street parking occupancy was East Hastings Street with 152 vehicles parked when it was surveyed; and
- The increased number of vehicles parked within the study area during the day, especially on streets without residential parking restrictions, suggests that the increased on-street parking demand during the day is likely generated by the Fair.

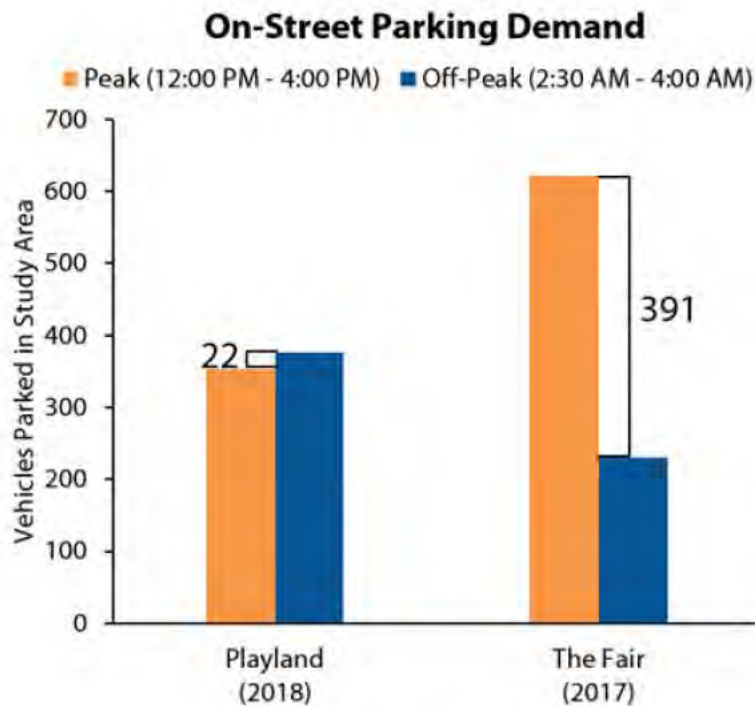
Figure 2-2: On-Street Parking Demand During Peak and Off-Peak times (Source: TransTech)

Although the peak on-street parking demand during the Fair was estimated from the survey to be approximately 391 vehicles, the true demand is likely higher as this value only includes vehicles parked on the streets, but anecdotally, Fair-related vehicles were also observed parking in alleys and on private residential properties where permitted by the local residents.

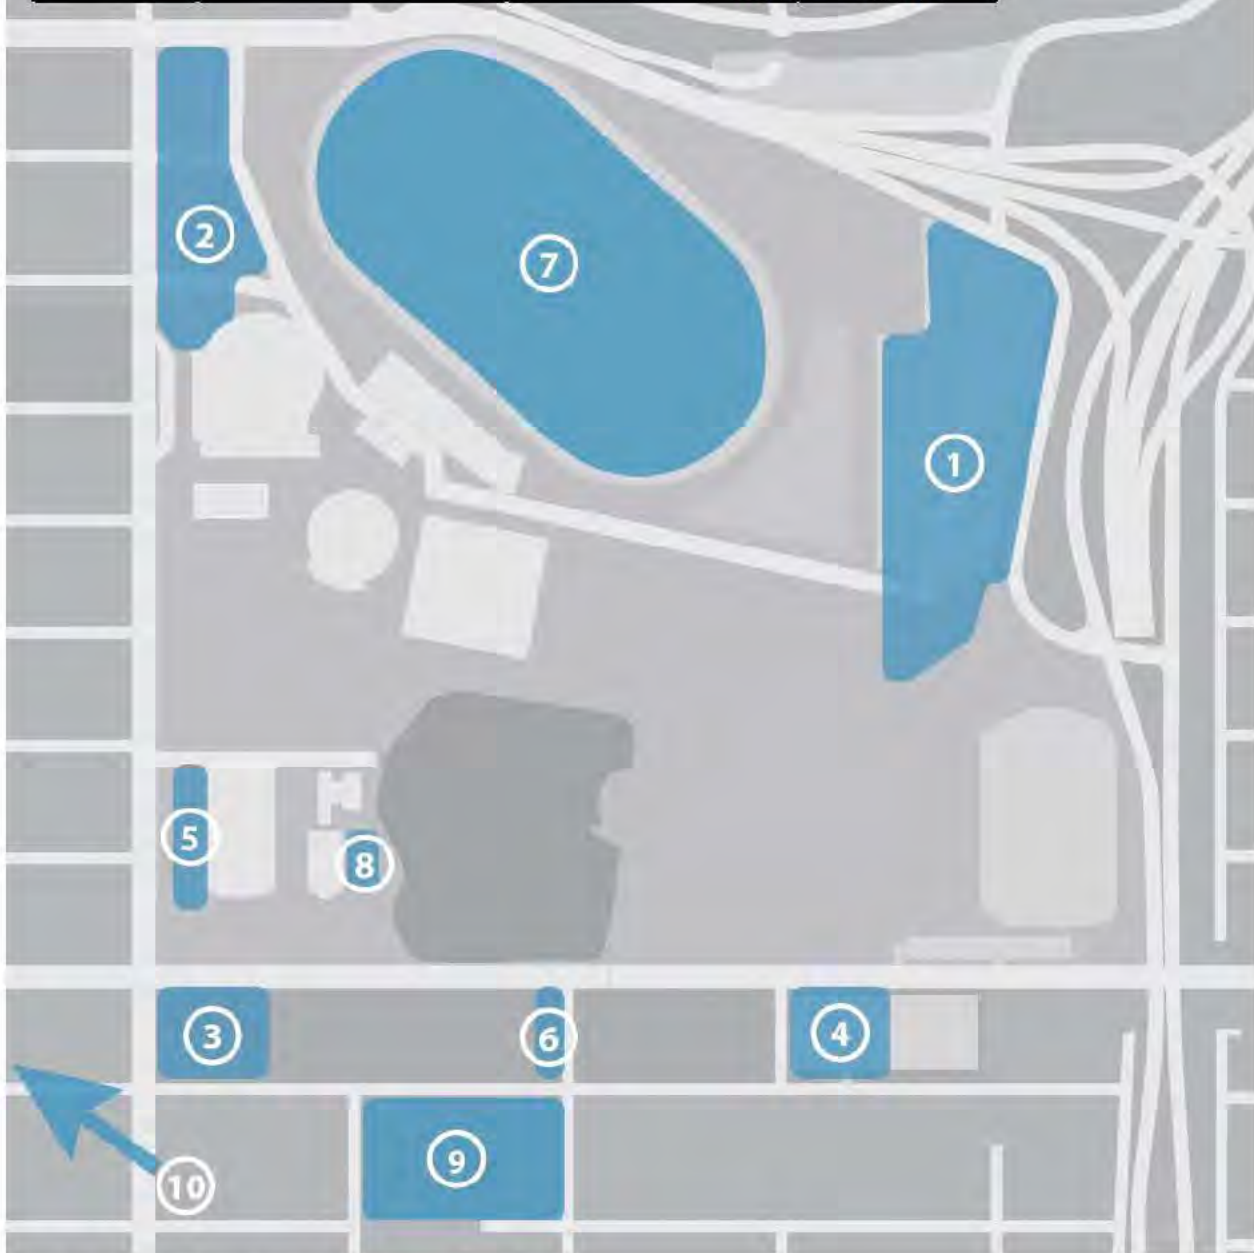
Figure 2-4: Fair Off-Street Parking Lots (Source: TransTech)

Ten off-street parking lots were identified by TransTech on August 26, 2017 that are available during the annual Fair, with a total off-street parking inventory of **3,710 spaces**. The locations and identified inventories of these lots are shown in **Table 2-2** and **Figure 2-4**, respectively.

Lot No.	Name	Description	Inventory
1	Lots 9B and 9C	Visitor Parking	876
2	Lots 7, 8, Pacific Coliseum	Visitor Parking	571
3	Pender & Renfrew Lot	Visitor Parking	354
4	Lot 16	Visitor Parking	277
5	Lot 1	Visitor Parking	55
6	Community Centre Lot	Visitor Parking	28
7	Racetrack Infield	Visitor Parking	1,200
8	Gate 15 Lot	Staff/Back-of-House Parking	41
9	Hastings Elementary	Staff/Back-of-House Parking	100
10	Dr. A.R. Lord Elementary	Staff/Back-of-House Parking	208
Total:			3,710

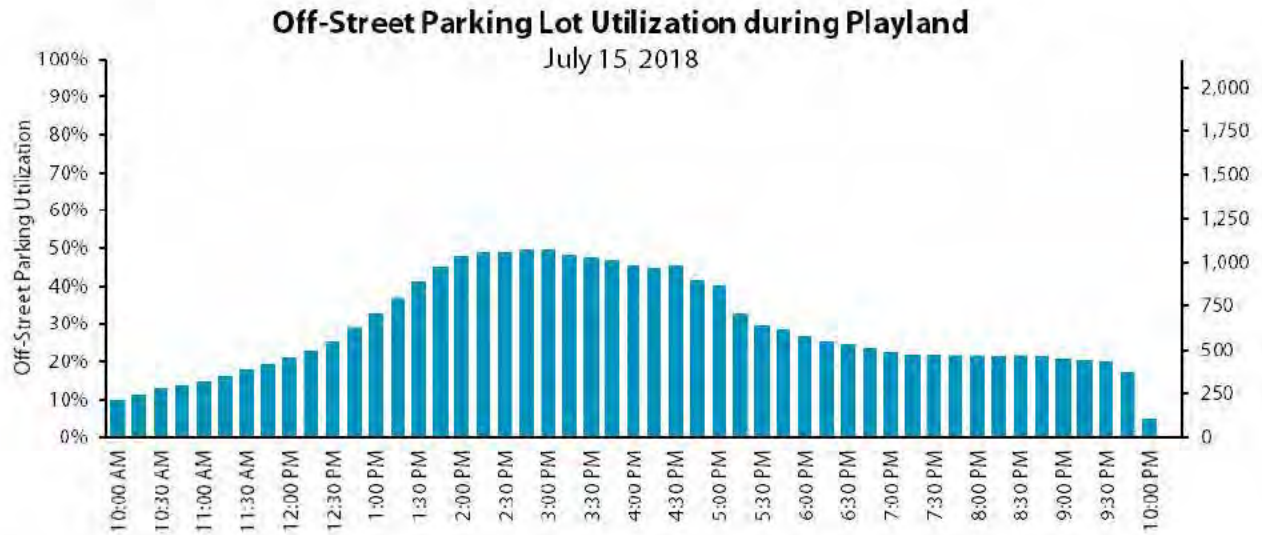
Figure 2-5: Off-Street Parking Demand by Time-of-Day during Playland (Source: TransTech)

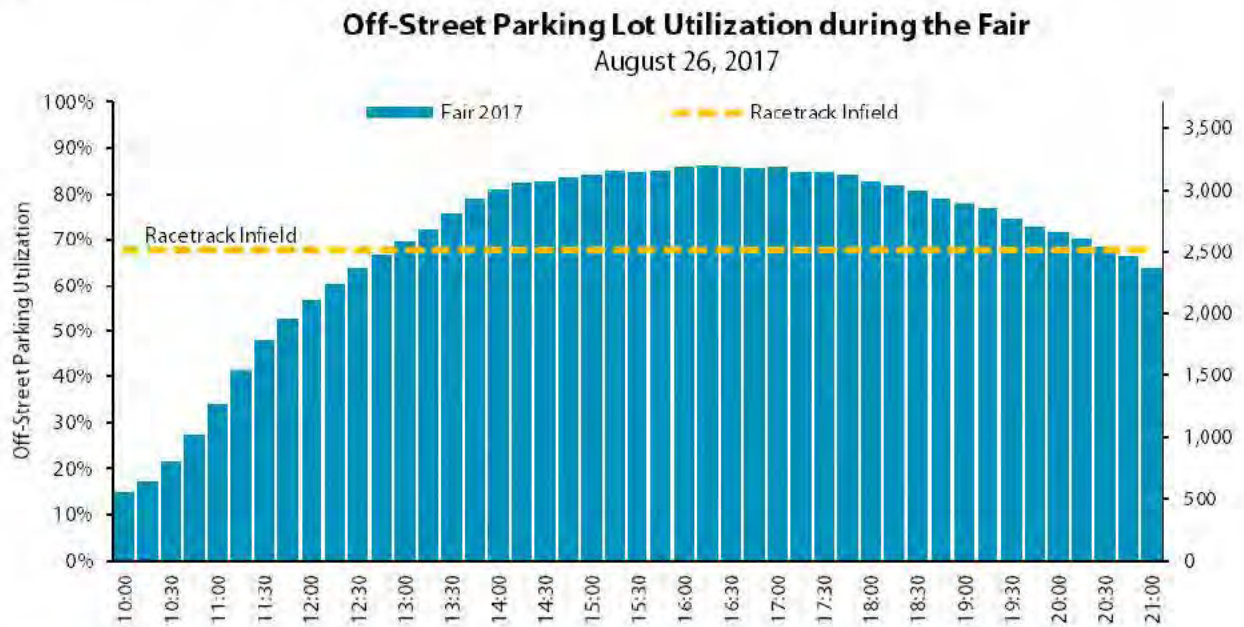
Figure 2-6: Off-Street Parking Demand by Time-of-Day during the Fair (Source: TransTech)

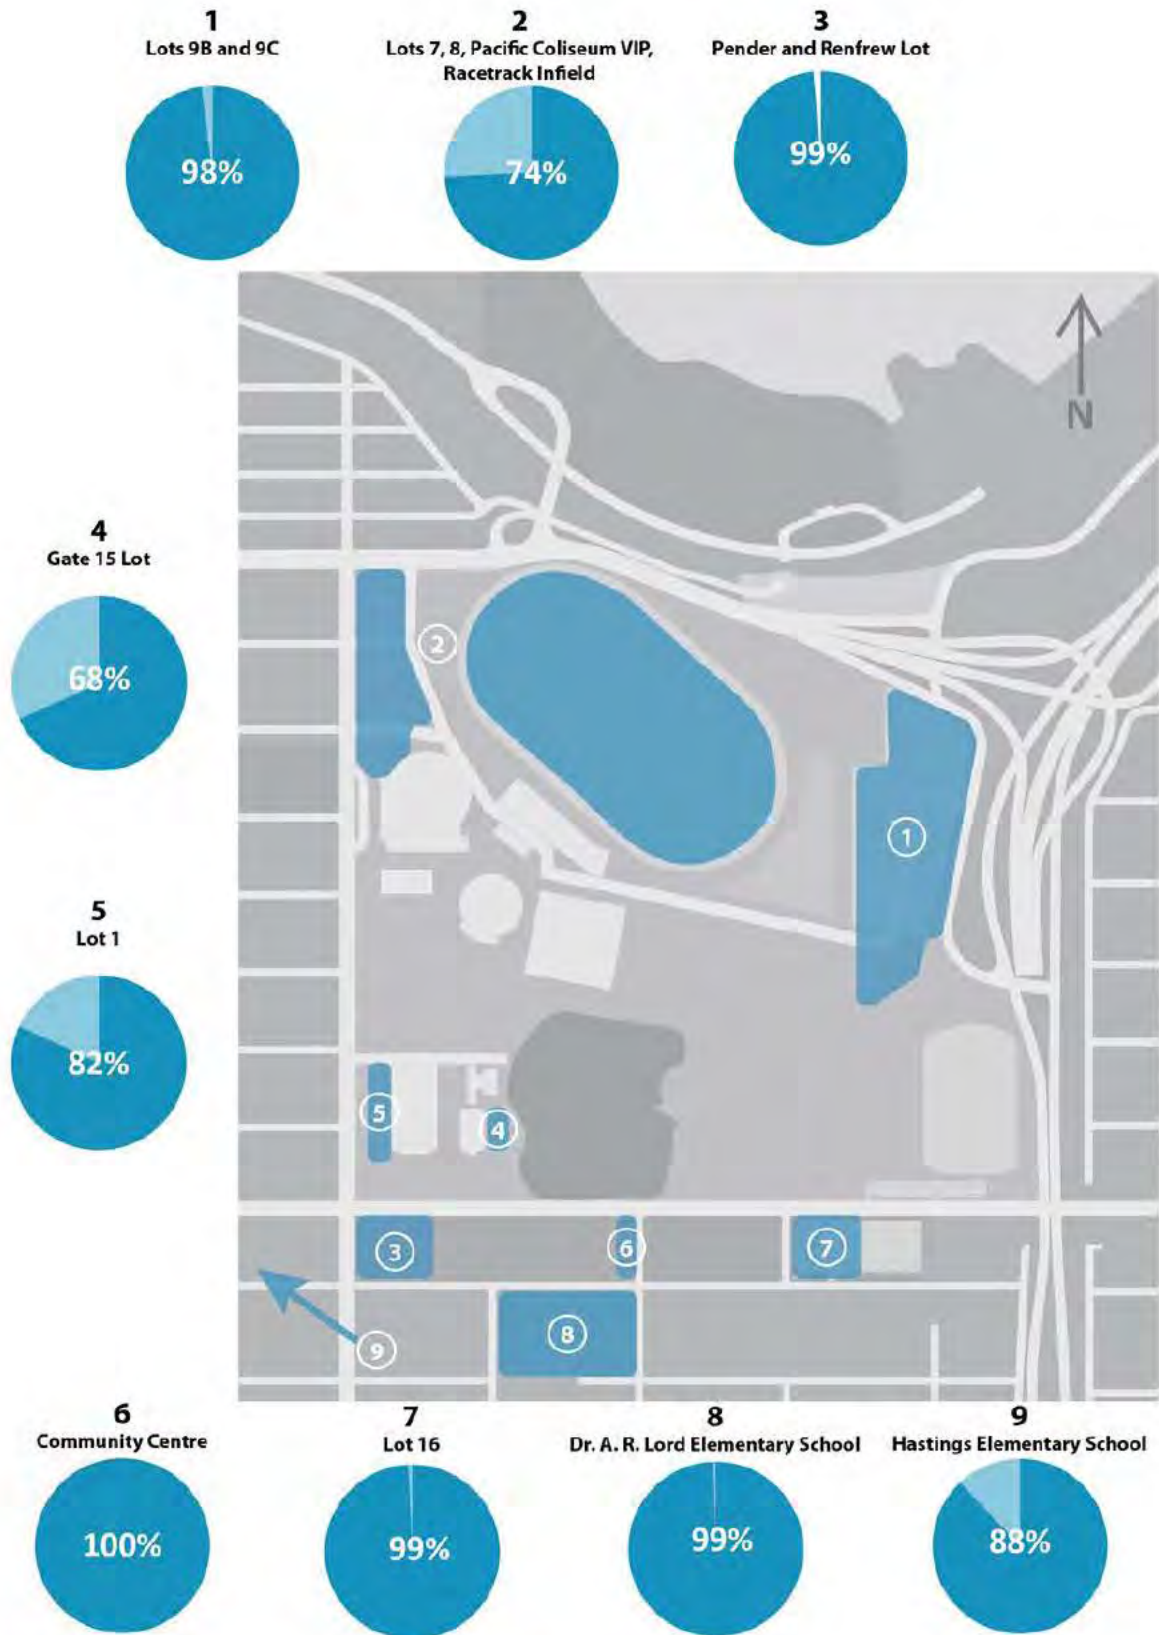
Figure 2-8: Utilization of Off-Street Parking Lots at Peak Demand (Fair) (Source: TransTech)

Figure 2-8 shows the occupancy of each parking lot during peak utilization at 4:15 PM. The estimated off-street parking inventory during the Fair is 3,710 parking spaces when vehicles are also parked in the Racetrack infield.

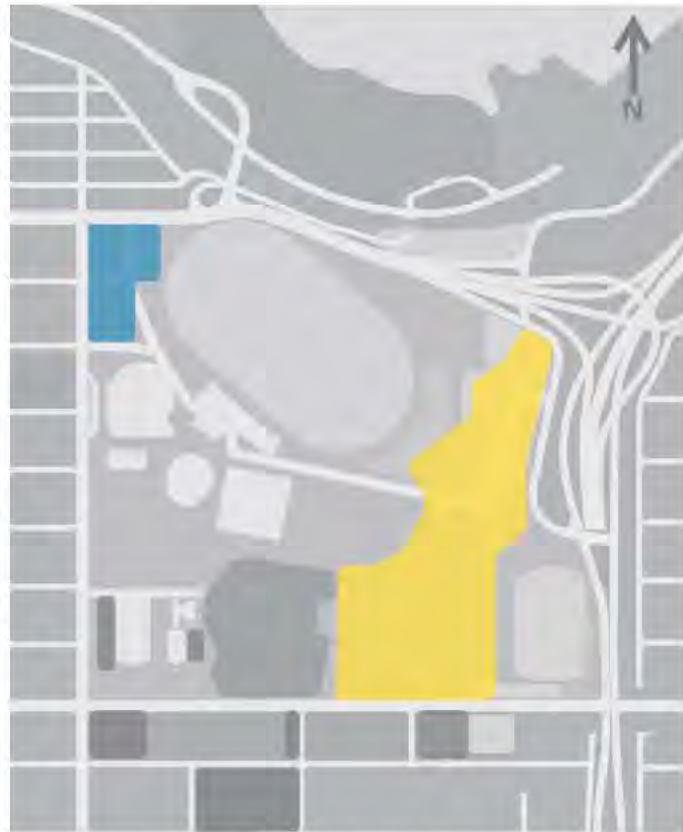
Figure 2-11: Option 1 Parkade in northwest corner of Hastings Park

estimates in **Table 2-5**, this would meet the target Fair parking demand in 2029 with a surplus of 204 parking spaces, and meeting the target Playland parking demand with a surplus of 564 parking spaces. The comparisons in parking demands and supplies for Option 1 are summarized in **Table 2-8** for both Playland and the Fair scenarios.

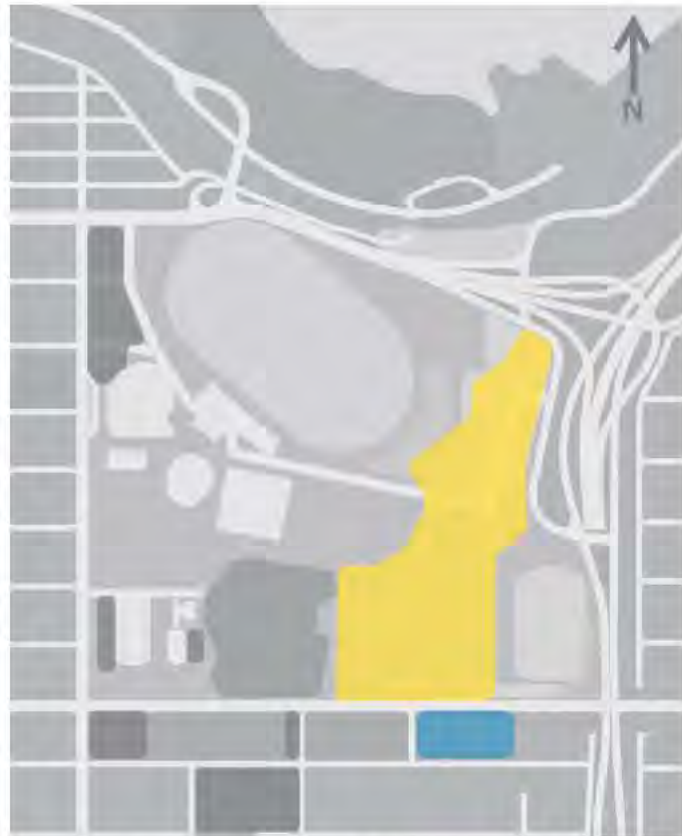
Figure 2-12 Option 2 4-Level Parkade in Location of Lot 16

It is estimated that a four-level parkade with 371 spaces per level would provide approximately 1,324 additional parking spaces (not including the assumed 160 parking spaces to be designated for the E-Comm building) for Hastings Park, bringing the off-street parking supply to 4,037 spaces during the Fair and 2,537 spaces during Playland.

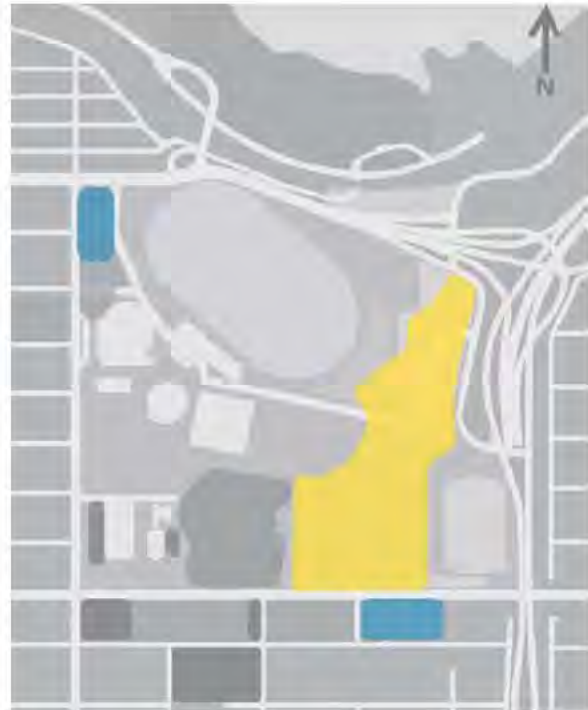
Figure 2-13: Option 3 Phased Parkade Construction in Lot 16 and Northwest Corner

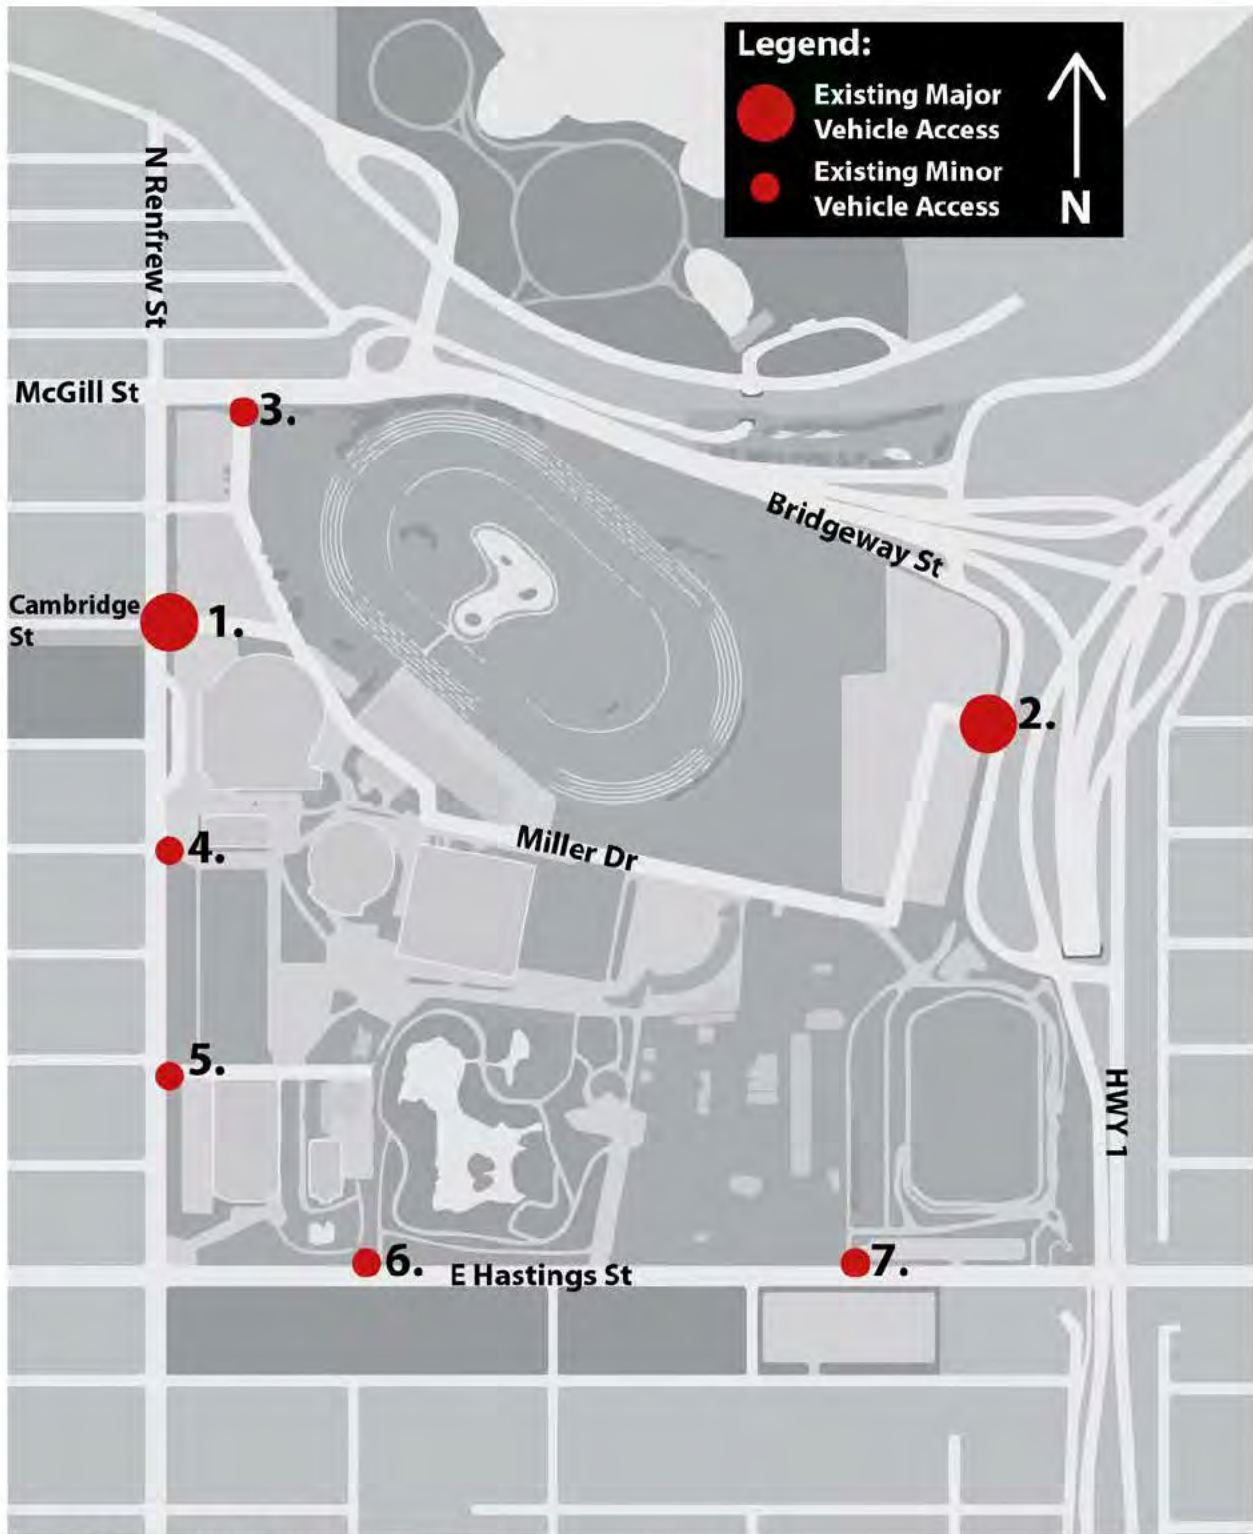
Figure 3-1: Existing Vehicle Accesses at Hastings Park

7. **Gate 12** is a minor vehicle access on the south side of the park from East Hastings Street. This gate provides access to the Empire Fields Parking lot via a one-way inbound driveway on the west side of the lot, and a one-way outbound driveway on the east side.

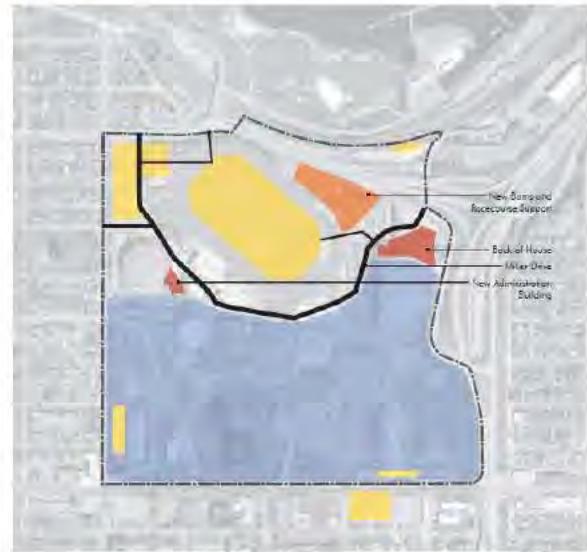
Figure 3-2: Future Hastings Park Vehicular Routes and Parking Areas. (Hastings Park - PNE Master Plan)

The Master Plan's proposed internal vehicular routing and organization, shown in **Figure 3-2**, aims to create a clear pedestrian and vehicle organization by consolidating parking and vehicle accesses in the northern side of the park, with the exception of a few minor lots retained in the southern portion. The future access locations contemplated in the Master Plan are shown in **Figure 3-3** are discussed in the sections below.

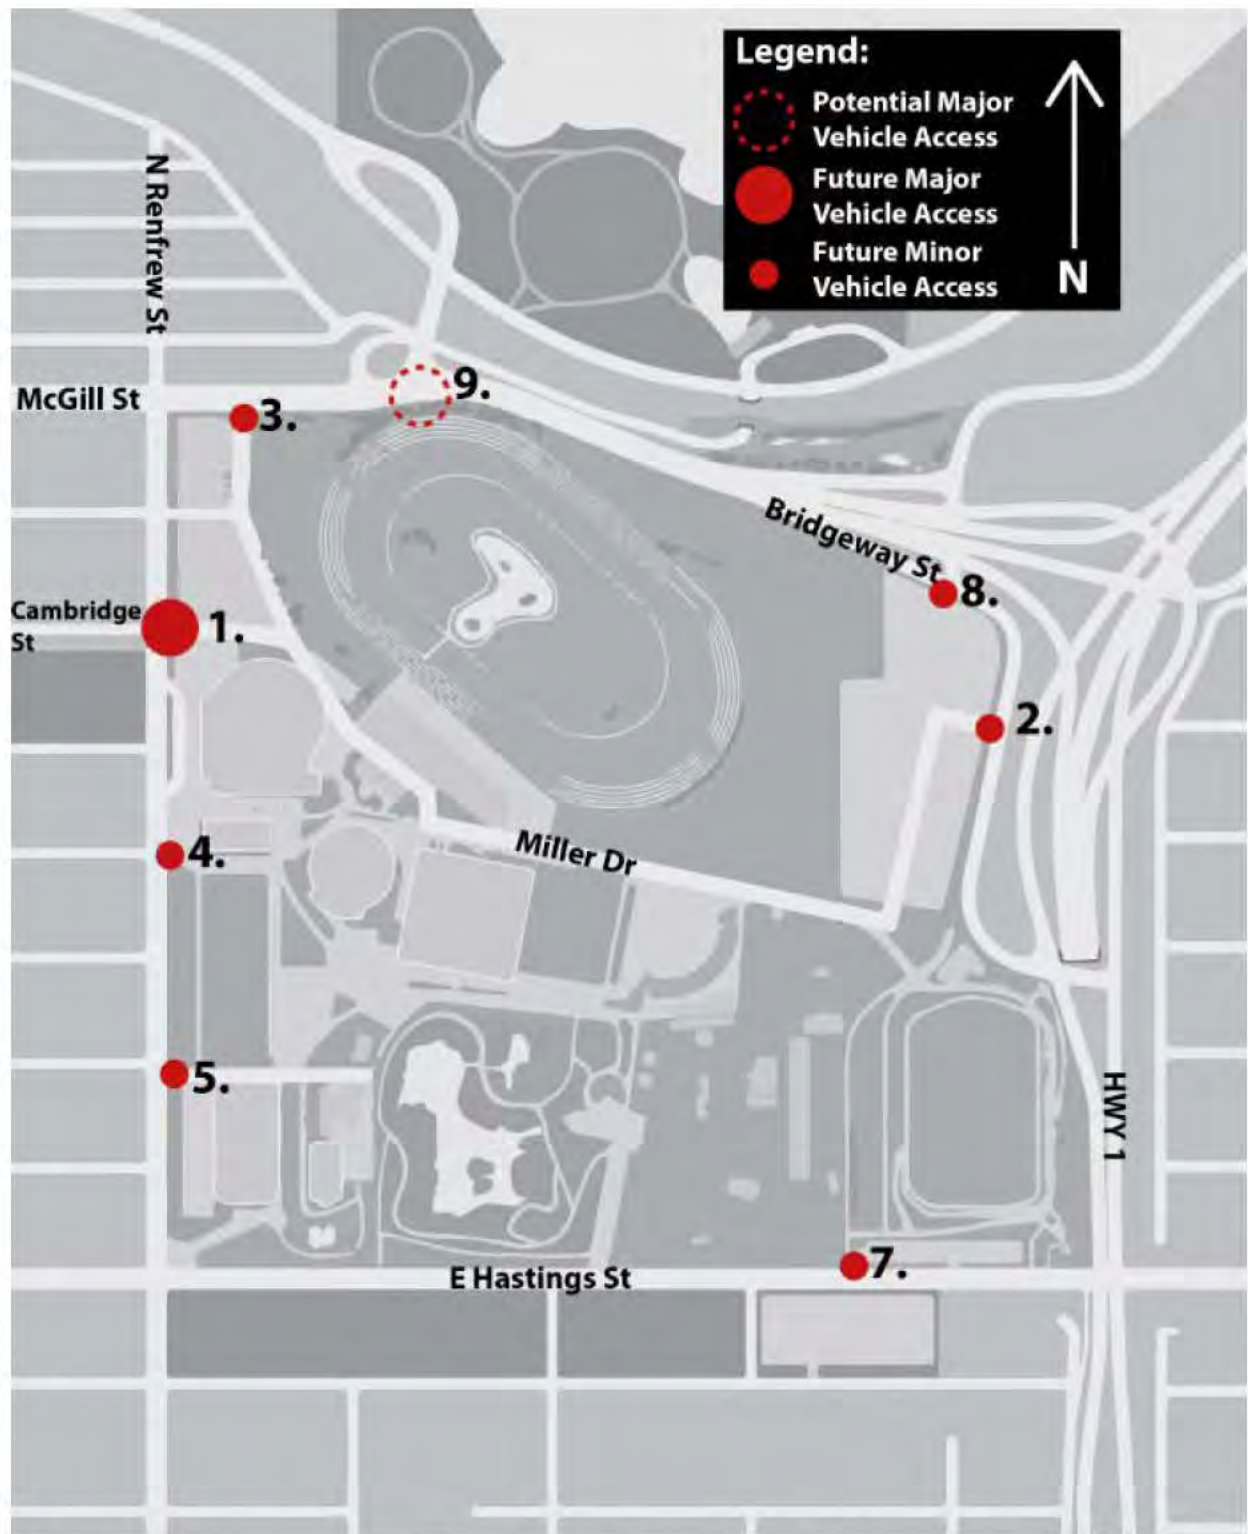
Figure 3-3: Future Vehicle Access Locations following the Redevelopment of Hastings Park (Source: Hastings Park-PNE Master Plan)

9. Location 9 is a proposed vehicle access in the Hastings Park Master Plan. This location should only be considered if providing a parking structure within the racetrack infield.

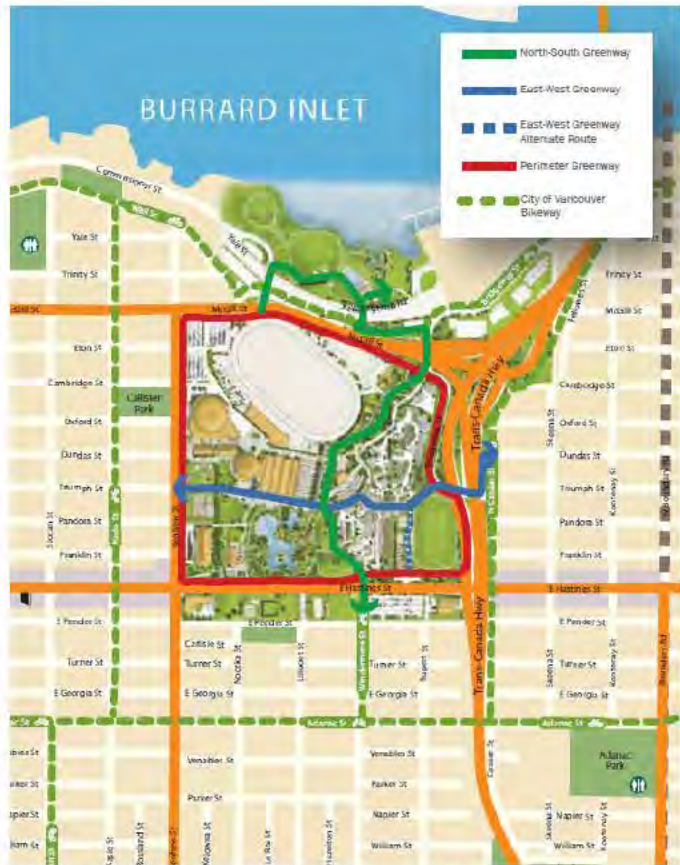
Figure 3-4: Pedestrian and Cycling Routes and Connections at Hastings Park (Master Plan)

Based on the information provided in the Master Plan, the redevelopment of Hastings Park plans to provide a total of 5.4 kilometers of pedestrian and bicycle routes through the park. The routes proposed in the Master Plan, shown in **Figure 3-4**, propose to:

- Create a pedestrian and bicycle connection to New Brighton Park;
- Provide east-west and north-south active transportation corridors that bisect the park and connect to city-wide greenways;
- Encircle Hastings Park with separated pedestrian and bicycle routes;
- Introduce traffic calming to Renfrew Street to accommodate a Park Perimeter Greenway and shorten crossing distances on local streets and creating “gateways” to the Park.

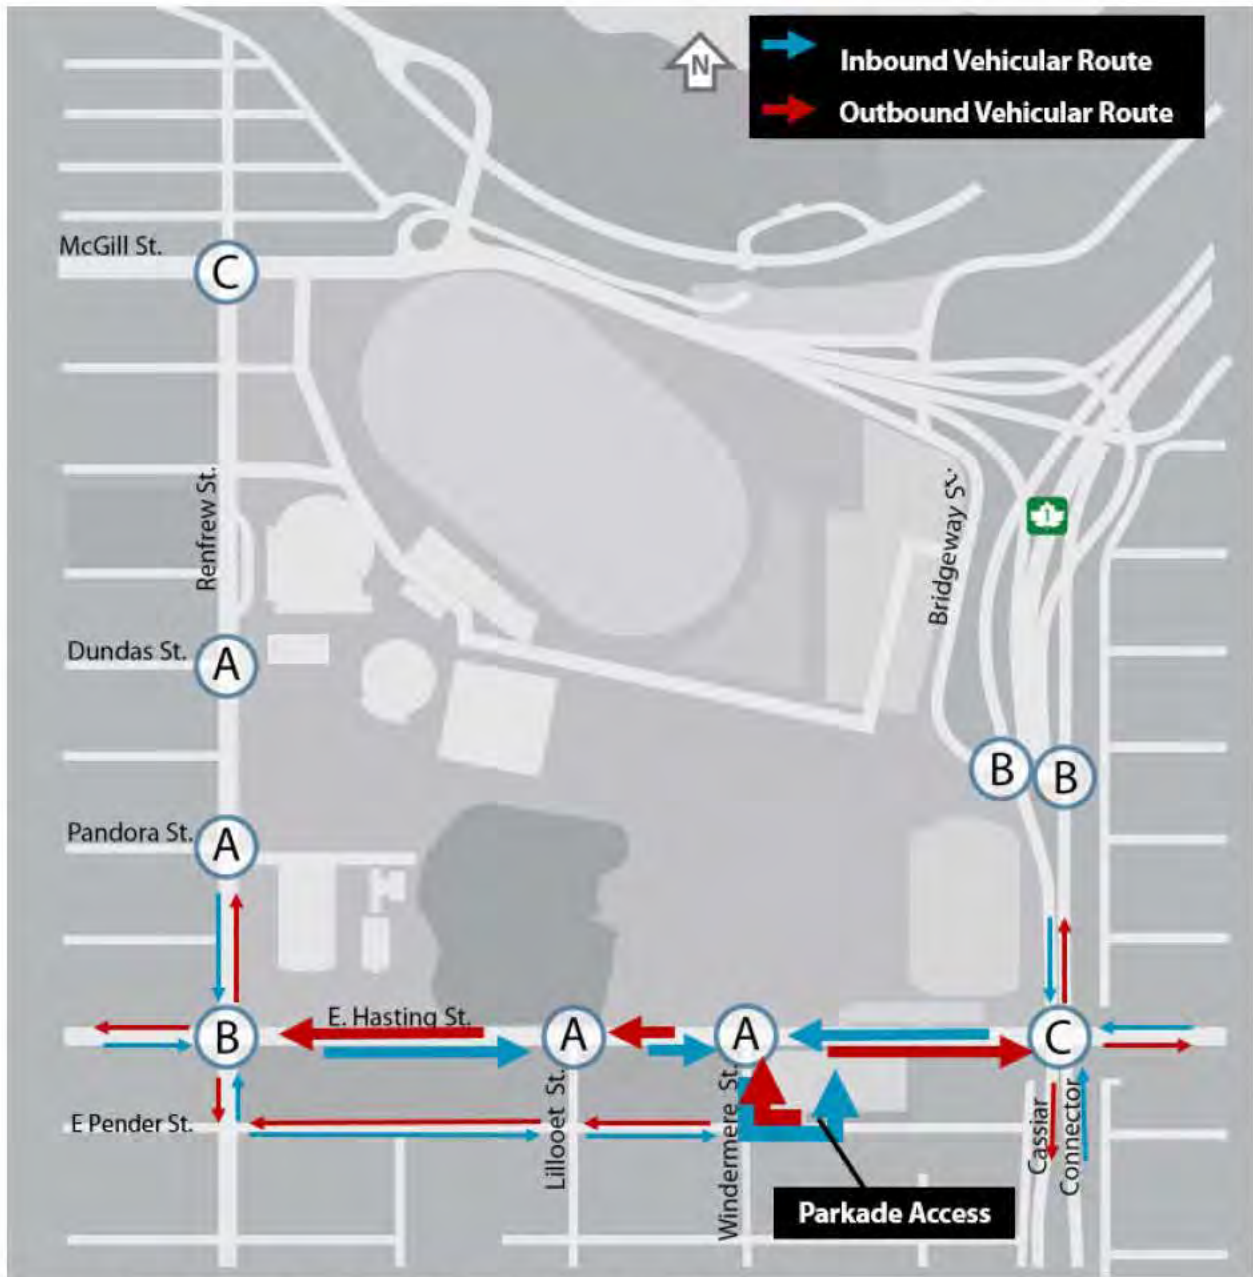
Figure 4-4: Potential Vehicle Routing based on Proposed Lot 16 Parkade Structure

If a parkade is constructed as part of the long-term parking strategy of Hastings Park, additional consideration should be given to the positioning of the primary accesses will impact nearby intersections, particularly the intersection of McGill Street and North Renfrew Street.

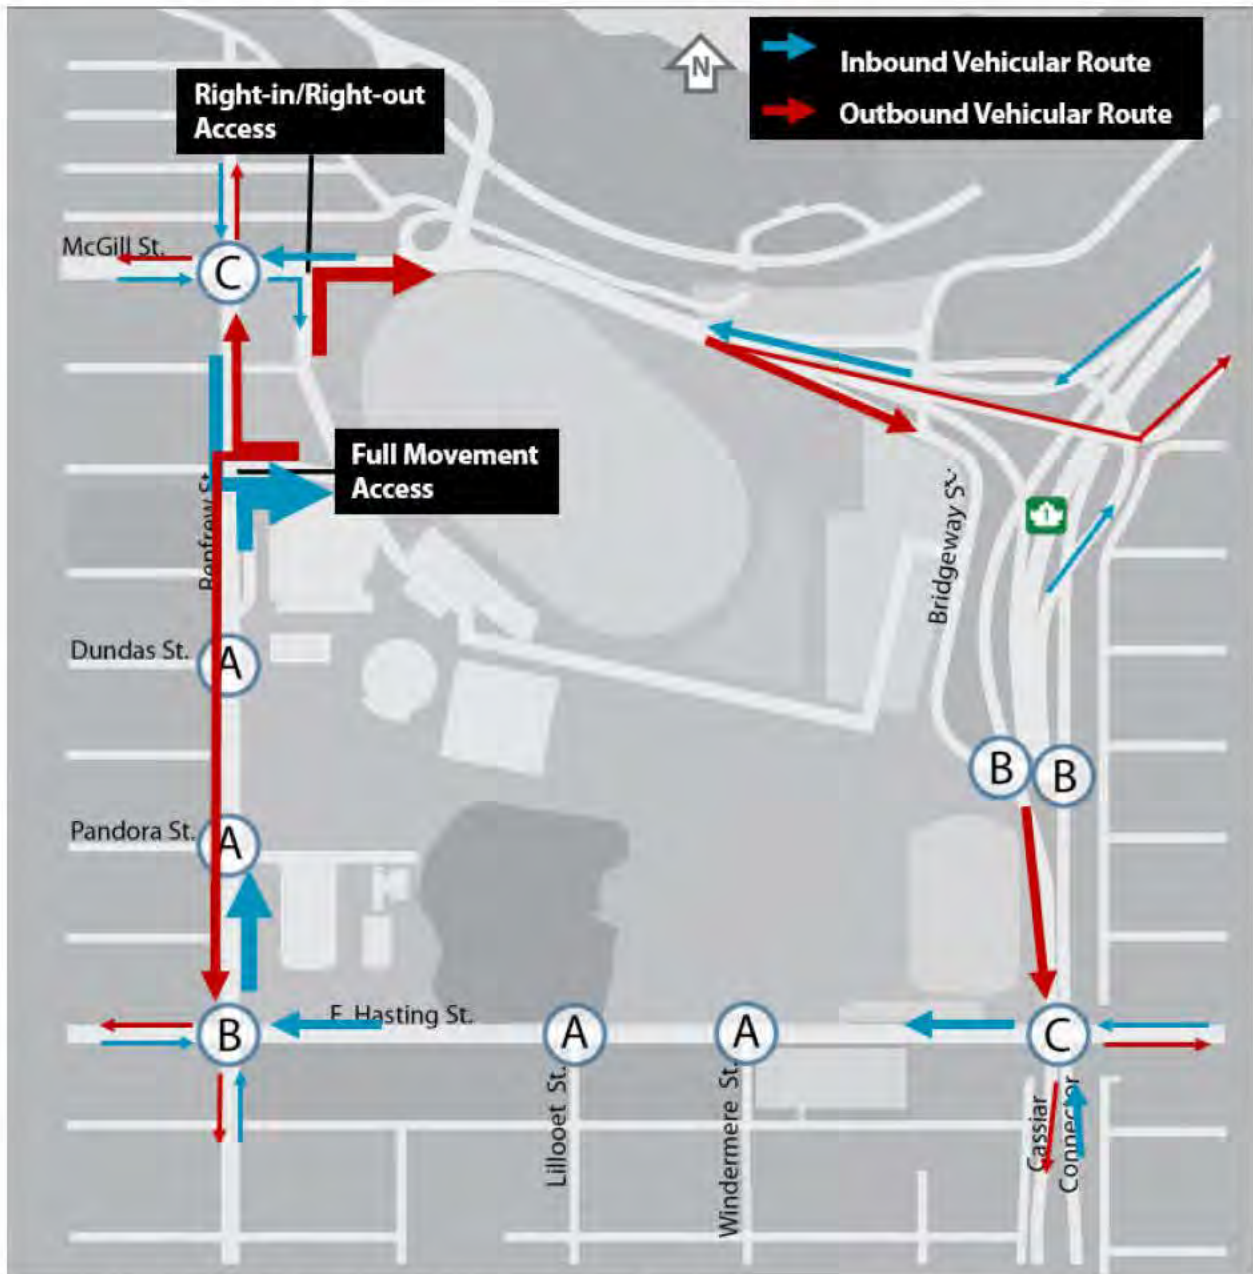
Figure 4-5: Potential Vehicle Routing based on Northwest Parking Consolidation
