3.2 Tree Risk Assessment

Hastings Park Traffic, Parking, and Access Study Draft Rev. 1

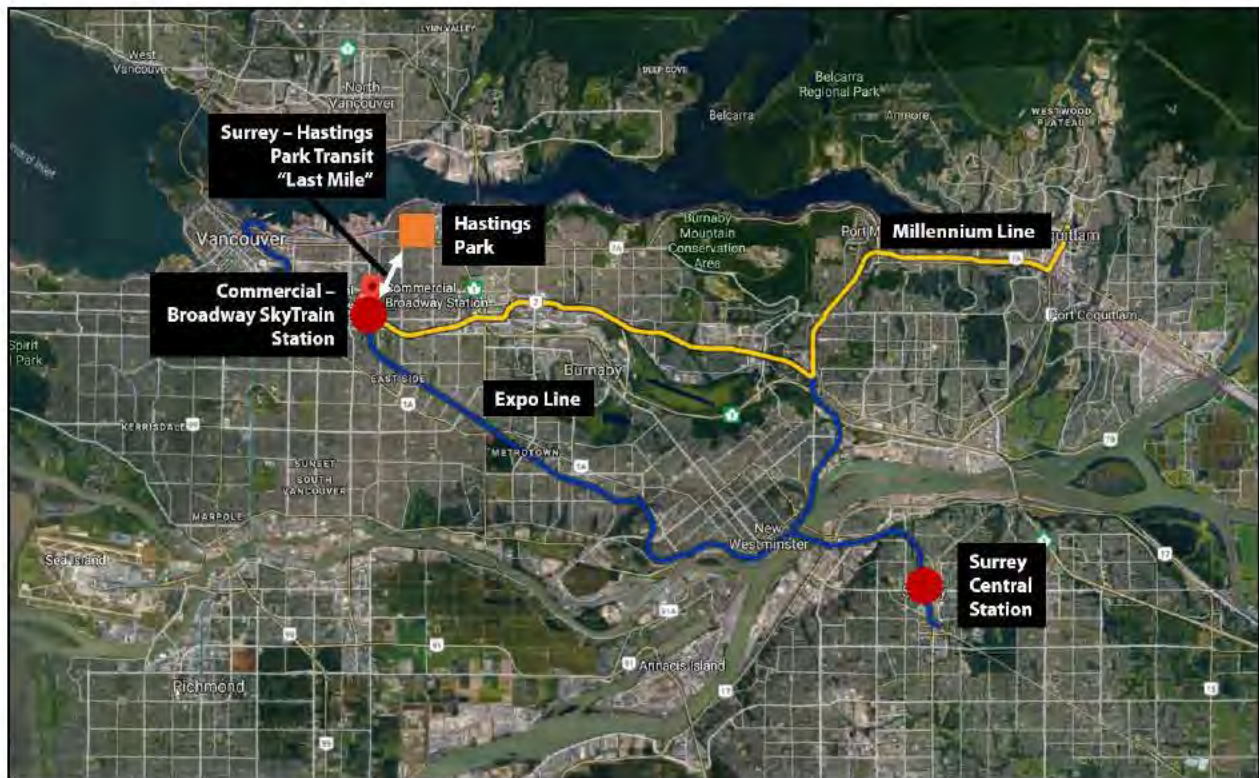
Figure 5-2: Location of Hastings Park in proximity to the nearest Millennium Line and Expo Line SkyTrain Stations. (Google Maps)

The trip from Surrey to Hastings Park is shown in **Figure 5-2**. Currently, it takes approximately 60 to 75 minutes to take transit from downtown Surrey (Surrey Central Station) to Hastings Park, but only 25 to 35 minutes to drive (Google Maps). As it only takes 25 minutes to SkyTrain from Surrey Central Station to the 29th Avenue Station, the remaining 35 to 50 minutes of travel time by transit comes from the “last mile”, or, taking the bus from the station to Hastings Park.

A frequent shuttle service with no stops between the station to the park could reduce this transit travel time from 60 to 75 minutes to 35 to 40 minutes (Google Maps), making the transit travel time comparable to vehicles driving the same distance. It currently takes 30 minutes to take the SkyTrain from Surrey Central Station to Commercial Drive Station, and a shuttle from the Commercial Drive station would take approximately 5 to 15 minutes. Additional time associated with waiting for the shuttle and pedestrian loading/offloading of the shuttle could be offset by providing a drop-off area for the shuttle directly within Hastings Park.
