## **ARBORIST REPORT**

### **TREE MANAGEMENT FOR PROPOSED DEVELOPMENT**

INITIAL ISSUANCE DATE: November 23, 2023 REVISION # **6 September 25, 2025**

**3803, 3815, and 3823 West 10<sup>th</sup> Avenue, Vancouver**

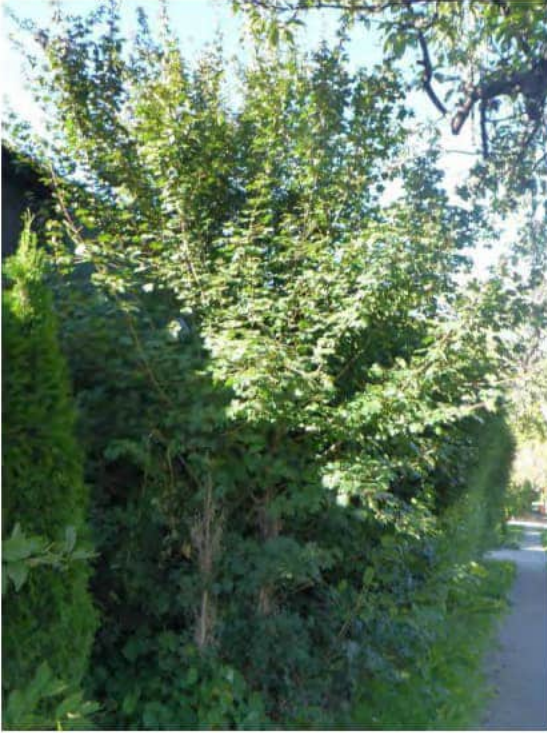
Photo #1, Tree #250

| Tag/ID | Survey ID | Loc | # of Trees | Common name,<br>(Botanical) | DBH<br>ISA | DBH<br>CITY | DBH<br>TPZ | Bylaw Y/N | Ht (m) | Spr (m) | LCR (%) | Class | Assessment Findings: | Viability | Optimal<br>RPZ | City RPZ<br>(min) | ACTION | RPZ (m) | CPZ (m) |
|---|---|---|---|---|---|---|---|---|---|---|---|---|---|---|---|---|---|---|---|
| 250 | N | ON | 1 | Field maple<br>(Acer campestre) | 12+11 | 23 | 16 | Y | 5 | 3 | 90 | 0 | <ul style="list-style-type: none"> <li>• DBH of a single stem equivalent is calculated based on the area of measured stems (12+11cm<sup>2</sup>) at 1.4m above grade for protection setback calculation purposes.</li> <li>• Appears topped at 1m and 2m with epicormic growth.</li> <li>• Codominant stems at 0.5m above grade.</li> <li>• ~2.0m from building foundation; ~2.0m from sidewalk edge.</li> <li>• Crown biased to the east and south (phototropic).</li> </ul> RATIONALE: <ul style="list-style-type: none"> <li>• DIRECT CONFLICT WITH THE UNDERGROUND PARKING STRUCTURE.</li> </ul> | P | 5 | 1.5 m | REMOVE | | |

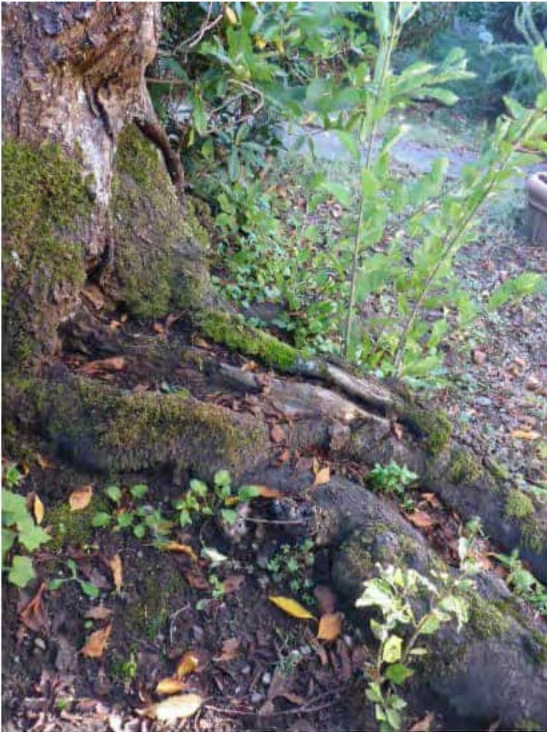
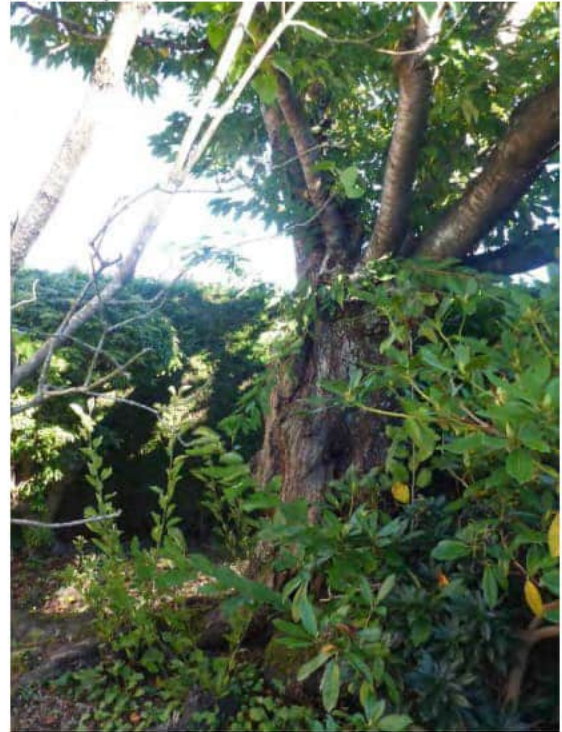
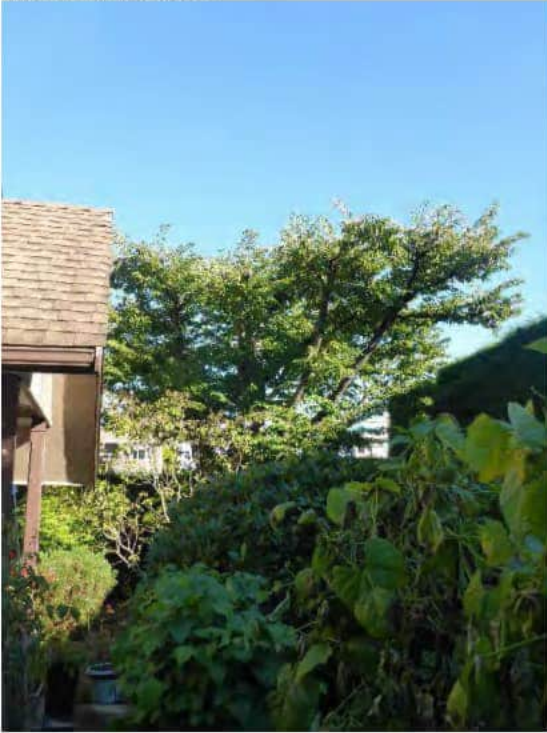
Photo #3, Tree #255

| Tag/ID | Survey ID | Loc | # of Trees | Common name,<br>(Botanical) | DBH<br>ISA | DBH<br>CITY | DBH<br>TPZ | Bylaw Y/N | Ht (m) | Spr (m) | LCR (%) | Class | Assessment Findings: | Viability | Optimal<br>RPZ | City RPZ<br>(mIn) | ACTION | RPZ (m) | CPZ (m) |
|---|---|---|---|---|---|---|---|---|---|---|---|---|---|---|---|---|---|---|---|
| 255 | Y | ON | 1 | Flowering cherry<br>(Prunus serrulata) | 80 | 80 | 80 | Y | 7 | 1 W, S5 | 60 | 0 | <ul style="list-style-type: none"> <li>• Topped at 6m above grade with epicormic growth.</li> <li>• 30cm scaffold historically girdled (not severe).</li> <li>• Roots restricted on the south and west side causing walkway heaving.</li> <li>• Decay observed on a 20cm and 40cm diameter exposed roots on the south and north side respectively.</li> <li>• Cankered; Historic branch breakage.</li> <li>• Cavity with calluses on the north side of the stem at 1.5m above grade.</li> </ul> RATIONALE:<br>POOR CONDITION IN DIRECT CONFLICT WITH THE UNDERGROUND PARKING STRUCTURE. | P | | 5.2 m | REMOVE | | |

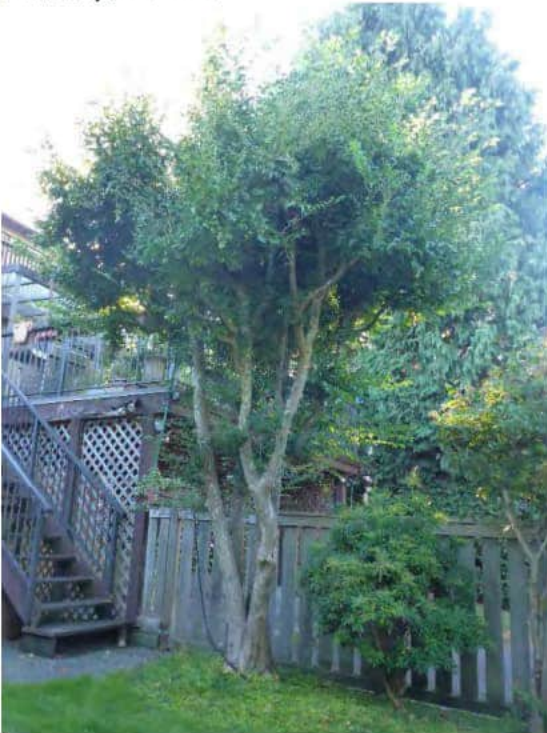
Photo #7, Tree #258

| Tag/ID | Survey ID | Loc | # of Trees | Common name,<br>( <i>Botanical</i> ) | DBH<br>ISA | DBH<br>CITY | DBH<br>TPZ | Bylaw Y/N | Ht (m) | Spr (m) | LCR (%) | Class | Assessment Findings: | Viability | Optimal<br>RPZ | City RPZ<br>(min) | ACTION | RPZ (m) | CPZ (m) |
|---|---|---|---|---|---|---|---|---|---|---|---|---|---|---|---|---|---|---|---|
| 258 | Y | ON | 1 | Japanese snowbell<br>( <i>Styrax japonicus</i> ) | 17+15<br>+16+1<br>3+9 | 48 | 32 | Y | 4 | 2.5 | 30 | 0 | <ul style="list-style-type: none"> <li>• DBH of a single stem equivalent is calculated based on the area of measured stems (17+15+16+13+9cmø) at 1.4m above grade for protection setback calculation purposes.</li> <li>• Multiple stems attached at ~0.2m above grade.</li> <li>• Crown raise pruned to 2.5m above grade with epicormic growth.</li> <li>• Branch collar decay.</li> <li>• Possible root restriction from concrete pads ~1.0m away on the south and west side.</li> <li>• Dead branches.</li> </ul> <p>RATIONALE:<br/>DIRECT CONFLICT WITH THE UNDERGROUND PARKING STRUCTURE.</p> | P | 4.5 | 3.1 m | REMOVE | | |

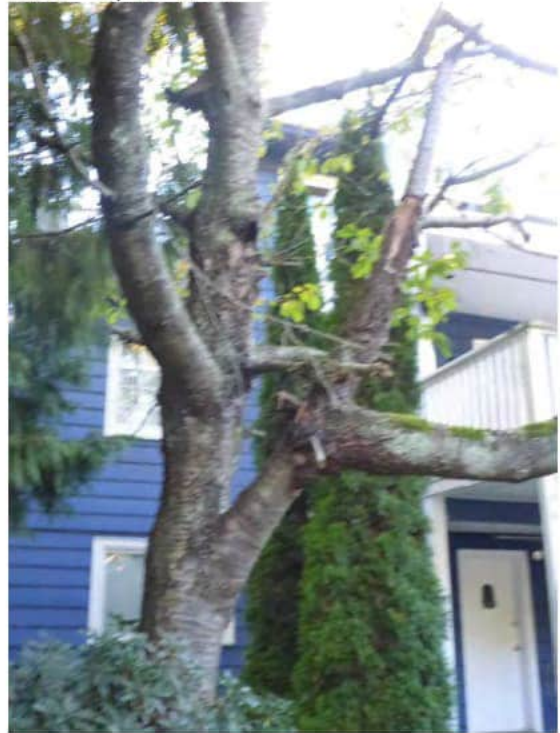
Photo #10, Tree #261

| Tag/ID | Survey ID | Loc | # of Trees | Common name,<br>(Botanical) | DBH<br>ISA | DBH<br>CITY | DBH<br>TPZ | Bylaw Y/N | Ht (m) | Spr (m) | LCR (%) | Class | Assessment Findings: | Viability | Optimal<br>RPZ | City RPZ<br>(min) | ACTION | RPZ (m) | CPZ (m) |
|---|---|---|---|---|---|---|---|---|---|---|---|---|---|---|---|---|---|---|---|
| 261 | Y | ON | 1 | Flowering cherry<br>(Prunus serrulata) | 33 | 33 | 33 | Y | 10 | 4.0 S1 | 30 | G | <ul style="list-style-type: none"> <li>• Crown biased to the west (shaded by #260).</li> <li>• Severely cankered.</li> <li>• Topped at 3m with dead and decaying branches (some have failed).</li> <li>• ~30% dieback overall.</li> </ul> <p>RATIONALE:<br/>POOR CONDITION IN DIRECT CONFLICT WITH THE UNDERGROUND PARKING STRUCTURE.</p> | P | | 2.1 m | REMOVE | | |

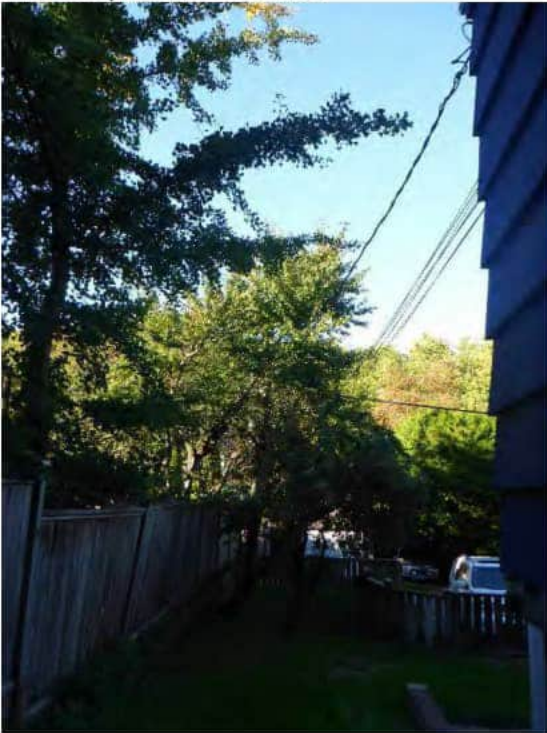
Photo #13, Tree #266 and #267

| Tag/ID | Survey ID | Loc | # of Trees | Common name,<br>( <i>Botanical</i> ) | DBH<br>ISA | DBH<br>CITY | DBH<br>TPZ | Bylaw Y/N | Ht (m) | Spr (m) | LCR (%) | Class | Assessment Findings: | Viability | Optimal<br>RPZ | City RPZ<br>(min) | ACTION | RPZ (m) | CPZ (m) |
|---|---|---|---|---|---|---|---|---|---|---|---|---|---|---|---|---|---|---|---|
| 266 | Y | ON | 1 | Common pear<br>( <i>Pyrus communis</i> ) | 14+11 | 25 | 18 | Y | 3 | 2.5 | 35 | G | <ul style="list-style-type: none"> <li>DBH of a single stem equivalent is calculated based on the area of measured stems (14+11cmø) at 1.4m above grade for protection setback calculation purposes.</li> <li>Butt decay.</li> <li>Brown spots on foliage.</li> <li>Leaning and crown biased to the east.</li> <li>Upper crown contact with utility wires.</li> </ul> RATIONALE:<br>POOR CONDITION IN DIRECT CONFLICT WITH THE UNDERGROUND PARKING STRUCTURE. | P | 4.5 | 1.6 m | REMOVE | | |

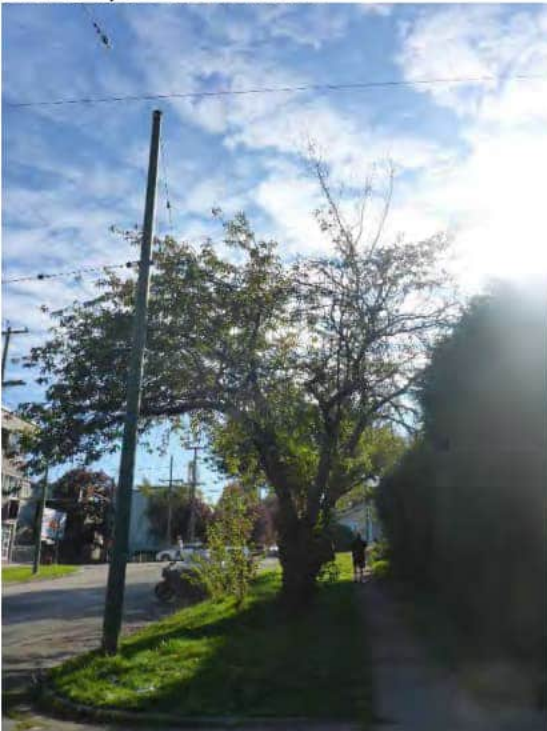
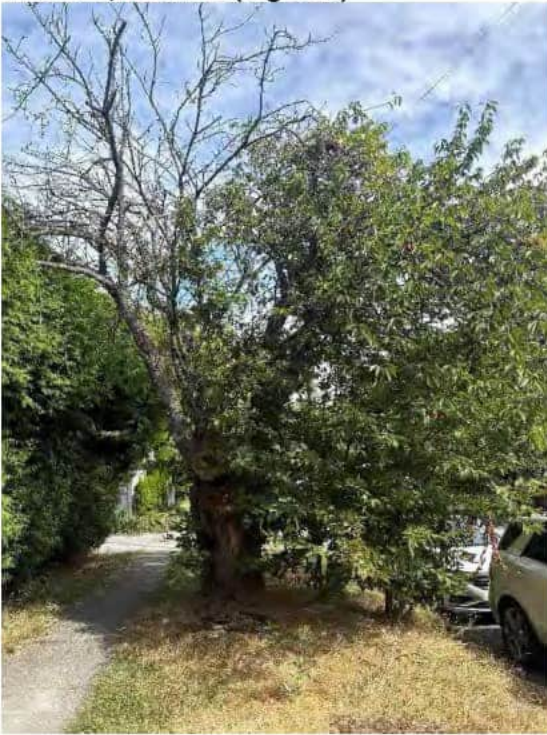
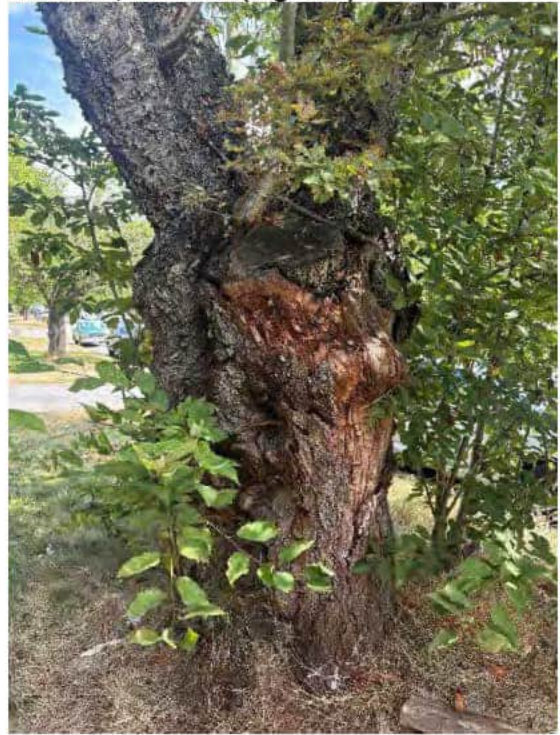
Photo #15, Tree #C01 and H01

| Tag/ID | Survey ID | Loc | # of Trees | Common name,<br>(Botanical) | DBH<br>ISA | DBH<br>CITY | DBH<br>TPZ | Bylaw Y/N | Ht (m) | Spr (m) | LCR (%) | Class | Assessment Findings: | Viability | Optimal<br>RPZ | City RPZ<br>(min) | ACTION | RPZ (m) | CPZ (m) |
|---|---|---|---|---|---|---|---|---|---|---|---|---|---|---|---|---|---|---|---|
| C01 | Y | CITY | 1 | Flowering cherry<br>(Prunus serrulata) | 105 | 105 | 105 | Y | 10 | 5.5 W5 | 35 | O | <ul style="list-style-type: none"> <li>• Cankered.</li> <li>• Downward extending branch collar and stem decay from historic scaffold removal.</li> <li>• 25cm scaffold decay (east side of crown).</li> <li>• Epicormic growth.</li> <li>• Eastern crown contact with overhead utility wires.</li> <li>• Sidewalk heaving on the west side from restricted roots.</li> <li>• NW crown (~20% of overall crown %) is dead.</li> </ul> <p>RATIONALE:</p> <ul style="list-style-type: none"> <li>• CONFLICTS WITH LOGISTICS AND WORK PLAN PLUS CIVIL WORKS (SEE NOTES ON APPENDIX C). PA TO OBTAIN APPROVAL FROM THE PARKS DEPARTMENT - URBAN FORESTRY HAVE BEEN RECEIVED. CONDITIONS OF APPROVAL MUST BE MET BY PROJECT BEFORE CUTTING</li> </ul> | P | | 6.8 m | REMOVE | | |

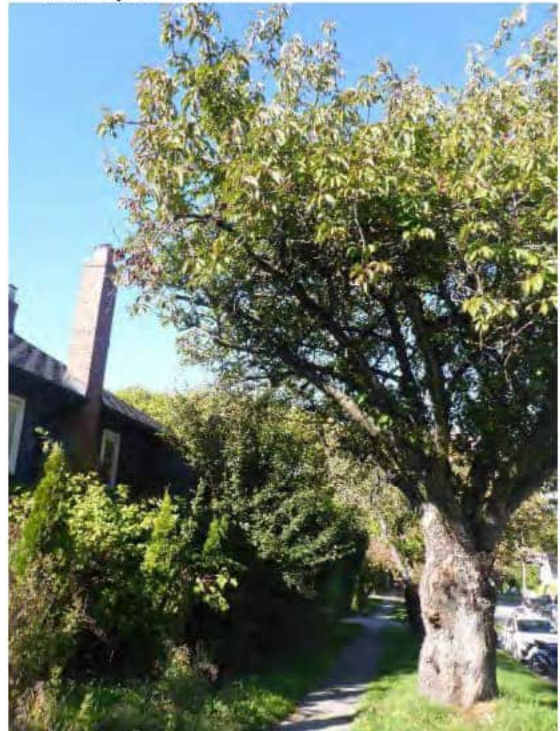
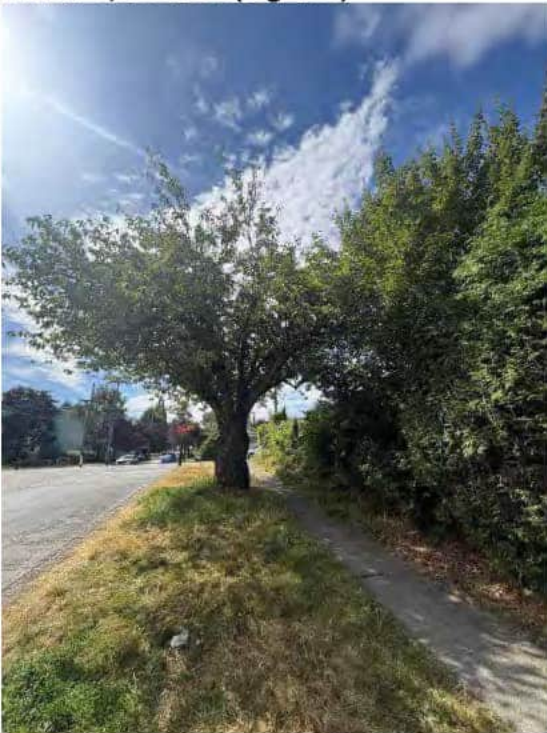
Photo #16, Tree #C02

| Tag/ID | Survey ID | Loc | # of Trees | Common name,<br>( <i>Botanical</i> ) | DBH<br>ISA | DBH<br>CITY | DBH<br>TPZ | Bylaw Y/N | Ht (m) | Spr (m) | LCR (%) | Class | Assessment Findings: | Viability | Optimal<br>RPZ | City RPZ<br>(min) | ACTION | RPZ (m) | CPZ (m) |
|---|---|---|---|---|---|---|---|---|---|---|---|---|---|---|---|---|---|---|---|
| C02 | Y | CITY | 1 | Flowering cherry<br>( <i>Prunus serrulata</i> ) | 110 | 110 | 110 | Y | 10 | 6 | 50 | 0 | <ul style="list-style-type: none"> <li>Few dead branches in the interior crown.</li> <li>Large pruning wounds with possible decay from historic limb removal.</li> <li>Sidewalk heaving on the west side from restricted roots.</li> </ul> RATIONALE: <ul style="list-style-type: none"> <li>CONFLICTS WITH LOGISTICS AND WORK PLAN PLUS CIVIL WORKS (SEE NOTES ON APPENDIX C). PA TO OBTAIN APPROVAL FROM THE PARKS DEPARTMENT - URBAN FORESTRY HAVE BEEN RECEIVED. CONDITIONS OF APPROVAL MUST BE MET BY PROJECT BEFORE CUTTING.</li> </ul> | G | 11 | 7.2 m | REMOVE | | |

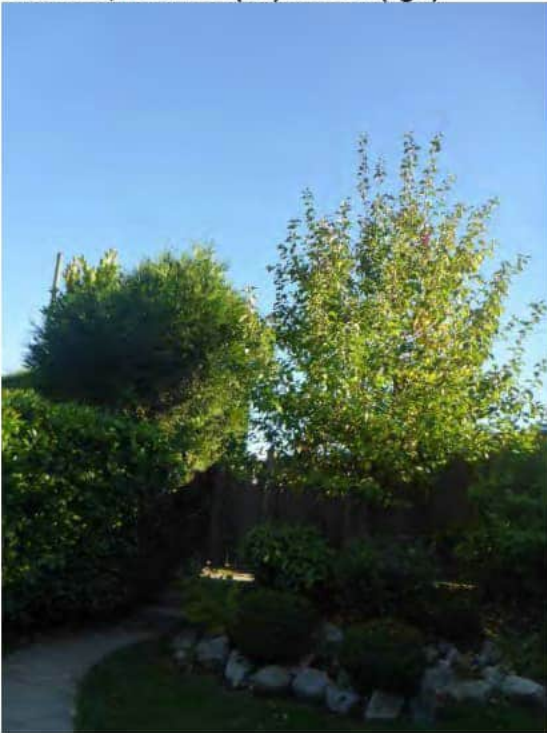
Photo #17, Tree #C03 (left) and C04 (right)

| Tag/ID | Survey ID | Loc | # of Trees | Common name,<br>( <i>Botanical</i> ) | DBH<br>ISA | DBH<br>CITY | DBH<br>TPZ | Bylaw Y/N | Ht (m) | Spr (m) | LCR (%) | Class | Assessment Findings: | Viability | Optimal<br>RPZ | City RPZ<br>(min) | ACTION | RPZ (m) | CPZ (m) |
|---|---|---|---|---|---|---|---|---|---|---|---|---|---|---|---|---|---|---|---|
| C03 | N | CITY | 1 | Western redcedar<br>( <i>Thuja plicata</i> ) | 25, 15 | 40 | 25 | Y | 4 | 1.7 | 80 | G | <ul style="list-style-type: none"> <li>DBH is representative of the largest of measured stems (25, 15cmØ) at 1.4m above grade for protection setback calculation purposes.</li> <li>Topped at 1m with weakly attached replacement leaders.</li> <li>Crown reduction pruned for sidewalk and entry way clearance on the west and south side.</li> <li>Growing on a north facing slope, roots are likely asymmetrical.</li> <li>Lower crown merged with H05.</li> </ul> RATIONALE: <ul style="list-style-type: none"> <li>WE UNDERSTAND THAT APPROVAL FROM THE PARKS DEPARTMENT - URBAN FORESTRY HAVE BEEN RECEIVED. CONDITIONS OF APPROVAL MUST BE MET BEFORE CUTTING.</li> </ul> | P | 3.7 | 2.6 m | REMOVE | | |
| C04 | N | CITY | 1 | Apple<br>( <i>Malus sp.</i> ) | 13 | 13 | 13 | Y | 5 | 1.8 | 80 | 0 | <ul style="list-style-type: none"> <li>Growing on a north facing slope, roots are likely asymmetrical.</li> </ul> RATIONALE: <ul style="list-style-type: none"> <li>WE UNDERSTAND THAT APPROVAL FROM THE PARKS DEPARTMENT - URBAN FORESTRY HAVE BEEN RECEIVED. CONDITIONS OF APPROVAL MUST BE MET BEFORE CUTTING.</li> </ul> | G | 3.8 | 0.8 m | REMOVE | | |

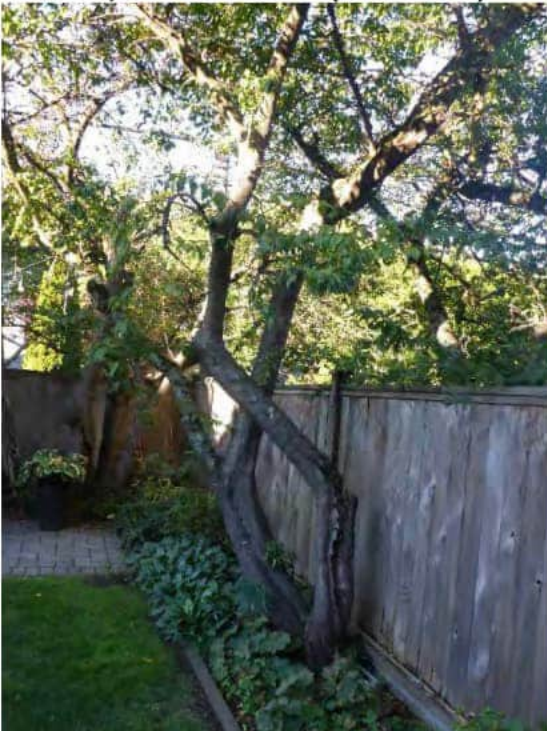
Photo #19, Tree #N02 and N03 (front and rear)

| Tag/ID | Survey ID | Loc | # of Trees | Common name,<br>(Botanical) | DBH | ISA | DBH | CITY | DBH | TPZ | Bylaw Y/N | Ht (m) | Spr (m) | LCR (%) | Class | Assessment Findings: | Viability | Optimal<br>RPZ | City RPZ<br>(min) | ACTION | RPZ (m) | CPZ (m) |
|---|---|---|---|---|---|---|---|---|---|---|---|---|---|---|---|---|---|---|---|---|---|---|
| <b>N02</b> | <b>N</b> | OFF | 1 | Common plum<br>(Prunus domestica) | 24, 20 | | 44 | | <b>24</b> | | Y | 9 | 3.9 | 65 | G | <ul style="list-style-type: none"> <li>• DBH is representative of the largest of measured stems (24, 20cmø).</li> <li>• Root restricted on the east side from grade differential of ~0.6m (retaining wall).</li> <li>• ~10% dieback.</li> <li>• ~3.4m crown overhanging development site.</li> <li>• Severe stem decay; eastern stem is ~60% cavity from decay (failure direction would most likely be W given the location of girdling).</li> <li>• This tree is likely high risk; reassessment required before construction commences.</li> </ul> | P | 5.9 | 2.9 m | <b>PROTECT</b> | | 3.9 |
| <b>N03</b> | <b>N</b> | OFF | 1 | Common plum<br>(Prunus domestica) | 28, 24, 27 | | 79 | | <b>28</b> | | Y | 7 | 4.5 | 30 | G | <ul style="list-style-type: none"> <li>• DBH is representative of the largest of measured stems (28, 24, 27cmø).</li> <li>• Root restricted on the east side from grade differential of ~0.6m (retaining wall).</li> <li>• Topped with weakly attached replacement leaders.</li> <li>• ~35% dieback.</li> <li>• Drop crotch pruned for utility line clearance.</li> <li>• ~3.5m crown overhanging development site.</li> <li>• Severe trunk decay observed on all 3 stems.</li> <li>• ~15cm wide Ganoderma fruiting body observed on the east side of the eastern stem at ~0.1m above grade.</li> <li>• This tree is likely high risk; reassessment required before construction commences.</li> </ul> | P | 6.5 | 5.1 m | <b>PROTECT</b> | | 4.5 |

- Per above, these trees will be protected as shown on the Tree Management Drawing.
- We understand that the condition of these trees was referred to the neighbouring owner for their information and consideration for treatment in context to risk mitigation at their discretion, and there has been no action to date.
- The project arborist will re-assess these trees prior to commencement of construction to provide updated recommendations in context to worker safety within the site.
