Vancouver Green Infrastructure

PERFORMANCE MONITORING REPORT 2023-2025

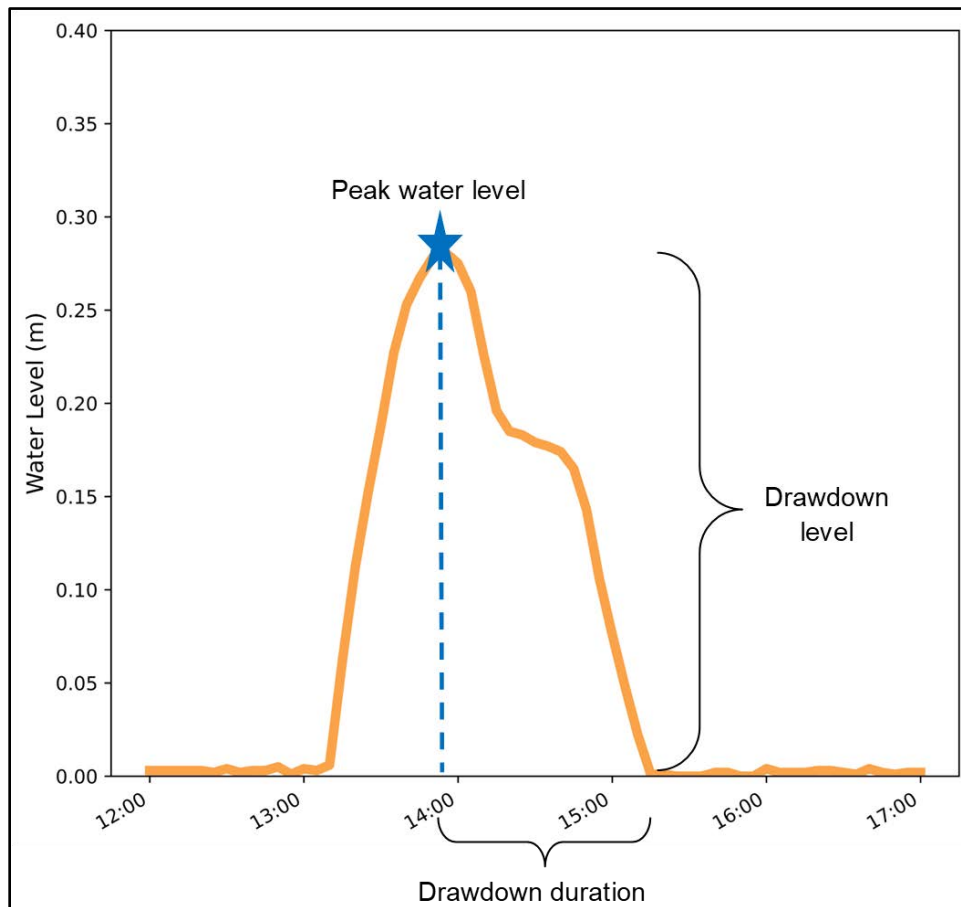
Figure 3: Example of water level response to show calculation of drawdown duration and drawdown rate

The water level and rainfall data were plotted in Python to check for any inconsistencies or invalid data, any outliers or missing values. Using the *find_peaks* function in Python, the water level data was analyzed to determine drawdown rate and drawdown duration for each rainfall event. Drawdown rate is defined as the rate at which water exits the GRI system during and following a rainfall event and is calculated by dividing the drawdown level (from peak water level to water level before rainfall) by the drawdown duration (Figure 3). Drawdown rate is compared to the design infiltration rate. The design infiltration rate is determined by infiltration rate testing of native soils beneath the GRI system prior to construction and installation and is a conservative estimate of the real drawdown rate.

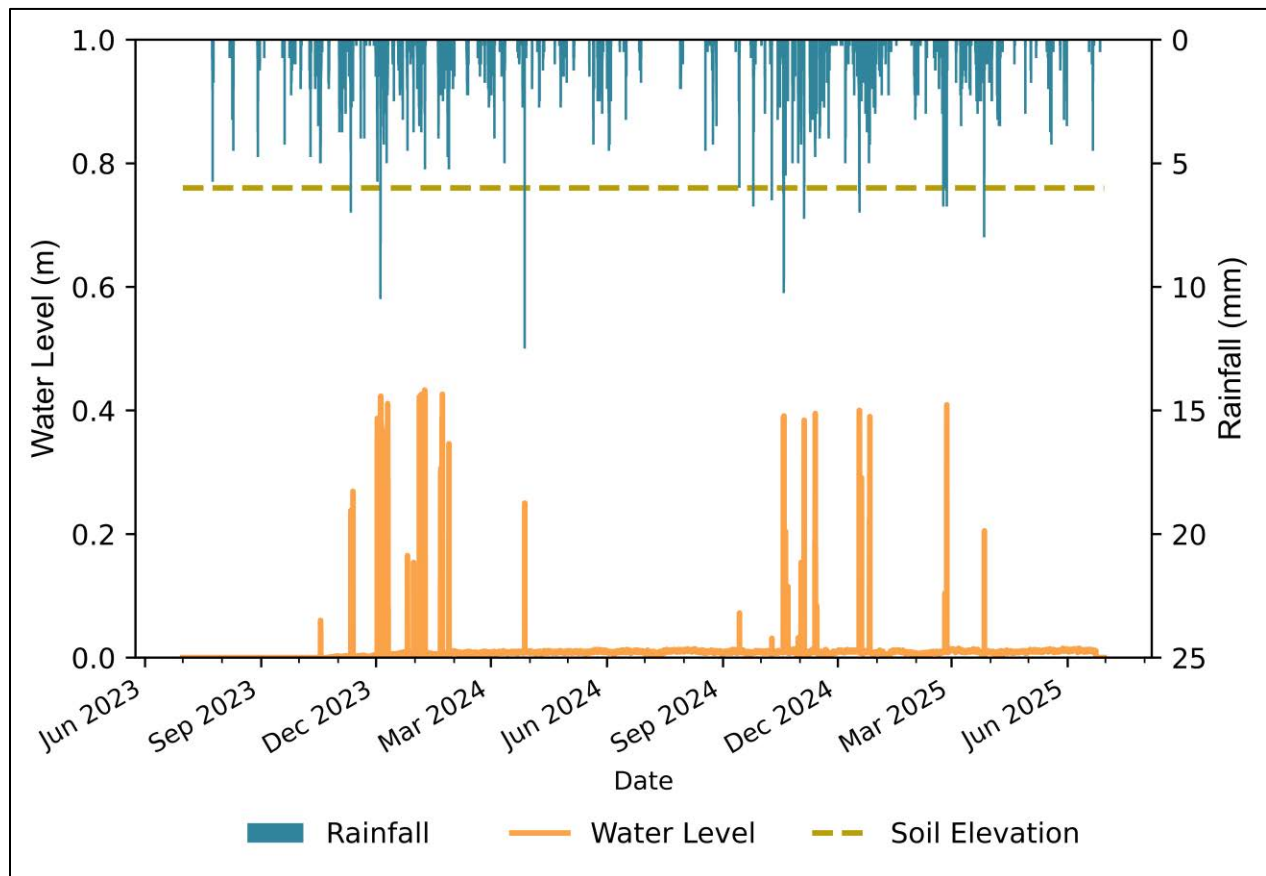
Figure 4: Average hourly water level response at 63rd Ave. and Yukon St. bioretention and total hourly rainfall at Manitoba rain gauge from July 1, 2023 to June 30, 2025

The monitoring well generally demonstrated a drawdown time of a few hours. Between 2018 and 2025, 110 events produced a water level change for which the drawdown time and drawdown rate were calculated, as shown in Table 2. Water level and rainfall response from July 2023 to June 2025 are shown in Figure 4. Visual inspections of this site during a rainfall event in 2023 indicated only 20% of the area was ponded and not using the overflow (Figure 5).

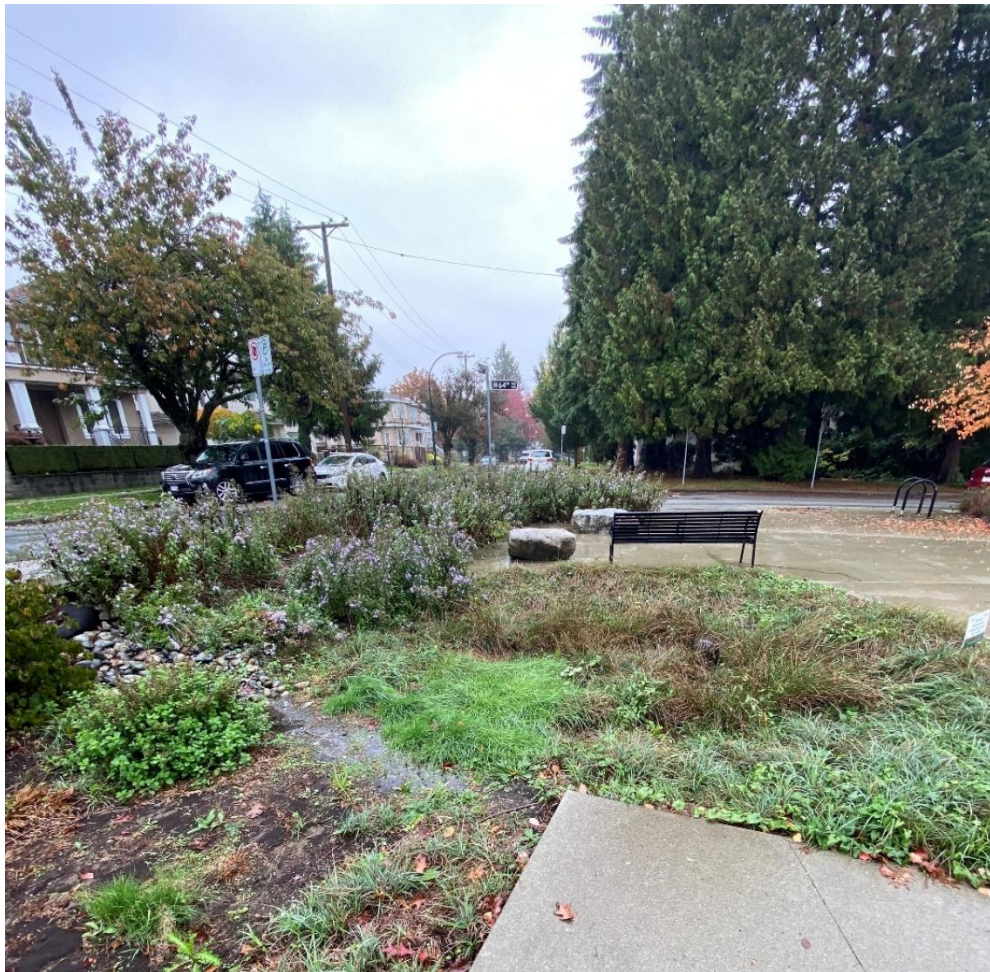
Figure 5: 63rd Ave. and Yukon St. bioretention during fall 2023 rainfall event. Only 20% of ponding area contained standing water

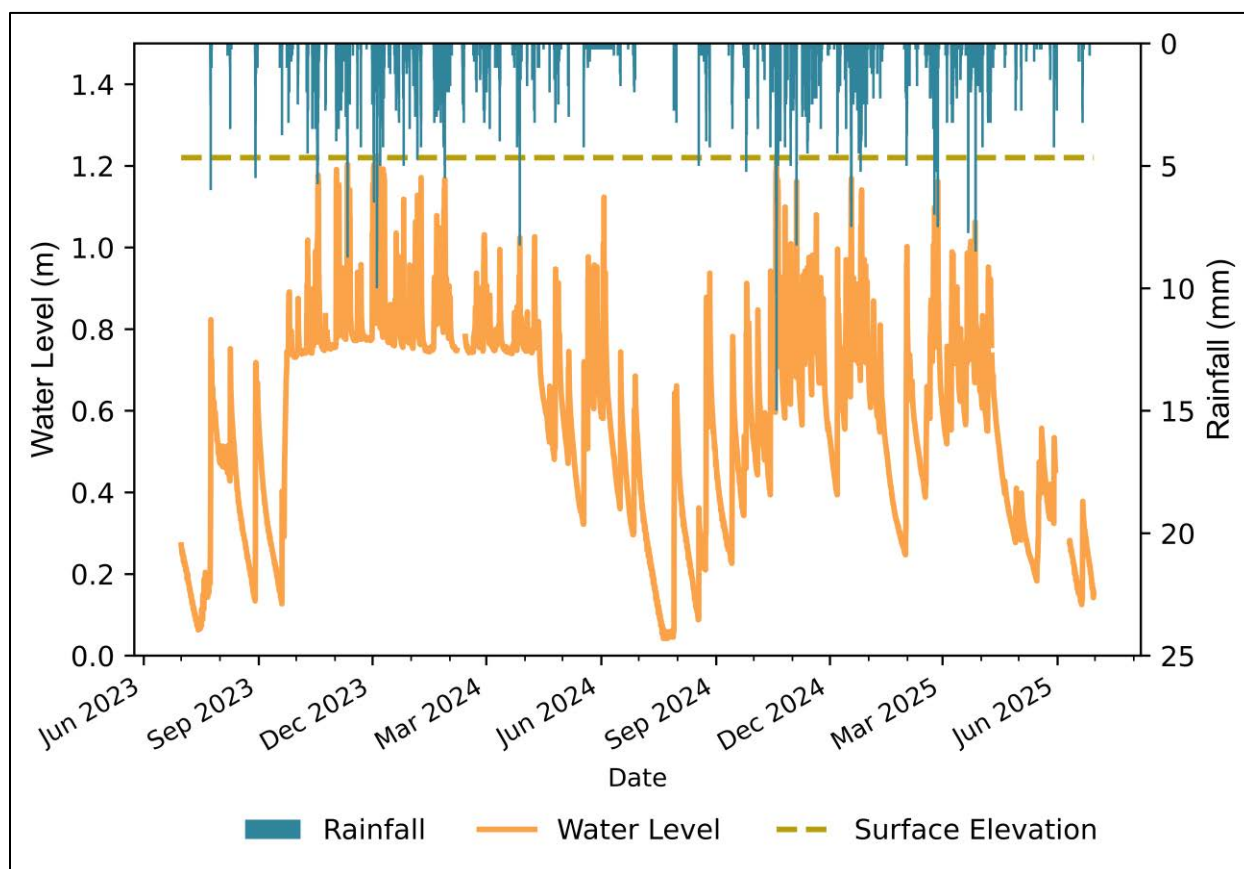
Figure 7: Average hourly water level response at Quebec St. and 2nd Ave. North RTT and total hourly rainfall at Creekside rain gauge from July 1, 2023 to June 30, 2025

The north well displayed water level changes for 245 rainfall events over the 2020-2025 monitoring period. The average drawdown rate has slightly decreased since the previous monitoring report from 8.7 mm/h to 7.8 mm/h, but still very similar. This well almost never fully drained down and often during the wet weather season had an elevated standing water level between rainfall events (Figure 7). The amount of sediment in the catchbasins and distribution pipes might have caused clogging of the system slowing down infiltration. Water level analysis showing drawdown duration and drawdown rate from 2020-2025 is shown in Table 3.

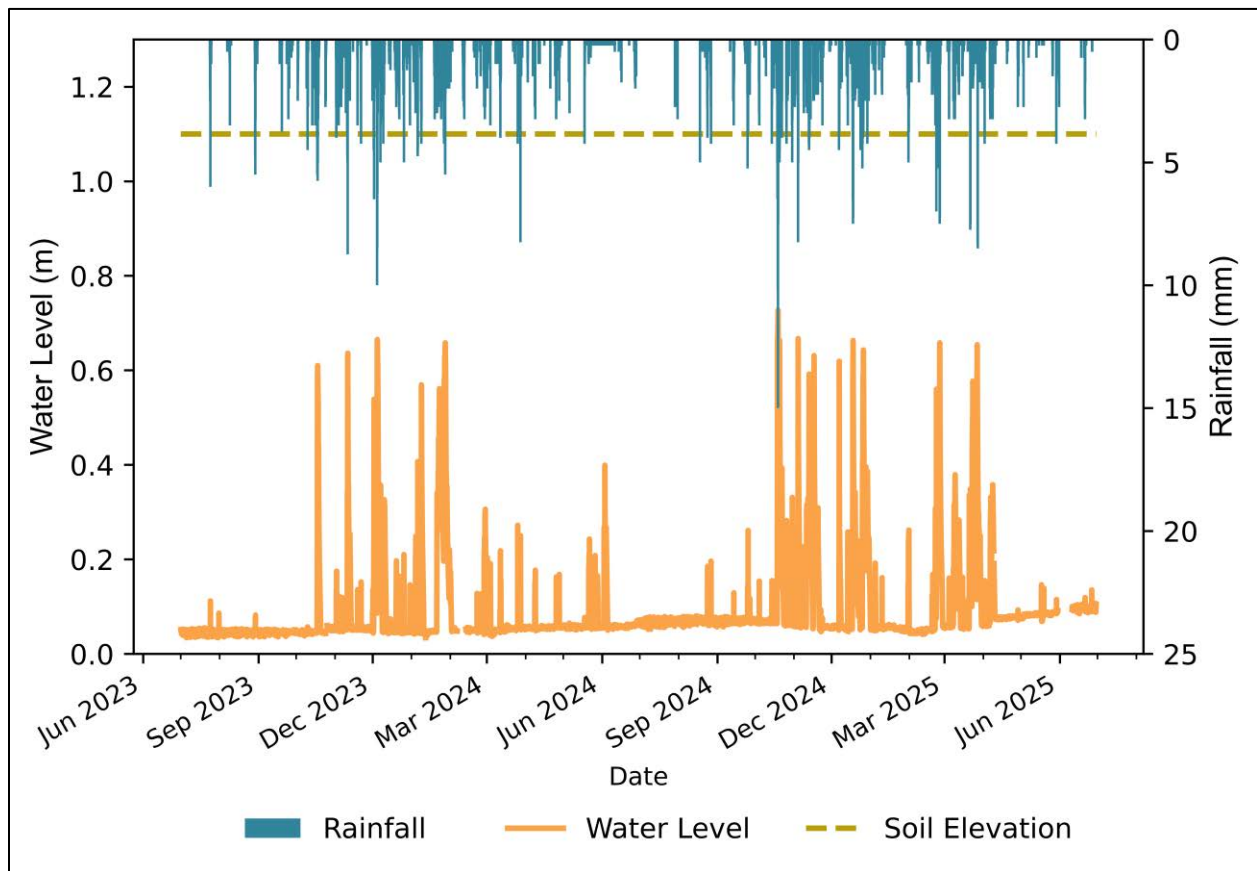
Figure 9: Average hourly water level response at Richards St. Block H bioretention and total hourly rainfall at Creekside rain gauge from July 1, 2023 to June 30, 2025

Drawdown times increased slightly since the last monitoring report from 14 hours in 2021-2023 to 18 hours in 2021-2025. The average drawdown rate has slightly decreased since the last report from 40 mm/h to 34 mm/h. The drawdown rate for typical and large rainfall events has decreased slightly, however the drawdown rate for extreme rainfall events has increased. Overall, the drawdown times and rates have still exceeded the design infiltration rate. Since the start of monitoring to June 2025, there have been 163 water level responses to rainfall events, with an average drawdown time of 18 h and an average drawdown rate of 34 mm/h. See Table 5 for the water level analysis and Figure 9 for the water level and rainfall response from July 2023 to June 2025.

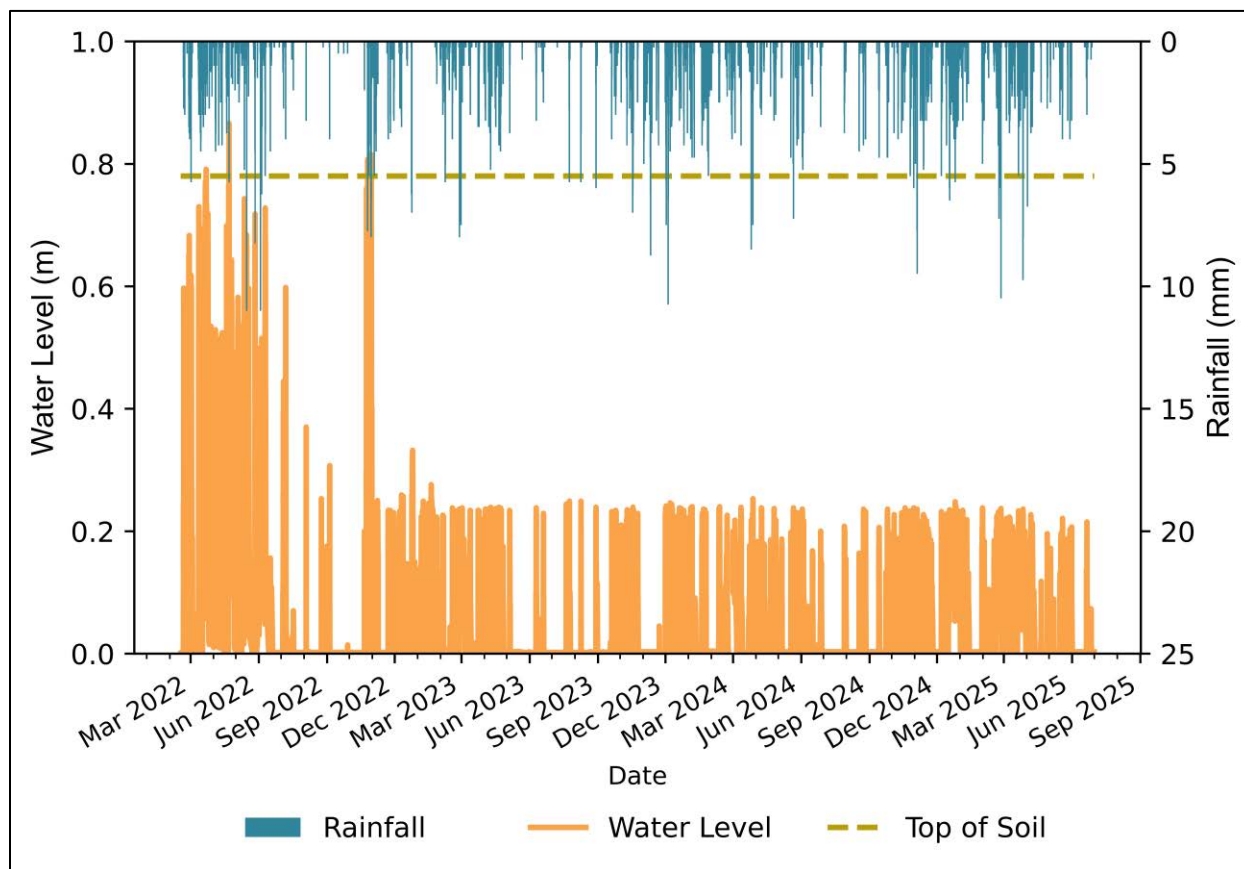
Figure 13: Average hourly water level response at Haro St. and Jervis St. bioretention and total hourly rainfall response at West End rain gauge from February 2022 to June 30, 2025

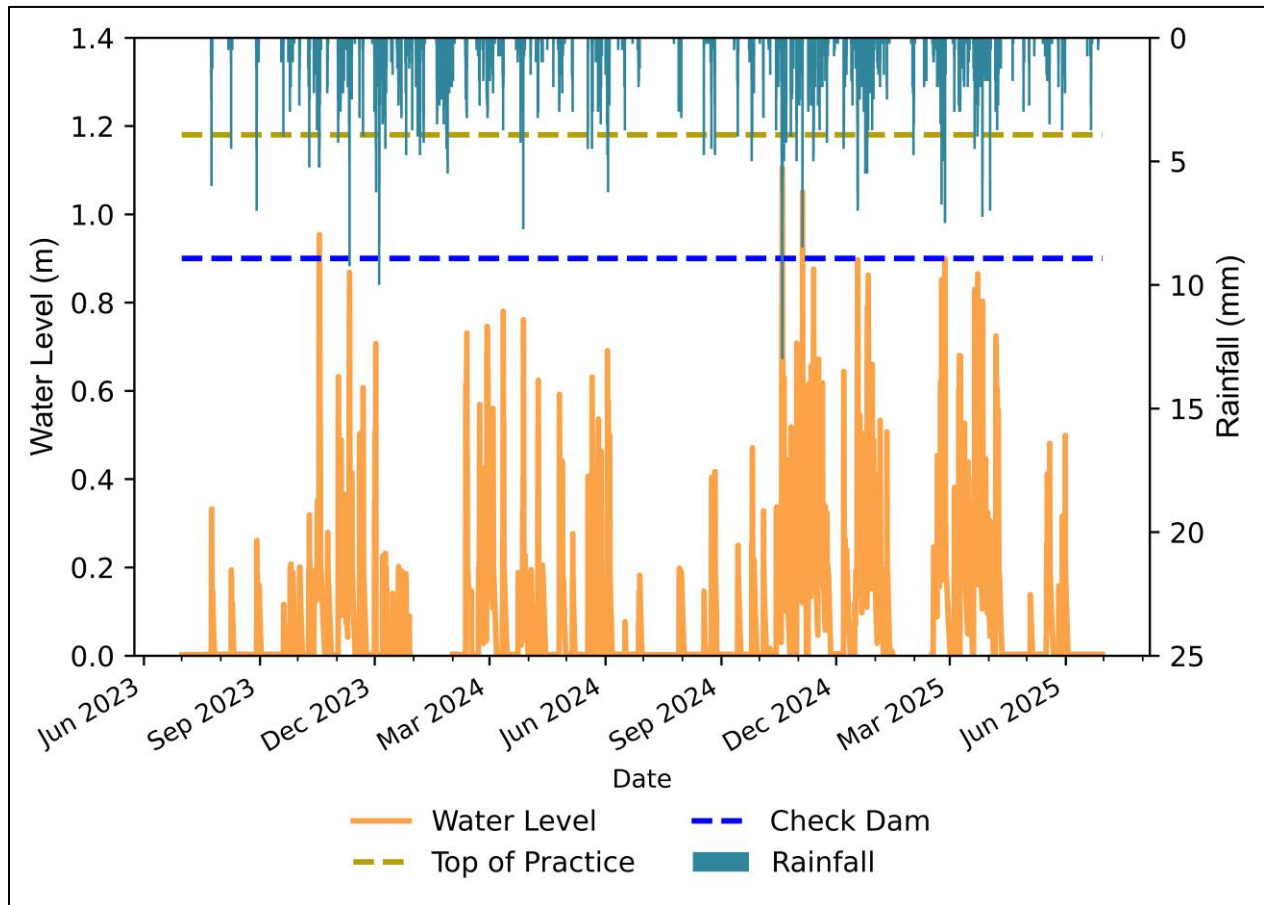
Figure 15: Average hourly water level response at W10th Ave. and Heather St. RTT and total hourly rainfall at Vancity rain gauge from July 1, 2023 to June 30, 2025

The system had not been flushed since it was constructed and during 2025 condition assessments, the east cleanout and the inlet catchbasins contained significant amount of sediment and debris. The distribution pipes have since been flushed/cleaned in summer 2025. We do not think that the sediment accumulation is affecting the drawdown rate, as the native soil is the likely limit on the drawdown rate, so the slower drawdown rate may be more representative of the true conditions at this site.

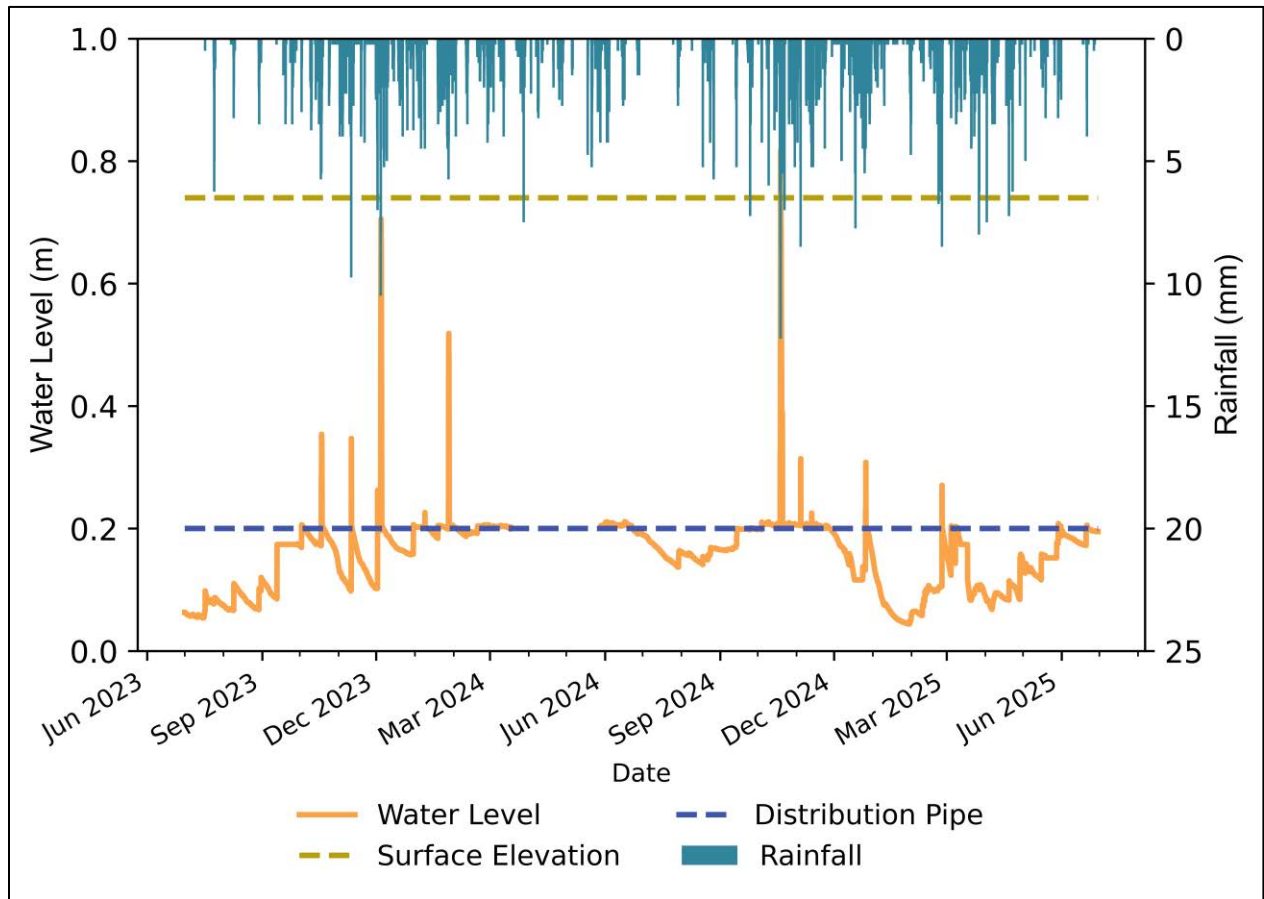
Figure 18: Average hourly water level response at Harriet Laneway infiltration trench and total hourly rainfall at Trout Lake rain gauge from July 1, 2023 to June 30, 2025

The monitoring well only responded to rainfall events over 24 mm. Standing water was always observed in the well, and the drawdown above the distribution pipe in the clear crush was quick but slowed below the distribution pipe as it infiltrated into the native soil. The new extension for the private property rear-yard drainage did not seem to have reduced the infiltration capacity of the system. During extreme rainfall events the water level did fill the depth of the trench and had a slow drawdown time exceeding 72 hours. However, the average drawdown rate exceeded the design infiltration rate, and has increased to 8.9 mm/h from 6.9 mm/h from the previous monitoring report. Water level response can be seen in Figure 18. Due to logger battery issues, data is missing between March 2024 and May 2024. Rainfall events, drawdown rates and drawdown durations are shown in Table 10.

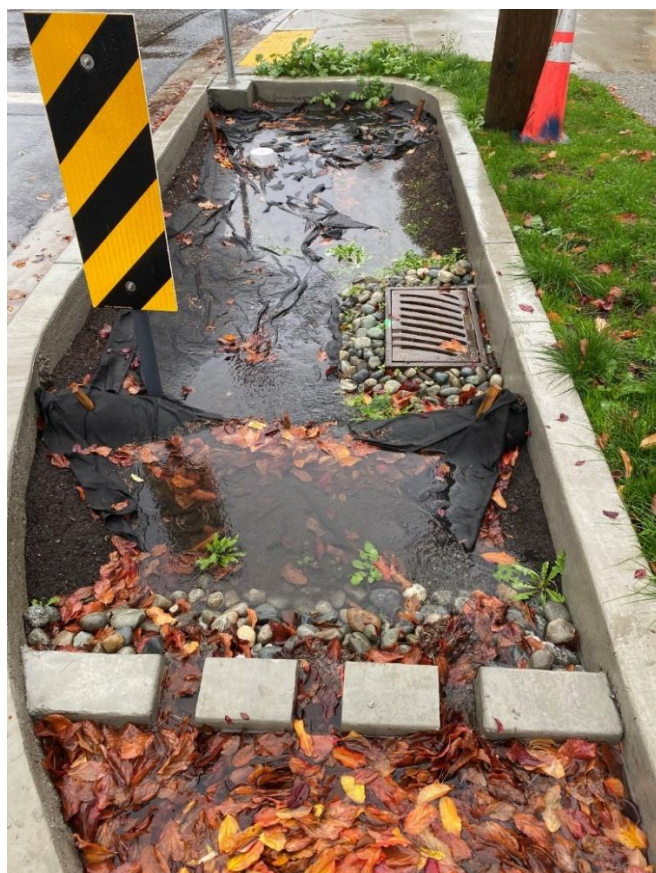
Figure 21: Lillooet St. and Kitchener St. bioretention during October 2023 large rainfall event prior to planting

The bioretention at Lillooet St. and Kitchener St. has a drainage area of 200 m². Since the geotechnical investigation found high native soil infiltration rates here, it was designed with no underdrain, merely 45-cm of growing medium above a 10-cm clear crush layer. It was designed with an infiltration rate of 70 mm/h, and from water level monitoring it had been found to have an average drawdown rate of 41 mm/h, and a very quick average drawdown duration of 6.3 hours. Water level response is shown Figure 20 and water level analysis is shown in Table 12. The system was inspected during a rainfall event after it was newly constructed but not yet planted, and the ponded area was about 90% and was not using the overflow (Figure 21).

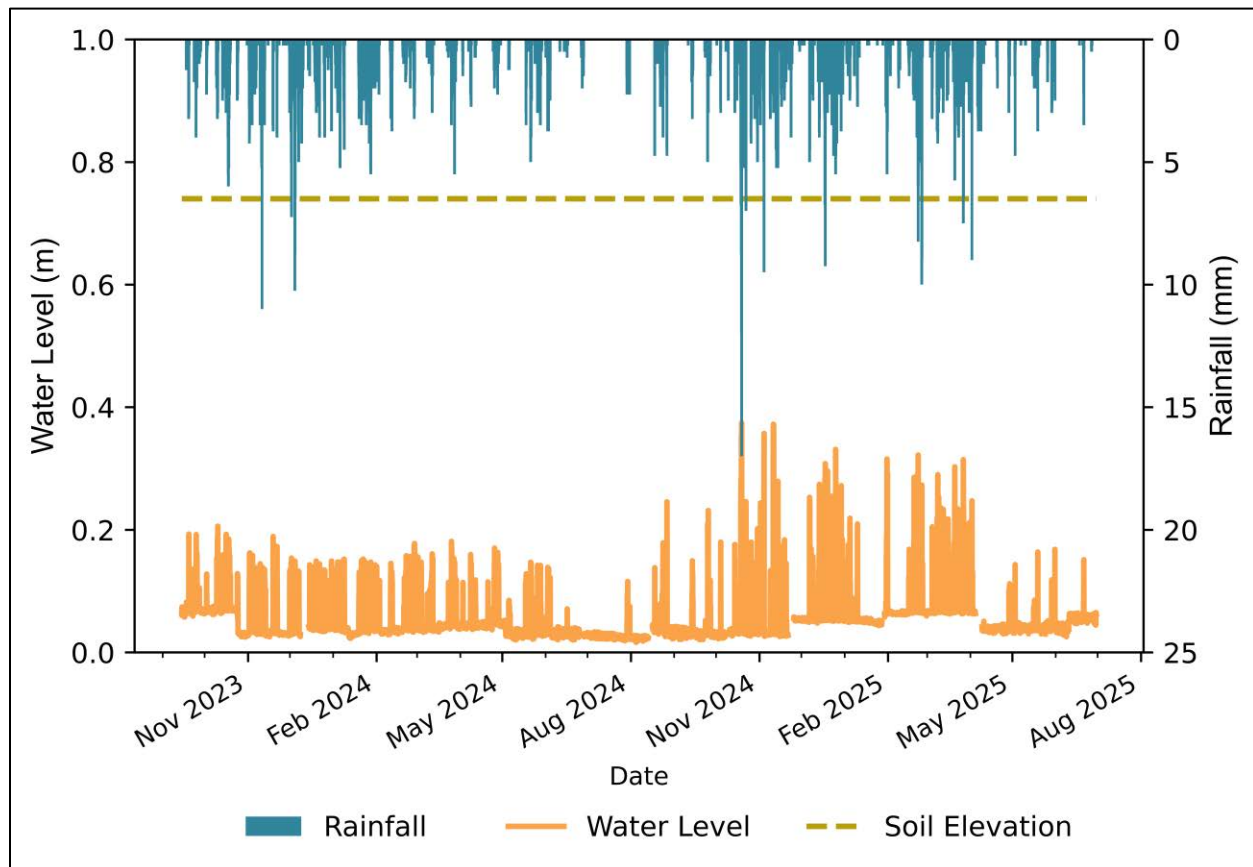
Figure 22: Average hourly water level response at Windermere St. and Grant St. bioretention and total hourly rainfall at Templeton Secondary School rain gauge from September 2023 to June 30, 2025

The design of this bioretention practice is the same as other bioretention in this area. It contains a 10-cm clear crush drainage layer, overlain by a non-woven geotextile and a 45-cm growing medium layer with no underdrain and an overflow catchbasin. This system has a larger drainage area of 435 m². The average drawdown rate was slightly higher in this bioretention system at 47 mm/h and it also exhibited a very quick average drawdown duration of 5.5 hours. See Figure 22 for water level response and Table 13 for water level analysis. The system was inspected after it was newly constructed but not yet planted during a large rainfall event in October 2023 and was fully ponded and using the overflow. Observations during large rainfall events since have had it less ponded (60%) but still using the overflow.

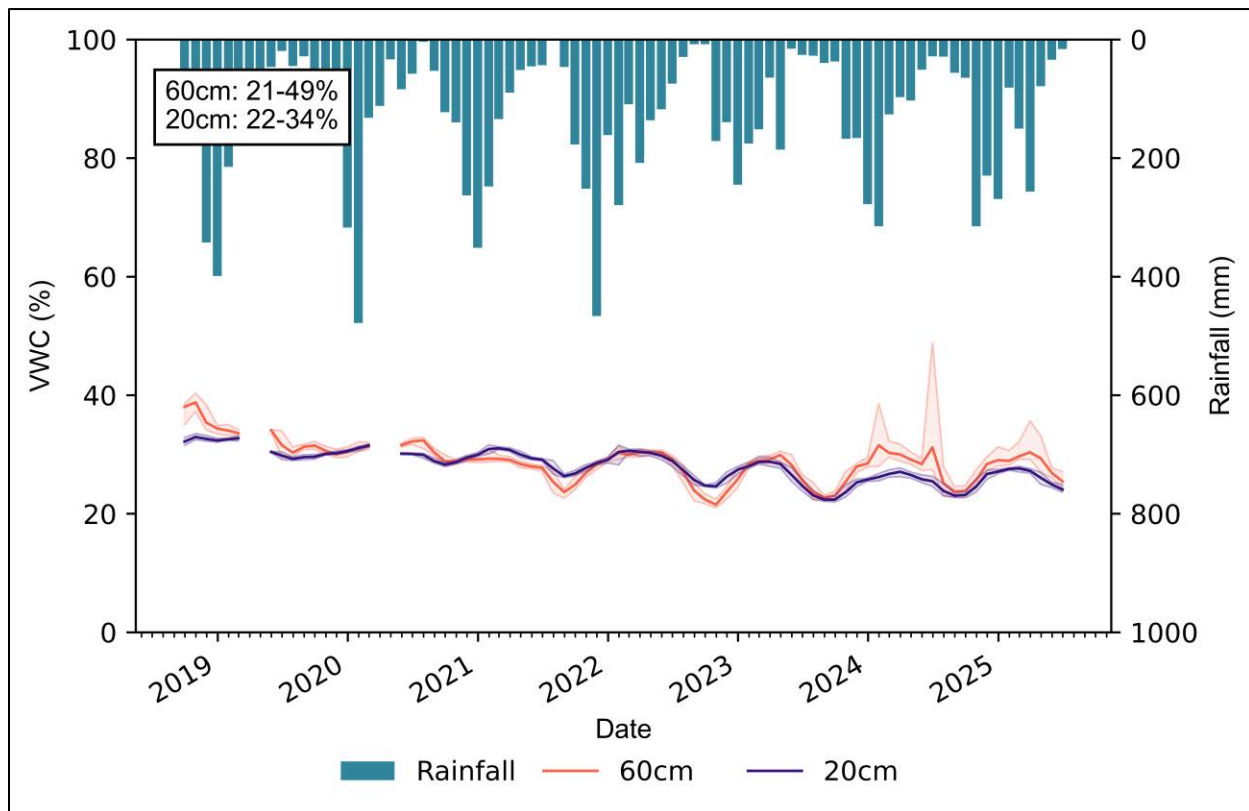
Figure 27: Monthly VWC maximums, minimums and means at 60-cm and 20-cm depth at Quebec St. and 1st Ave. RTT and total monthly rainfall at Creekside rain gauge from 2018 to 2025

readings. Some corresponded to rainfall, but the highest soil moisture occurred in June 2024. The reason was unknown for this spike. Possible reasons include the sensor aging and starting to malfunction, the sensor tip moving within the structural soil or nearby trees being watered causing a spike in moisture levels. However we did not see the same response in the 20-cm depth sensor. The 20-cm depth sensor had little variation and the soil moisture ranged from 22-34%. Rainfall and VWC monthly maximums, minimums and means for the 60-cm and 20-cm depth sensors are shown in Figure 27.

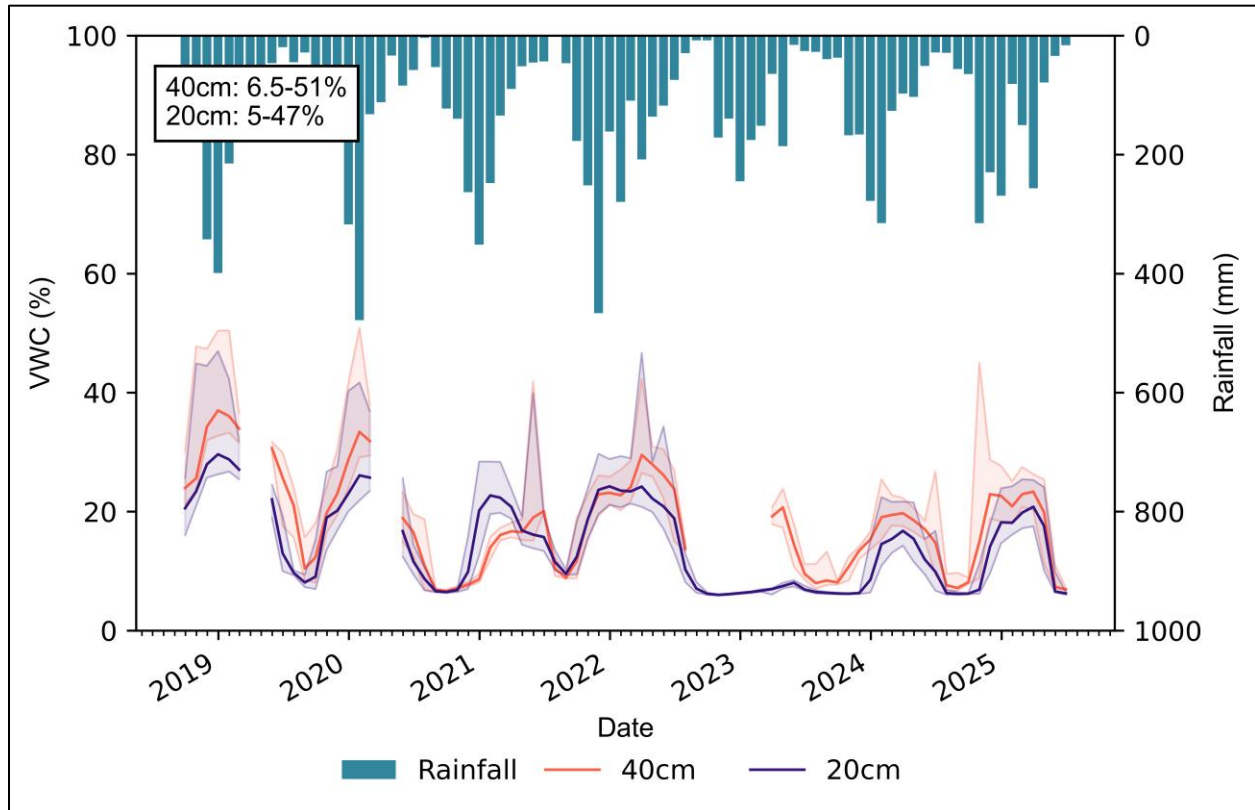
Figure 28: Monthly VWC maximums, minimums and means at 40-cm and 20-cm depth at Quebec St. and 1st Ave. bioswale and total monthly rainfall at Creekside rain gauge from 2018 to 2025

and the 20-cm depth ranged from 5-47%. The 20-cm depth sensor showed very little response during 2023, but had begun to show variation in VWC in 2024. The soil moisture at the 40-cm depth were generally higher than at 20-cm. The pronounced seasonal variation compared to the other sites is likely influenced by the GRI typology. The soils in a bioswale are more exposed to evaporation and transpiration that can cause moisture loss. Rainfall and VWC monthly maximums, minimums and means for the 40-cm and 20-cm depth are shown in Figure 28.

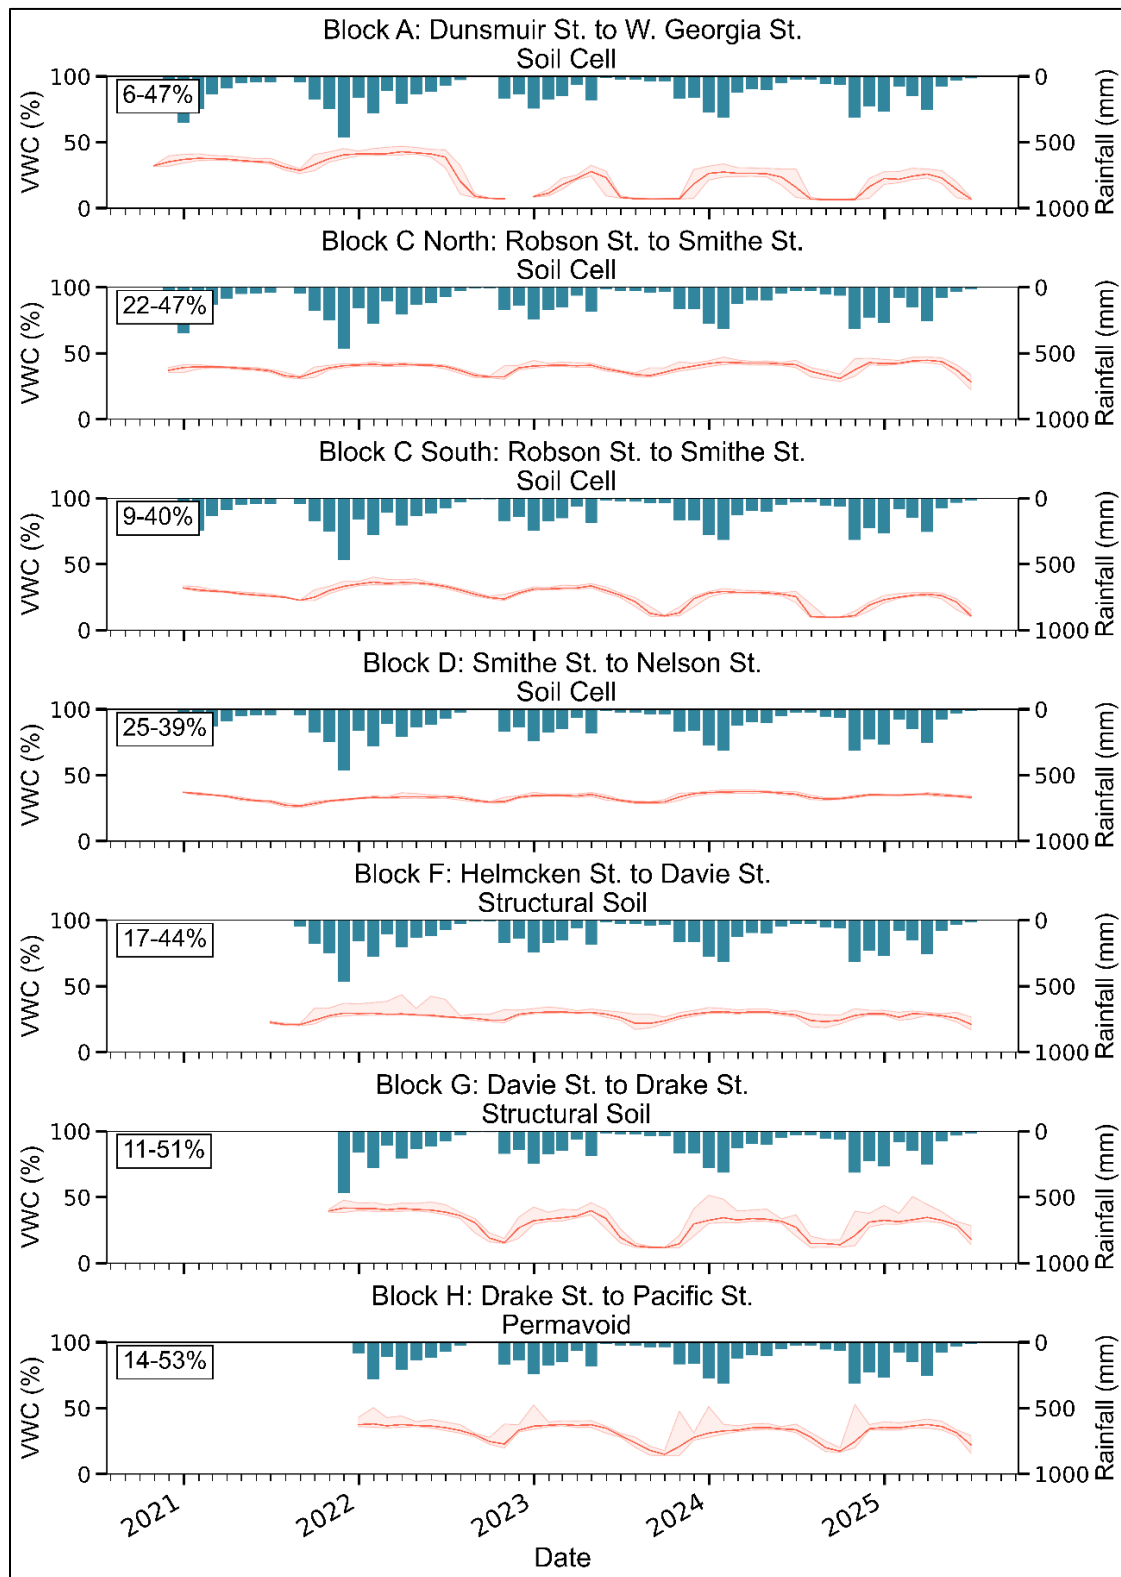
Figure 29: Monthly VWC maximums, minimums and means for Richards St. Block A-H and total monthly rainfall at Creekside rain gauge from 2021 to June 30, 2025

A trend among the soil moisture monitoring at all blocks was that the lowest soil moisture occurred in September, which was after months of very low rainfall, and before higher rainfalls in October. The exception to this was summer 2021 for Blocks A-D, though the moisture likely stayed high in these months since the trees were new and were receiving regular watering. Establishment period watering stopped in summer 2023 for Blocks A-D, and November 2023 for Blocks E-G, and so summer 2024 was the first summer without external watering, and the low moisture levels were not significantly lower than in 2023 and 2022.

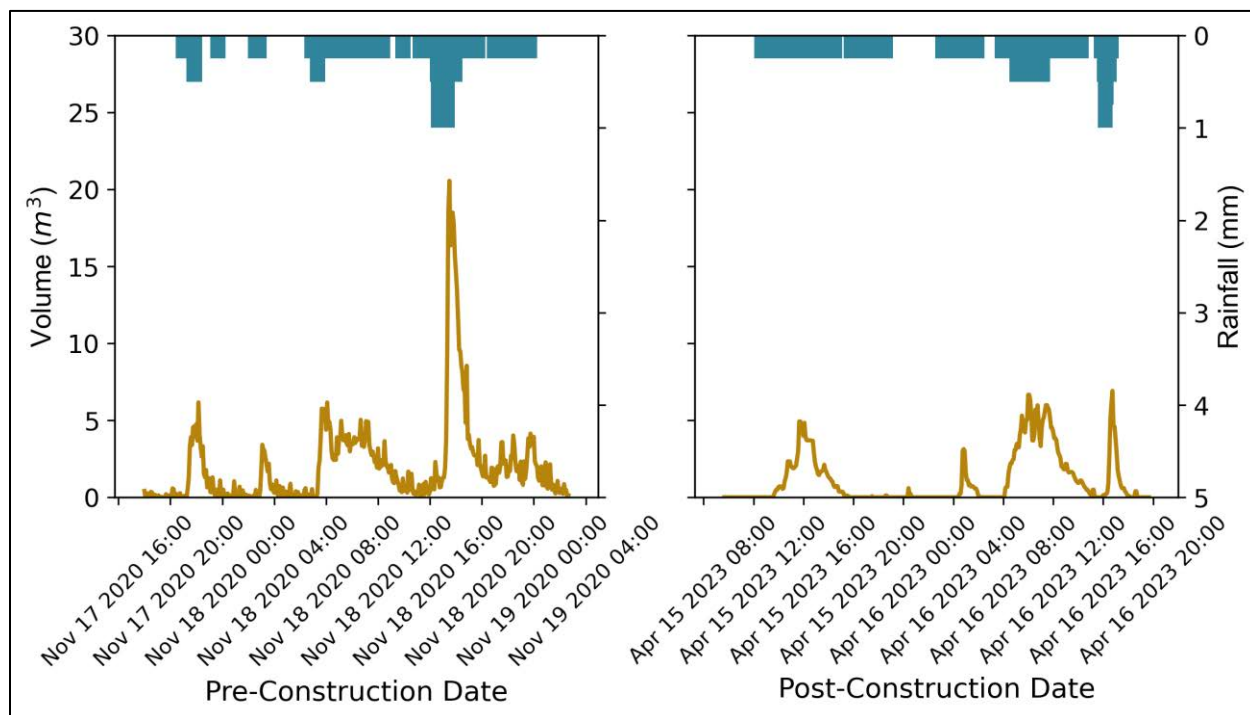
Figure 32: Pre- and post-construction large rainfall event sewer volume comparison
