# Vancouver Green Infrastructure Performance Monitoring Report

April 2022

City of Vancouver, Engineering Department, Green Infrastructure Implementation Branch

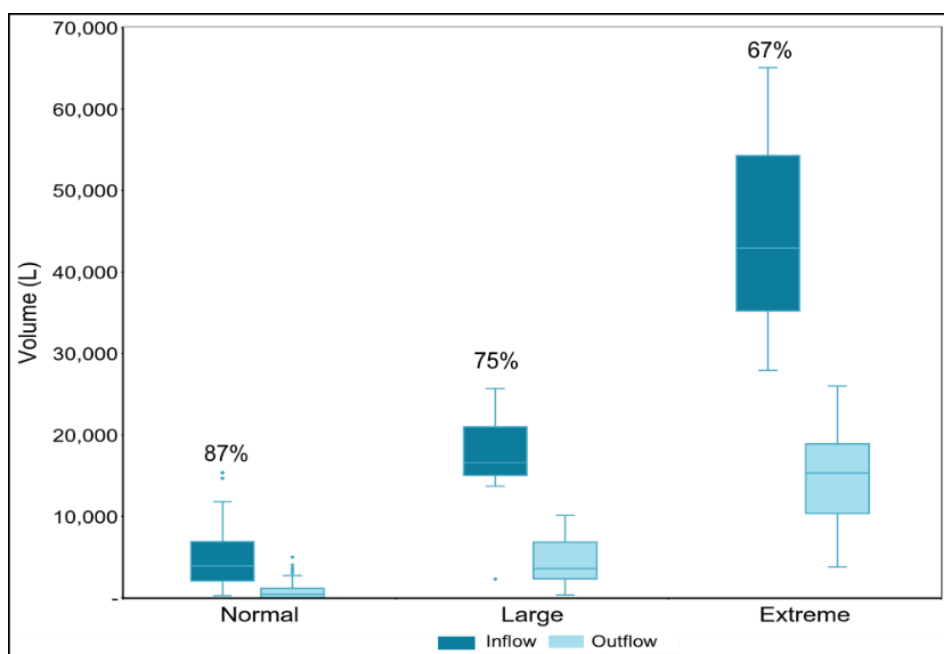
*Boxplots of inflow and outflow volumes and percent volume reduction for different size storm events at Quebec & 1<sup>st</sup> Location C RTT*

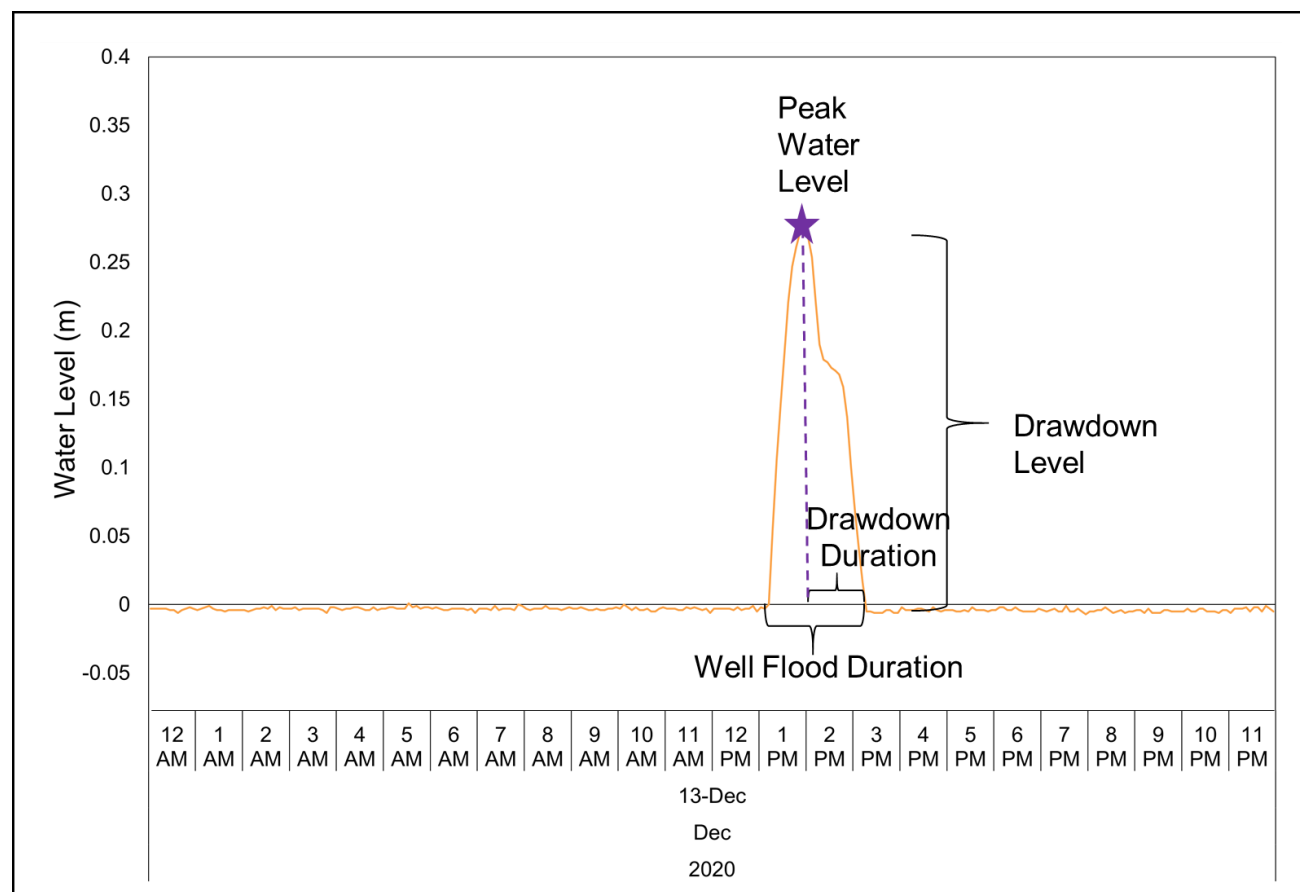
Figure 6 Example of water level response to show calculation of well flood duration, drawdown duration and drawdown rate.

Each individual storm event and water level change was analyzed to determine the well flood duration, drawdown rate and drawdown time. Well flood duration is the total time of rainfall response within the monitoring well. Drawdown duration is the time between peak water level and the return to the water level before the rainfall event (Figure 6). Drawdown rate is defined as the rate at which water exits the bioretention system duration and following a rainfall event, and is calculated by dividing the drawdown level (from peak water level to water level before rainfall) by the drawdown duration. Drawdown rate is compared to the design infiltration rate. The design infiltration rate was determined by infiltration rate testing of native soils beneath the GRI system prior to construction and installation, and is a conservative estimate of the real drawdown rate.

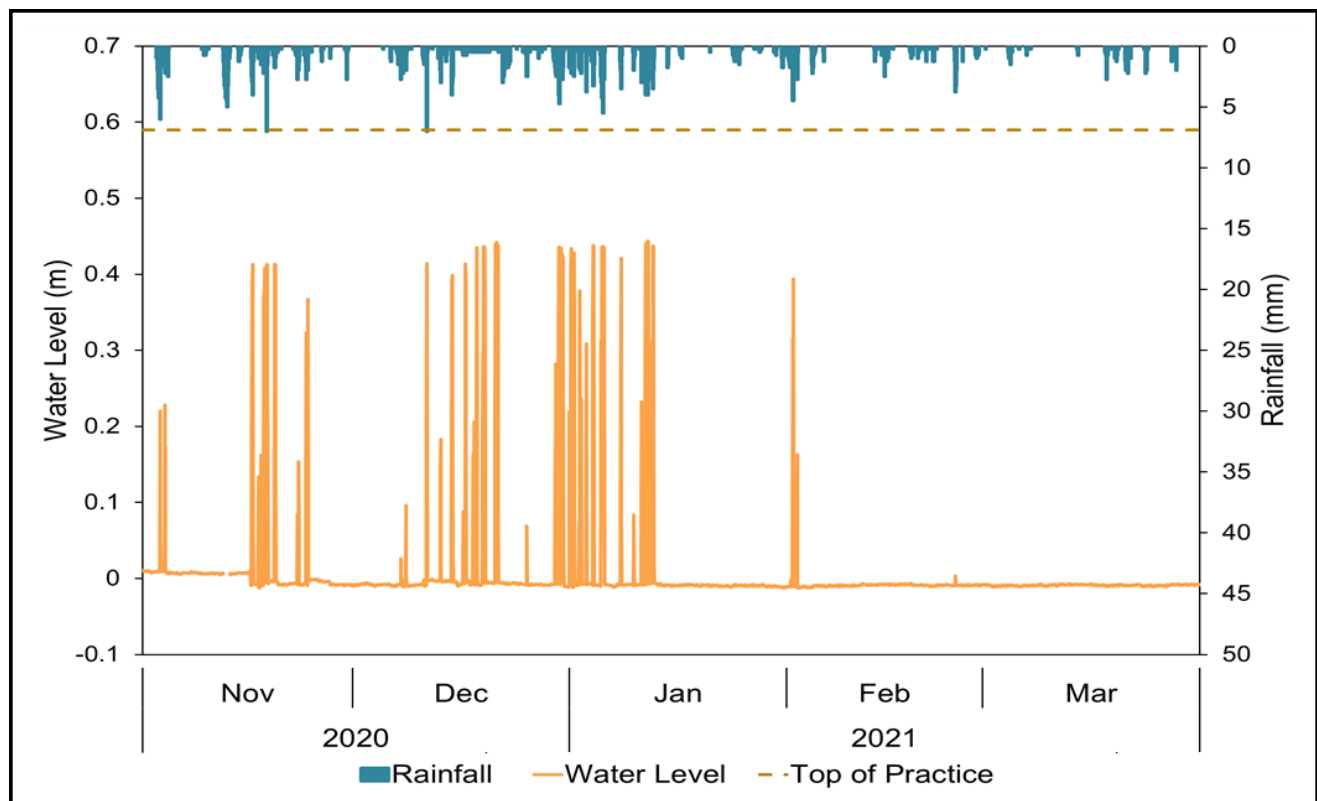
Figure 7 Yukon & 63<sup>rd</sup> hourly average rainfall and water level response.

Sustained rainfall amounts and rainfall intensity above 5 mm/h would generate a water level response at the Yukon St & 63<sup>rd</sup> Ave system. The north monitoring well generally demonstrated drawdown within a few hours and drawdown rates above 300 mm/h. The water level monitoring results from the 2020-2021 wet season are shown on Figure 7. The system was monitored throughout 2018-2021 as well, however there are with intermittent data outages and the whole monitoring period is not shown in graph format. Between 2018 and 2021, 52 rainfall events produced a water level change for which the well flood duration, drawdown time and drawdown rate were calculated and compared to the design infiltration rate, as shown in Table 3.

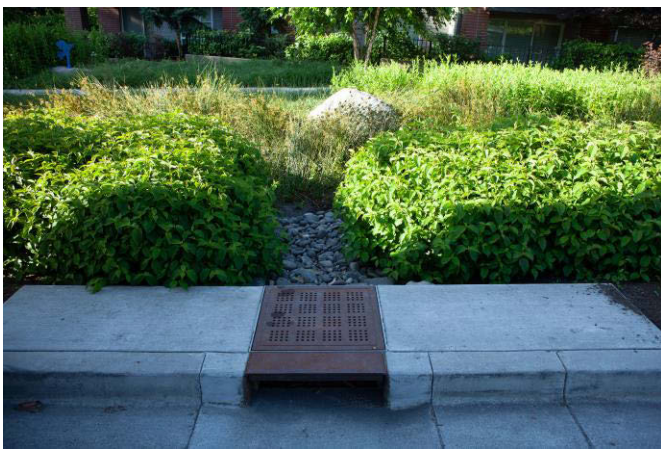
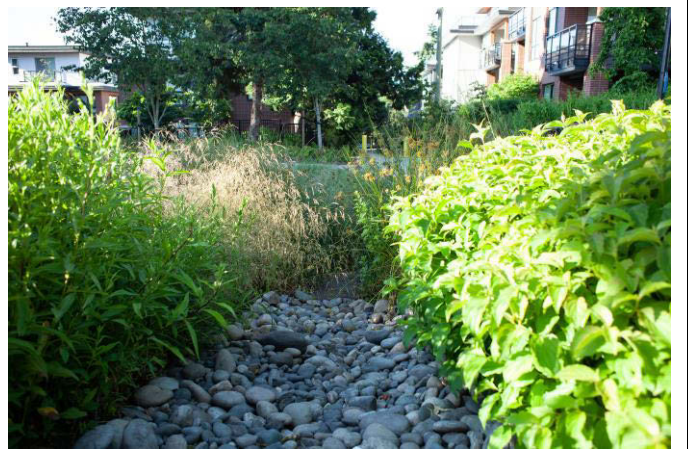
During rainfall events, we observed that runoff from the contributing drainage area (63<sup>rd</sup> Ave, Yukon St) was completely captured by the bioretention system. The system draws down quickly so that ponding does not stay at the surface for longer than the duration of the rainfall event, and surface ponding only occurs during large events. The vegetation at this site has established well, though maintenance was required frequently following installation due to an excessive amount of 'Morning Glory' and local asters growing larger than 0.6 m tall. Maintenance is done four times per year and includes vegetation cutback and clearing inlets. An extra round of maintenance was required in August in response to a resident complaint about the excessive growth of 'Morning Glory'. The system was also inspected following a large rain events, and 24 hours after a rain event had stopped and ponding at the surface was not observed, which meets our objectives. Photos from wet and dry weather inspections are shown below.

Dry weather inspections at Yukon & 63<sup>rd</sup> bioretention system, July 2021

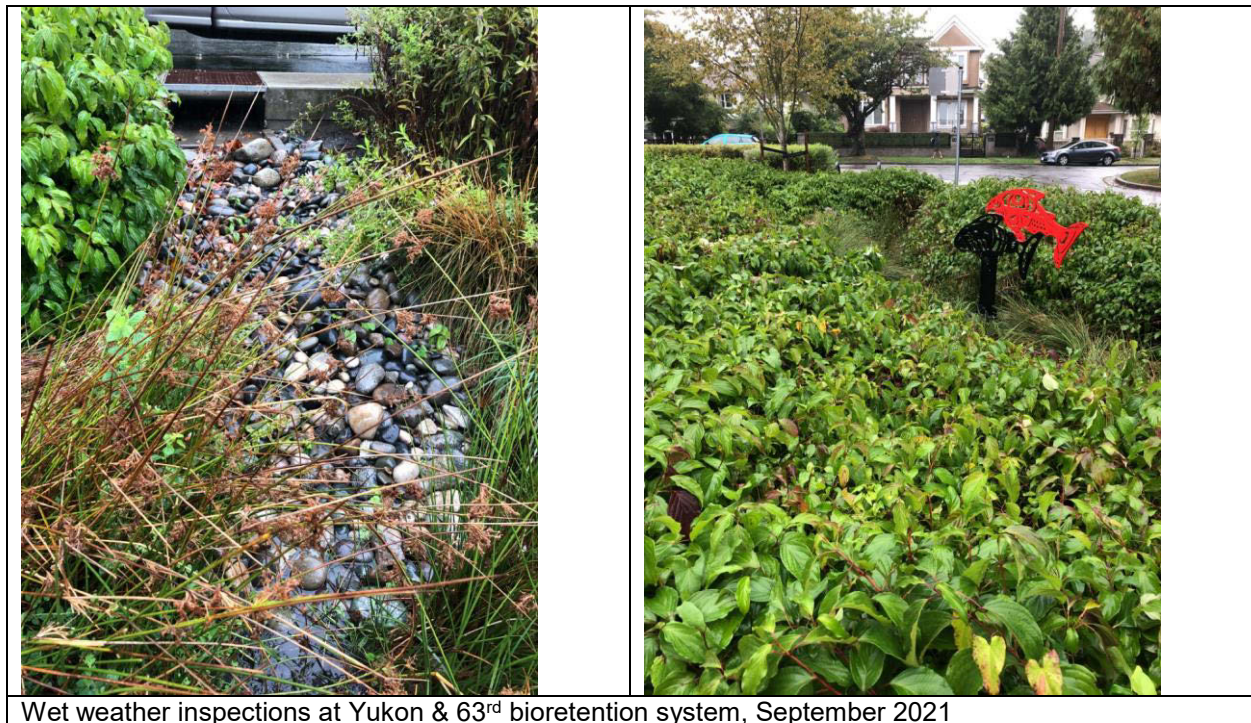
Wet weather inspections at Yukon & 63<sup>rd</sup> bioretention system, September 2021

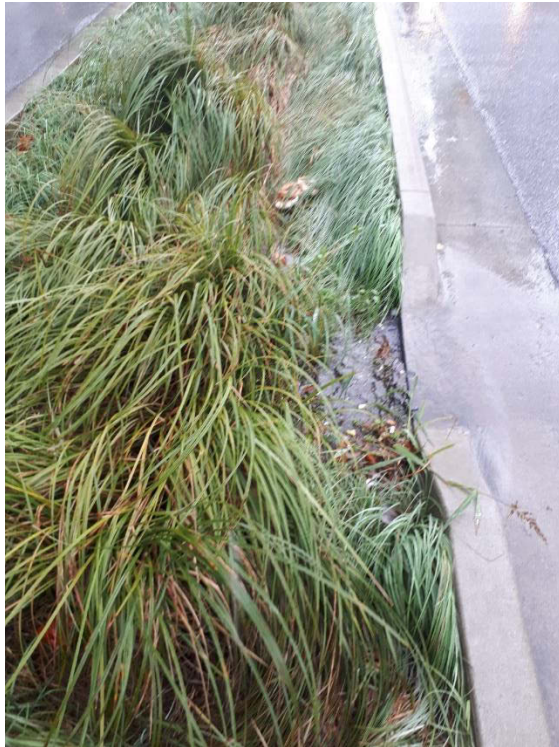
The monitoring well at Location D only demonstrated water level increases during five events over its monitoring period. The rainfall events required to produce a response in water level were greater than 19 mm, and had high intensities. Even with these high-intensity storm events, water level responses were minor and were generally observed to be less than 10-cm. We think the lack of response is due to the siting of the well and due to fast drawdown times within this system. The monitoring well was located far from the normal inlets, and due to rapid infiltration rates, it was hypothesized that water does not extend horizontally to include the

monitoring well, and instead drains vertically beneath the system. This was verified using visual observations during large storm events. Ponding could be seen at the inlet, but ponding in the cell did not extend along the surface to near where the monitoring well was located.

*Photo of inlet ponding at Quebec & 1<sup>st</sup> Location D during rain event*

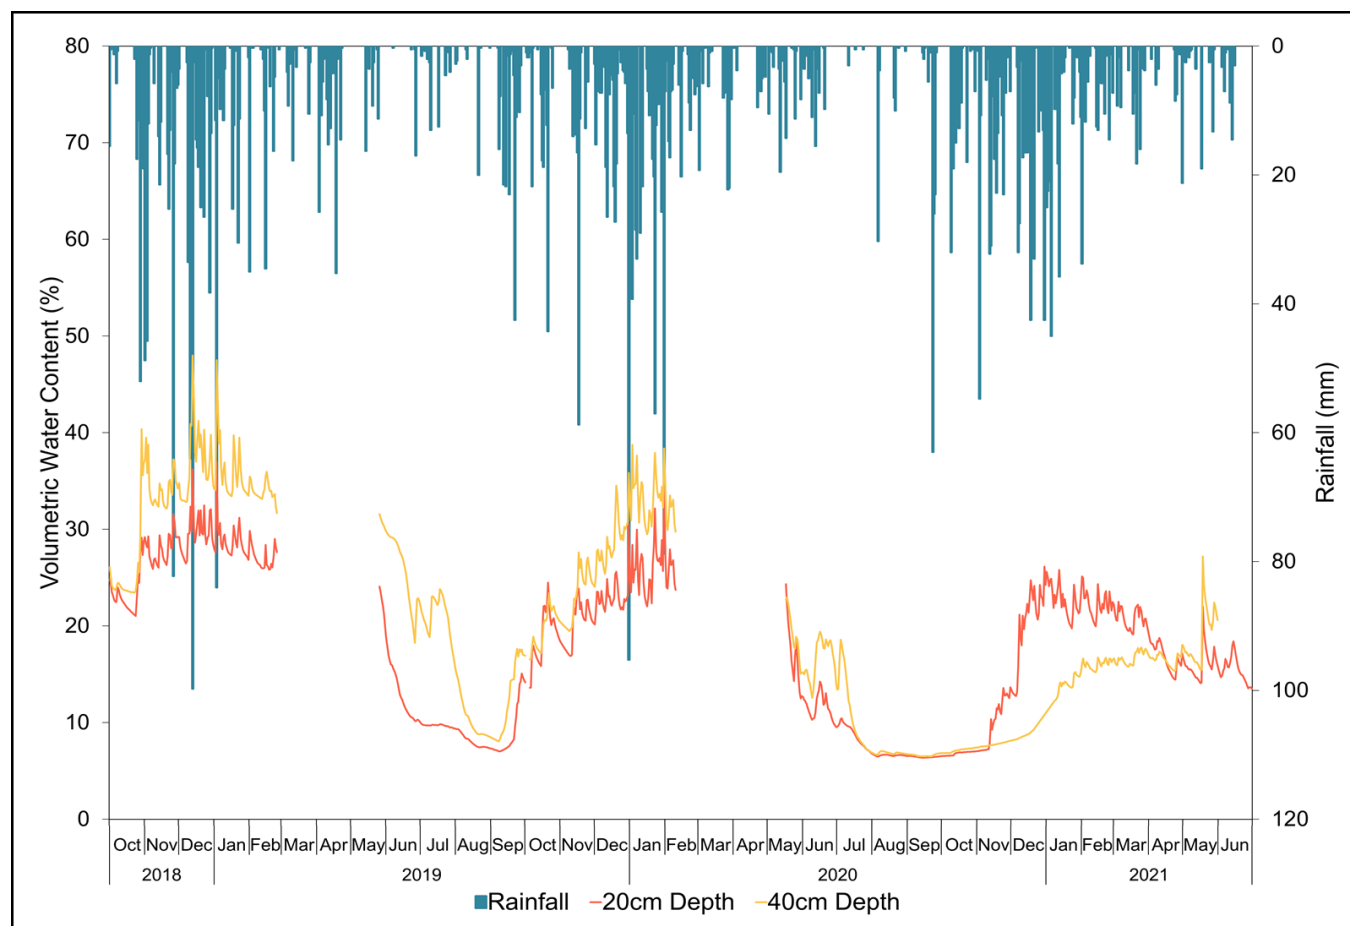
Figure 11 Daily average volumetric water content at 20-cm and 40-cm depth in Location D bioswale

Both soil sensors installed in the bioswale are functional and provide data on volumetric water content, electrical conductivity and temperature since October 2018. Seasonal variation in moisture levels is very apparent, with moisture levels being at the highest during the wet seasons when there is the greatest amount of rainfall, and the lowest during the hot dry summer months. The moisture levels at 20-cm depth range between 5-40% over the monitoring period and the moisture levels at 40-cm range between 5-50%. The moisture levels at 40-cm depth are generally greater than at the 20-cm depth. The 2020-2021 monitoring period is an exception to this, where the moisture levels were similar to each other over the dry periods, and then the moisture at 20-cm was higher over the wet season. The pronounced seasonal variation compared to the other sites is likely influenced by the GRI typology. Being in a bioswale, the sensors are more exposed to evaporation and transpiration that can cause moisture loss. The rainfall and volumetric water content for the entire monitoring period is shown in Figure 11.

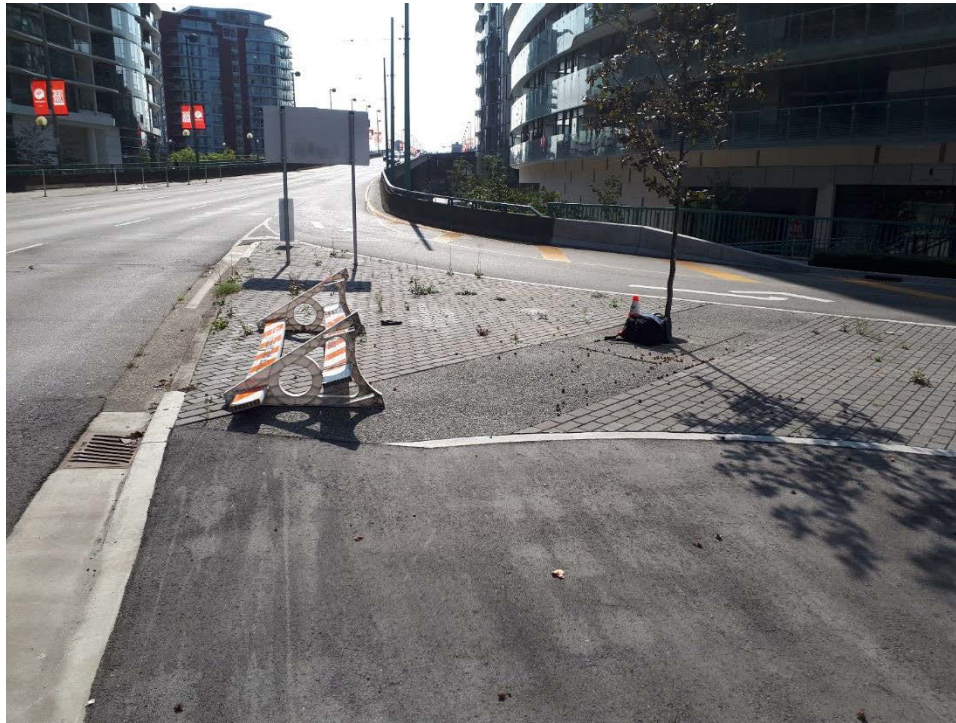
At site visits, the tree appears in good health. Weeds have been noticed to grow out from the joints of the permeable pavement, reaching heights of greater than 1 m in some cases. Maintenance during the summer months is required to pull the weeds. We suspect due to the location, there is not a lot of foot traffic over the permeable pavement and weeds have the ability to establish themselves.

*Photo of permeable pavement at Expo & Smithe, September 2020*
