Welcome

Project Goal

To improve the comfort and safety of the North False Creek Seaside Greenway between Burrard and Granville Bridges for people of all ages and abilities, through the development of an updated signage and pavement marking plan that can be implemented quickly.

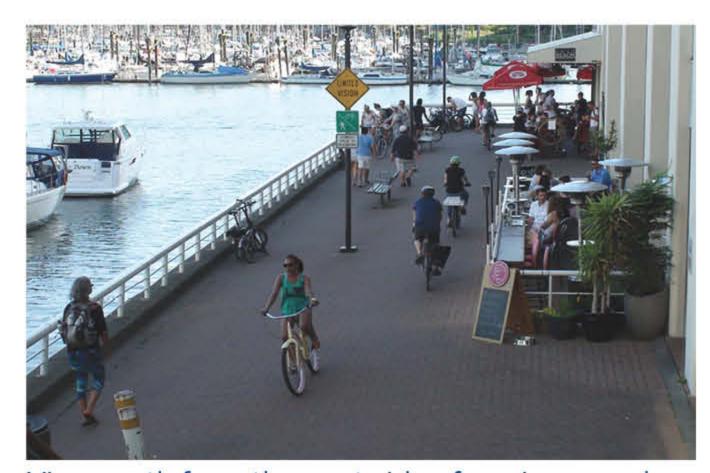
View south from the west side of marina, people cycling and walking share the seawall between the water and restaurant patios.

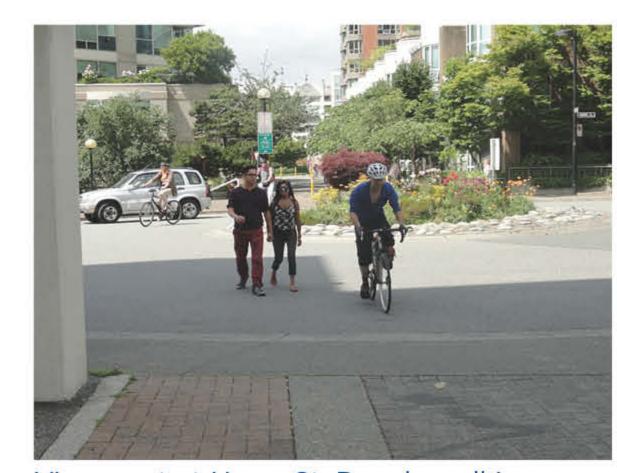
View west at Howe St. People walking, cycling and driving share a culs-de-sac.

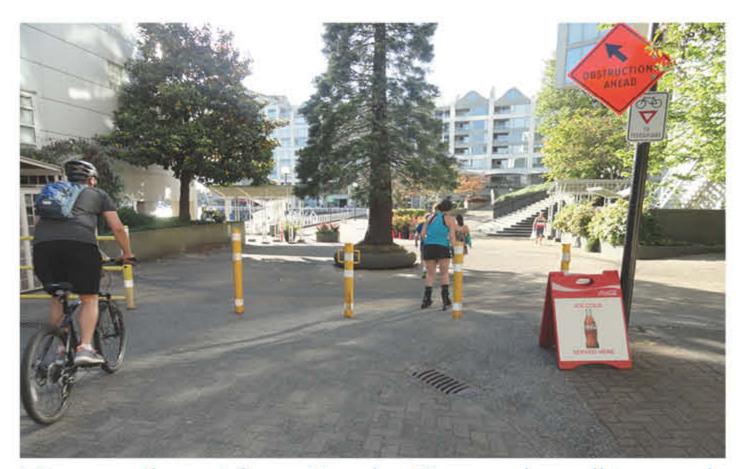
View southwest from Hornby St, people walking and cycling share space across private property with a large signature tree.

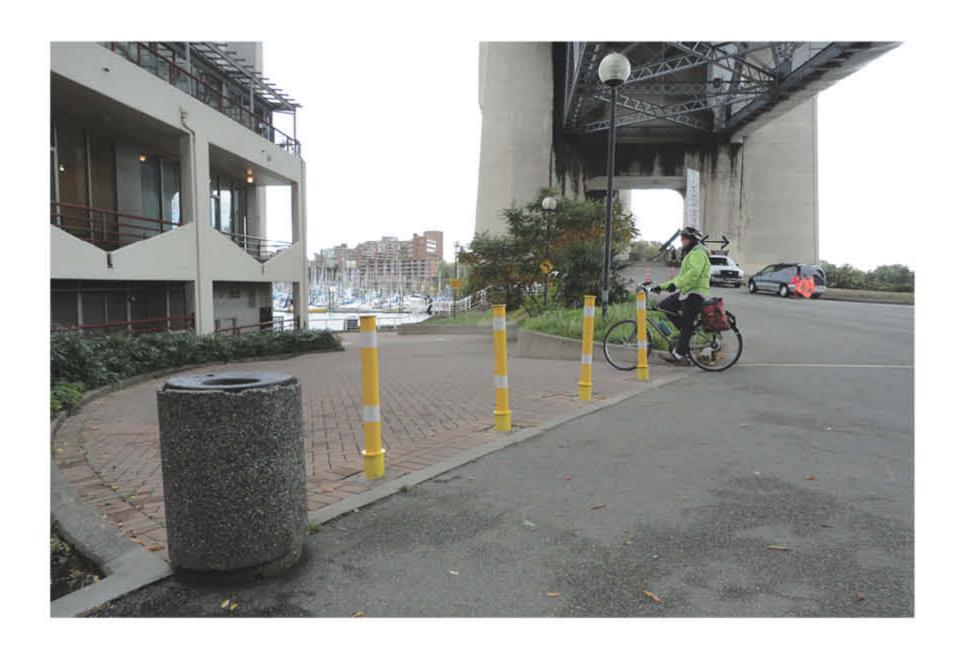
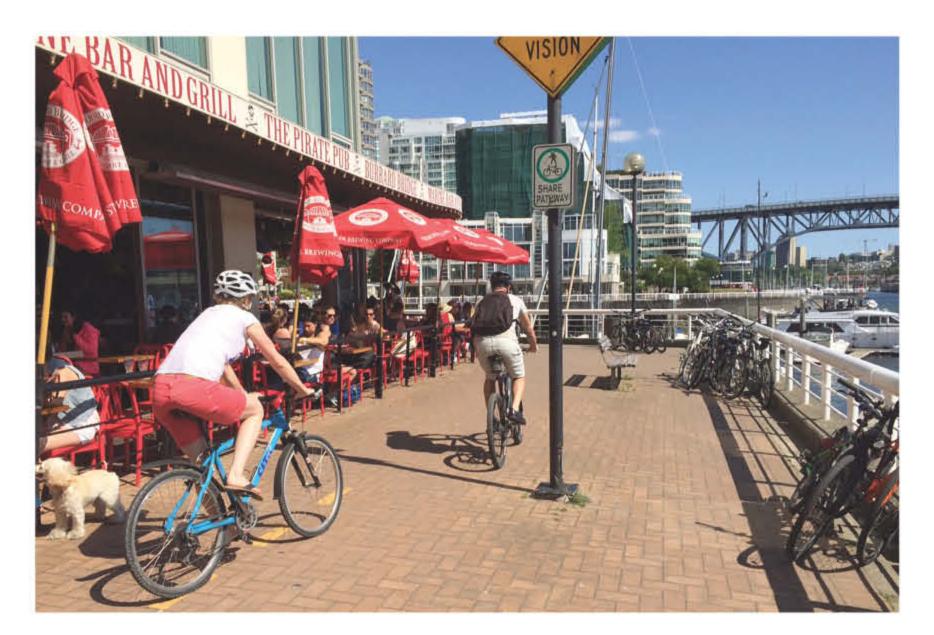
Location 1

- Downhill section enables people on bikes to pick up speed going into a tight corner.
- Bike parking on Seawall railings.

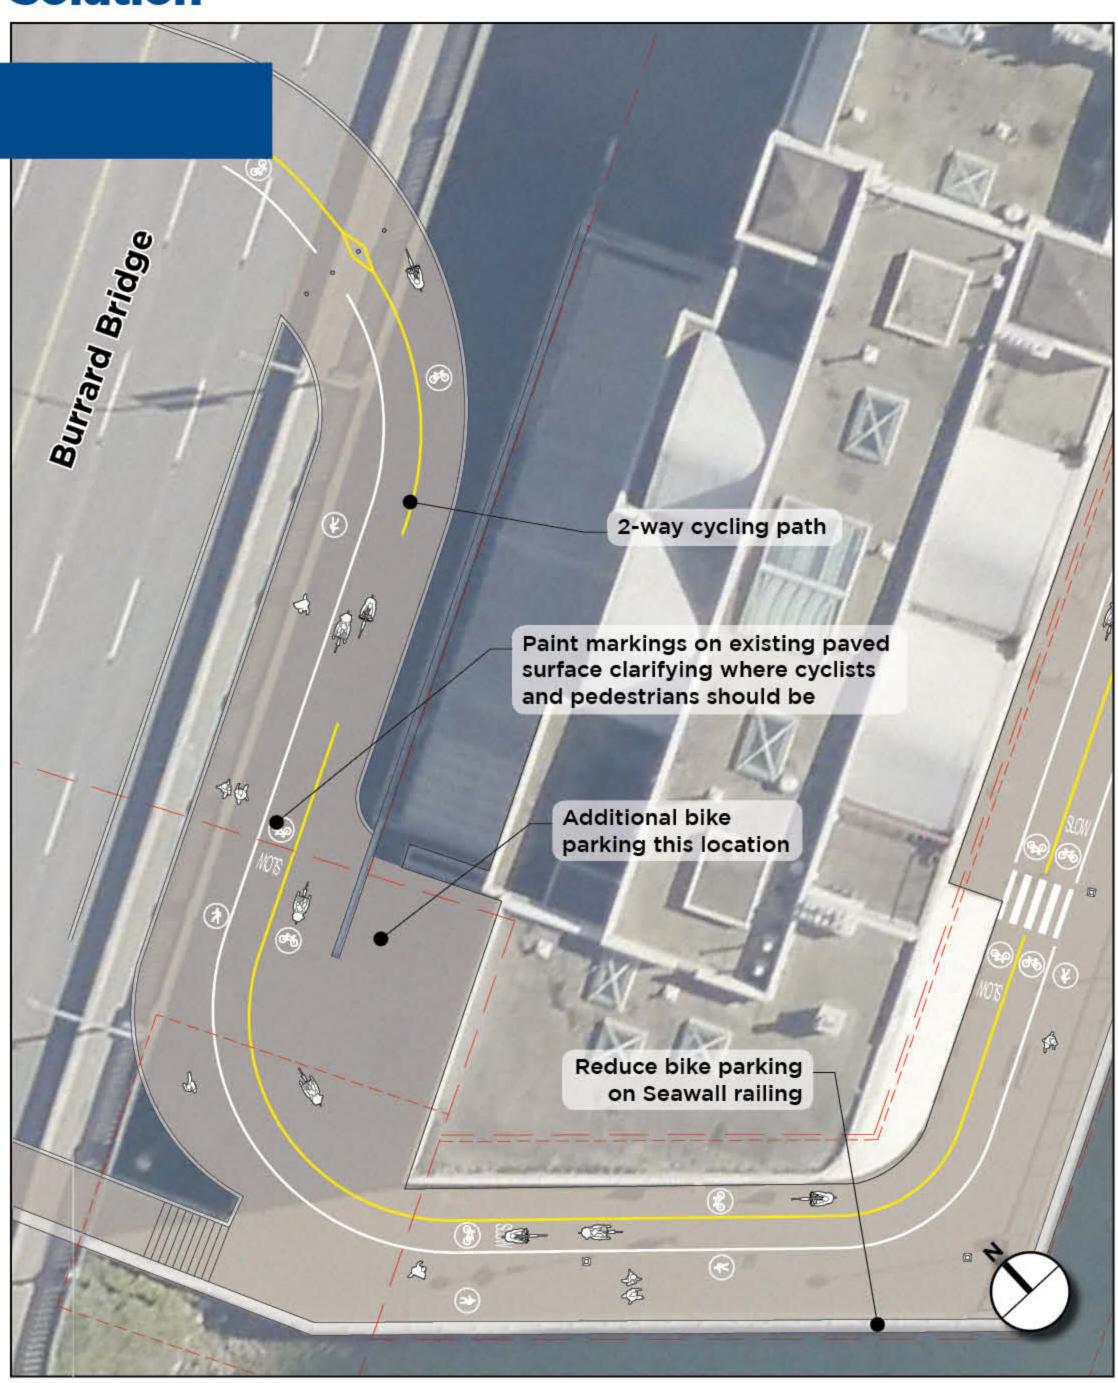
Solution

- Paint markings that clearly delineate where people walking and people cycling should be in relation to one another. Narrowing the area for people on bikes will also help reduce speed.
- Paint markings and signage to warn people cycling to slow in areas where conflicts with people walking may occur.

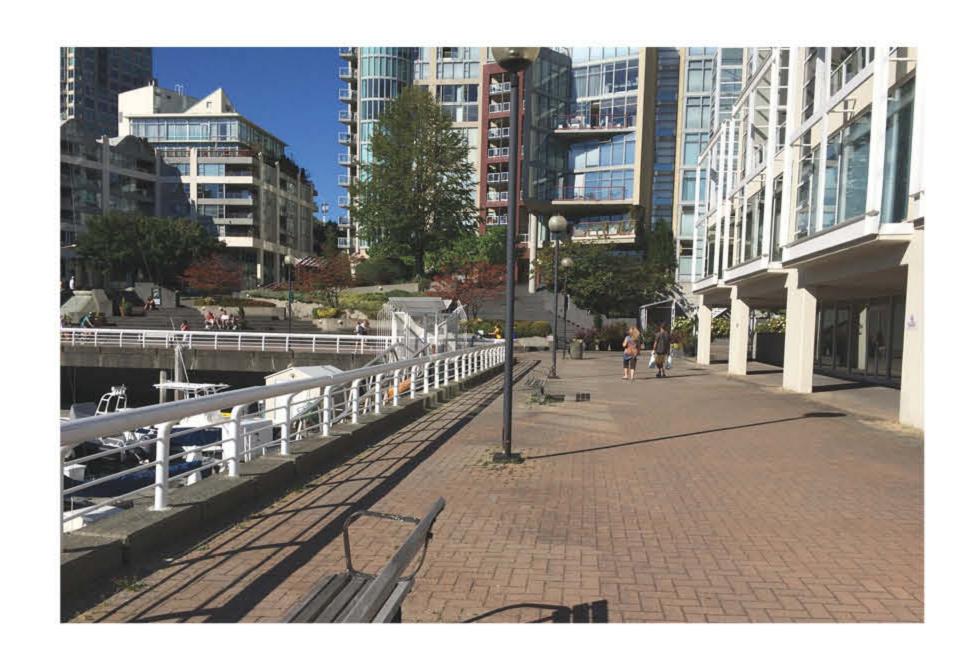
Location 2

Shared walking and cycling on Seawall path intended for walking only.

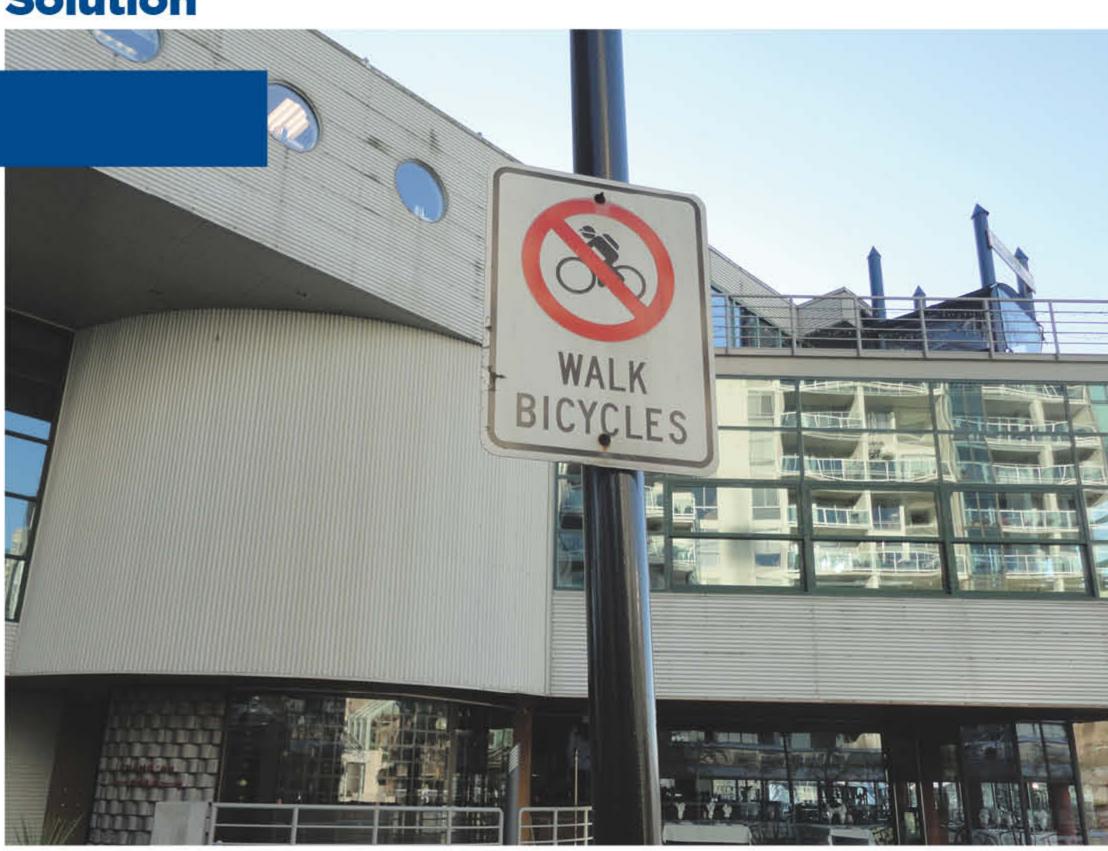
Solution

Additional signage to reinforce this part of the Seawall as an area reserved for walking, or people walking with their bicycles.

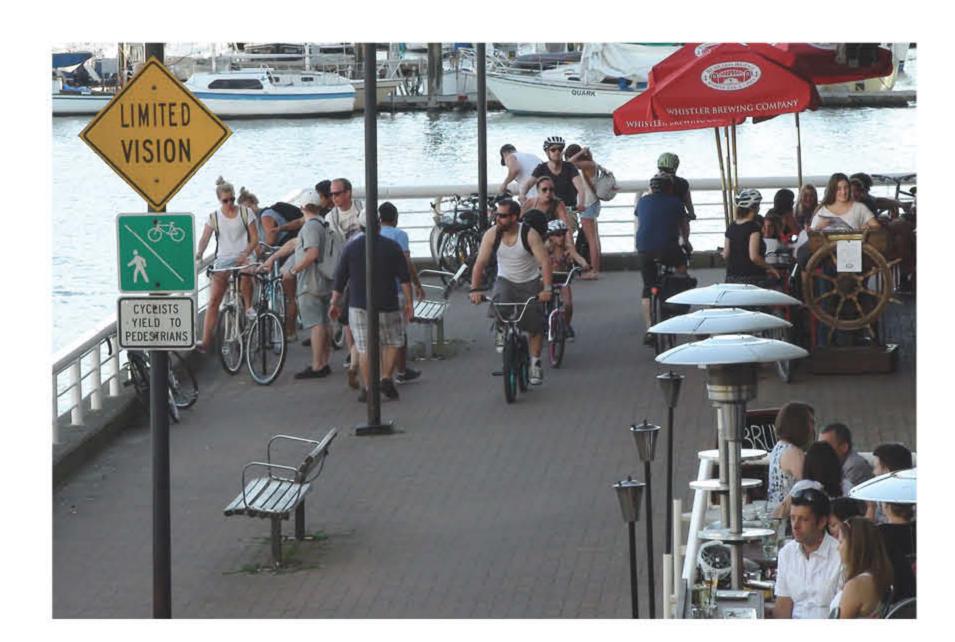
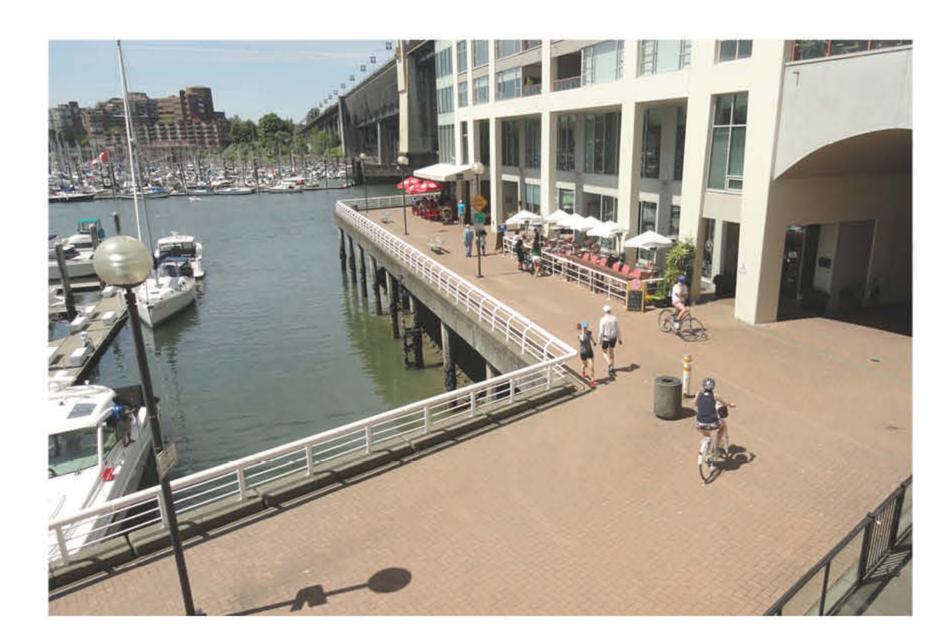
Location 3

- Very tight space adjacent to patios and sharp corners.
- Heavy volumes of walking and cycling traffic.

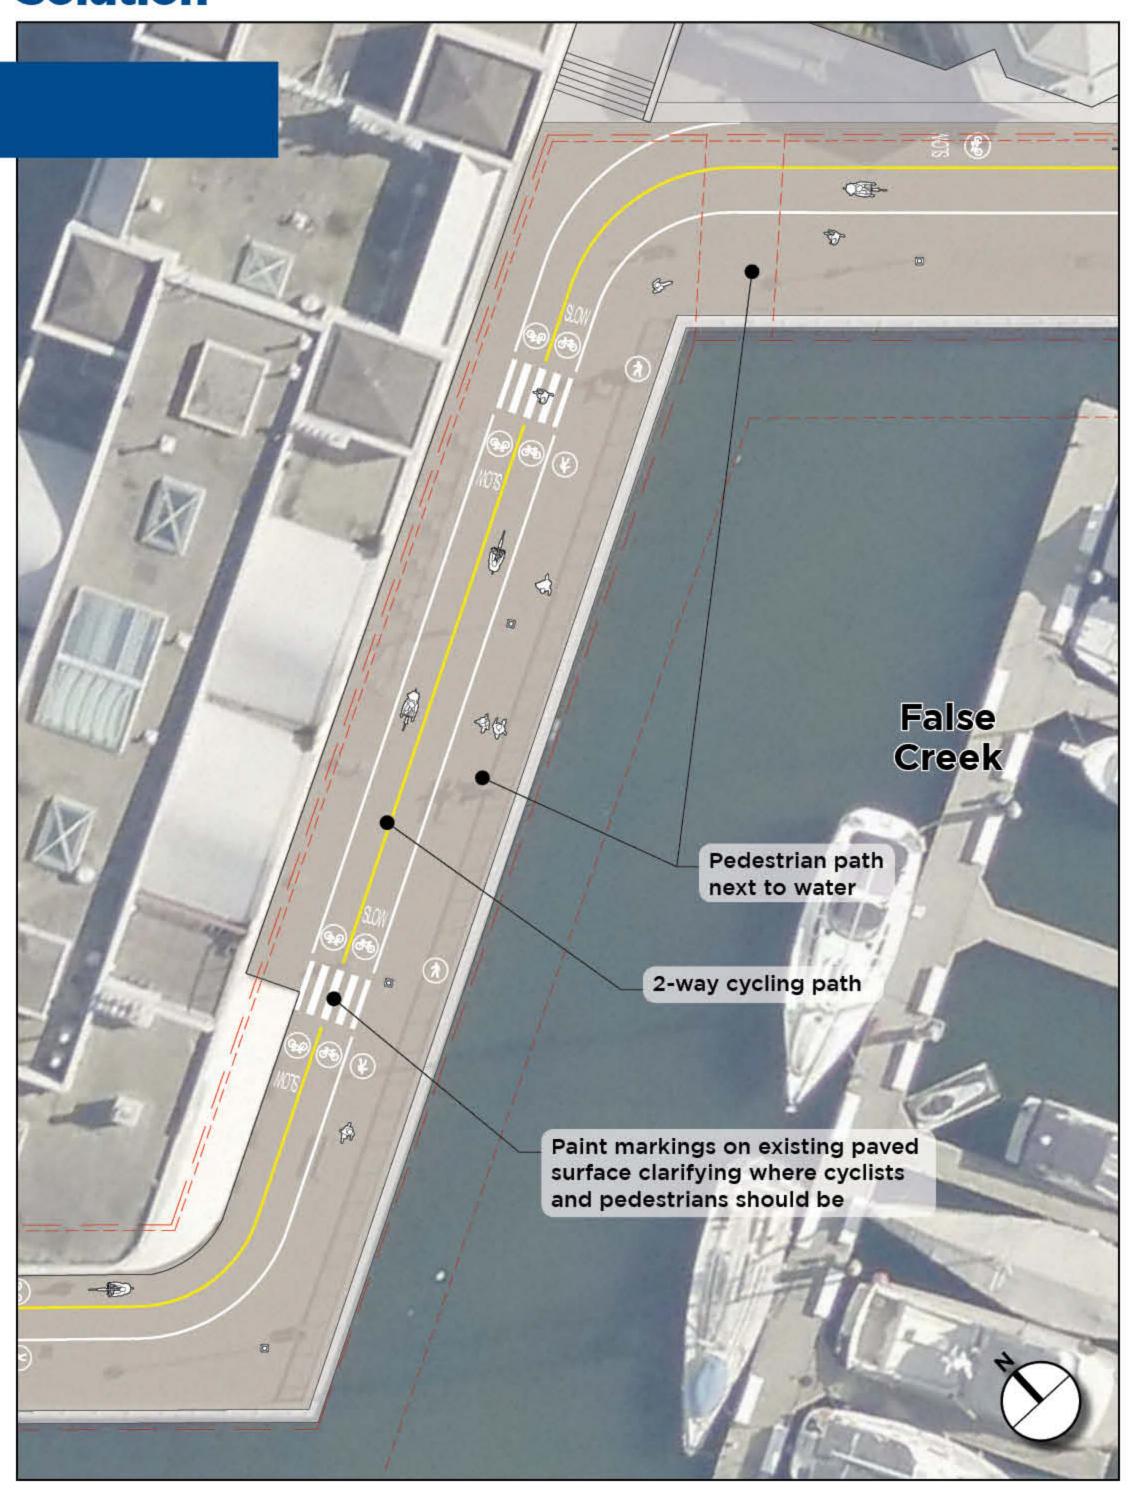
Solution

- · Paint markings that clearly delineate where people walking and people cycling should be in relation to one another. Narrowing the area for people on bikes will also help reduce speed.
- Paint markings and signage to warn people cycling to slow in areas where conflict with people walking may occur.

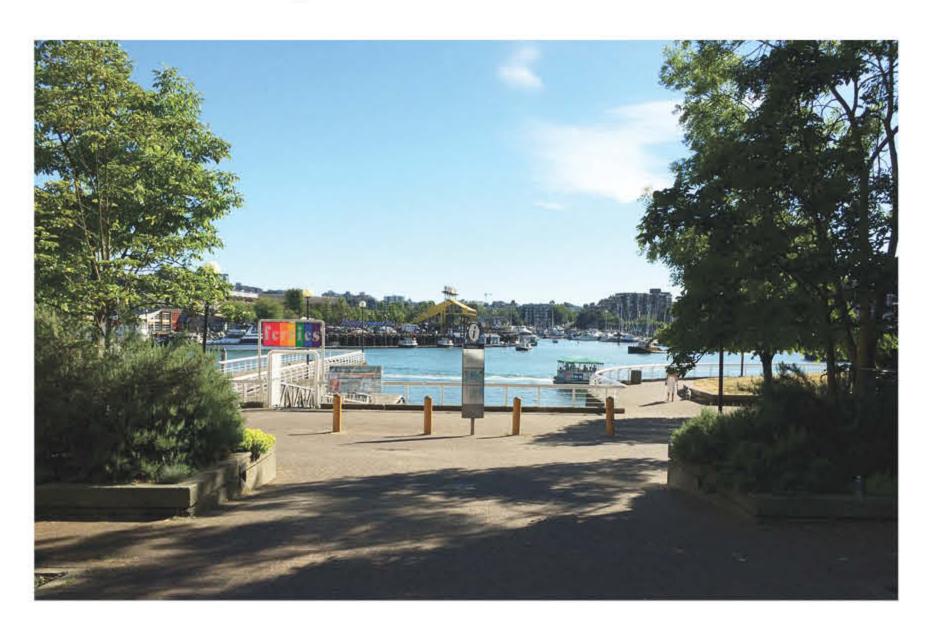
Location 4

Walking and cycling access to False Creek ferry dock.

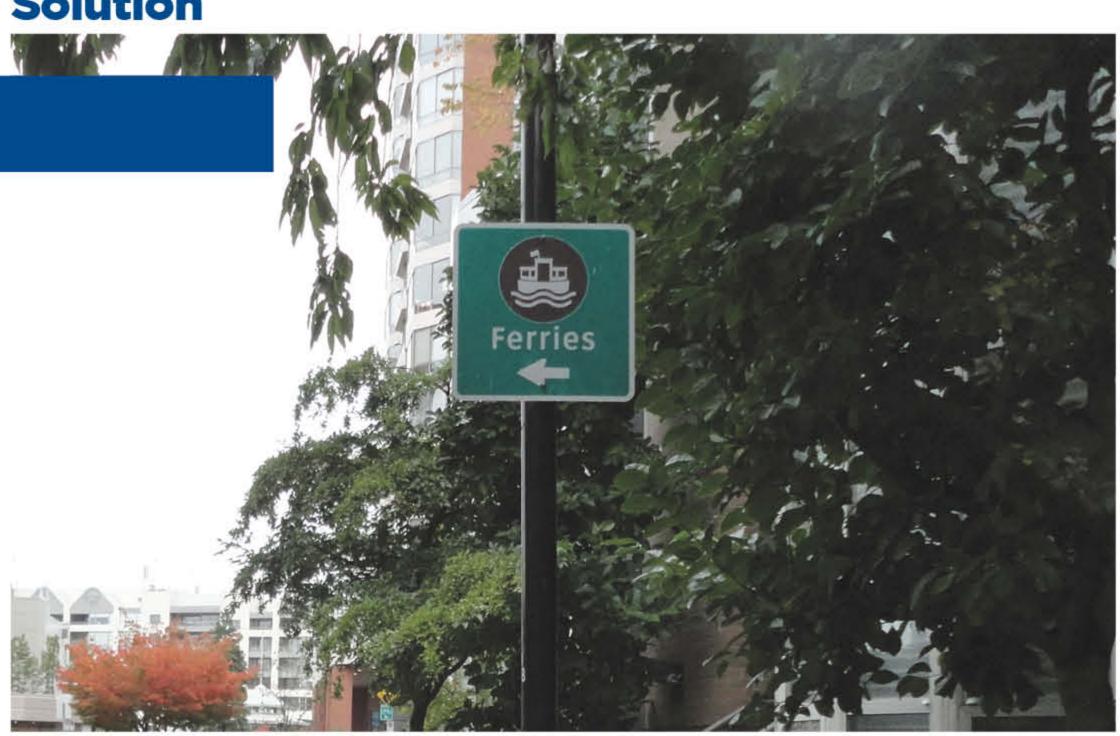
Solution

- Access to False Creek Ferry dock by people on bikes will be preserved.
- Additional markings and signs to reinforce this as a shared space

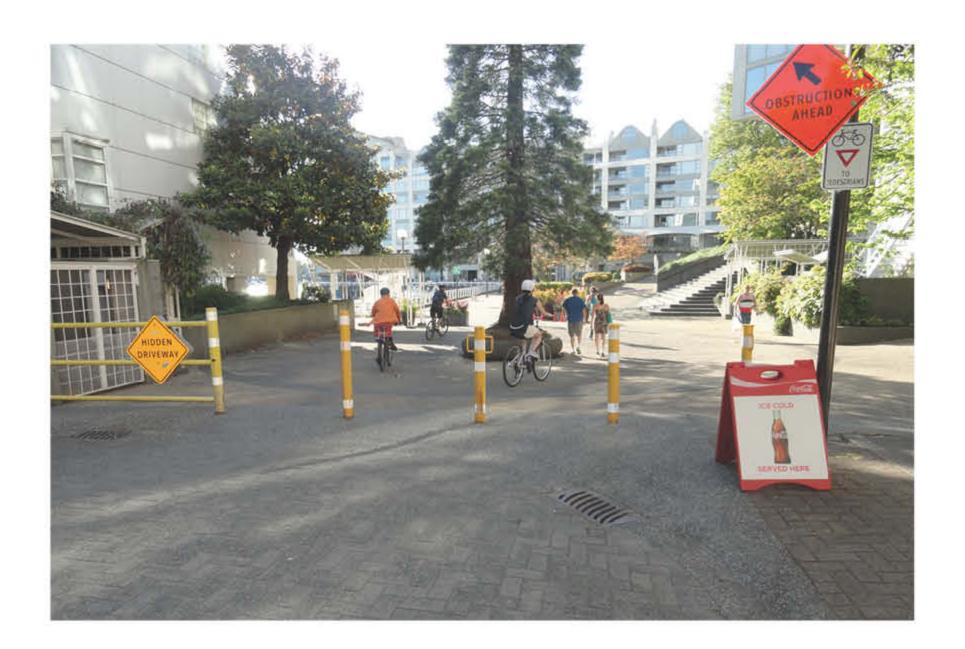
Location 5

- Seawall route crosses private property within statutory right of way.
- Downhill section enables bikes to pick up speed entering shared spaces.

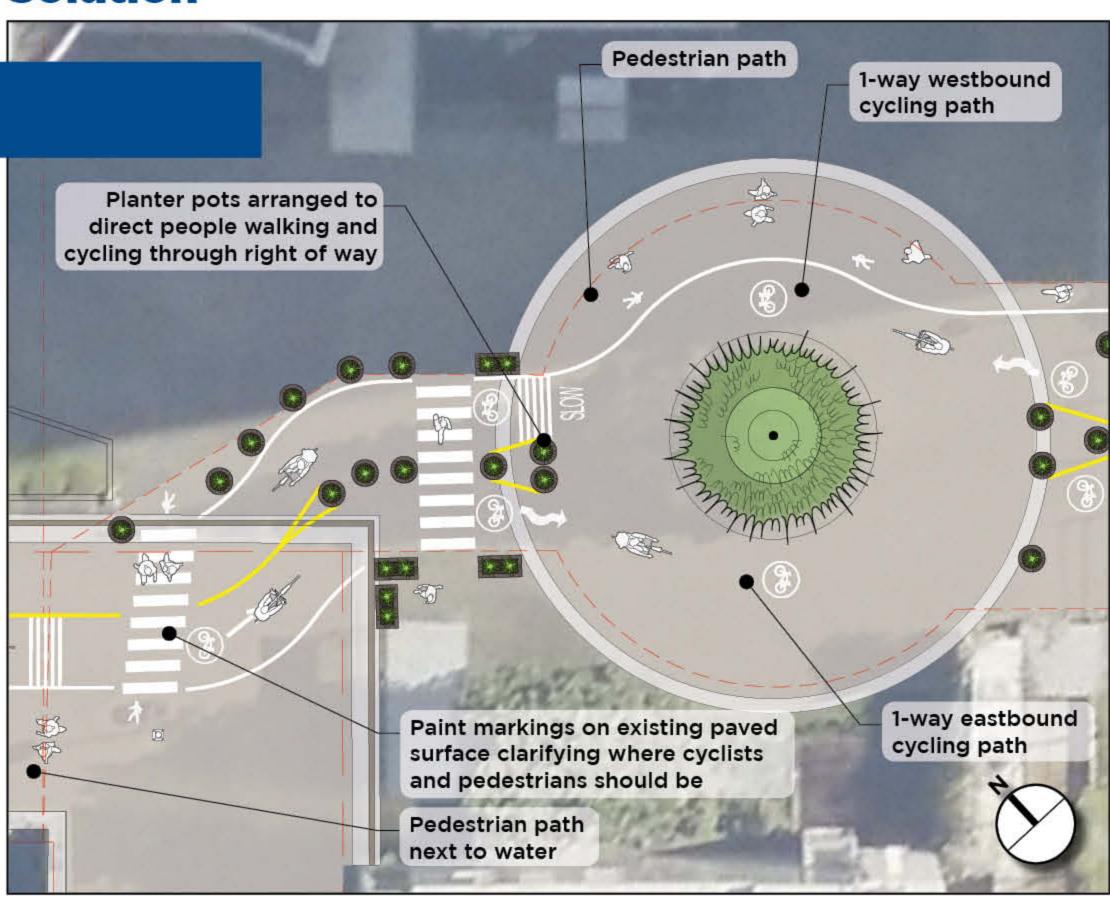
Solution

- Paint markings and portable planter pots to clearly delineate where people walking and people cycling should be in relation to one another.
- Adjustment of bollards to further clarify and delineate where different seawall users should be and to encourage people on bikes to ride counterclockwise around tree.
- Paint markings and signage to warn cyclists to slow in areas where people on foot cross the bike path frequently

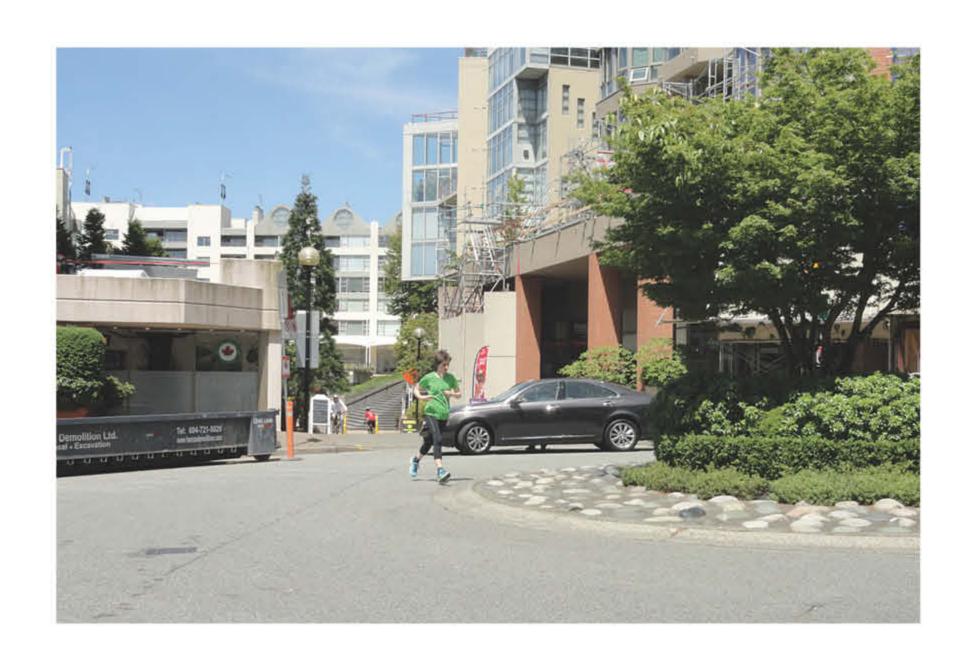
Location 6

- Large traffic circles with intersecting driveways, pickup and drop-off activity and many people walking and cycling cross.
- Few markings or signs to delineate space.

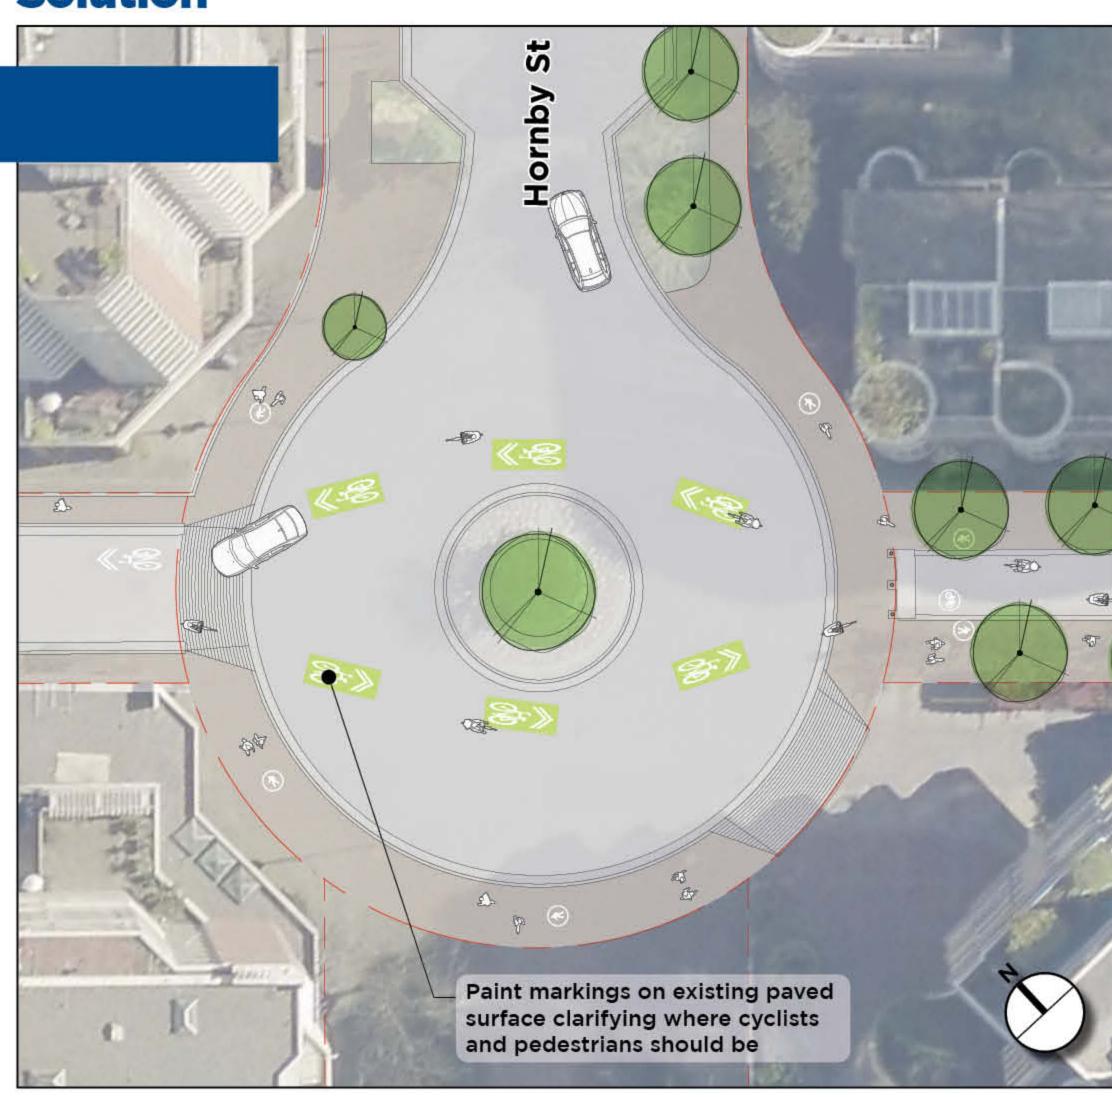
Solution

- Paint markings on the road surface of the culs-de-sac to indicates to people driving that the road surface is shared with people cycling along Seabreeze Walk.
- Yield signage for people driving and cycling to give way to those already in the circles.
- Markings and signs directing people to cycle counter-clockwise around circles.

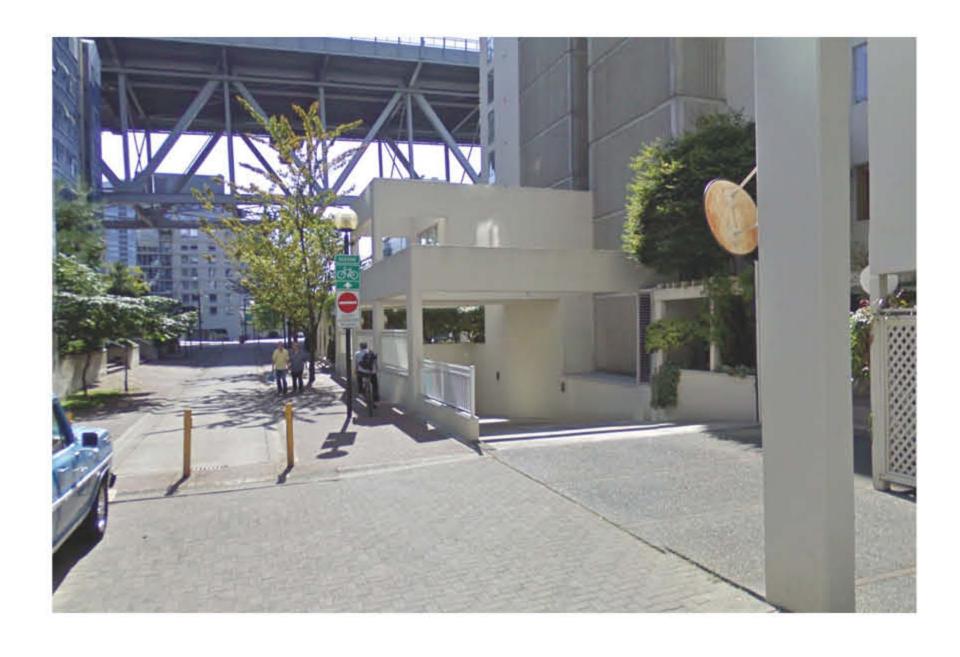
Location 7

Less visible driveway crossing.

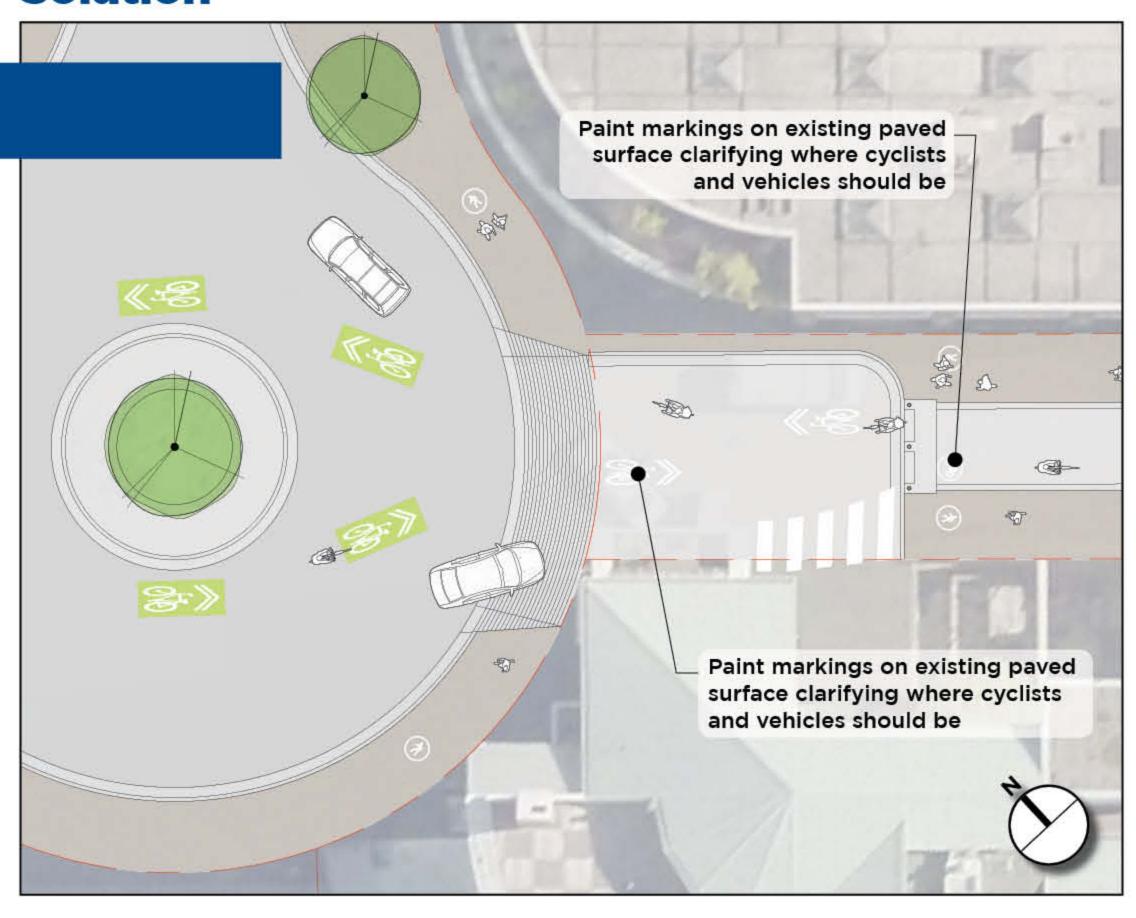
Solution

Additional markings to highlight the presence of people walking and cycling through space.

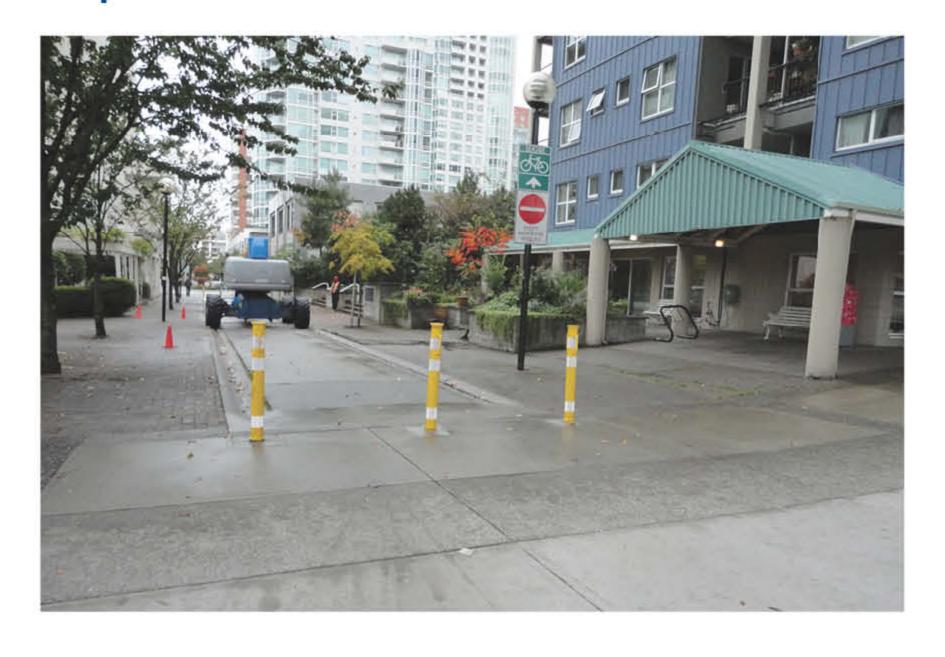
Location 8

Few markings or signs to delineate space.

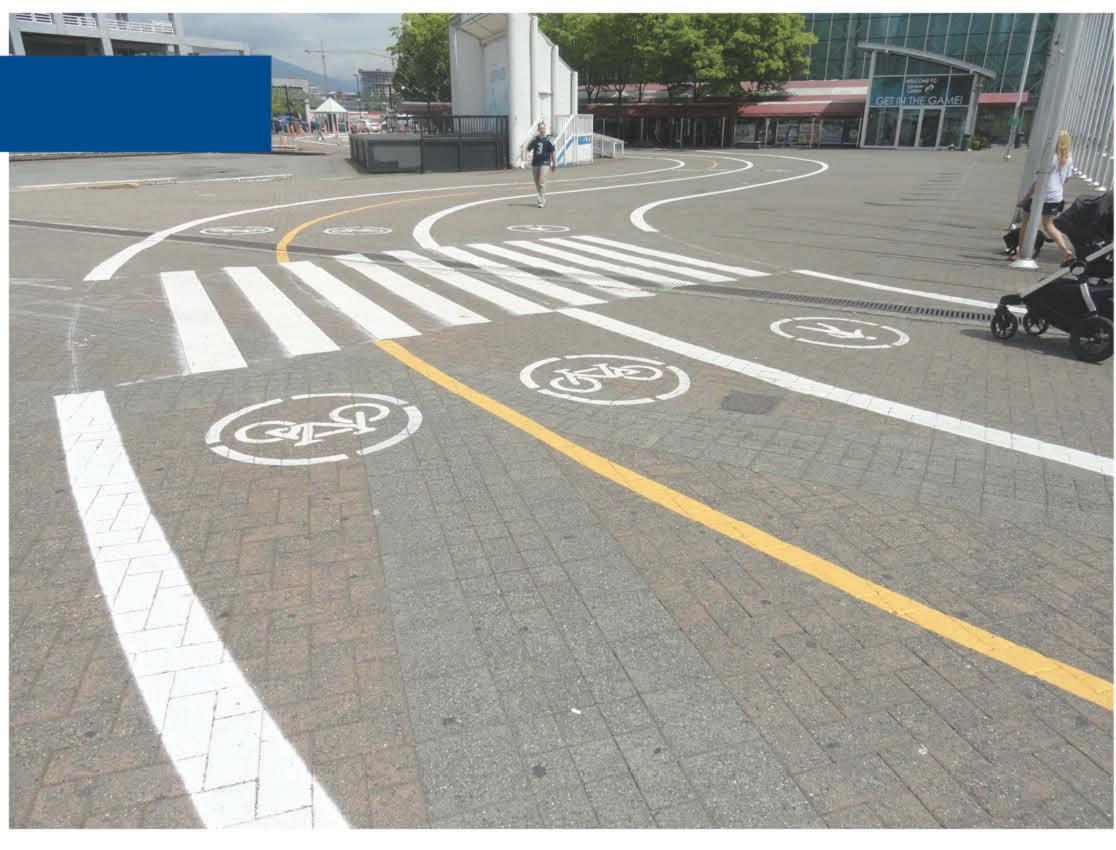
Solution

Paint markings that clearly delineate where people walking and people cycling should be in relation to one another.
