16.0 Photo Selection

Units 149, 155, 159, 165, 169, and 175 Grouse Walk (Little Mountain Site)

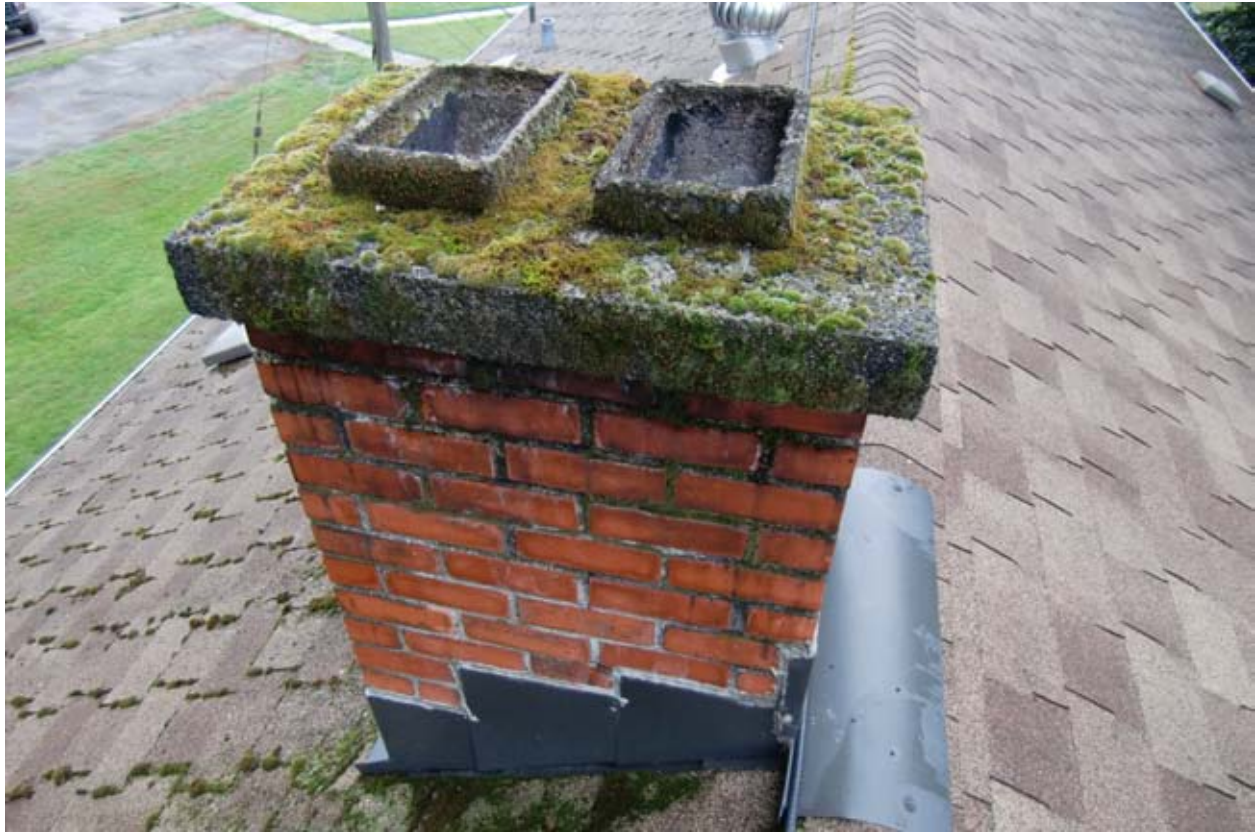
The sloped (approximately 10/12 pitch) roofing appears to be a single layer of interlocking composition shingles installed over a tar felt underlay on solid shiplap (board) sheathing. (Refer to Section 8.0)

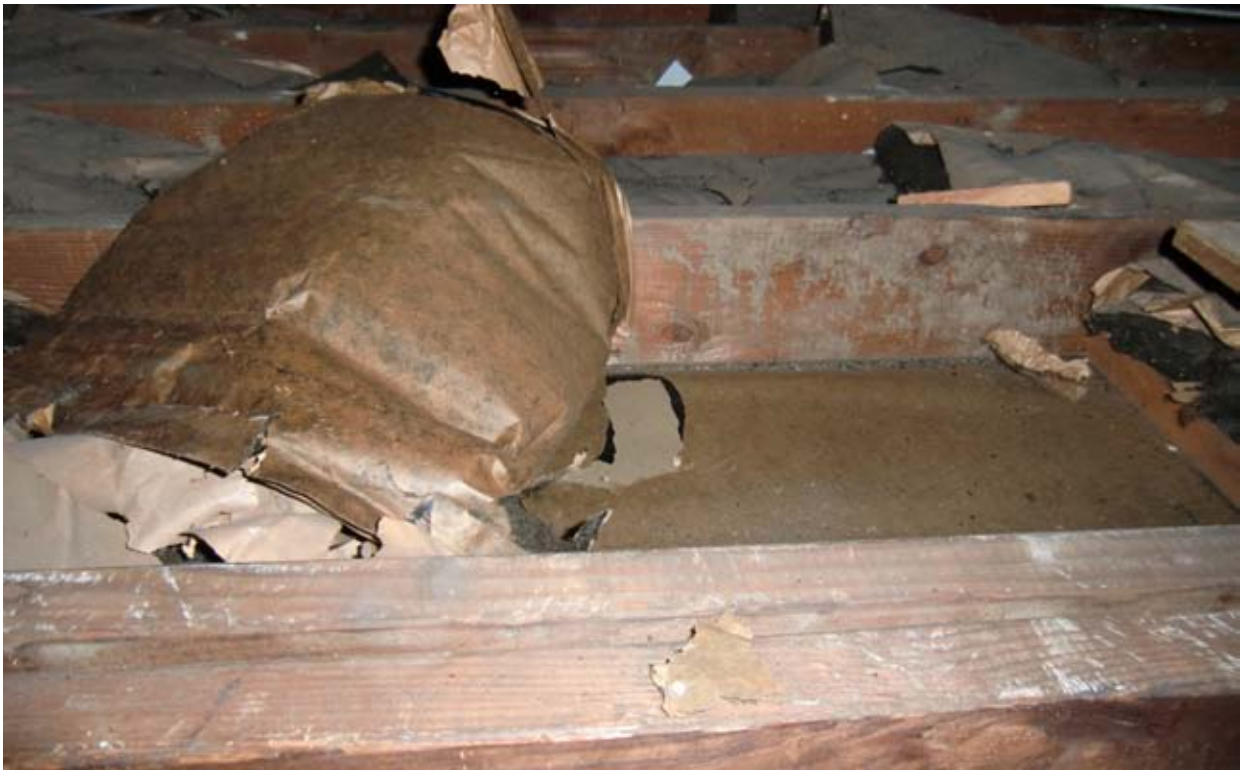
The attic structure is 2 x 4 rafters with collar ties and knee walls. (Refer to Section 9.0)
