## **APPENDIX B**

### **Past Condition Inspection Reports**

**Bridge No. D-8**  
**Dunsmuir Viaduct**  
**between**  
**Beatty St. & Main St.**

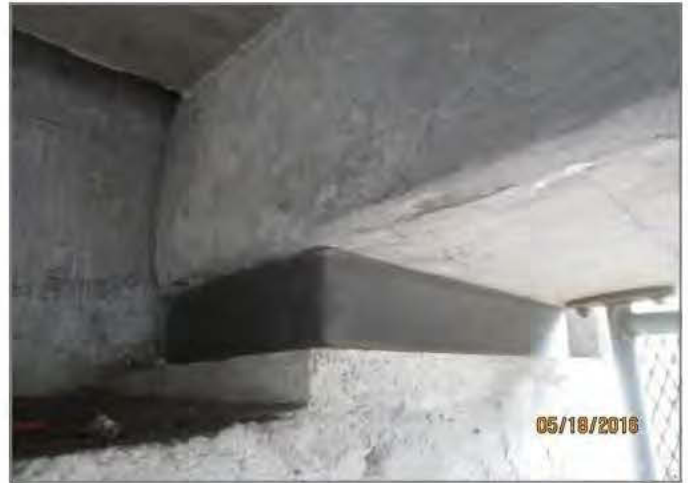
G2. Typical bearing condition at on-ramp abutment (DM2).

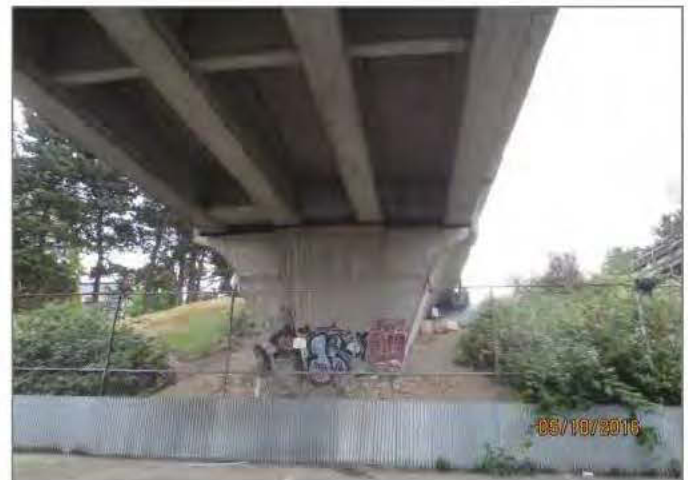
6. Retaining Wall: Failure of retaining wall at base of east abutment (D2) has permitted slope creep of hillslope resulting in the moderate undermining of approach structure elements. Footing on each side approach undercut for appx. 1500 mm. Issue has been known for a long period; no structural concerns observed.

G4. General view of east abutment at D2.

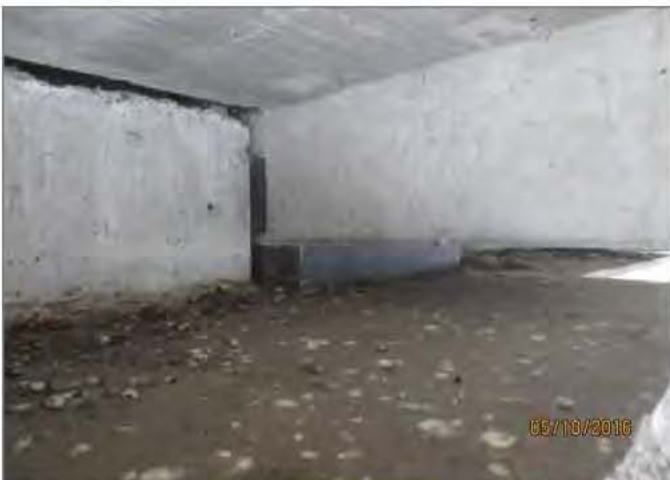
G5. Typical bearing condition at east abutment (D2).

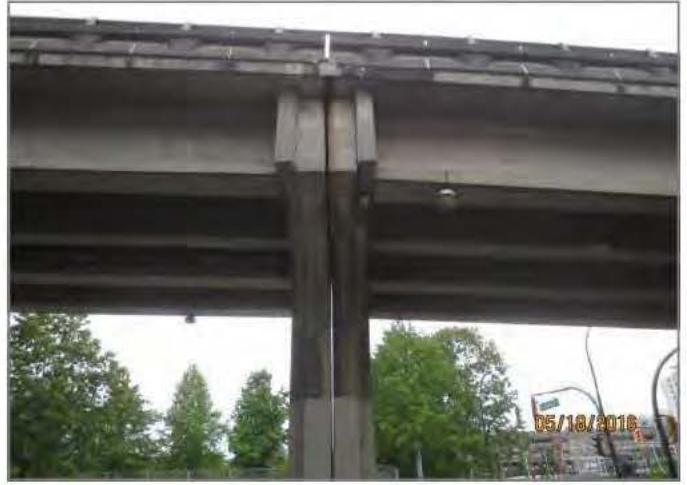
G8. Gap between piers at expansion joint; Pier DM5 shown.

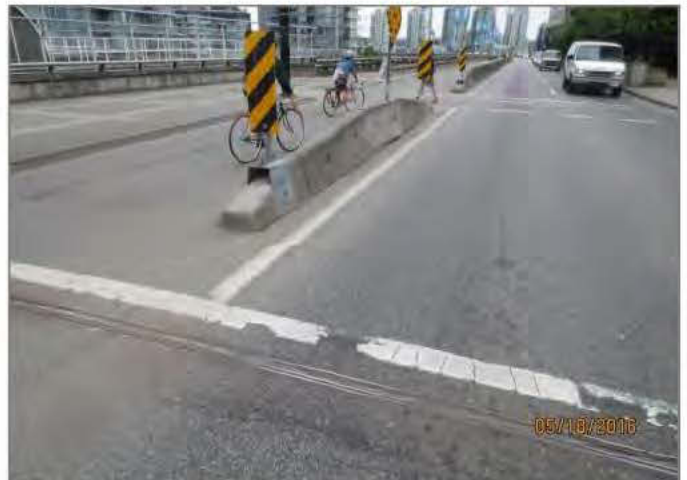
G12. Deck joint at west abutment (D23).

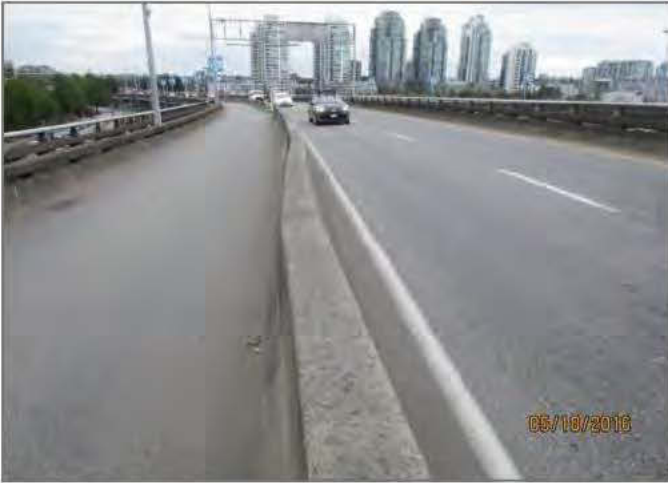
D19. Slight misalignment of traffic barrier near Pier D15.

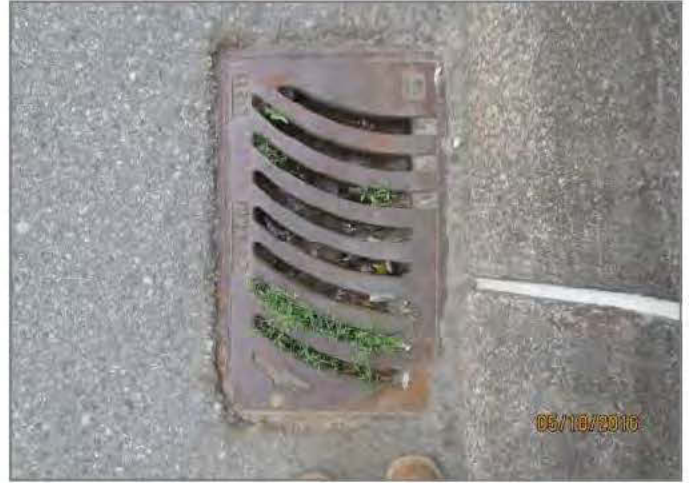
D20. Drain basin filled with debris and vegetation at DM5.

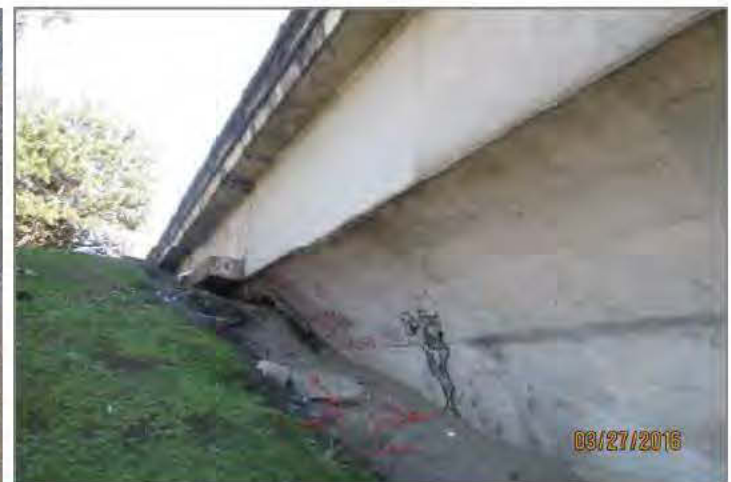
P2. Erosion of soil from north side of east abutment.

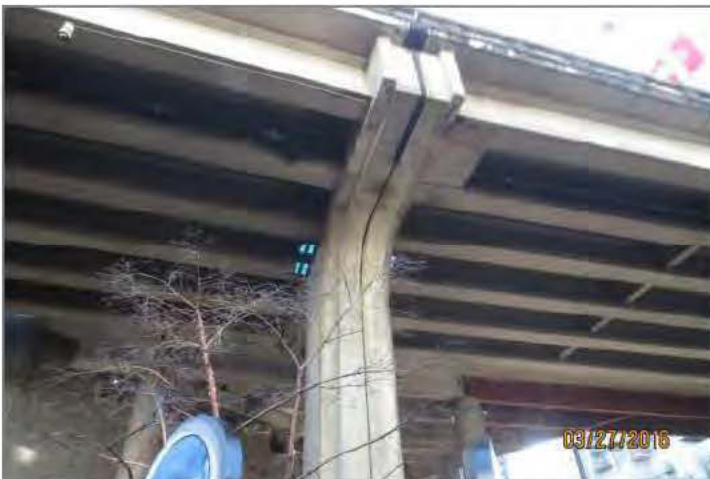
P7. Pier cap joint seal installed at Rogers Arena Plaza.

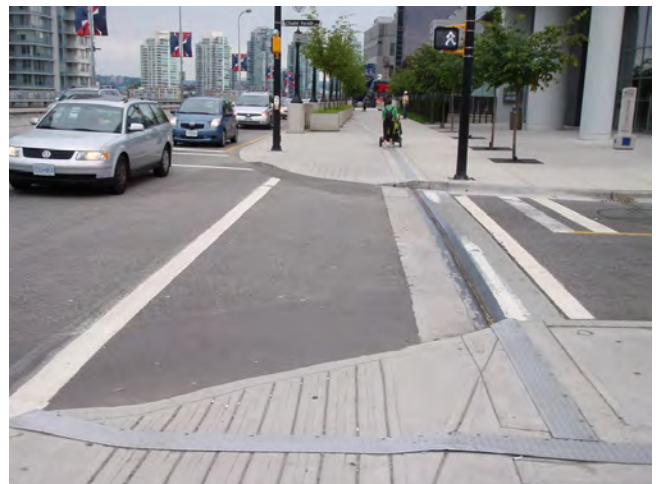
D-8 I-06.jpg  
Longitudinal joint between deck and sidewalk structure at west approach.

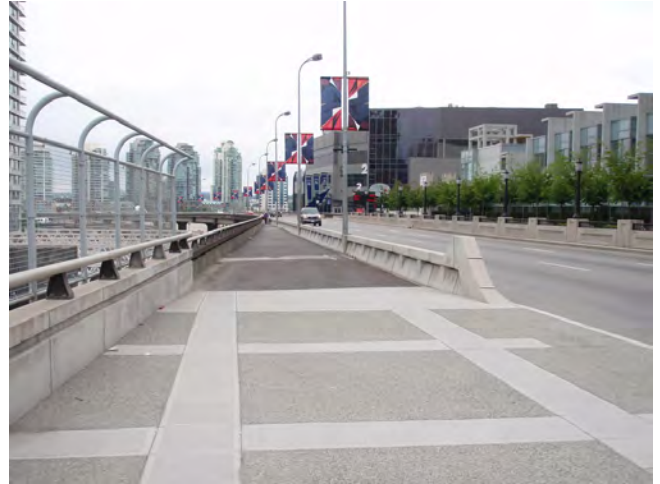
D-8 I-14.jpg  
Sidewalk flair and replacment bridge rail in west approach.
