BCA Report

Pine Tree Apartment

Address 300 Pine Street

Report Generated On:2017-03-23 15:01:25

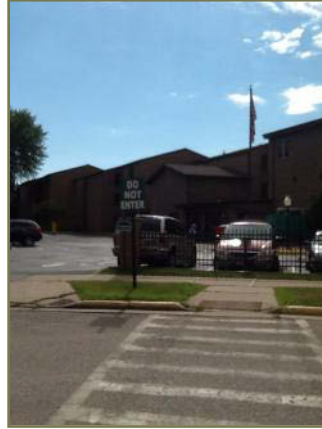
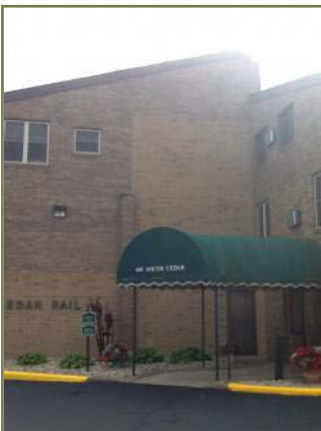
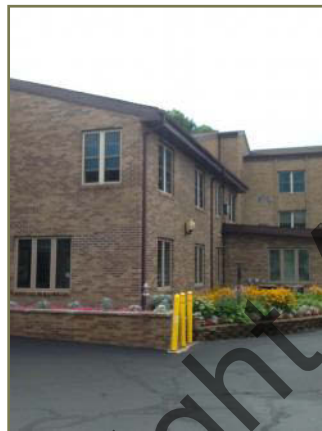
Category	B10 - Superstructure
Element Number	1
Last Major Action	1982
Brief Description	Solid brick with metal studs
Commentary	
Overall Condition	■ Good

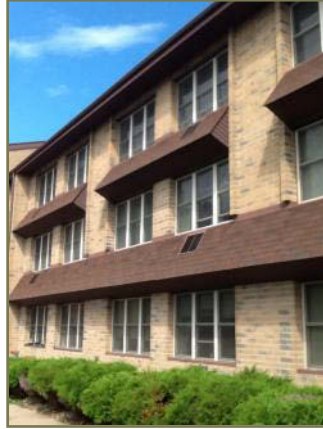
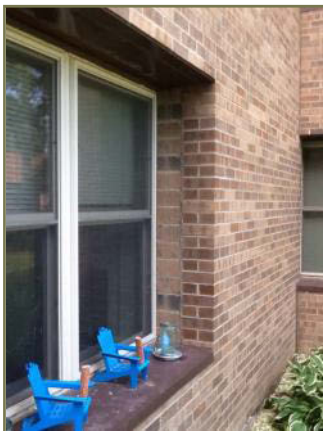
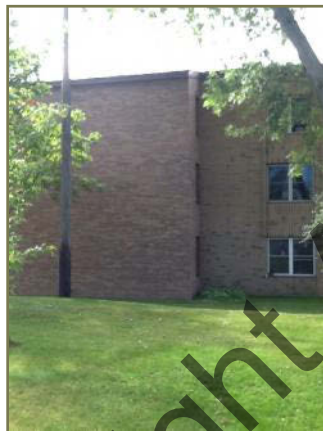
Category	B2010 - Exterior Walls
Element Number	1
Last Major Action	2000
Brief Description	Metal studs with brick exterior. M3.5" fiberglass insulation
Commentary	North side was re-bricked in spots due to wind penetration.
Overall Condition	■ Good

Action Summary:	Repair exterior walls.
Action: Commentary	
Action Type	Repair
Year	2037
Repeat Interval	37
Priority	Low
Priority Score	19.00

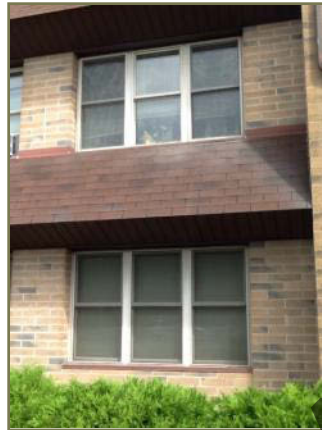
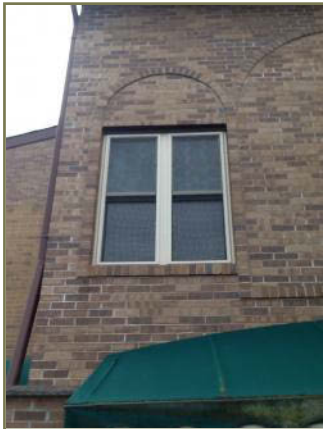
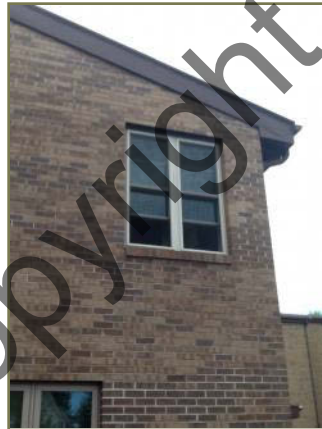
Category	B2020 - Exterior Windows*
Element Number	1
Last Major Action	2005
Brief Description	Vinyl double hung low energy glass windows.
Commentary	Replaced in 2005.
Overall Condition	■ Good

Action Summary: Replace exterior windows.

Action: Commentary	
Action Type	Replacement
Year	2037
Repeat Interval	32
Priority	Low
Priority Score	16.50

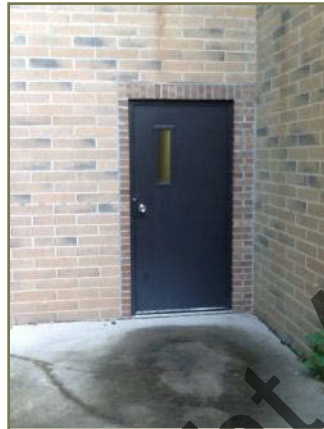
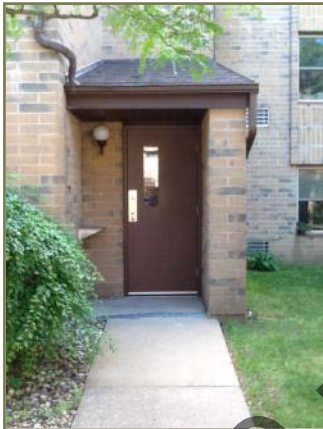
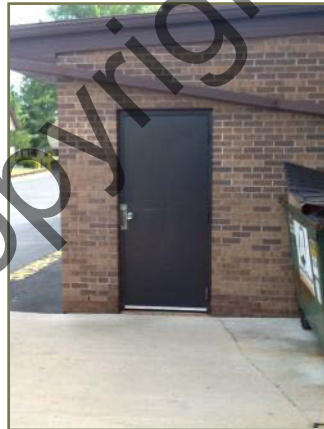
Category	B2030 - Exterior Doors*
Element Number	1
Last Major Action	2002
Brief Description	Main entrances are sliding glass doors. Other entrances are metal service doors with glass windows.
Commentary	A fix of original doors, which have some rusting, and doors replaced in 2002. Replacing with fiber glass doors in 2015, last added new doors as part of addition in 2002
Overall Condition	■ Fair

Action Summary: Replace exterior doors

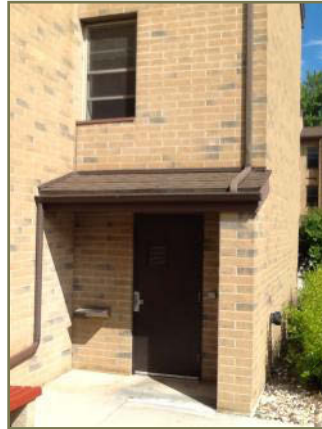
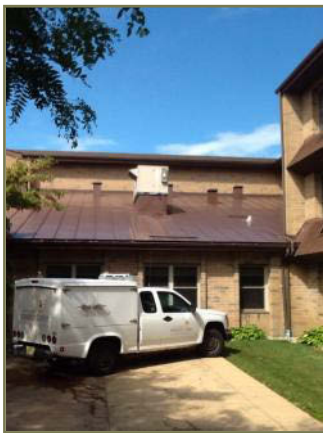
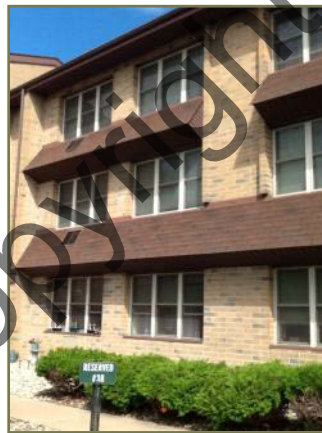
Category	B30 - Roofing
Element Number	1
Last Major Action	2013
Brief Description	Metal shingle Decro product
Commentary	Replaced in 2013 with a 50 year warranty. The eaves-trough was buried into the storm sewer in 2000.
Overall Condition	■ Good

Action Summary:	Replace roofing
Action: Commentary	
Action Type	Replacement
Year	2035
Repeat Interval	22
Priority	Low
Priority Score	15.00

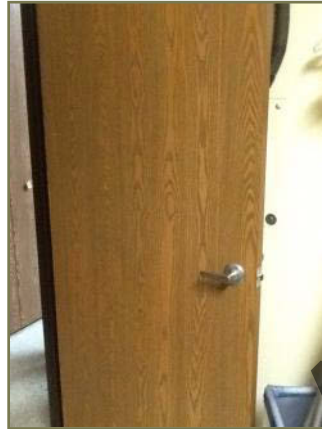
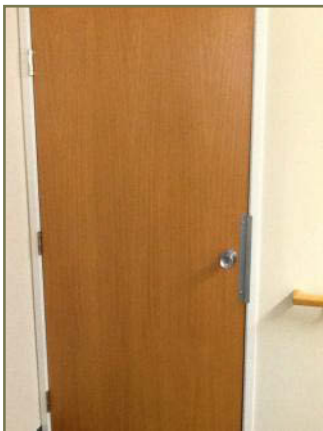
Category	C1050 - Interior Doors - Common Area
Element Number	1
Last Major Action	1982
Brief Description	Wood doors and metal fire doors leading to the stairwells
Commentary	Doors do not appear to be original but there is no record of them being replaced.
Overall Condition	■ Good

Action Summary:	Replace common area doors
Action: Commentary	
Action Type	Replacement
Year	2032
Repeat Interval	25
Priority	Low
Priority Score	12.00

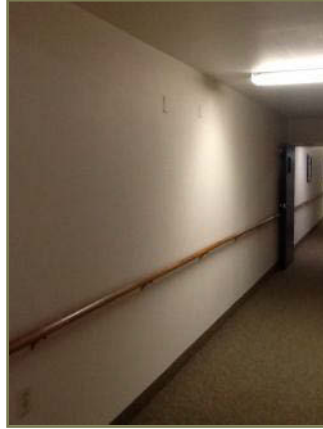
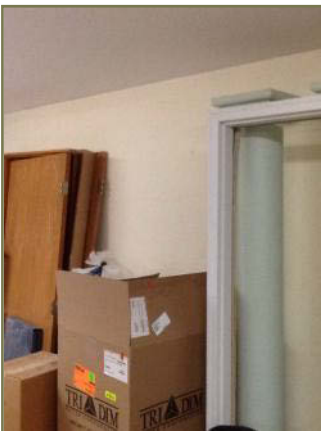
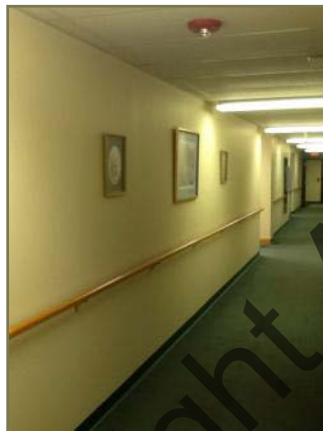
Category C3050 - Wall Finishes - Common Area
Element Number 1
Last Major Action 2008
Brief Description Painted drywall in the common areas
Commentary Building painted in 2008, entrance was repainted in 2013.
Overall Condition ■ Good

Action Summary:	Replace common area walls
Action: Commentary	
Action Type	Replacement
Year	2020
Repeat Interval	12
Priority	Low
Priority Score	12.75

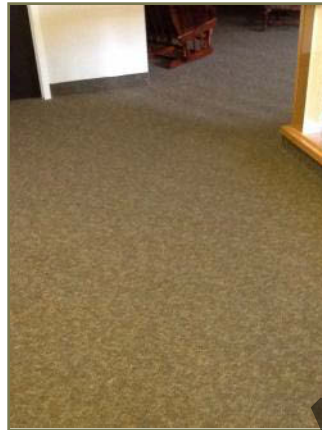
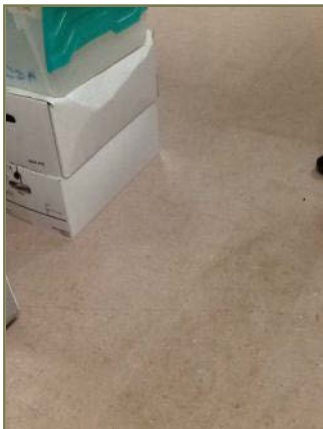
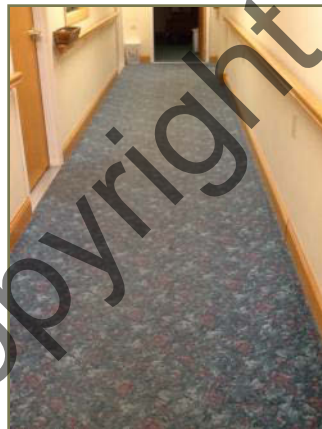
Category	C3070 - Floor Finishes - Common Area
Element Number	1
Last Major Action	1982
Brief Description	Carpeting in the common areas on the 1st and 3rd floors
Commentary	1st & 3rd floors are in need of replacement.
Overall Condition	■ Poor

Action Summary:	Replace carpeting on the 1st and 3rd floors.
Action: Commentary	
Action Type	Replacement
Year	2017
Repeat Interval	24
Priority	Medium
Priority Score	30.25

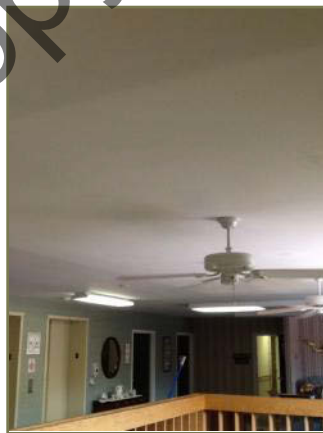
Category C3090 - Ceiling Finishes - Common Area
Element Number 1
Last Major Action 1982
Brief Description Common areas have dropped ceiling and acoustic tiles.
Commentary Acoustic tiles are replaced as needed.
Overall Condition ■ Good

Action Summary: Replace common area ceilings

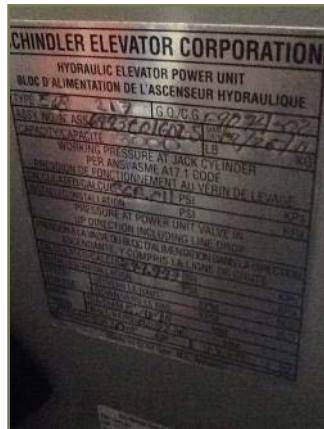
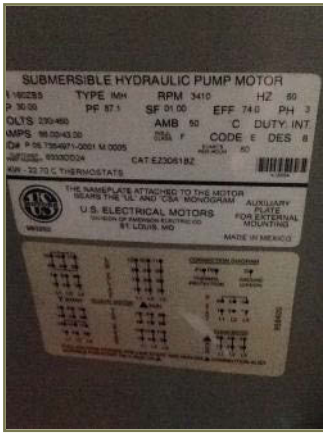
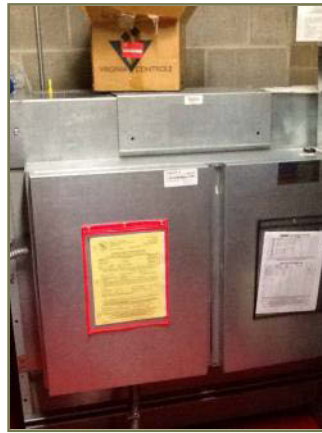
Category	D1010 - Elevators & Lifts
Element Number	1
Last Major Action	2009
Brief Description	(2) Elevators, (1) Hydrolic elevator, (1) Electric service elevator with front and back doors.
Commentary	Upgraded operators controls in 2009.
Overall Condition	■ Good

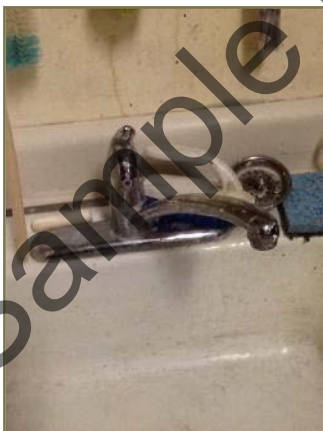
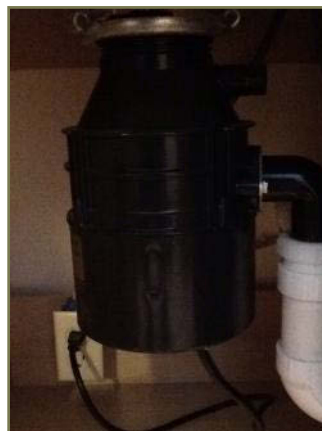
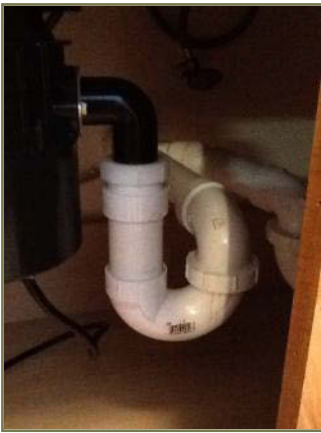
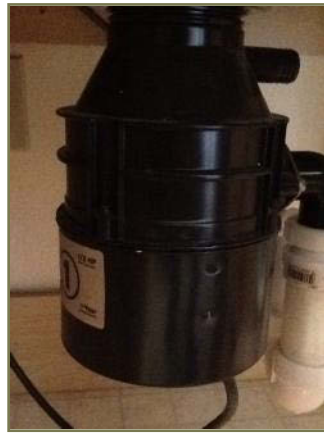
Commentary Replaced in 2000.

Overall Condition ■ Good

Action Summary: Replace plumbing fixtures

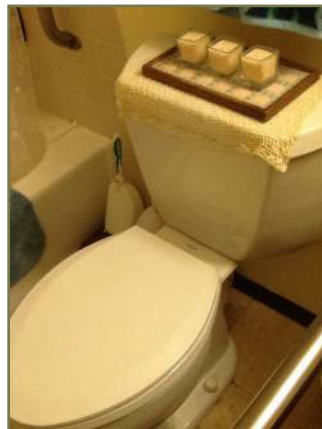
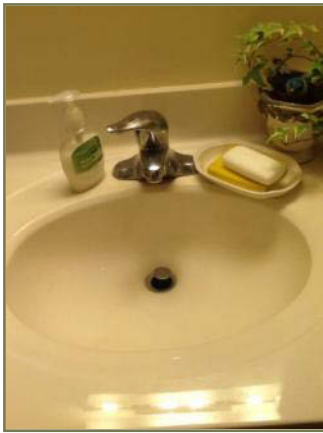
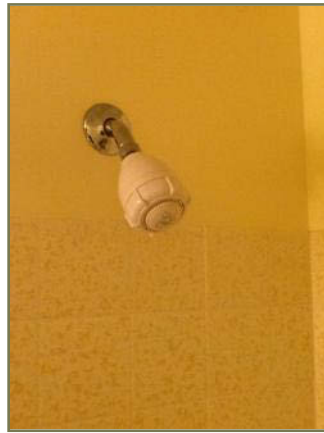
Category	D2050 - Domestic Water Distribution - Units
Element Number	1
Last Major Action	1982
Brief Description	Copper supply lines and PVC drain lines in common areas and units.
Commentary	All appear to be in good condition.
Overall Condition	■ Fair

Action Summary: Replace unit piping

Action Type	Replacement
Year	2019
Repeat Interval	37
Priority	Medium
Priority Score	20.75

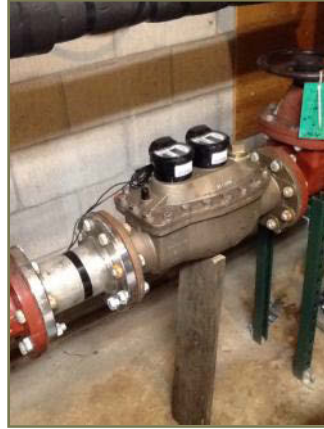
Category	D2070 - Domestic Water Distribution - Main
Element Number	1
Last Major Action	1982
Brief Description	Main water distribution, hot water line has re-circulator pump on it, drain piping is PVC.
Commentary	Concealed System: the piping system is of an unknown age. There have been some pin hole leaks reported, so repair and replacement is recommended.
Overall Condition	■ Fair

Action Summary: Replace main water piping

Action Type	Replacement
Year	2019
Repeat Interval	37
Priority	Medium
Priority Score	20.75

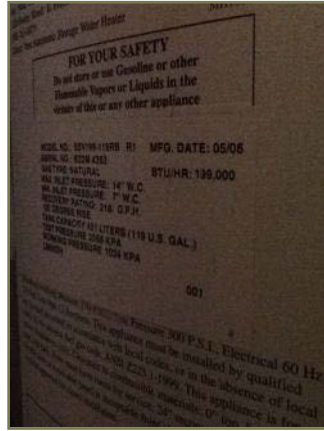
Category	D2095 - Domestic Water Heaters
Element Number	1
Last Major Action	2006
Brief Description	(3) Voyager gas fired water heaters, 119 gal, 199,000 BTU/Hr,
Commentary	Replaced in 2006, upgrading control boards in 2015. The heaters are past their life expectancy, but remain functional in fair condition, so replacement can be deferred.
Overall Condition	■ Fair

Action Summary: Replace water heater

Action Type	Replacement
Year	2020
Repeat Interval	10
Priority	Low
Priority Score	16.25

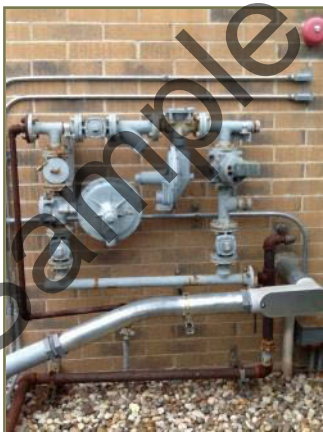
Category	D3012 - Gas Supply System
Element Number	1
Last Major Action	1982
Brief Description	Gas meter outside.
Commentary	No issues noted by staff
Overall Condition	■ Good

Action Summary: Replace gas supply

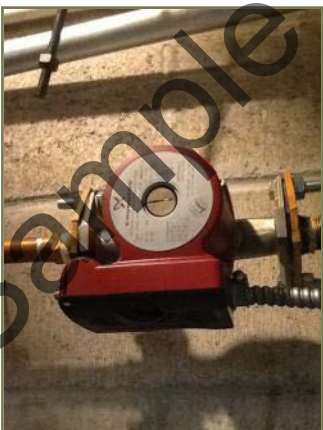
Category	D3025 - Primary HVAC Pumps*
Element Number	1
Last Major Action	1982
Brief Description	(1) small HVAC pump
Commentary	No issues noted by staff
Overall Condition	■ Good

Action Summary: Replace HVAC pump

Action Type	Replacement
Year	2032
Repeat Interval	25
Priority	Low
Priority Score	18.00

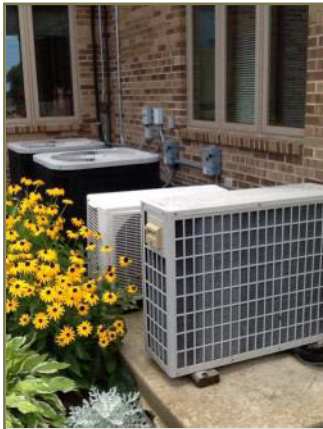
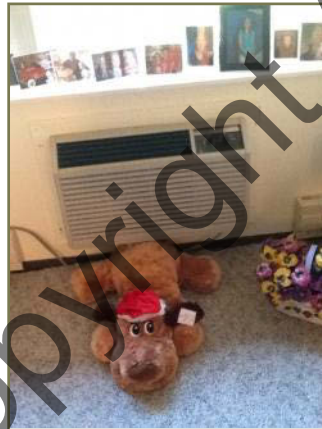
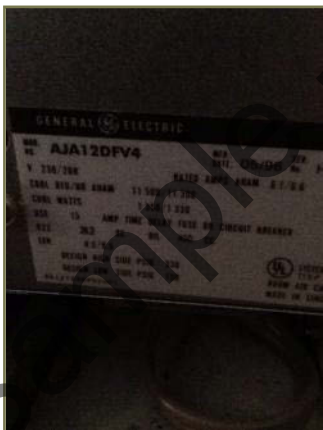
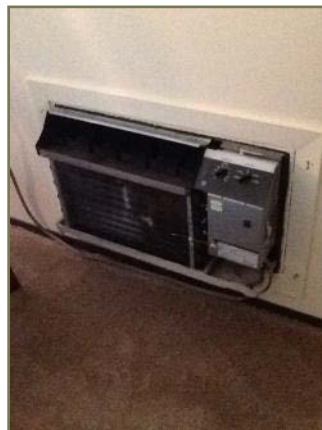
Category	D3034 - Packaged Air Conditioning Units*
Element Number	1
Last Major Action	2000
Brief Description	ACs in offices, community and hallways.
Commentary	No issues noted by staff
Overall Condition	■ Good

Action Summary: Replace common area air conditioners

Action Type	Replacement
Year	2032
Repeat Interval	25
Priority	Low
Priority Score	14.25

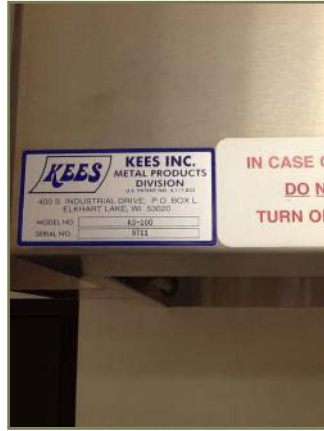
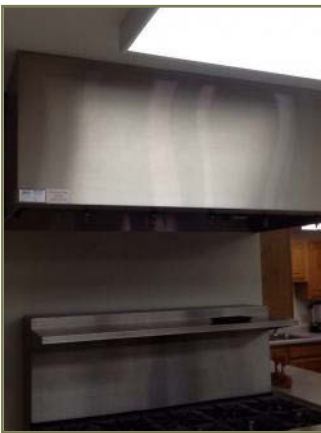
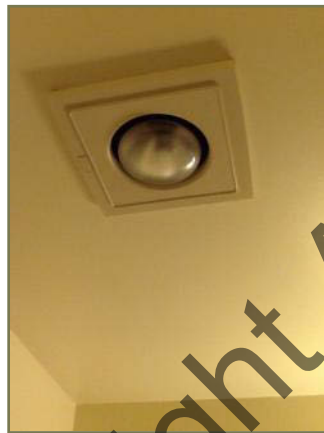
Category	D3045 - Exhaust Ventilation Systems
Element Number	1
Last Major Action	1982
Brief Description	Bathrooms have their own exhaust fans. There are ceiling vents in community room.
Commentary	The exhaust fans are past their life expectancy, remaining functional in fair condition but should be replaced soon.
Overall Condition	■ Fair

Action Summary:	Replace exhaust vents
Action: Commentary	
Action Type	Replacement
Year	2017
Repeat Interval	25
Priority	Medium
Priority Score	21.50

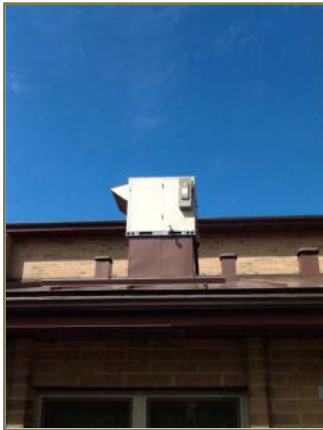
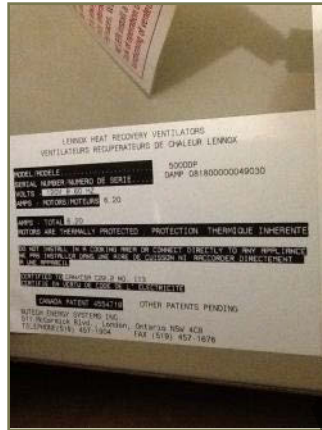
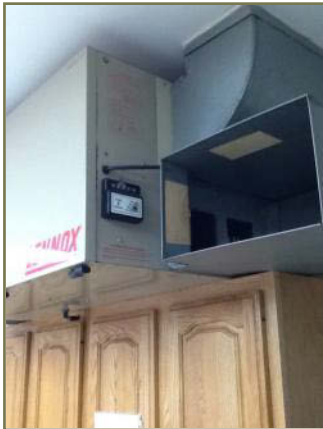
Category	D3058-D - Make-Up AHU*
Element Number	1
Last Major Action	2000
Brief Description	On roof over community room
Commentary	Unable to access for inspection
Overall Condition	■ Good

Action Summary:	Replace make-up AHU
Action: Commentary	
Action Type	Replacement
Year	2018
Repeat Interval	18
Priority	Low
Priority Score	7.50

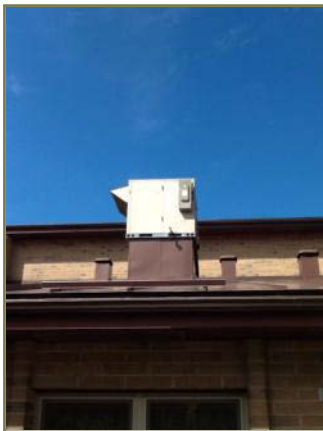
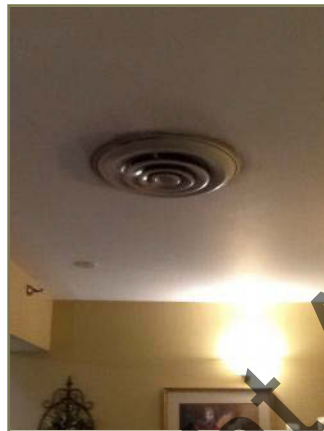
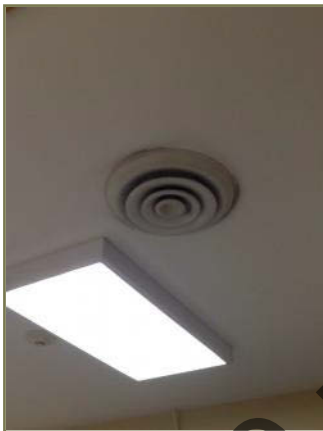
Category	D3058-D - Make-Up AHU*
Element Number	2
Last Major Action	2000
Brief Description	Box forced fan air/baseboard in hallways. Powered ceiling fans in community room.
Commentary	The air handler in attic was shut off after the first year due to noise complaint from tenant and not used since. Air handler above community room not accessible for inspection.
Overall Condition	■ Good

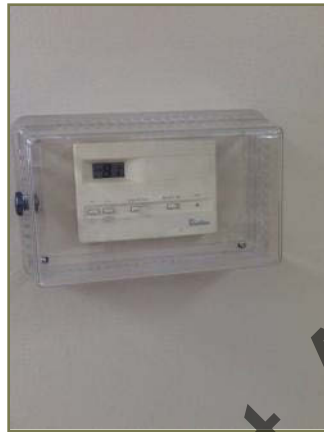
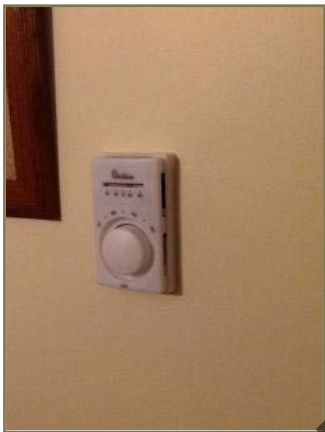
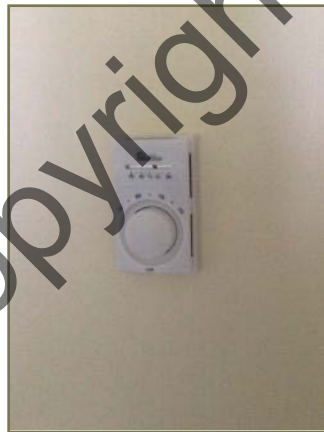
Category	D3060 - Controls And Instrumentation*
Element Number	1
Last Major Action	1982
Brief Description	Manual thermostat in lobby, in each bedroom and living room. Controls the baseboard electric heaters
Commentary	The thermostats are past their life expectancy, remaining functional in fair condition but should be replaced soon.
Overall Condition	■ Fair

Action Summary: Replace thermostats and controls

Action Type Replacement

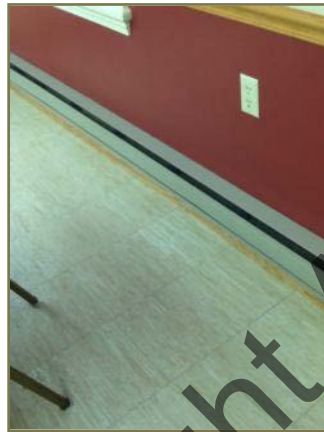
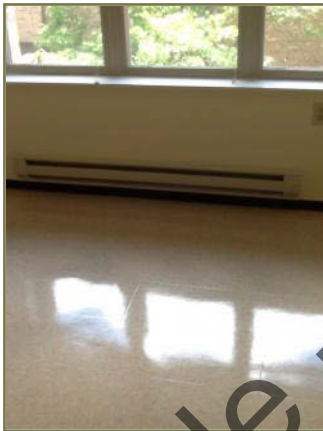
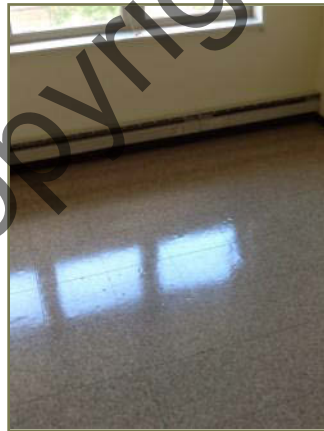
Commentary The exhaust fans are past their life expectancy, remaining functional in fair condition but should be replaced soon.

Overall Condition ■ Fair

Action Summary: Replace electric baseboards

Action Type	Replacement
Year	2022
Repeat Interval	15
Priority	Medium
Priority Score	22.25

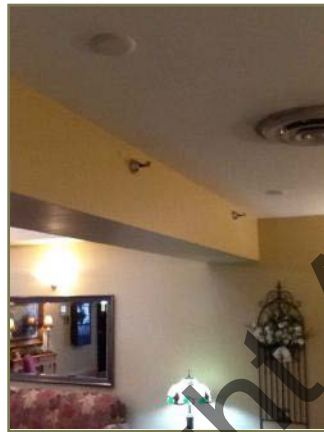
Category	D4010 - Sprinklers
Element Number	1
Last Major Action	1982
Brief Description	Sprinklers are only in front lobby.
Commentary	No issues reported, inspect and upgrade sprinkler system in accordance with the fire code. It is recommended to conduct a study to determine the remaining life & condition of the sprinkler system.
Overall Condition	■ Good

Action Summary:	Replace sprinklers
Action: Commentary	
Action Type	Replacement
Year	2029
Repeat Interval	47
Priority	Medium
Priority Score	21.00

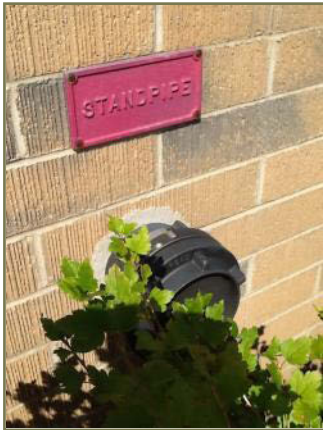
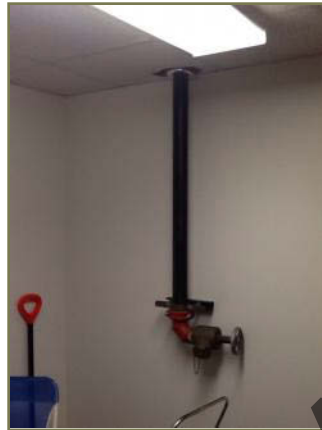
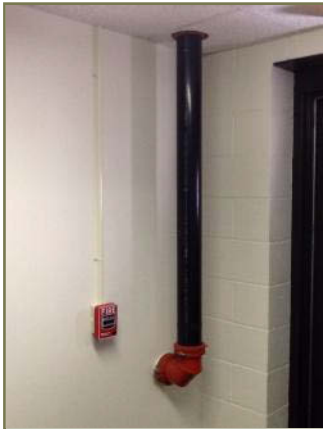
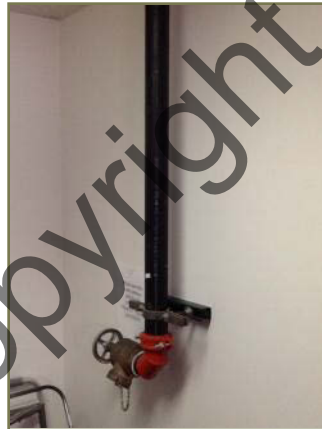
Category	D4020 - Standpipes
Element Number	1
Last Major Action	1982
Brief Description	Standpipes in each stairwell.
Commentary	No issues noted or reported. Upgrade as required by fire code.
Overall Condition	■ Good

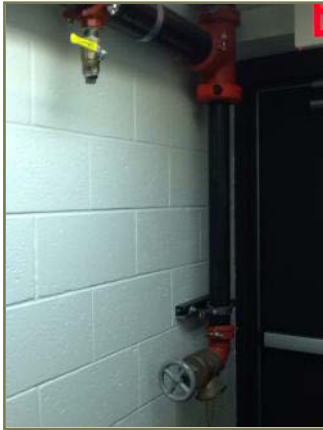
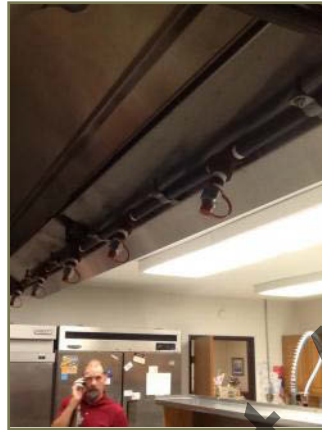
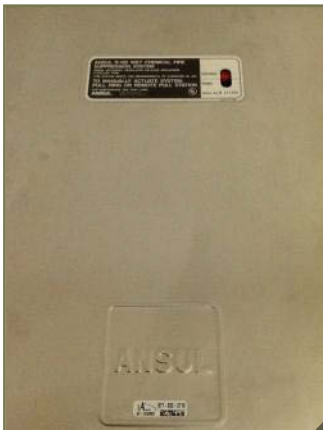
Category D4030 - Fire Protection Specialties
Element Number 1
Last Major Action 2000
Brief Description Hose connectors outside front lobby and throughout building, annul system above commercial stove in kitchen.
Commentary No issues reported, inspect and upgrade fire extinguishers in accordance with the fire code. All observed extinguishers have inspection tags.
Overall Condition ■ Good

Action Summary: Replace hose connectors

Action Type Replacement

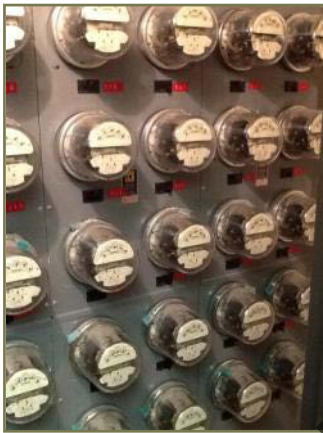
Element.574.cpqgl9yx.g9e.jpg

Commentary Some connections are broken. Electrical distribution is assumed to be beyond expected life and should be planned for replacement. Conduct an electrical study to determine remaining life and required repairs/upgrades.

Overall Condition ■ Poor

Action Summary: Replace main electrical

Conduct a study of the electrical panels & wiring to determine remaining life and cost of required upgrades & repairs.

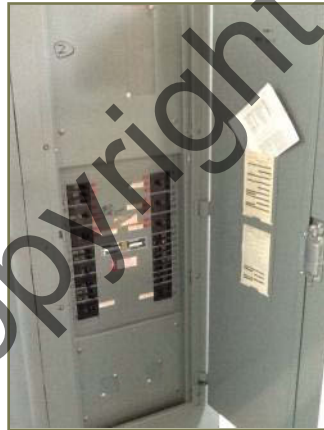
Element.575.a7mzi22t.i9u.jpg

Category	D5014 - Intermediate Electrical Service and Distribution*
Element Number	1
Last Major Action	1982
Brief Description	Square D brand electrical breaker boxes in hall on floor 1
Commentary	No issues noted or reported, unknown age. Electrical distribution is assumed to be beyond expected life and should be planed for replacement. Conduct an electrical study to determine remaining life and required repairs/upgrades.
Overall Condition	■ Poor

Replace intermediate electrical

Action Type	Replacement
Year	2017
Repeat Interval	30
Priority	Medium
Priority Score	36.25

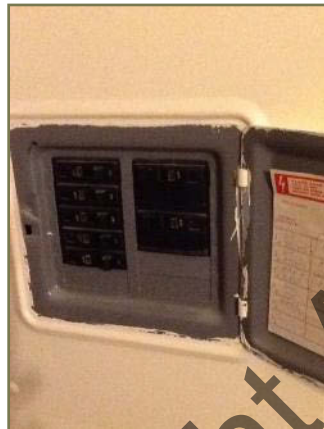
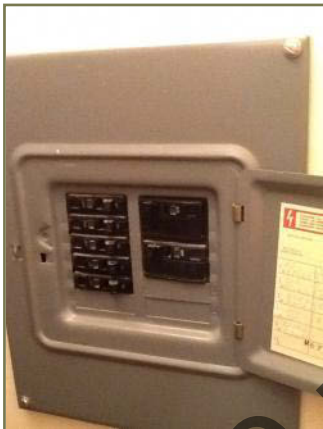
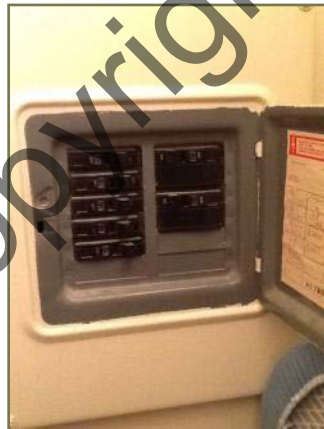
Category	D5015 - Unit Electrical Service and Distribution*
Element Number	1
Last Major Action	1982
Brief Description	100 amp panels and meters for each unit.
Commentary	Breaker boxes in each unit appear to be original. No issues noted or reported. Electrical distribution is assumed to be beyond expected life and should be planed for replacement. Conduct an electrical study to determine remaining life and required repairs/upgrades.
Overall Condition	<input type="checkbox"/> Good <input checked="" type="checkbox"/> Poor

Action Summary: Replace unit electrical

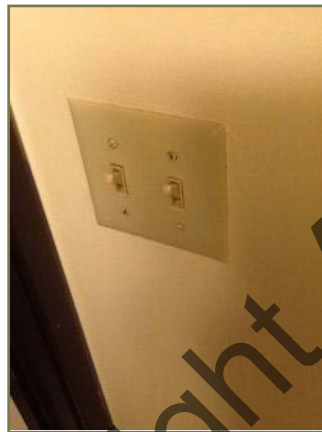
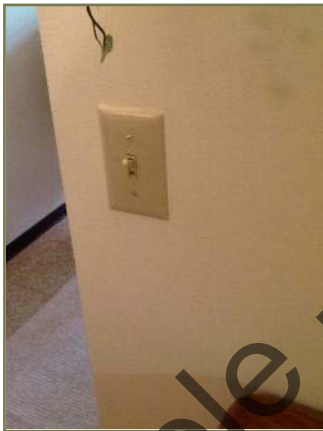
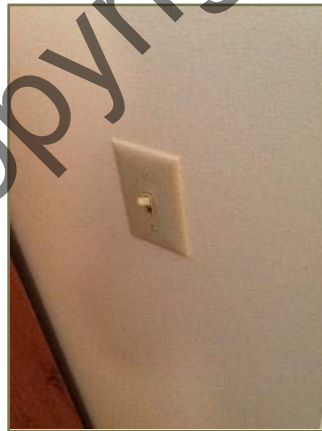
Category	D5021 - Branch Wiring
Element Number	1
Last Major Action	1982
Brief Description	Wiring is original throught out building
Commentary	Concealed system: no issues reported, the wiring is of an unknown age. It is assumed that the wiring has surpassed its expected life and may require repairs or replacement in the short term. Conduct an electrical study to determine remaining life and required repairs/upgrades.
Overall Condition	■ Fair

Action Summary: Replace branch wiring

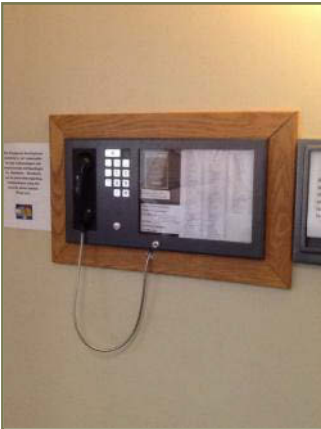
Element.551.dpc6iqzx.ecw.jpg

Actions**Action Summary:** Replace common area lighting**Action: Commentary****Action Type** Replacement**Year** 2028**Repeat Interval** 25**Priority** Low**Priority Score** 18.00**Sustainability Actions****D5032 - Intercommunications And Paging [1]****Category** D5032 - Intercommunications And Paging**Element Number** 1**Last Major Action** 1982**Brief Description** Paging system for visitors.**Commentary** The system appears to be original and would be beyond it's original lifespan.**Overall Condition** ■ Fair**Pictures**

Actions**Action Summary:** Replace paging system**Action: Commentary****Action Type** Replacement**Year** 2017**Repeat Interval** 25**Priority** Low**Priority Score** 19.25**Sustainability Actions**

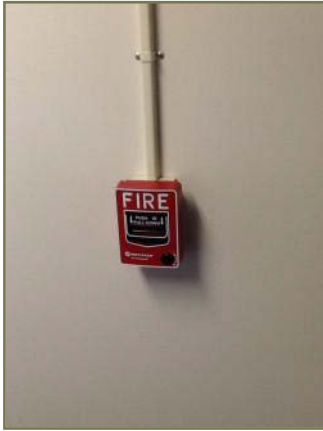
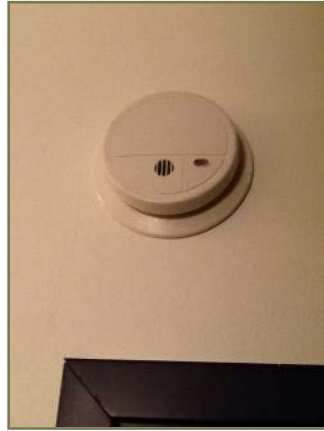
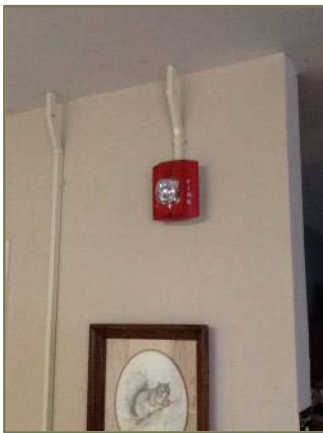
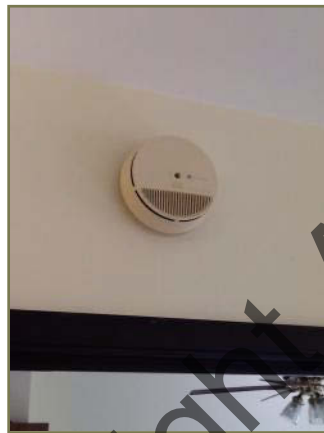
Category	D5037 - Fire Alarm System
Element Number	1
Last Major Action	2005
Brief Description	Fire Alarm System: Pull stations and hardwired smoke alarms through out building. Heat detector in maintenance area, battery powered CO2 installed by furnaces. Panel, external monitor, fire extinguishers through out halls and kitchens.
Commentary	No issues reported, inspect/replace/upgrade fire alarm systems in accordance with the fire code. Last updated in 2005.
Overall Condition	■ Good

Action Summary: Replace fire alarm system

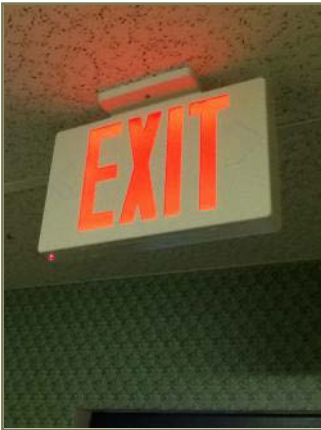
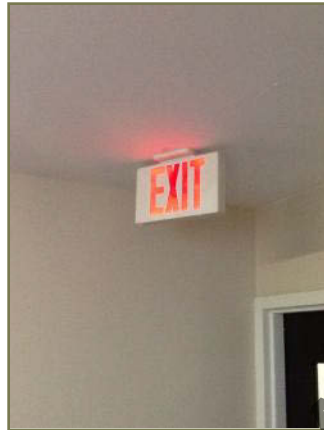
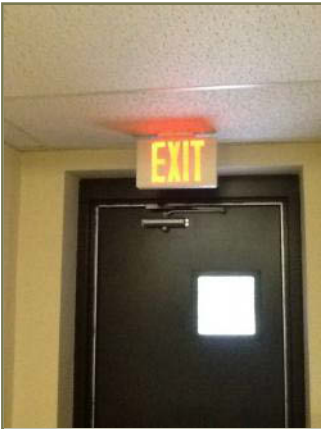
Category	D5091 - Exit & Emergency Light Systems*
Element Number	1
Last Major Action	2010
Brief Description	LED exit lights throughout building.
Commentary	It is recommended to replace emergency lighting with LED fixtures.
Overall Condition	■ Good

Action Summary: Replace emergency lighting

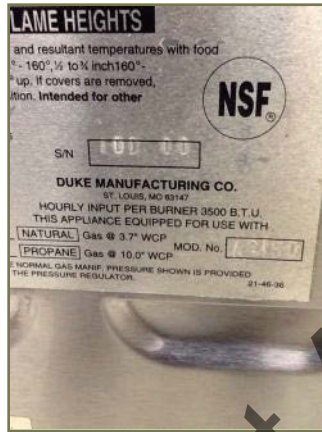
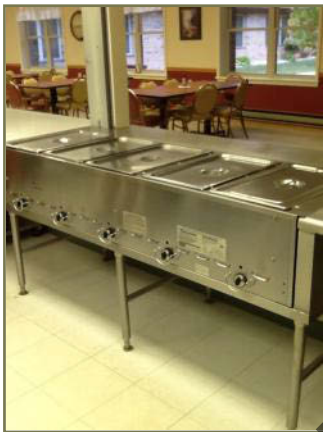
Category E1010 - Commercial Equipment
Element Number 1
Last Major Action 1995
Brief Description Hobart freezer, Maximum refrigerator, Southbend gas stove, and Duke warming ovens.
Commentary Commercial kitchen equipment is beyond expected life but was observed to still be in good condition.
Overall Condition ■ Good

Action Summary: Replace commercial equipment

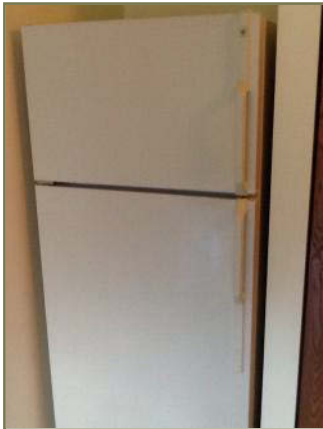
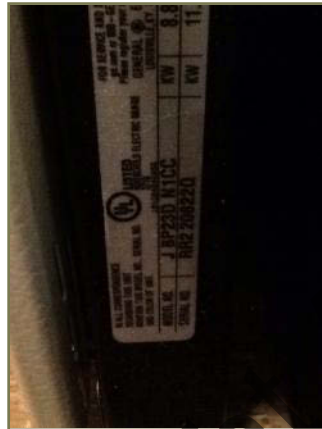
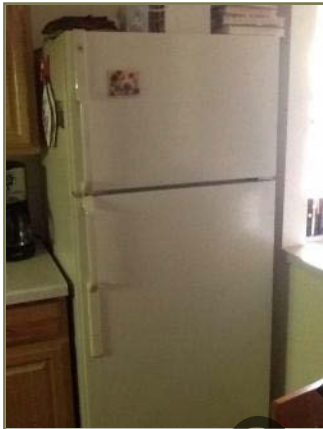
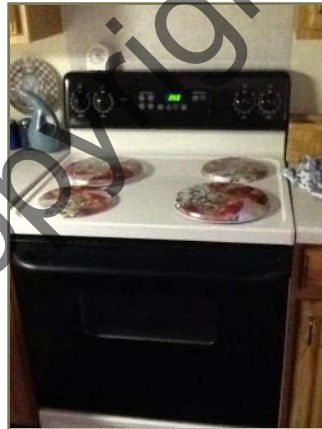
Category	E1041 - Residential Appliances*
Element Number	1
Last Major Action	2000
Brief Description	All stoves are identical except for (1) GE model jbp230n1cc. Fridges are Frigidaire, (15) are 17 cu ft, while (84) 16 cu ft. There is (1) Whirlpool 14 cu ft model et14nkxdn00.
Commentary	The appliances vary in age and are reported to be replaced on an as-needed basis. Overall in good condition.
Overall Condition	■ Good

Action Summary: Replace stoves and refrigerators

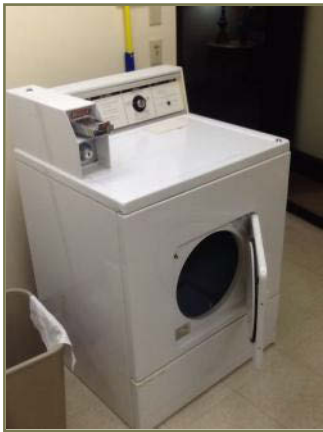
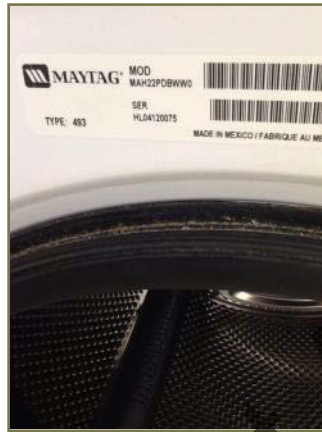
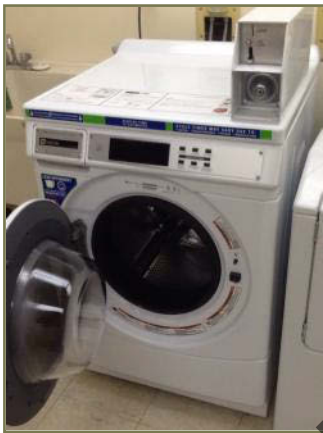
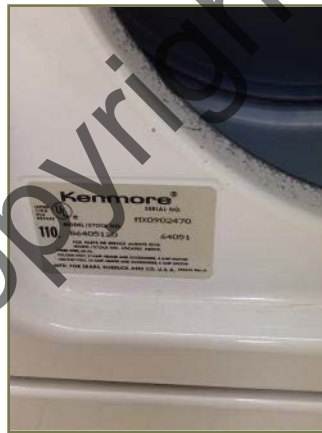
Category	E1042 - Laundry Room Equipment
Element Number	1
Last Major Action	2010
Brief Description	(6) Washers in building.
Commentary	Washers were last replaced in 2010.
Overall Condition	■ Good

Action Summary: Replace washer machines

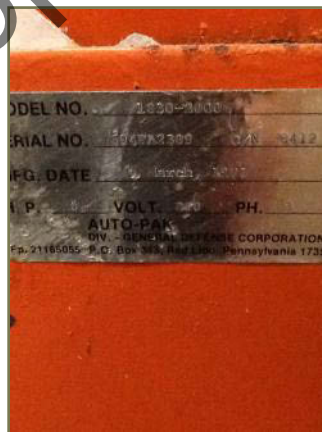
Element.562.wy3u2hvv.unm.jpg

Category F1046 - Trash Compactors
Element Number 1
Last Major Action 1982
Brief Description (1) Trash compactor original to the building.
Commentary The trash compactor is past life expectancy but was observed to still be in good condition.
Overall Condition ■ Good

Action Summary: Replace trash compactors

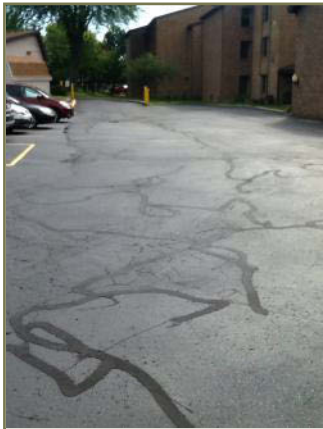
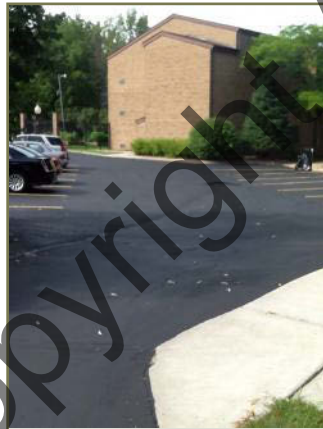
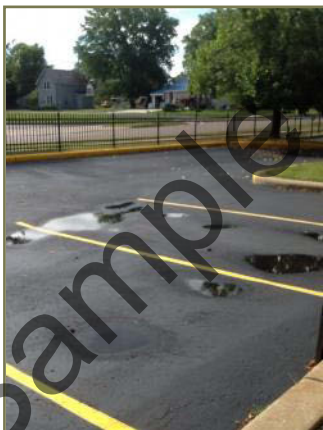
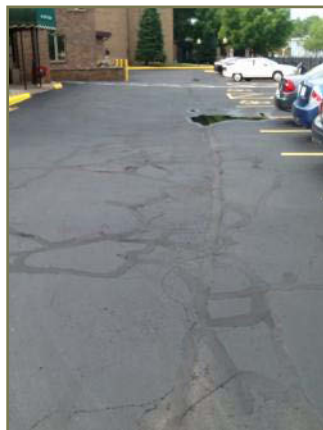
Category	G2020 - Parking Lots
Element Number	1
Last Major Action	2015
Brief Description	Asphalt parking lot.
Commentary	Re-sealed in 2015, in good condition.
Overall Condition	■ Good

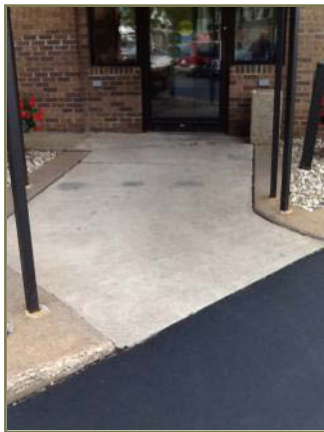
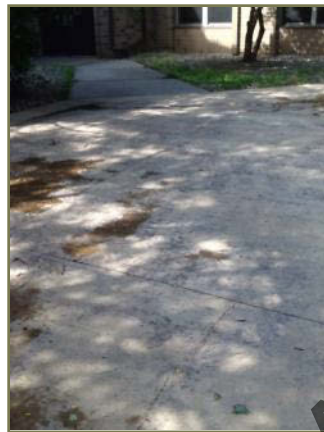
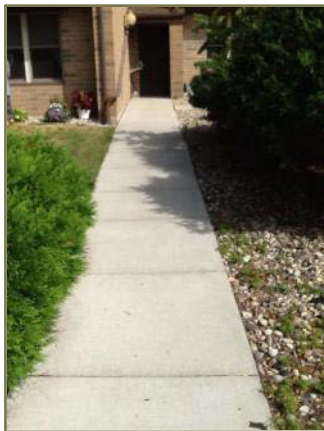
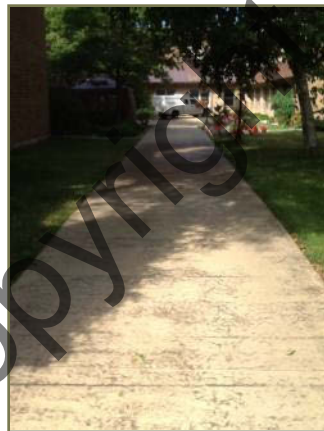
Category	G2030 - Pedestrian Paving
Element Number	1
Last Major Action	1982
Brief Description	Concrete sidewalks.
Commentary	Appears to be in good condition. No excessive spalling noted.
Overall Condition	■ Good

Action Summary:	Replace pedestrian paving
Action: Commentary	
Action Type	Replacement
Year	2026
Repeat Interval	22
Priority	Low
Priority Score	13.50

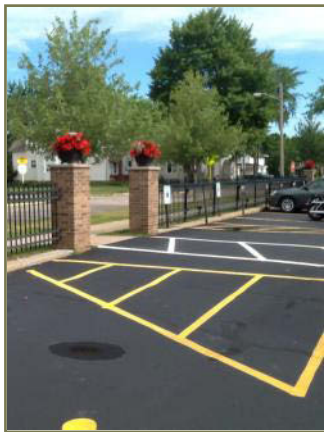
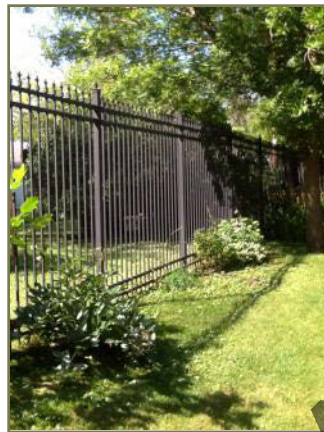
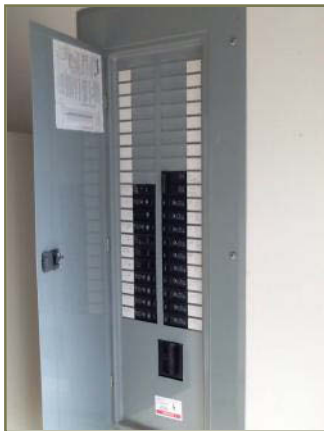
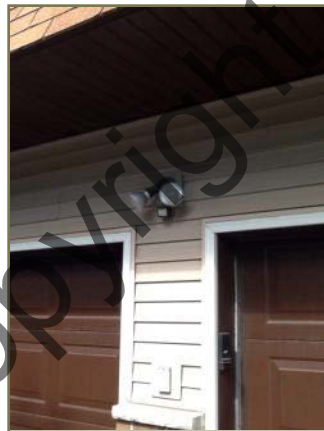
Category G2040 - Site Development
Element Number 1
Last Major Action 2005
Brief Description Wrought iron fencing around property.
Commentary
Overall Condition ■ Good

Action Summary: Replace fencing
Action: Commentary
Action Type Replacement
Year 2023
Repeat Interval 36
Priority Low
Priority Score 13.50

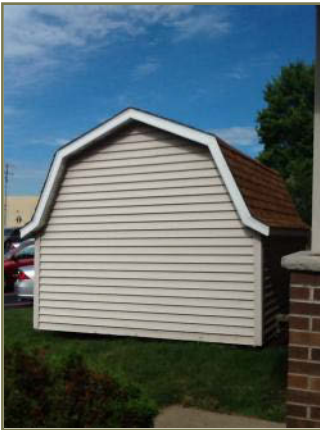
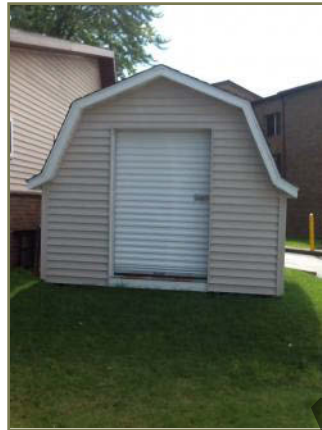
Category	G2049-B - Sheds
Element Number	1
Last Major Action	1998
Brief Description	Small shed with vinyl siding, asphalt shingles, garage door.
Commentary	No utilities in shed.
Overall Condition	■ Good

<u>Action Summary:</u>	Replace shed
Action: Commentary	
Action Type	Replacement
Year	2038
Repeat Interval	10
Priority	Low
Priority Score	7.50

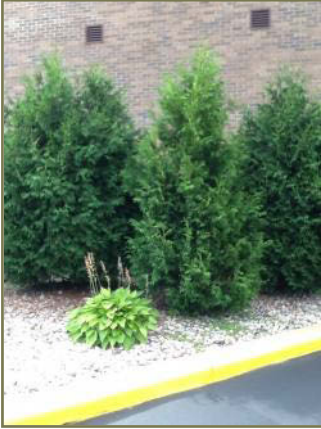
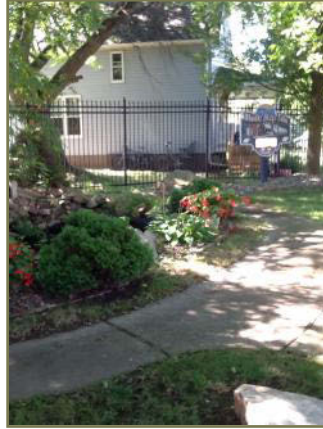
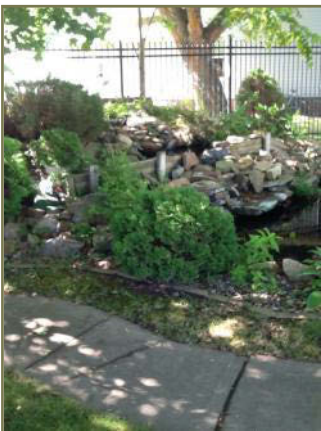
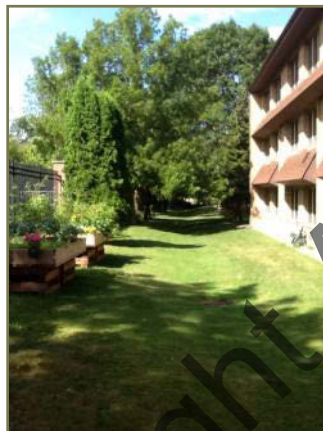
Category	G2050 - Landscaping
Element Number	1
Last Major Action	1982
Brief Description	Lawns, shrubs, trees, gardens
Commentary	Landscaped very well maintained.
Overall Condition	■ Good

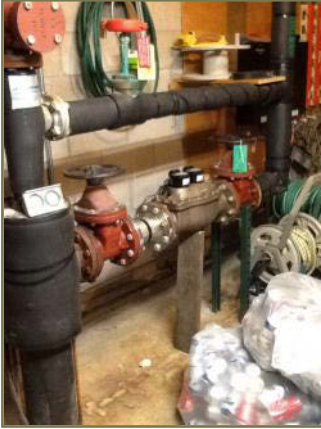
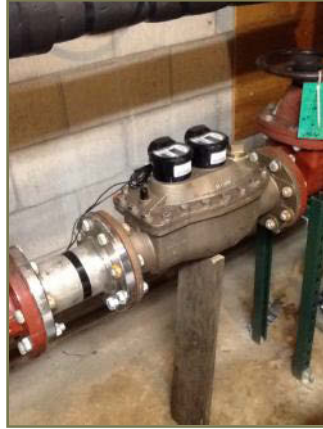
Category	G3010 - Water Supply
Element Number	1
Last Major Action	1982
Brief Description	Connected to city water
Commentary	Concealed System, no issues reported by site staff. A specialist review would be required to determine condition.
Overall Condition	■ Good

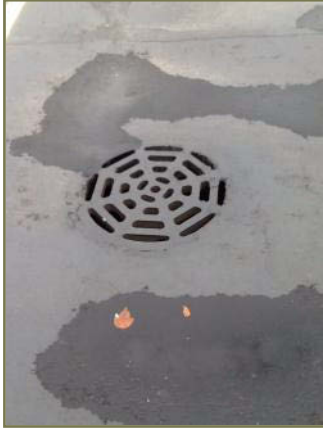
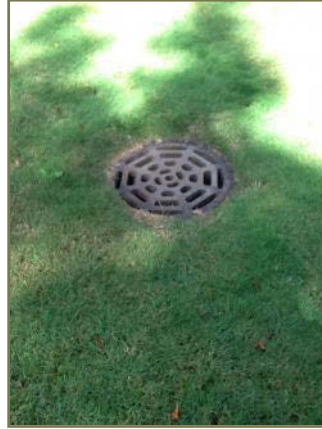
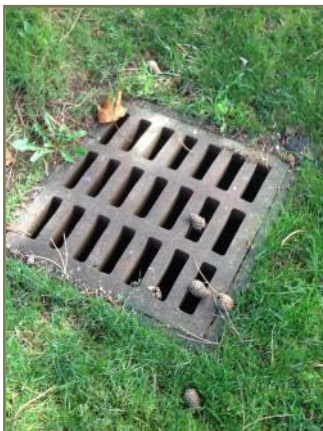
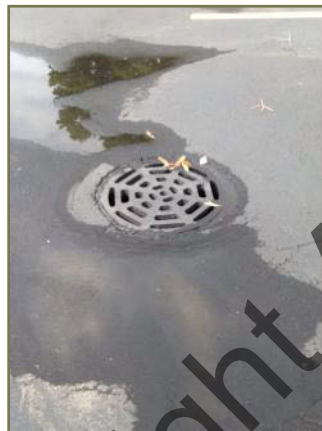
Category	G3030 - Storm Sewer
Element Number	1
Last Major Action	1982
Brief Description	Storm drains around property.
Commentary	Concealed system, no issues reported by site staff. A specialist review would be required to determine condition.
Overall Condition	■ Good

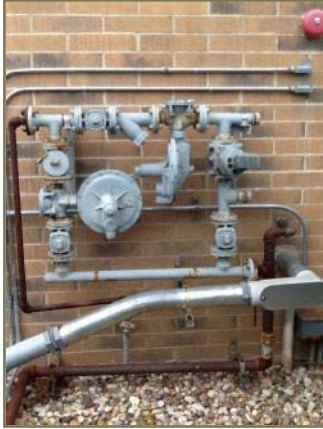
Element.593.ts4qb64n.fos.jpg

Category	G3060 - Fuel Distribution
Element Number	1
Last Major Action	1982
Brief Description	Gas supply & meters.
Commentary	Assumed to be maintained by service provider. No issues reported by site staff. A specialist review would be required to determine condition.
Overall Condition	■ Good

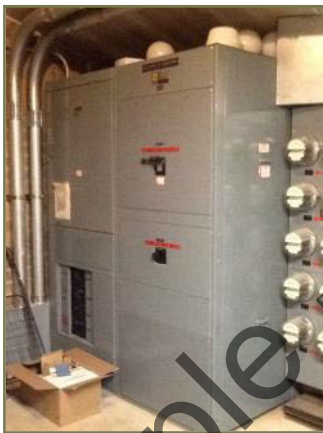
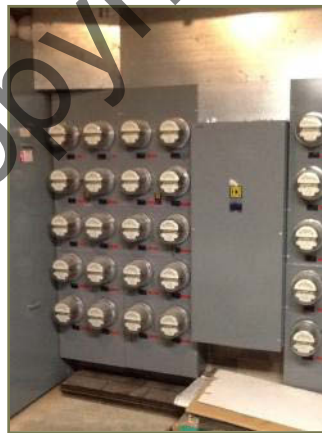
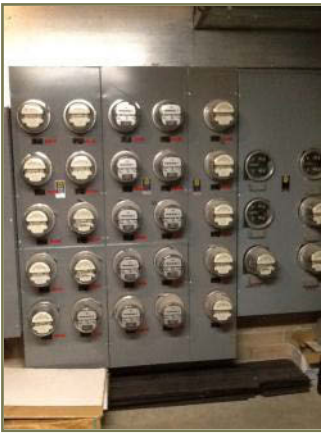
Category	G4010 - Electrical Distribution
Element Number	1
Last Major Action	1982
Brief Description	Each unit is metered individually.
Commentary	Assumed to be maintained by service provider. No issues reported by site staff. A specialist review would be required to determine condition.
Overall Condition	■ Good

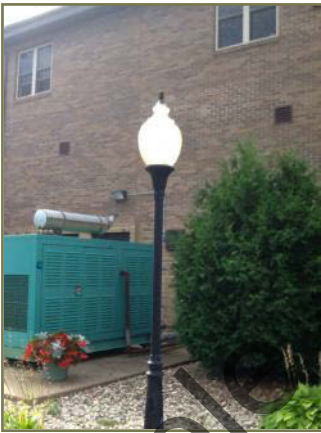
Element.594.5o6xehgc0.htc.jpg

Category	G4020 - Site Lighting
Element Number	1
Last Major Action	2005
Brief Description	(9) Pole lights are 70 watt infusion bulbs. (2) metal halide pole lights. (8) Building exterior lights are 40 watt infusion, (4) building exterior light are 70 watt metal halide and 7-19 watt cfl
Commentary	Site lighting is in good condition overall.
Overall Condition	■ Good

Action Summary: Replace site lighting
