BLACK HOUSE

144 EAST 6TH AVENUE, VANCOUVER, BC

HERITAGE CONSERVATION PLAN

MARCH 2024

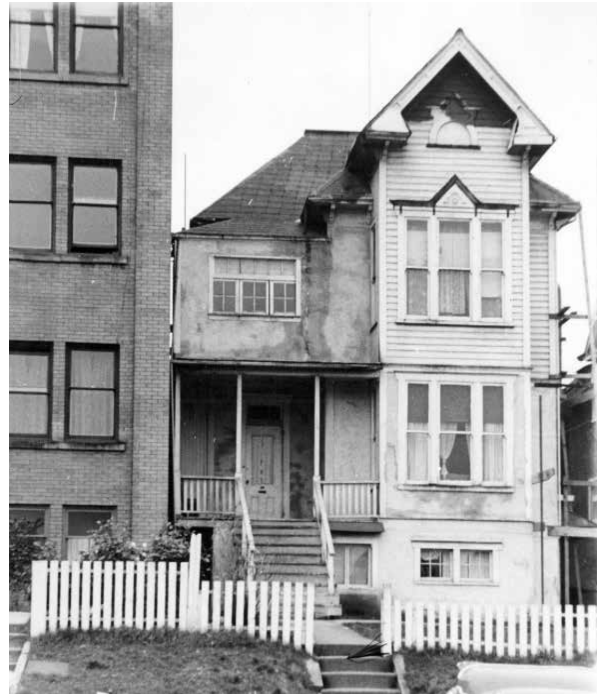
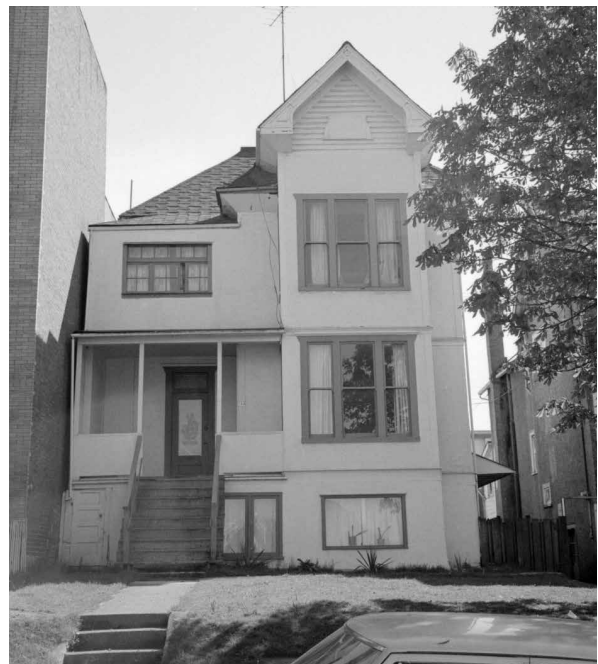
Top: 1958. Yates, A.L. Front elevation of historic residence at 144 East 6th Avenue [CVA Bu P508.15]

Bottom: 1974. Vancouver (B.C.). Planning Department. Front elevation of historic residence at 144 East 6th Avenue. [CVA 1095-03466]

- Structural engineer to conduct a detailed structural assessment to determine the current condition of the historic framing, and appropriate extent of interventions at rear.
- Preserve as much of the original framing of the historic building as possible, where structurally sound, and implement structural upgrades as required.
- Design structural or seismic upgrades so as to minimize the impact to the exterior character-defining elements
- Carefully dismantle any exterior character-defining elements that are unable to be relocated with the main structure including its chimney and front porch. Salvage all original materials in good, repairable condition, and reinstate upon relocation.

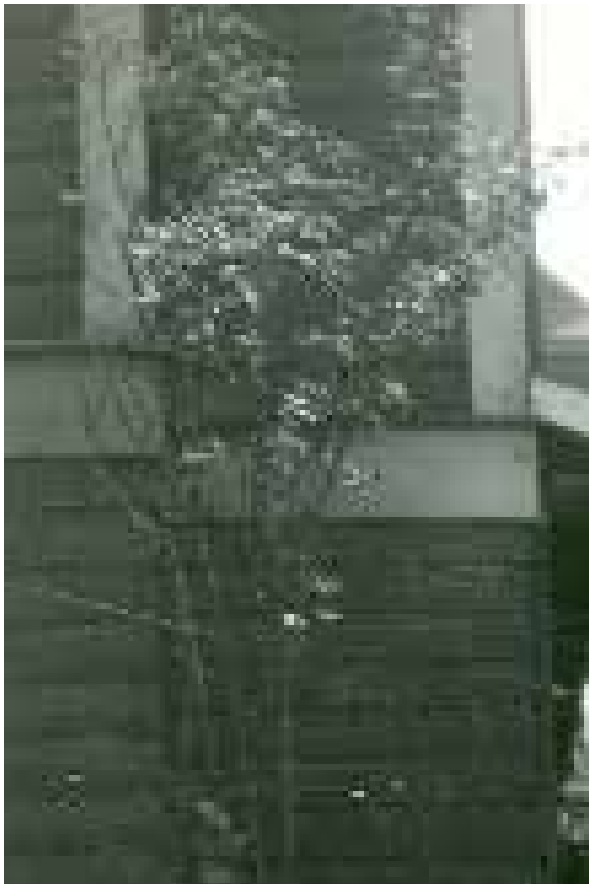
The surviving areas clad in narrow wood dropped siding are believed to be surviving original elements, and further investigation at these areas is required when access is available. Documentation of the original profile and dimensions of the surviving wood dropped siding will allow for in-kind replacement to be completed in a manner that is both physically and visually compatible with the original.

1948. Excerpt of family photograph at 144 East 6th ST Vancouver, showing original cladding configuration. [Courtesy of Young family]

As part of the redevelopment scheme, the exterior siding will be restored to its original configuration based on physical and documentary evidence. Intact wood siding will be preserved, where possible. All stucco cladding will be carefully removed to potentially reveal original wood dropped siding behind. If present, all original wood siding materials in good, repairable condition, should be preserved. Missing or severely

damaged siding can be replaced in-kind. Modifications and repairs of the exterior siding may be required following relocation.

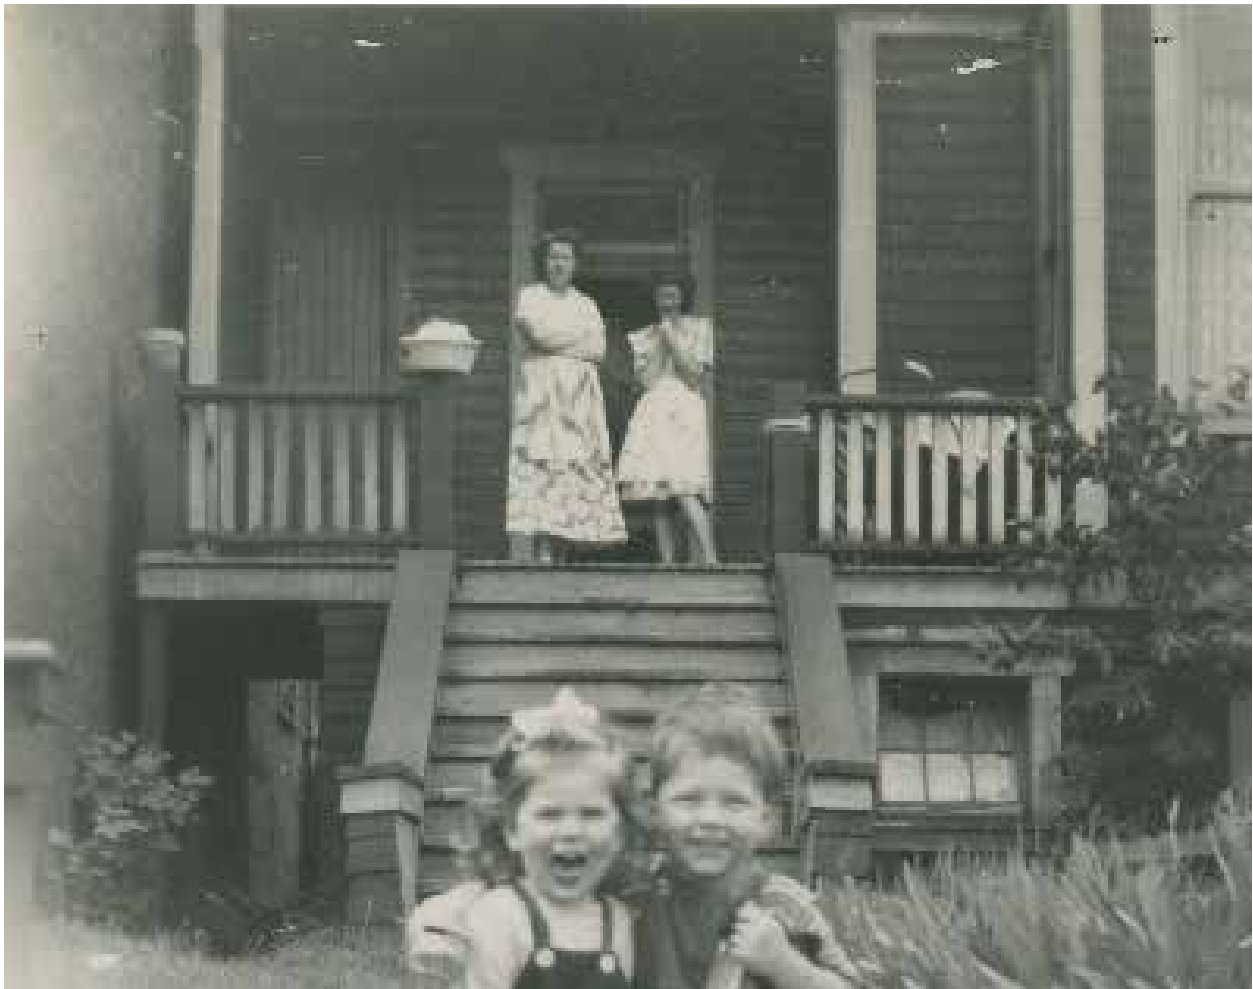
1948. View of front recessed verandah/porch in family photo at 144 East 6th St Vancouver. [Courtesy of Young family]

CONSERVATION STRATEGY: REHABILITATION

- Rehabilitate the front entry proportions of the residence by thoughtfully reconfiguring the
