DONNACONNA BLOCK

148 EAST 6TH AVENUE, VANCOUVER, BC

RECONSTRUCTION PLAN

MARCH 2024

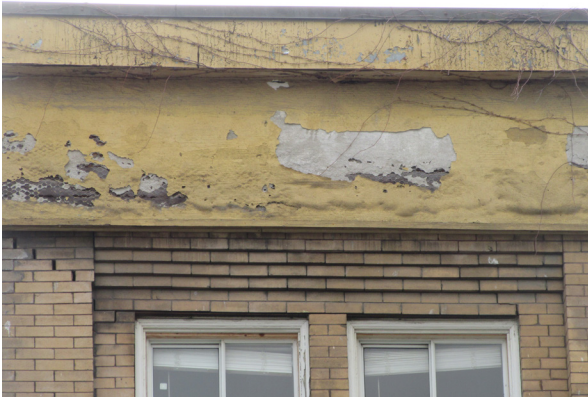
The brick faced façade (north façade and portion of south elevation) include sandstone sills characterized by a rock-face dressing. On the north façade, the sandstone sills run the length of each double assembly window opening. In general, the sandstone elements are in fair to poor condition. Notable signs of natural weathering include: discolouration and staining,

Brick corbel detailing above third floor windows.

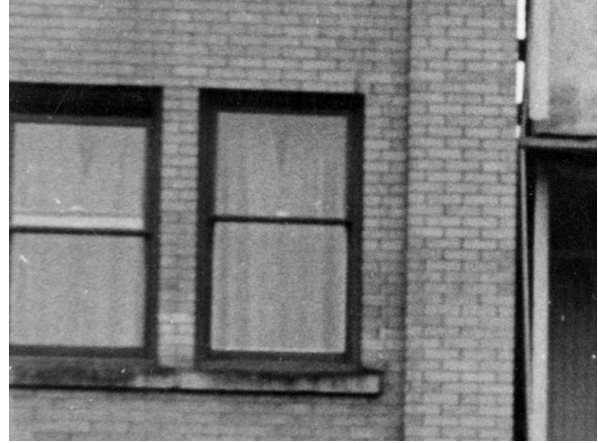
1958. Yates, A.L. 144 East 6th Avenue [CVA Bu P508.15] showing original fenestration design (1-over-1 with sash horns).

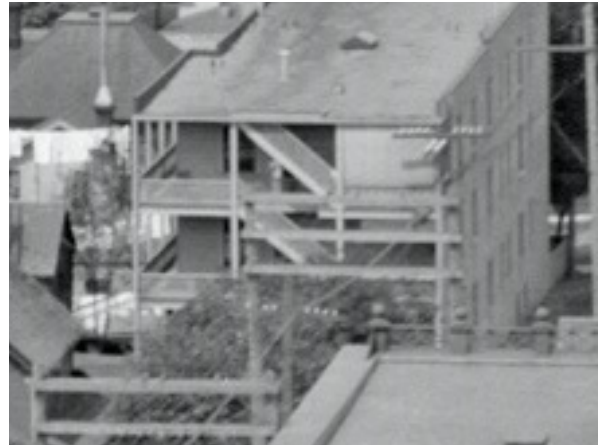
1913. Moore, W.J. Panorama of Vancouver [CVA PAN N161A] showing Donnacona Block's original wraparound balconies, exterior stairs and roof overhang. Rear exit doors are hidden by stairs.

Through the proposed development only the north façade will be reconstructed in a new location to the north of the existing. The extant door frame, transom, and sidelights of the north entry should be salvaged and assessed for possible reinstallation in the reconstructed north façade.

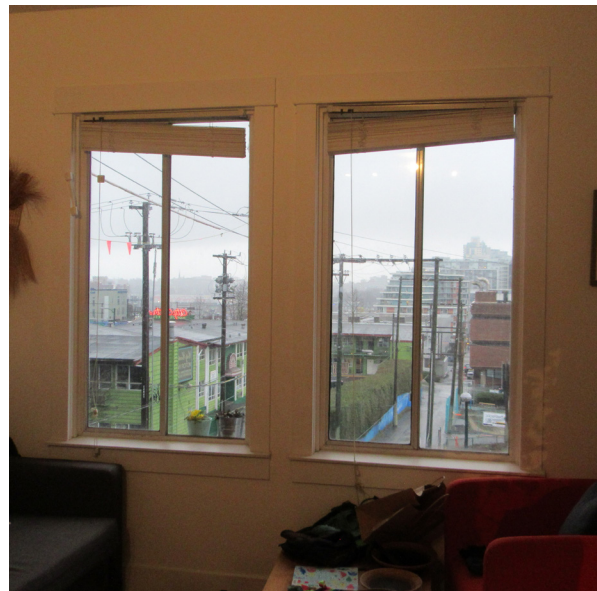
The Donnacona Block retains few remaining original interior wood element. Those noted during the site visit were trimwork and wood newel posts and open wood balustrade with square spindles at the north staircase. The elements have been painted and have localized areas of damage from use over time (e.g. scratches, dents, chips). Through the proposed redevelopment of the site the building will be demolished including the limited original interior elements.

Window casings.

CONSERVATION STRATEGY: DEMOLITION

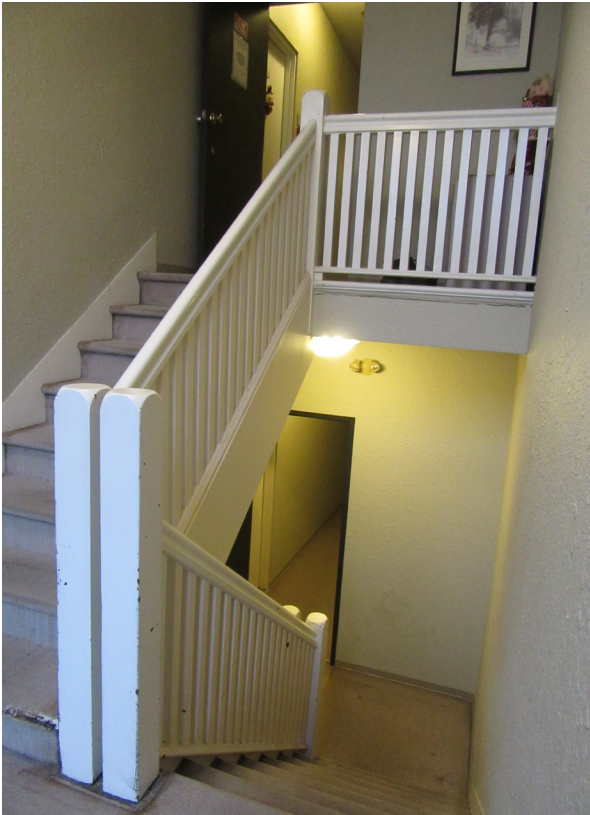
Open wood balustrade with square spindles and wood newel post.
