Conservation Plan

6825 West Boulevard, Vancouver, BC V6A 3E8

November 2020

6825 West Boulevard, Vancouver, BC

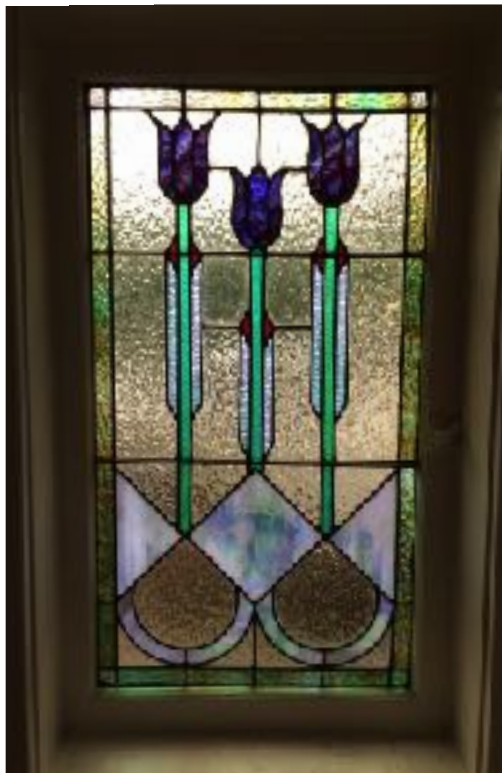
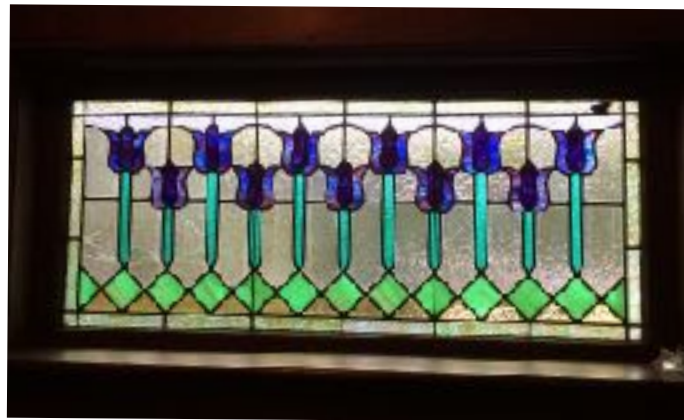
The tulip design stained glass windows on the east side of the house

The transoms of the first and second floor windows features stained glass in a geometric pattern
