Records related to Murray Hotel at 1119 Hornby Street:

1. Structural report prepared by Structural Solutions, dated January 4, 2019; and
2. City of Vancouver Annual Inspection Report prepared on January 16, 2019 by Inspector Nick Liu.

Project No.: K1397

Re: Structural Review of 1119 Hornby St., Vancouver, BC

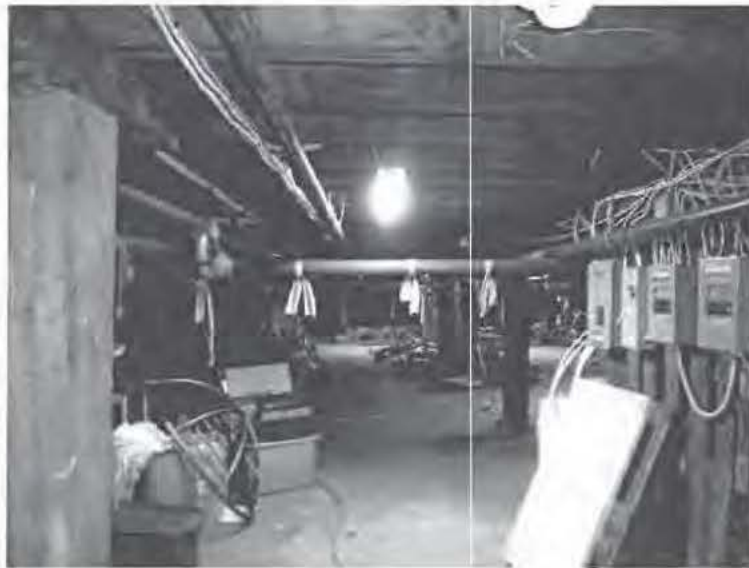
Figure 2, Basement framing with shoring to the left side.

report was not related to the structure. There was reference to shoring in the basement which is still in place per Figure 2.

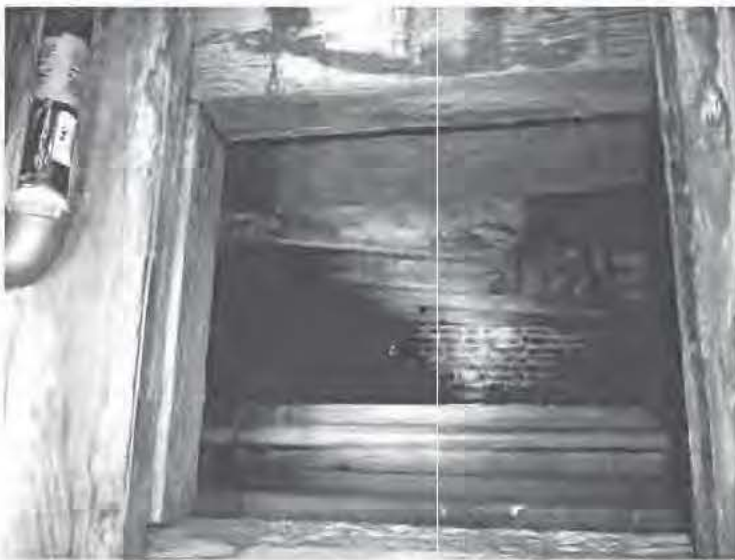
Figure 3, Opening just above roof access stairs showing roof void framing.

The roof is constructed with two layers of framing. There are horizontal ceiling joists with sloped rafters supported on the lower ceiling joists. There is a void between the two layers of framing but we were not able to access the void. We were able to see a limited area on the east side through a small opening above the roof access stairs (next to an old decommissioned elevator). Figure 3 shows a photo through the opening into the ceiling space. From our limited view and access, we did not observe any moisture or rot.

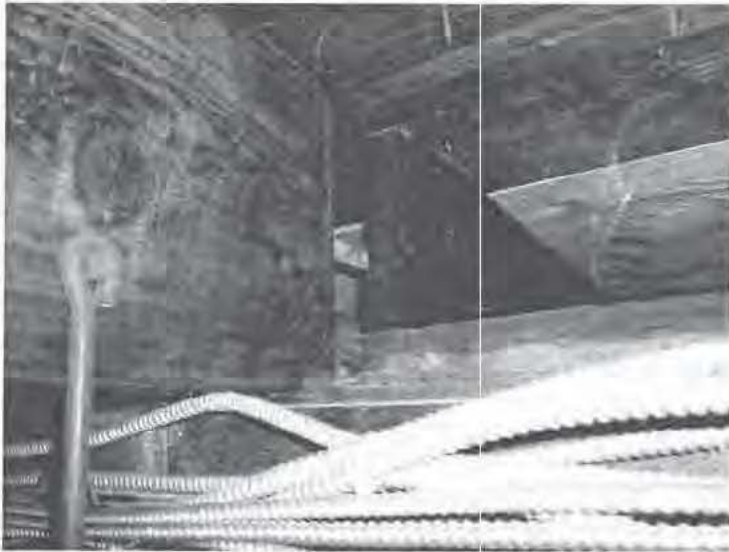
Figure 4, Small bearing area for the basement floor joists.

Item 2 indicates insufficient bearing for the joists for the support of the main floor. There is typically about 1.5" of bearing for the floor joist onto the support beams in the basement (see Figure 4). However, based on our second review we did observe some joists with substantially less than 1.5" of bearing and these areas did show some sign of the wood fibre crushing. The joists in these areas are also susceptible of detaching from the support beam. It is relatively cost effective to screw a 2x8 ledger to both sides of the basement beam. We would provide a detail prior to the commencement of work.

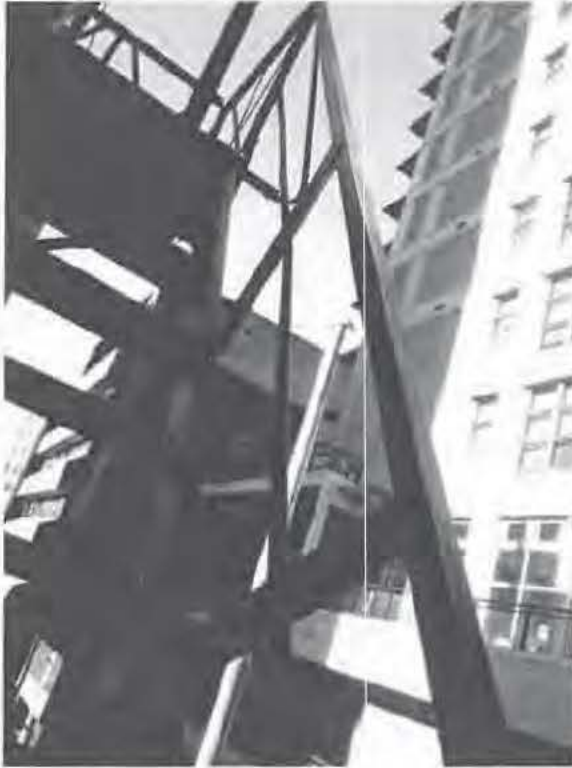
Figure 5, Broken connection between the east guard and fire escape stair.

Item 4 identifies the fire escape as being in dire structural condition. The guard on the west side of the stair has broken off and is no longer adequate to provide fall protection (see Figure 5). There are some loose connections left that are preventing the guard from falling into the back lane. There were also signs of corrosion through-out the fire escape. It is not possible to determine the condition of the attachment to the brick since it is concealed by the brick. There are two sets of stairwells in this building. The fire escape is accessed off of the west stairwell. Someone escaping has to access the stairwell to get to the fire escape. We recommend a code

consultant review the life safety benefit of having the fire escape. We can discuss different options but it is most likely the fire escape will either have to be removed or rebuilt. Obviously, if permitted, it would be least expensive to simply remove the fire escape. With the west stairwell, the fire escape does appear to be redundant.

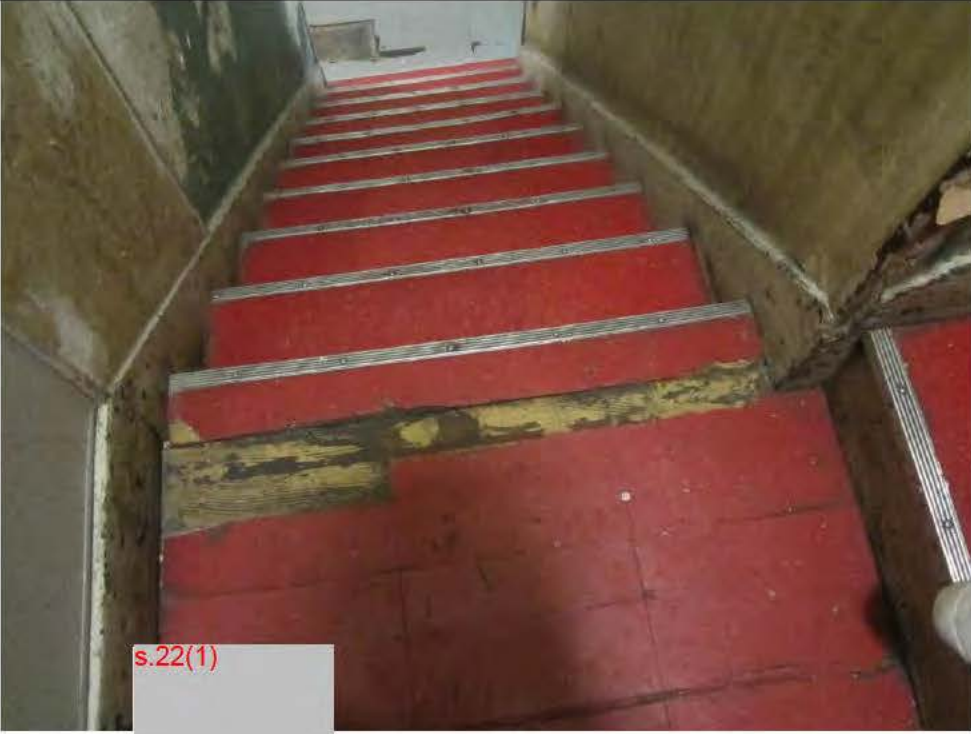
<p>Violation 7 Photo 11</p>

7. CA - 3rd to 4th floor staircase - Flooring was peeled - Section 13.1 (1) - Photo 11
8. CA - 2nd floor hallway near Room 204 - Ceiling surface cracked and peeled - Section 14.1 (2) - Photo 12

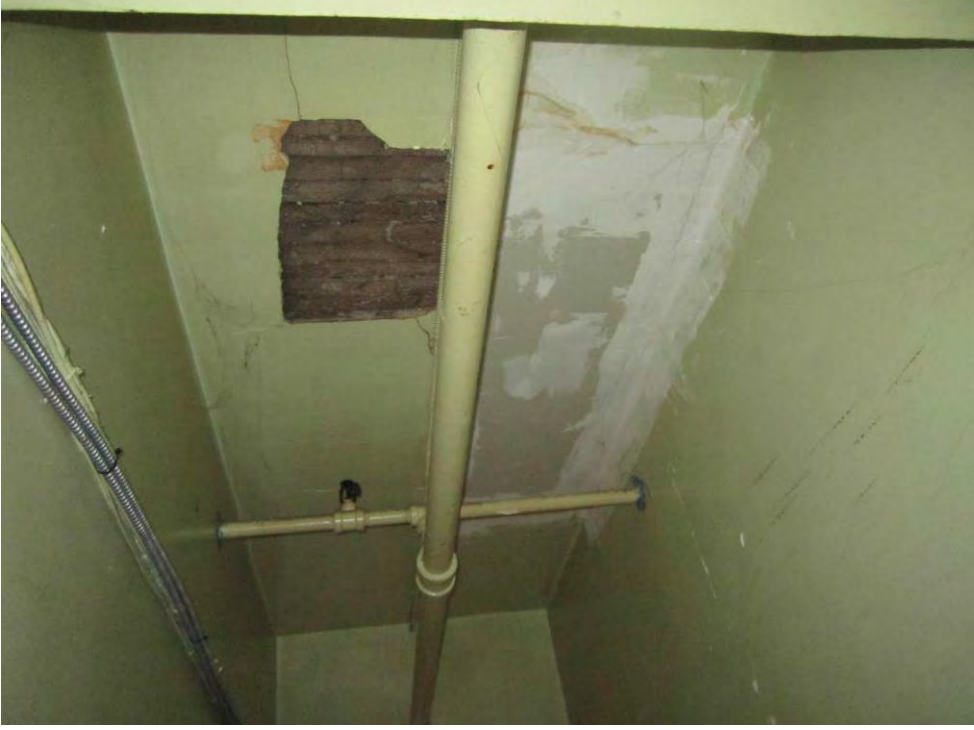
Violation 9 Photo 13

9. CA - 2nd floor hallway near Room 213 - Breach in the ceiling approx. 2'x3' Section 14.1 (2) - Photo 13
10. CA - 2nd floor hallway near Room 228 - Breach in the ceiling approx. 2'x3' Section 14.1 (2) - Photo 14

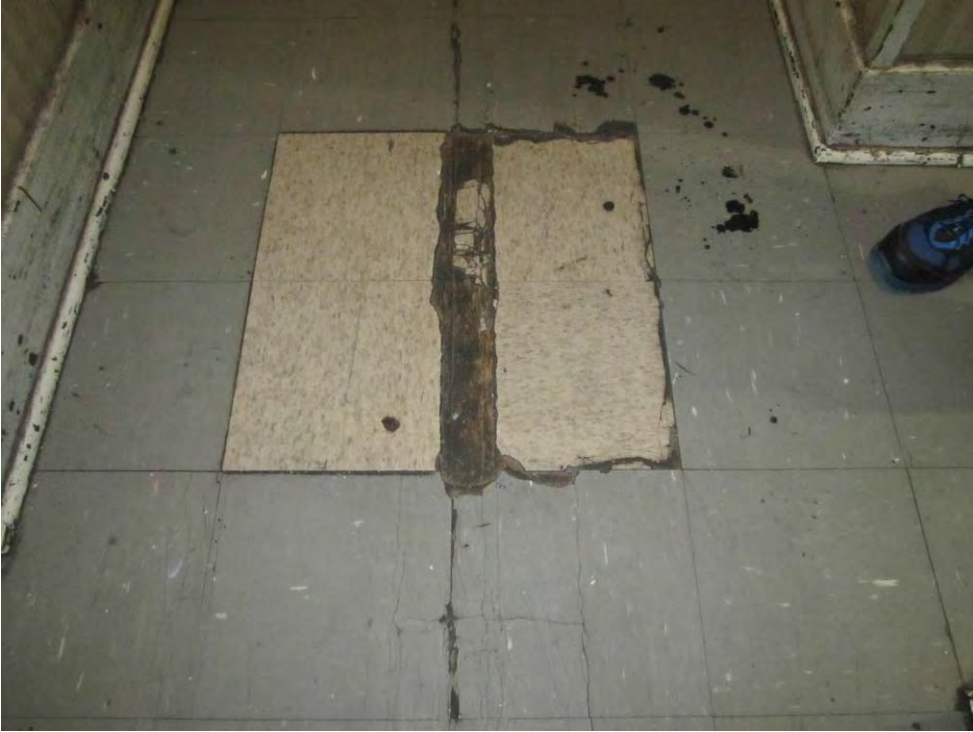
Violation 11 Photo 15

11. CA - 3rd floor hallway near Room 304 - Vinyl flooring was peeled approx. 6"x24" - Section 13.1 (1) - Photo 15
12. CA - 3rd floor hallway near Room 305 - Vinyl flooring was peeled approx. 6"x20" - Section 13.1 (1) - Photo 16

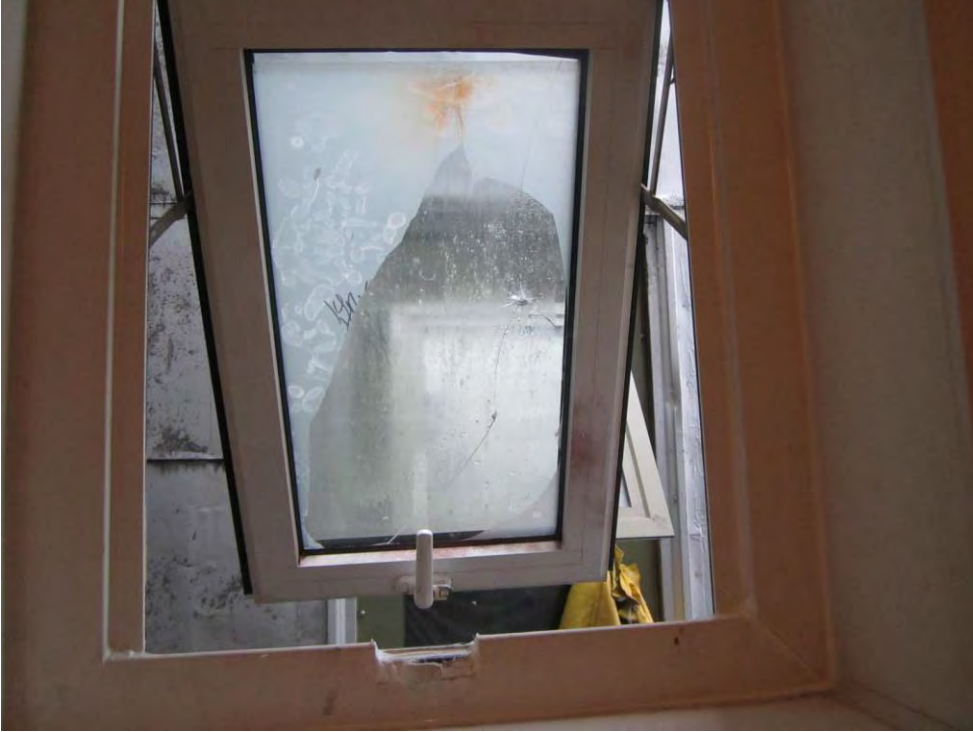
<p>Violation 19 Photo 23</p>

19. CA - Bathroom near Room 328 - Window - Section 13.1 (1) - The window pane is cracked - Section 21.10 (d) - Photo 23

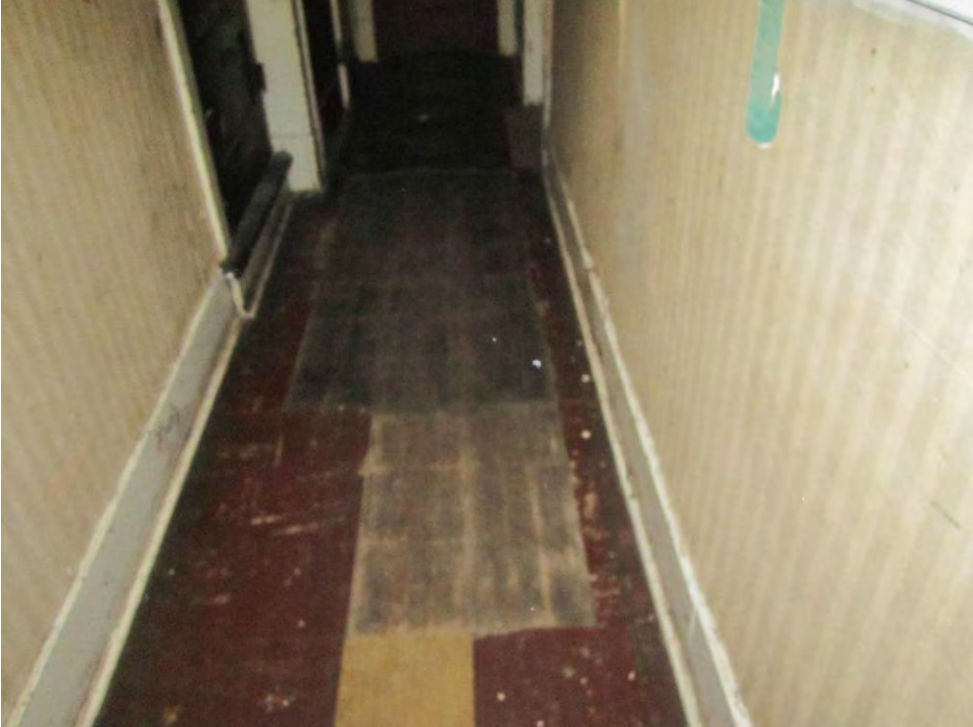
<p>Violation 20 Photo 24</p>
Photo	Description

20. CA - 4th floor hallway near Room 416 - Flooring surface missing approx. 2'x6' - Section 13.1 (1) - Photo 24
21. CA - 4th floor hallway near Room 419 - Ceiling insufficiently repaired (Plywood patch) - Section 14.1 (2) - Photo 25

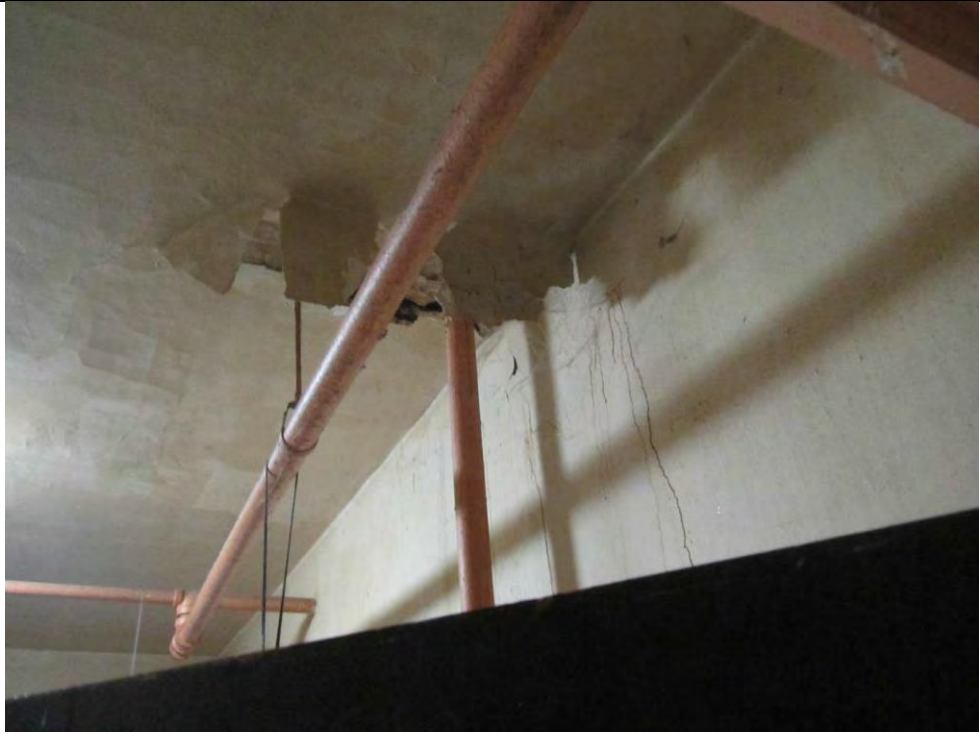
<p>Violation 26 Photo 30</p>
Photo	Description

25. s.22(1)
26. Room 105 - Breach in the ceiling approx. 1'x3' - Section 14.1 (2) - Photo 30
27. s.22(1)
28. Room 105 - No self-closer - Section 15.1 (1) - Photo 32

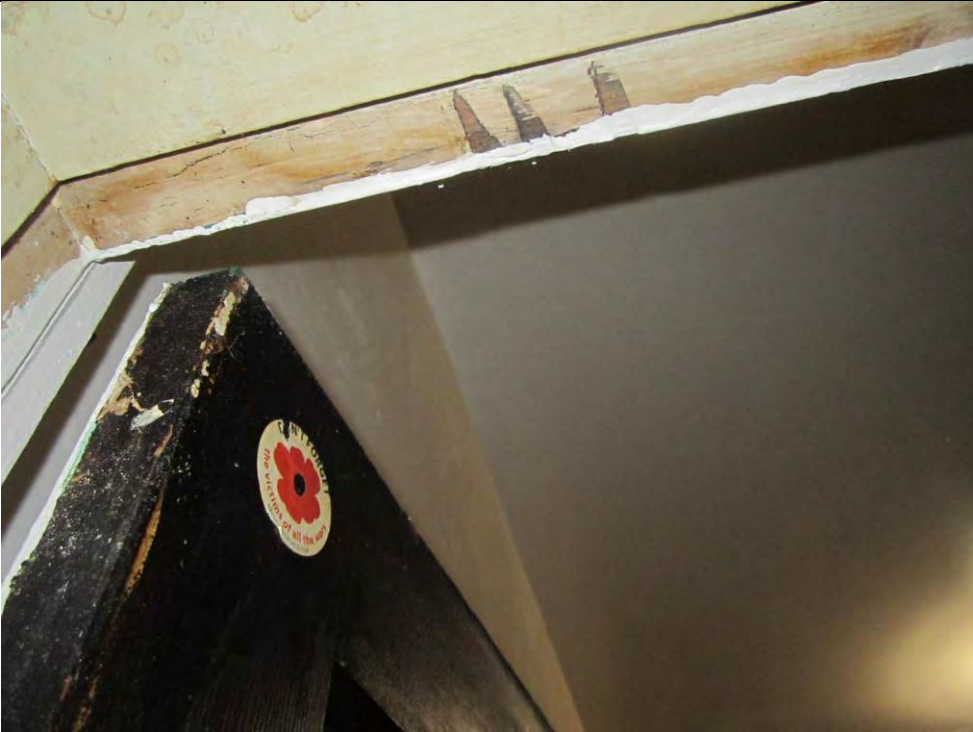
<p>Violation 31 Photo 36</p>
Photo	Description

31. Room 108 - No self-closer - Section 15.1 (1) - Photo 36
32. Room 109 - Vinyl flooring was peeled - Section 13.1 (1) - Photo 37
33. Room 113 - No self-closer - Section 15.1 (1) - Photo 38

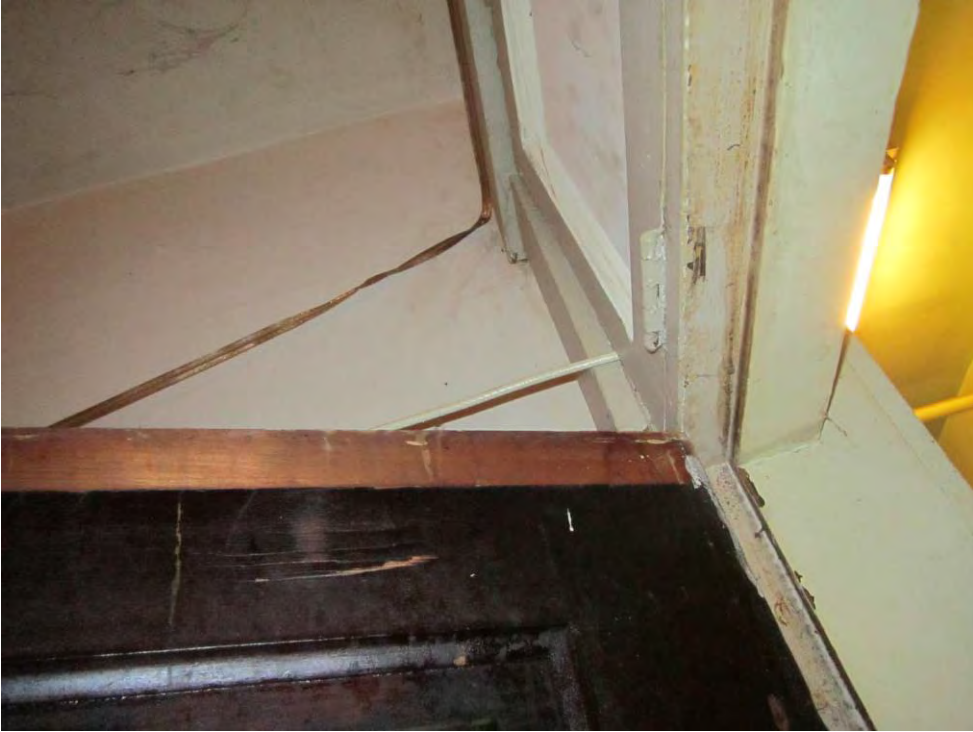
<p>Violation 34 Photo 39</p>

34. Room 114 - No self-closer - Section 15.1 (1) - Photo 39
35. Room 114 - Wall light fixture cracked - Section 21.10 (c) - Photo 40
36. Room 116 - Ceiling tile cracked - Section 21.10 (d) - Photo 41

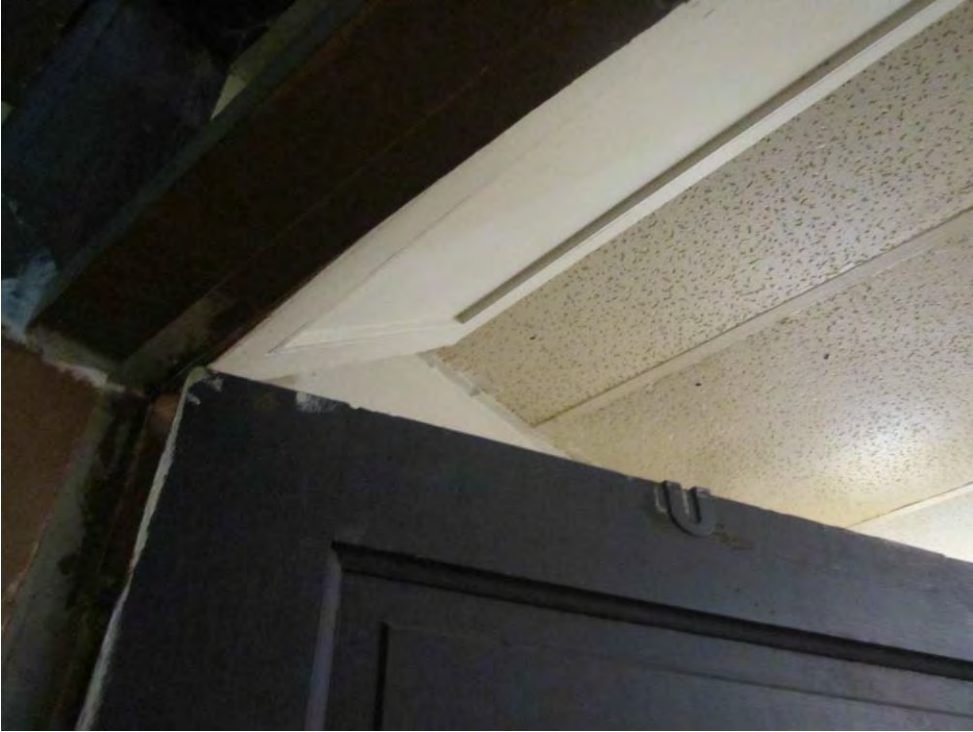
<p>Violation 38 Photo 43</p>

37. s.22(1)
38. Room 116 - No self-closer - Section 15.1 (1) - Photo 43
39. Room 118 - Dark discolouration on the wall by the sprinkler line consistent with mold - Section 21.10 (d) - Photo 44

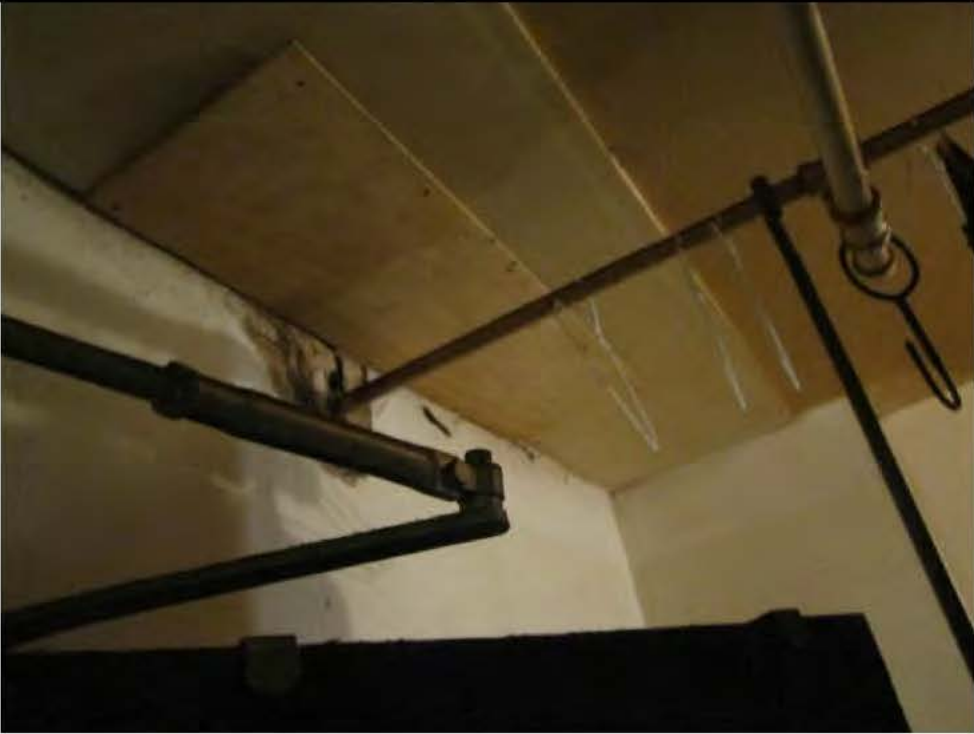
<p>Violation 40 Photo 45</p>

40. Room 118 - Ceiling insufficiently repaired (Plywood patch) - Section 14.1 (2) - Photo 45
41. Room 118 - Vinyl flooring was peeled - 13.1 (1) - Photo 46

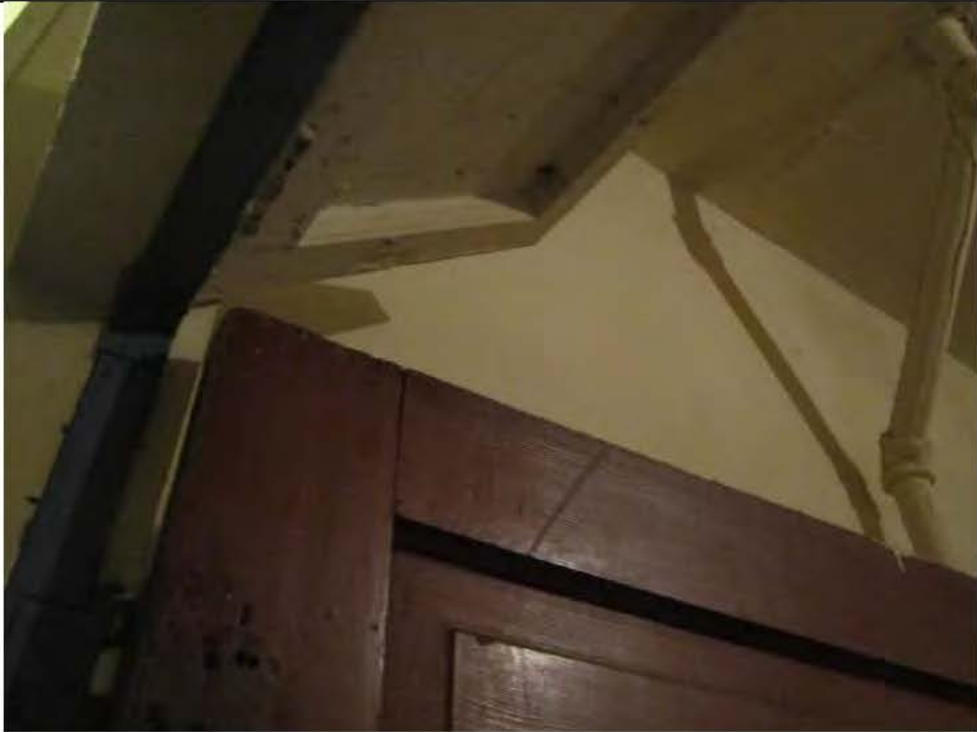
<p>Violation 43 Photo 48</p>
Photo	Description

43. Room 122 - No self-closer - Section 15.1 (1) - Photo 48
44. Room 122 - Ceiling is cracked - Section 14.1 (2) - Photo 49
45. Room 122 - Ceiling insufficiently repaired (Plywood patchwork) - Section 14.1 (2) - Photo 50

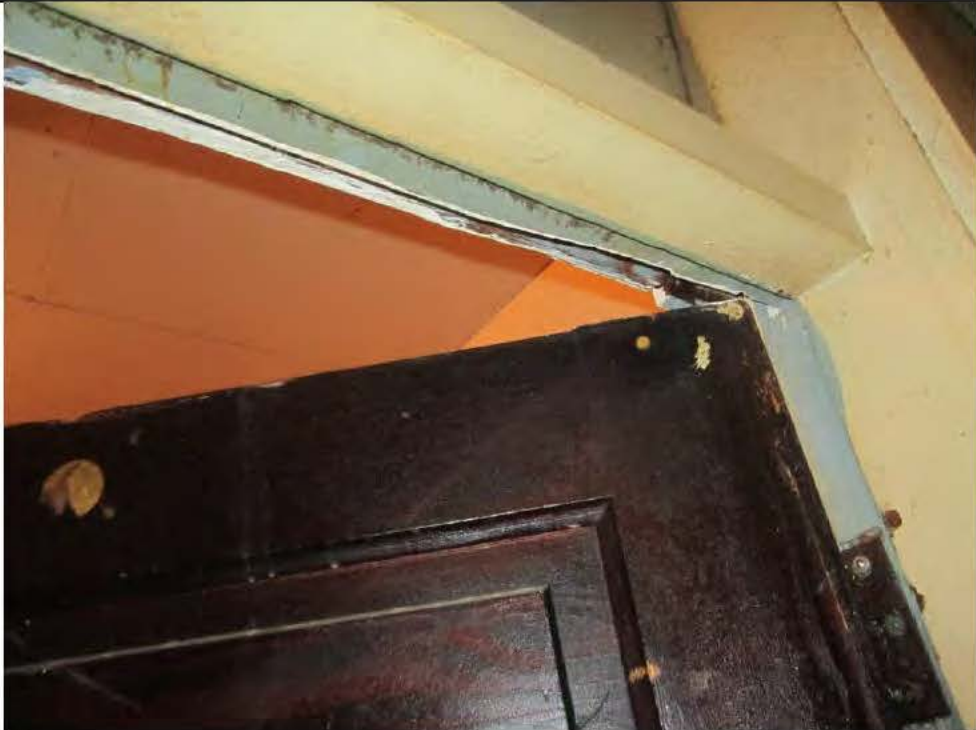
<p>Violation 48 Photo 52</p>
Photo	Description

48. Room 124 - No self-closer - Section 15.1 (1) - Photo 52
49. s.22(1)
50. Room 124 - Light fixture dislodged from ceiling - Section 21.10 (c) - Photo 53

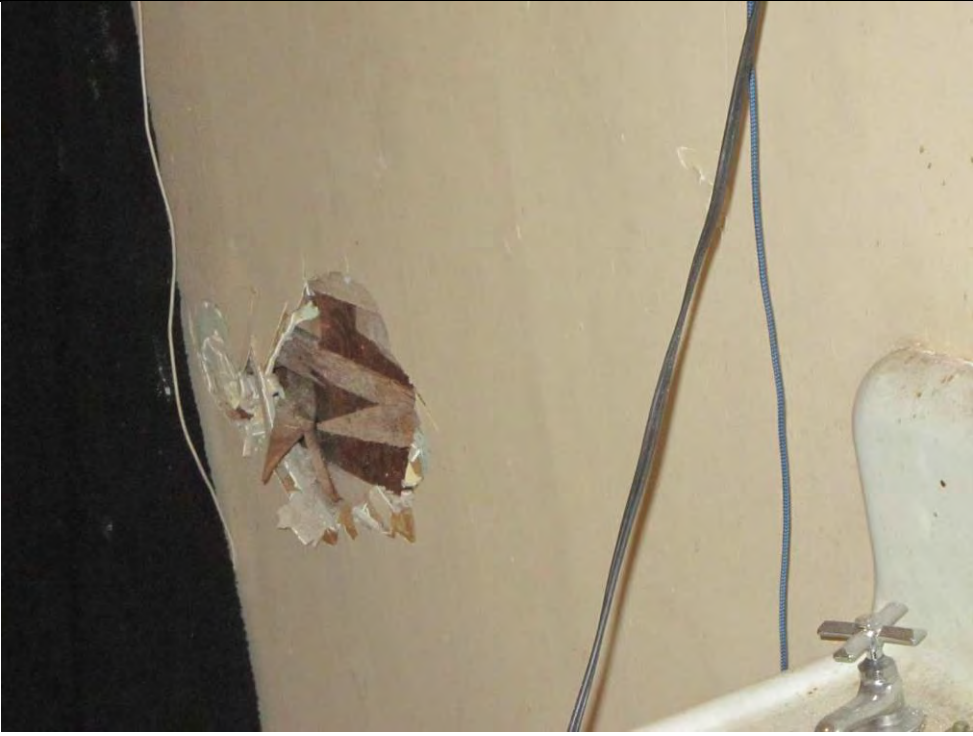
<p>Violation 55 Photo 58</p>
Photo	Description

53. Room 205 - No self-closer - Section 15.1 (1) - Photo 56
54. s.22(1)
55. Room 205 - Breach in the wall near the sink approx. 1'x1' - Section 14.1 (2) - Photo 58

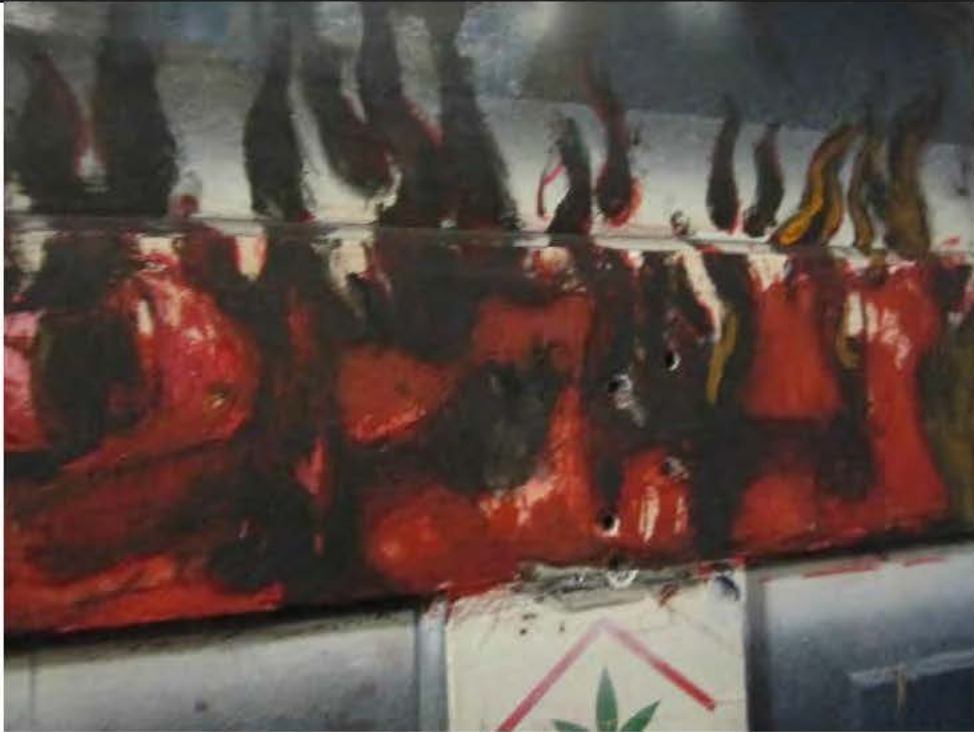
Photo	Description
 	<p>Violation 75 & 76 Photo 77</p>

- 75. Room 218 - Wall is cracked with dark stains - Section 14.1 (2) - Photo 77
- 76. Room 218 - Breach in the ceiling approx. 6"x6" with dark discolouration consistent with mold - Section 14.1 (2) - Photo 77

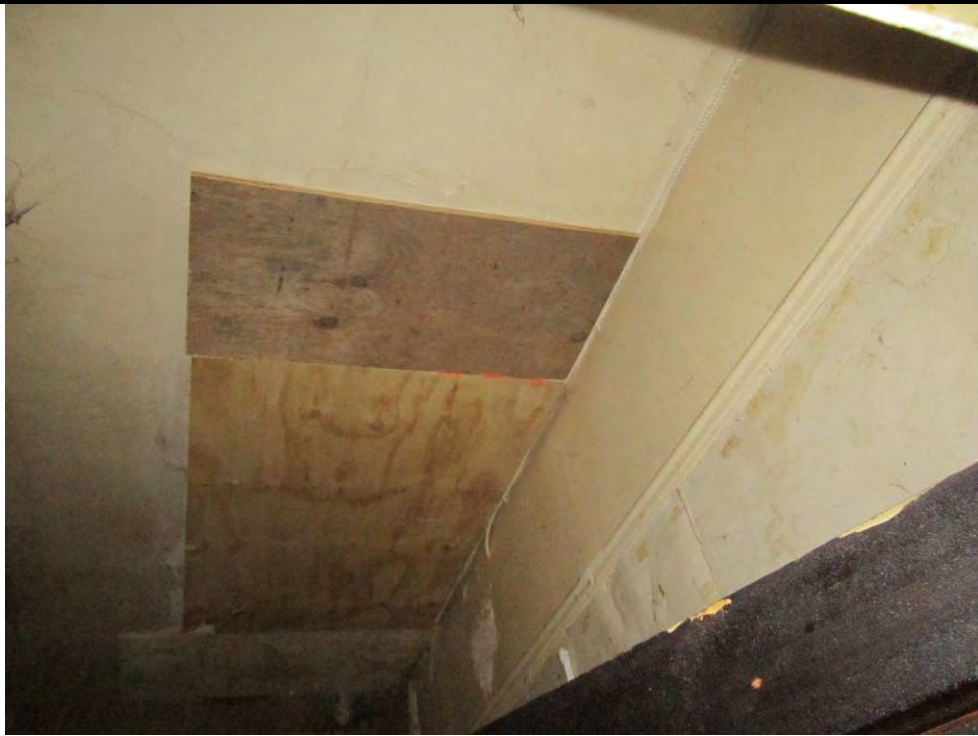
Violation 80 Photo 81
 	Violation 81 Photo 82
Photo	Description

- 77. Room 219 - Unit number not legible - 21.18 (a) - Photo 78
- 78. Room 220 - No self-closer - Section 15.1 (1) - Photo 79
- 79. s.22(1)
- 80. Room 220 - Ceiling insufficiently repaired (Plywood patch) - Section 14.1 (2) - Photo 81

- 81. Room 220 - Wall insufficiently repaired (Unfinished gypsum board) - Section 14.1 (2) - Photo 82
- 82. Room 221 - Breach in the ceiling approx. 2"x2" - Section 14.1 (2) - Photo 83

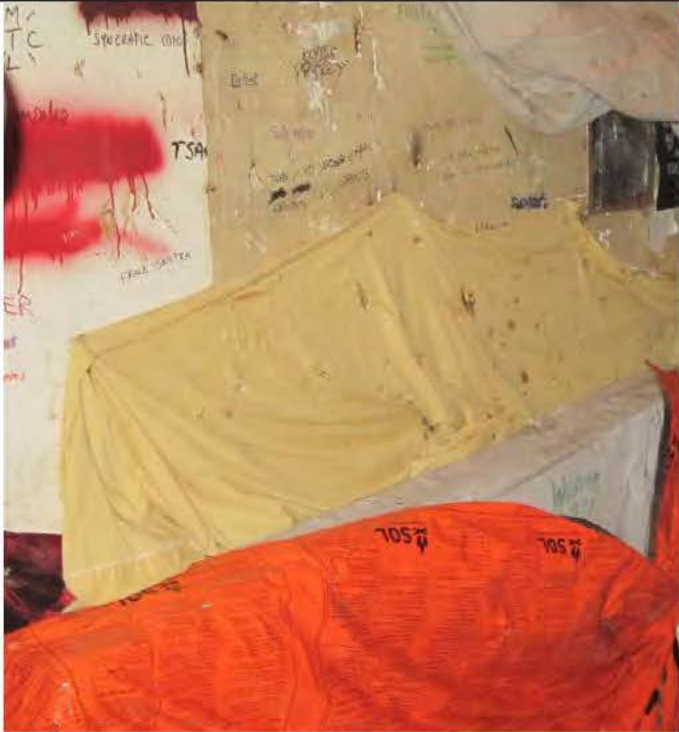
<p>Violation 83 Photo 84</p>
Photo	Description

- 83. Room 221 - Breach in the wall approx. 4'x8' - Section 14.1 (2) - Photo 84
- 84. Room 225 - Ceiling surfaced is peeled - Section 14.1 (2) - Photo 85

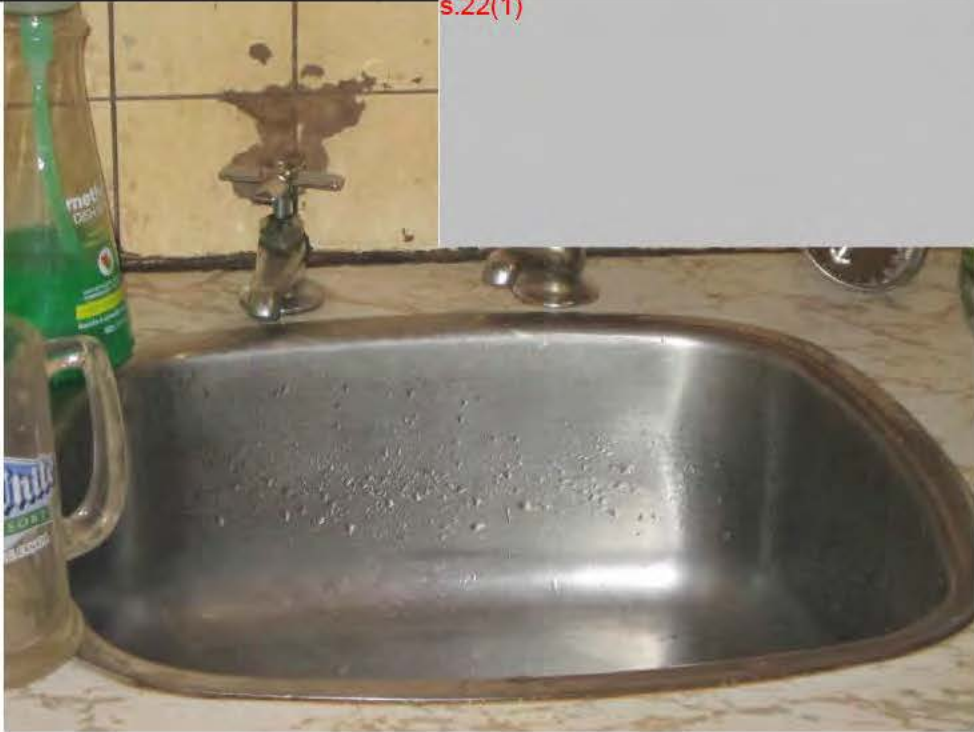
<p>Violation 85 Photo 86</p>
Photo	Description

- 85. Room 228 - No cold water from the sink - Section 21.10 (f) - Photo 86
- 86. Room 300 - Plumbing leak under the sink - Section 21.10 (f) - Photo 87

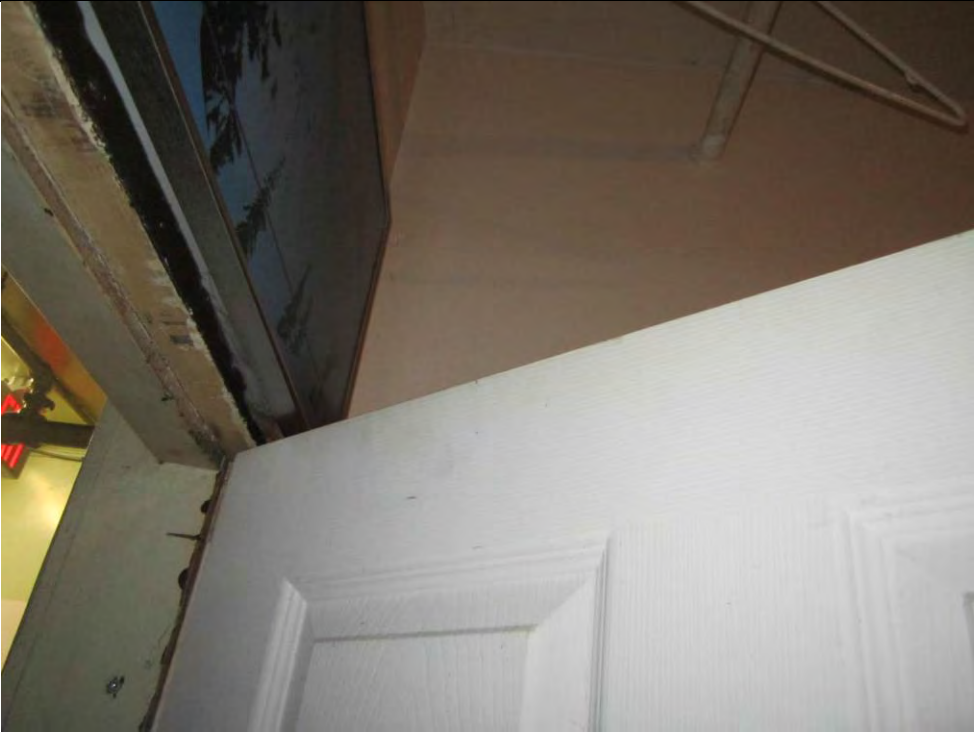
Violation 87 Photo 88
Photo	Description

- 87. Room 302 - No self-closer - Section 15.1 (1) - Photo 88
- 88. Room 303 - Radiator adjustment knob does not turn - Section 21.10 (c) - Photo 89
- 89. Room 303 - Several flooring tiles were peeled - Section 13.1 (1) - Photo 90

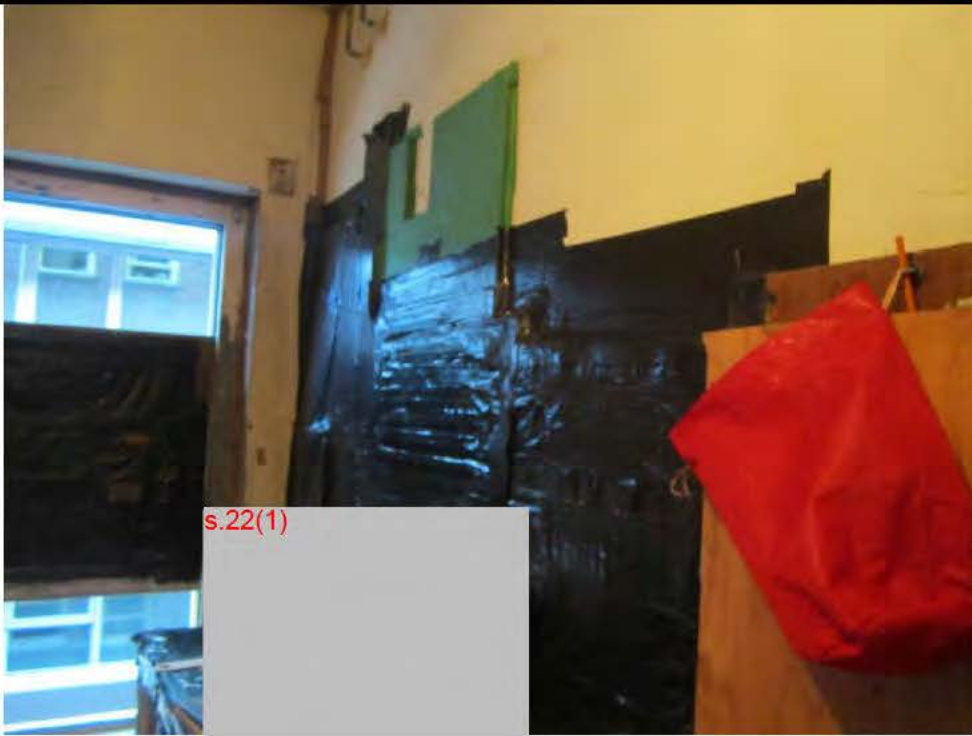
<p>s.22(1)</p>	<p>Violation 90 Photo 91</p>

- 90. Room 305 - Wall insufficiently repaired (Plywood and tape) - Section 14.1 (2) - Photo 91
- 91. Room 306 - Ceiling surface has peeled approx. 4"x6" - Section 14.1 (2) - Photo 92

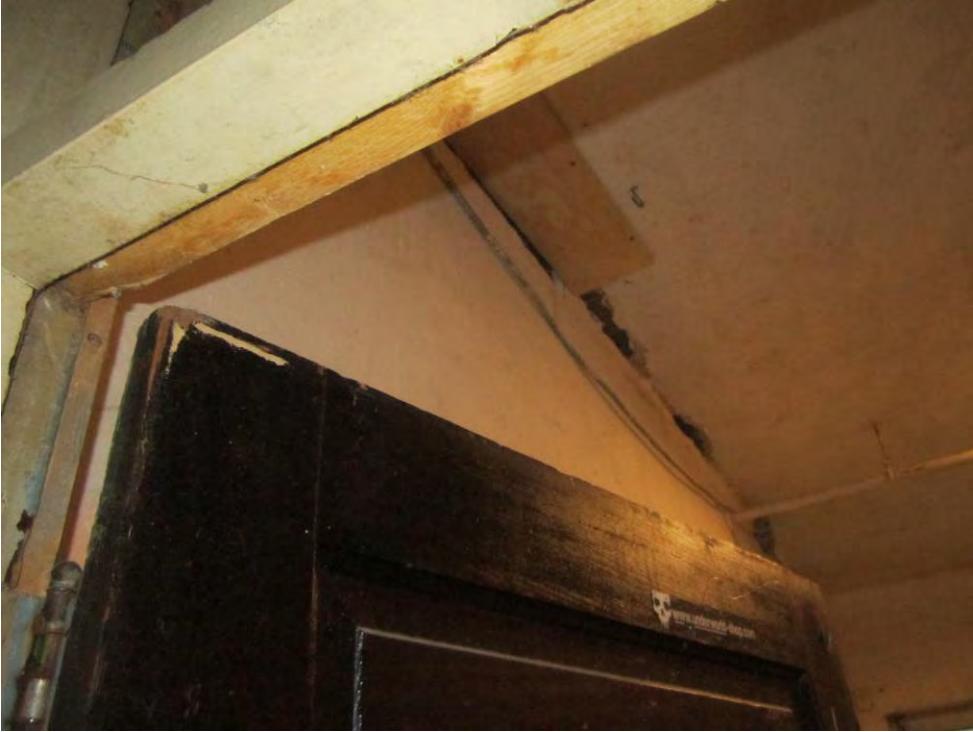
Violation 94 Photo 95

- 93. Room 308 - No self-closer - Section 15.1 (1) - Photo 94
- 94. Room 310 - No self-closer - Section 15.1 (1) - Photo 95
- 95. Room 310 - Locking hasp installed at the exterior of the door - Section 15.1 (1) - Photo 96

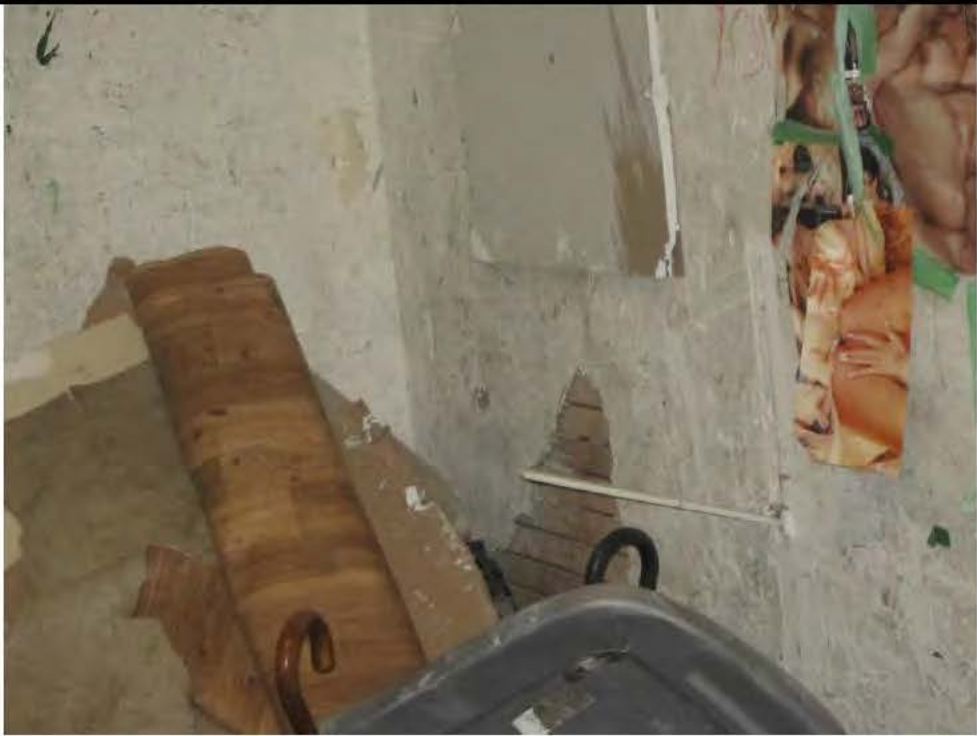
Violation 96 Photo 97
 	Violation 97 & 98 Photo 98
Photo	Description

- 96. Room 310 - Breach in the wall approx. 2'x3' -Section 14.1 (2) - Photo 97
- 97. Room 310 - Breach in the wall near the sink area approx. 5'x5' - Section 14.1 (2) - Photo 98

- 98. Room 310 - Sink dislodged from the wall and is not plumbed - Section 21.10 (f) - Photo 98
- 99. Room 311 - The window pane is cracked - Section 21.10 (d) - Photo 99

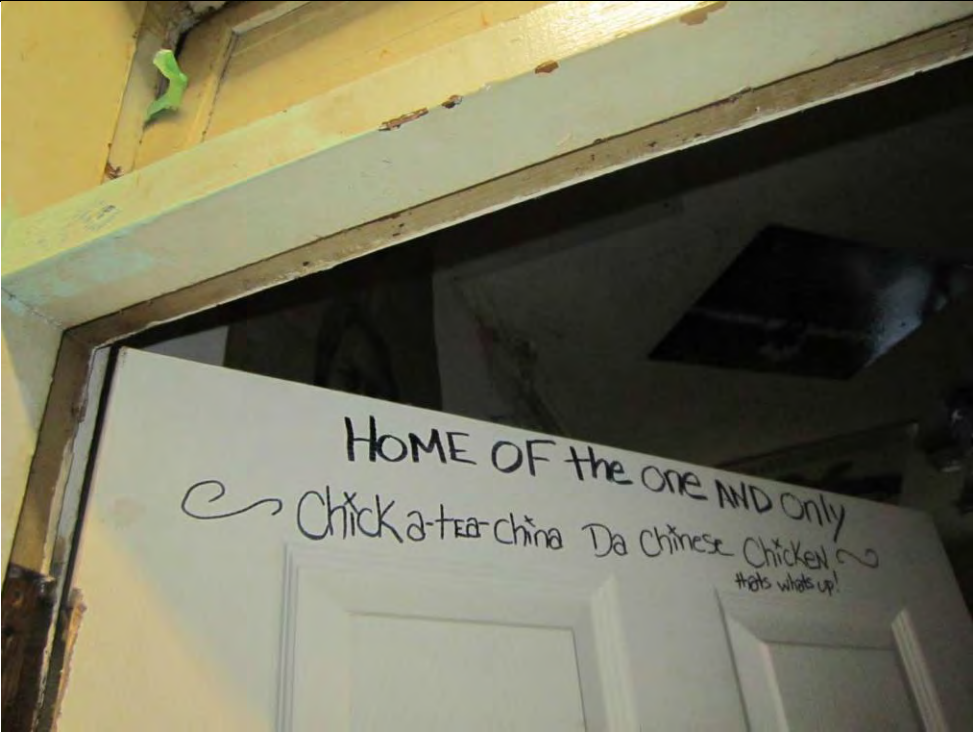
<p>Violation 100 Photo 100</p>
Photo	Description

- 100. Room 313 - No self-closer - Section 15.1 (1) - Photo 100
- 101. s.22(1)
- 102. Room 316 - No self-closer - Section 15.1 (1) - Photo 102
- 103. Room 316 - Ceiling tile missing - Section 21.10 (d) - Photo 103

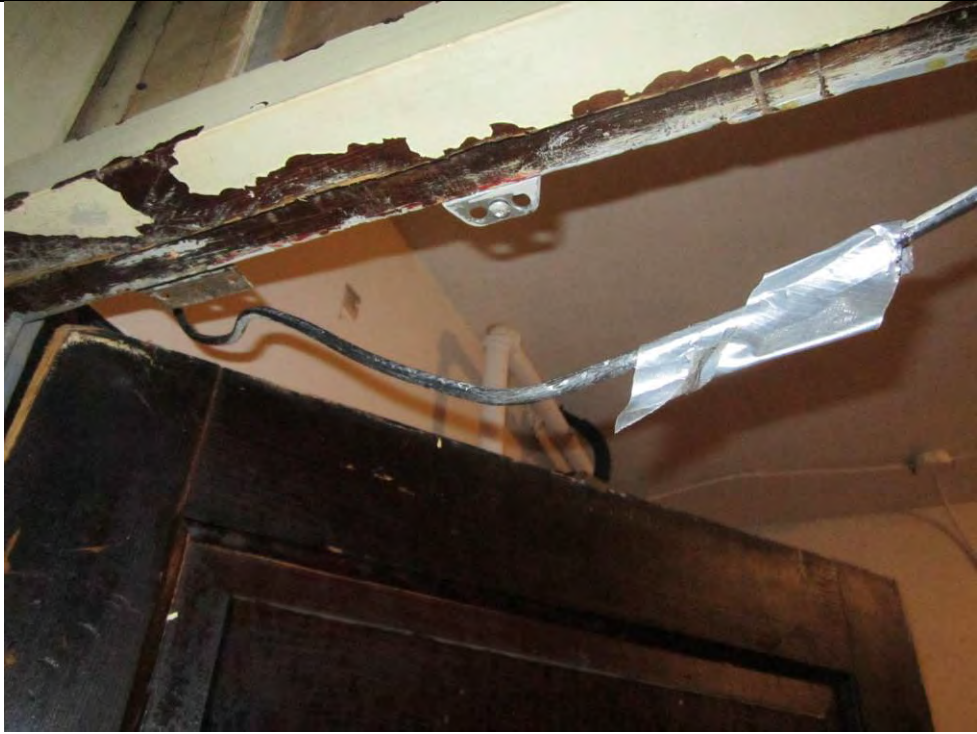
<p>Violation 104 Photo 104</p>
Photo	Description

- 104. Room 317 - No self-closer - Section 15.1 (1) - Photo 104
- 105. s.22(1)
- 106. Room 320 - No door handle - Section 21.10 (c) - Photo 106
- 107. s.22(1)

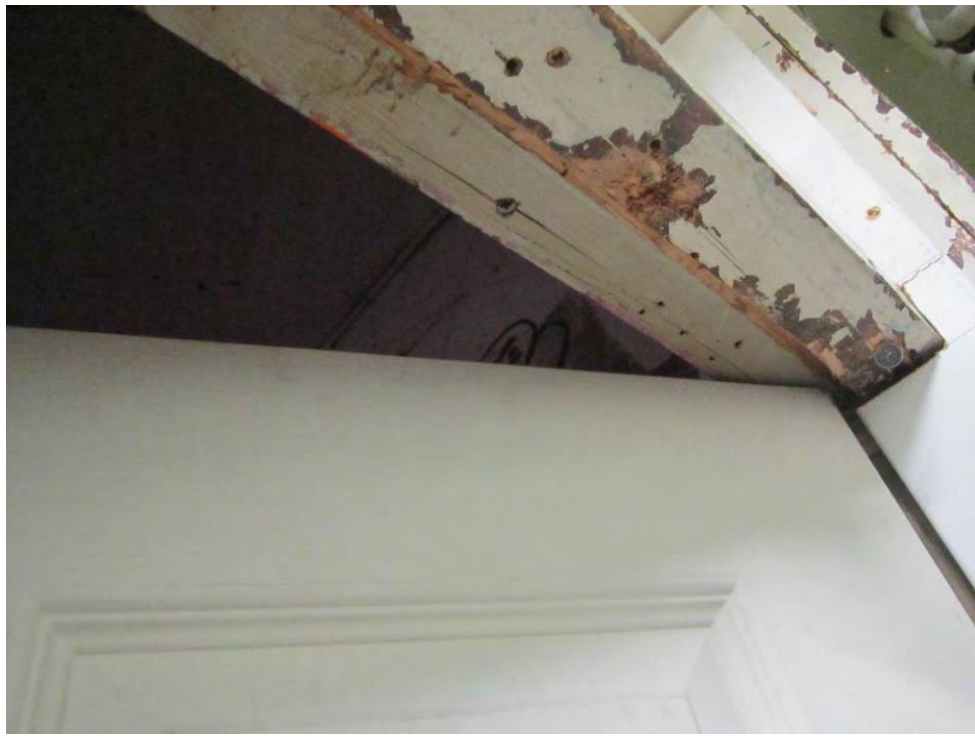
<div data-bbox="1136 1045 1307 1108" data-label="Text"><p>Violation 108 Photo 108</p></div>
Photo	Description

- 108. Room 320 - No self-closer - Section 15.1 (1) - Photo 108
- 109. Room 321 - Ceiling insufficiently repaired (Gypsum board patch) - Section 14.1 (2) - Photo 109

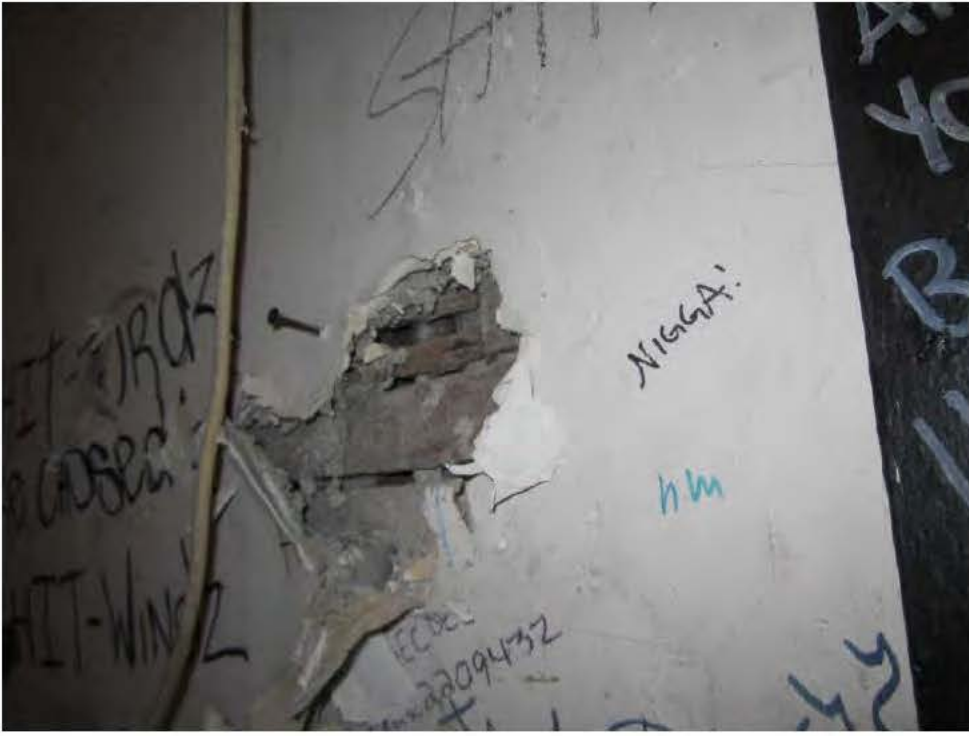
<p>Violation 113 Photo 113</p>

- 113. Room 324 - Breach in the wall approx. 1'x1' - Section 14.1 (2) - Photo 113
- 114. Room 327 - Ceiling insufficiently repaired (Plywood patch) - Section 14.1 (2) - Photo 114

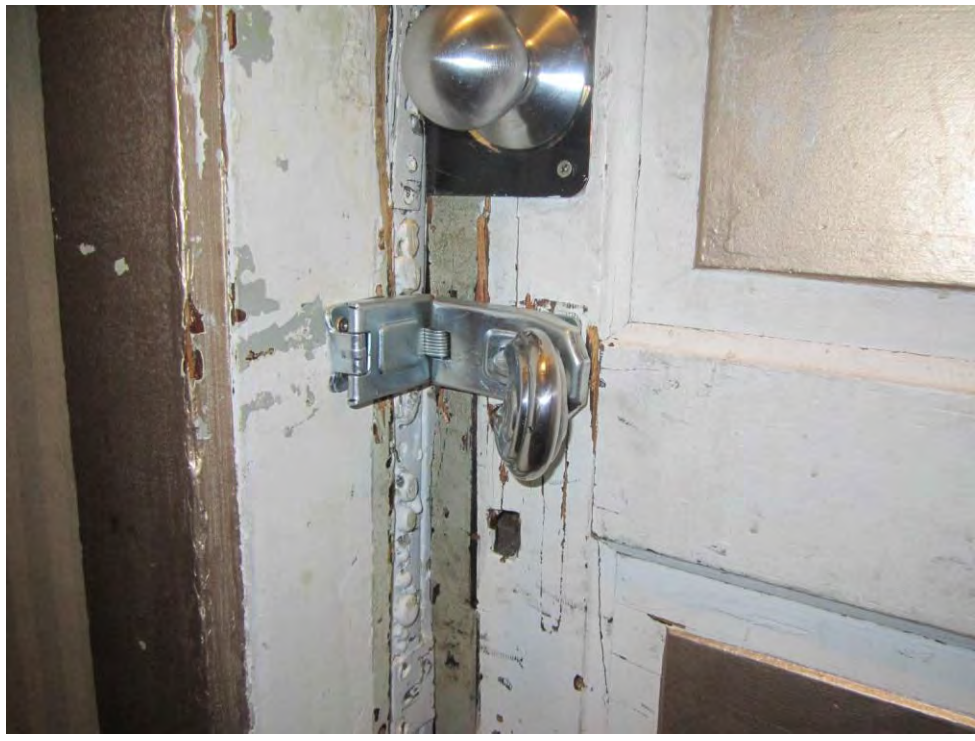
<div data-bbox="1138 1045 1305 1108" data-label="Text"><p>Violation 116 Photo 116</p></div>
Photo	Description

- 115. s.22(1)
- 116. Room 328 - Locking hasp installed at the exterior of the door - Section 15.1 (1) - Photo 116
- 117. Room 328 - Breach in the ceiling approx. 6"x8" - Section 14.1 (2) - Photo 117
