Records related to Murray Hotel at 1119 Hornby Street:

1. Structural report prepared by Structural Solutions, dated January 4, 2019; and
2. City of Vancouver Annual Inspection Report prepared on January 16, 2019 by Inspector Nick Liu.

Project No.: K1397

Re: Structural Review of 1119 Hornby St., Vancouver, BC

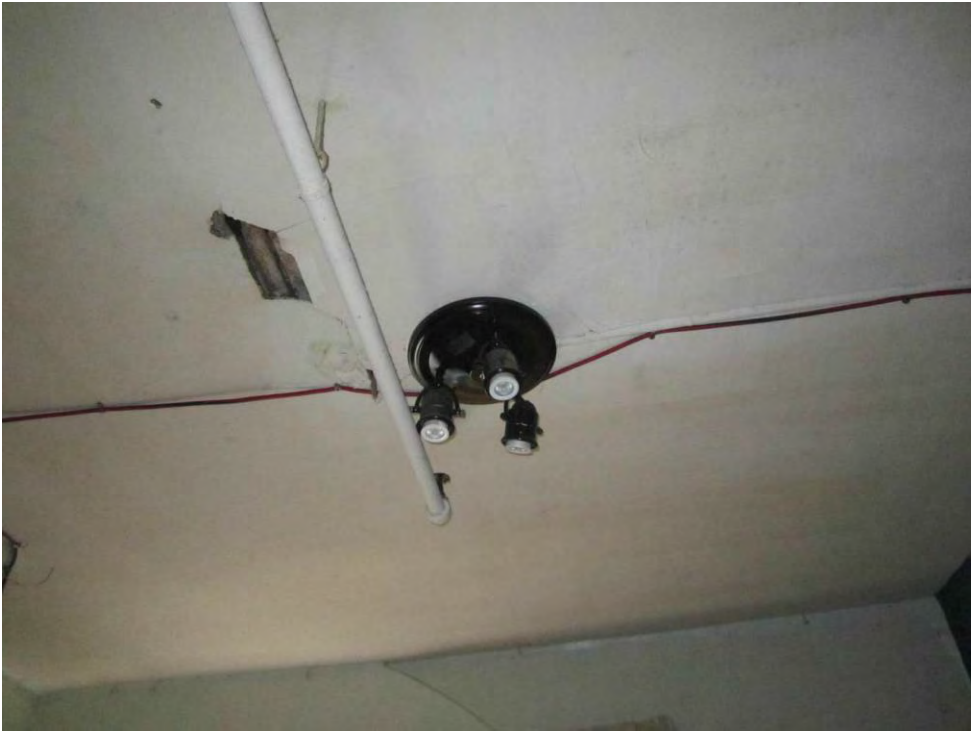
A photograph showing a ceiling with a white pipe running diagonally. A black light fixture with two small lights is mounted on the ceiling. A red wire runs horizontally across the ceiling. There is some damage to the ceiling material near the pipe.	<p>Violation 117 Photo 117</p>

- 115. s.22(1)
- 116. Room 328 - Locking hasp installed at the exterior of the door - Section 15.1 (1) - Photo 116
- 117. Room 328 - Breach in the ceiling approx. 6"x8" - Section 14.1 (2) - Photo 117

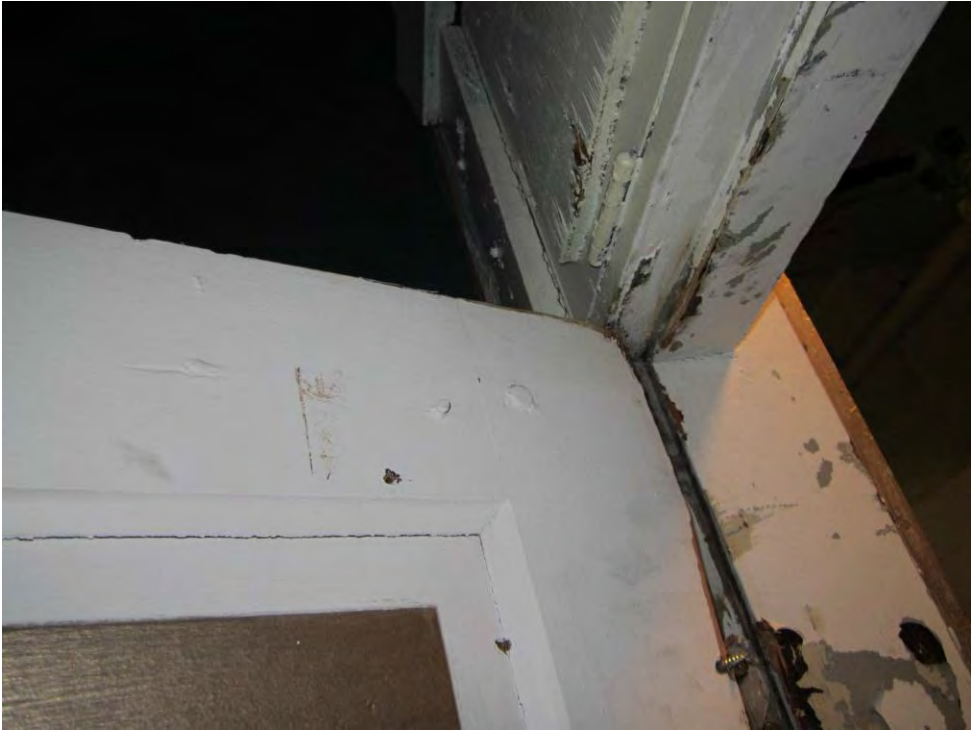
A photograph showing a corner of a room. The walls are white, and the paint is peeling and chipped away in several places. A door frame is visible on the left, and a window or opening is on the right. The floor is dark.	<p>Violation 118 Photo 118</p>
Photo	Description

- 118. Room 328 - No self-closer - Section 15.1 (1) - Photo 118

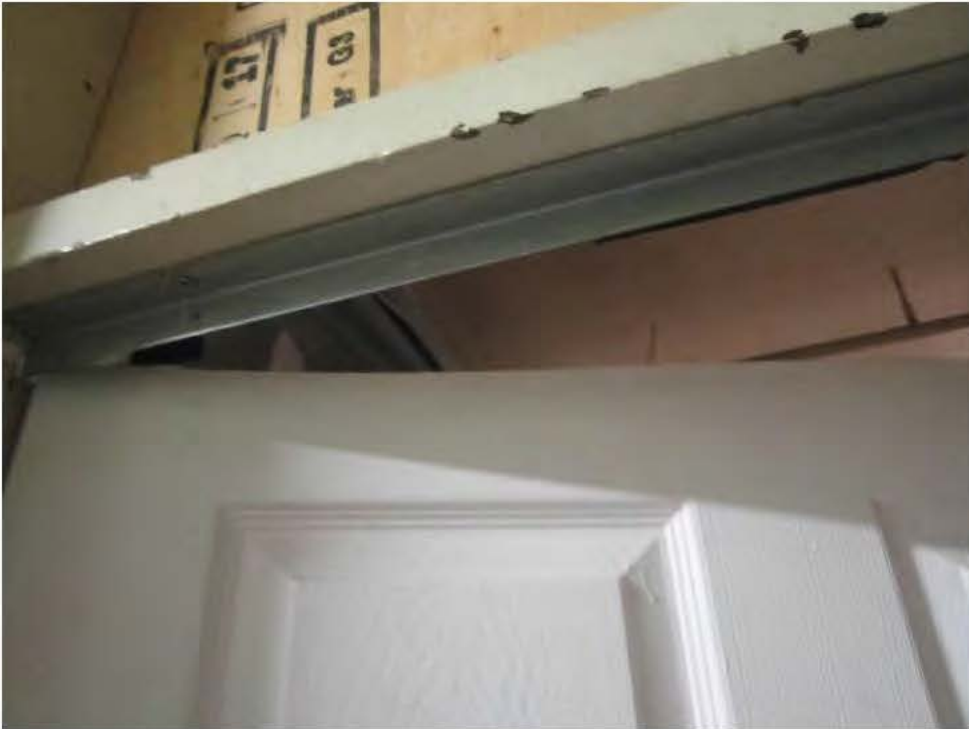
- 119. Room 400 - No self-closer - Section 15.1 (1) - Photo 119
- 120. Room 400 - Breach in the ceiling approx. 4'x4' - Section 14.1 (2) - Photo 120
- 121. Room 400 - Ceiling tile missing - Section 21.10 (d) - Photo 121

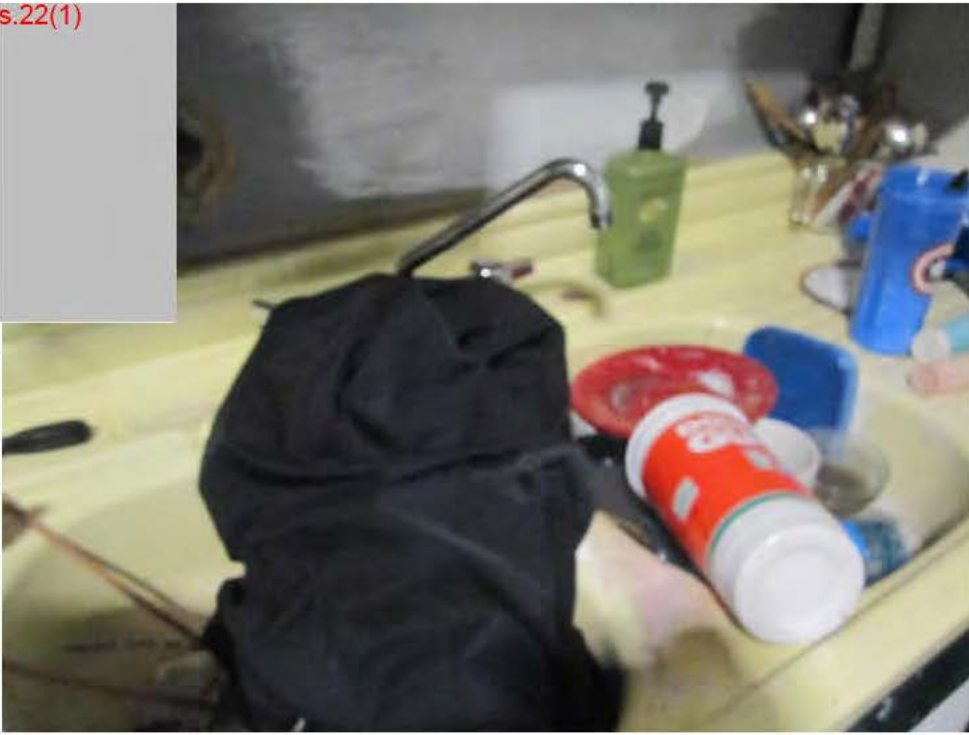
<p>Violation 123 Photo 122</p>
Photo	Description

- 122. Room 402 - No self-closer - Section 15.1 (1) - Photo 122
- 123. Room 402 - No cold water from the sink - Section 21.10 (f) - Photo 123
- 124. Room 403 - No self-closer - Section 15.1 (1) - Photo 124

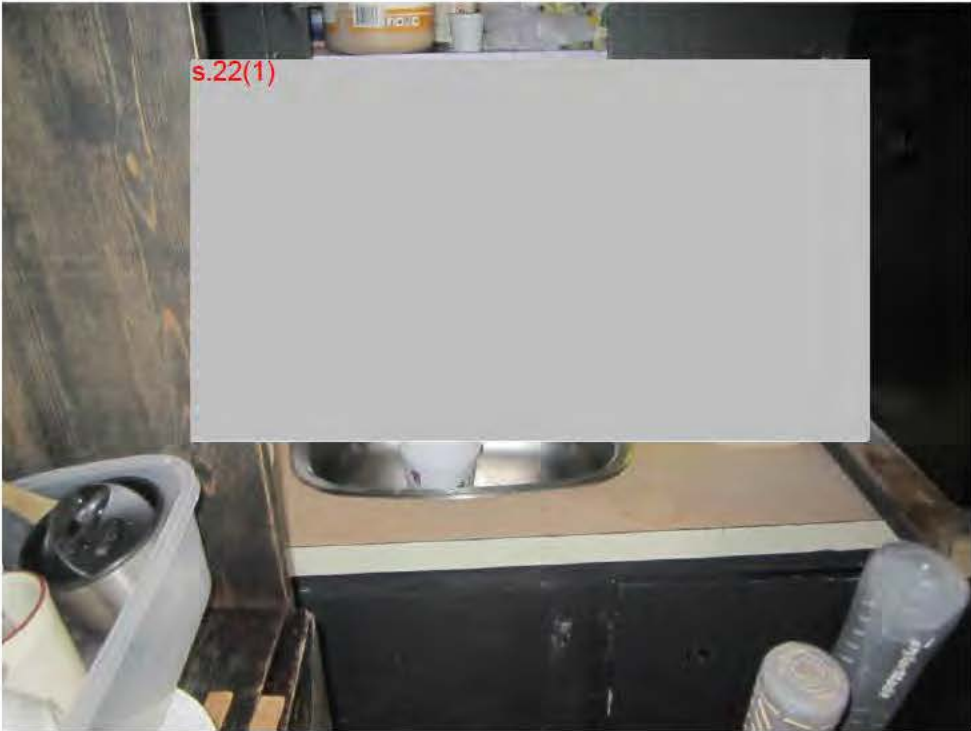
<p>Violation 140 Photo 139</p>
<div data-bbox="136 1003 220 1037" data-label="Text"><p>s.22(1)</p></div>

- 139. Room 415 - No cold water from the sink - Section 21.10 (f) - Photo 139
- 140. Room 416 - No cold water from the sink - Section 21.10 (f) - Photo 140

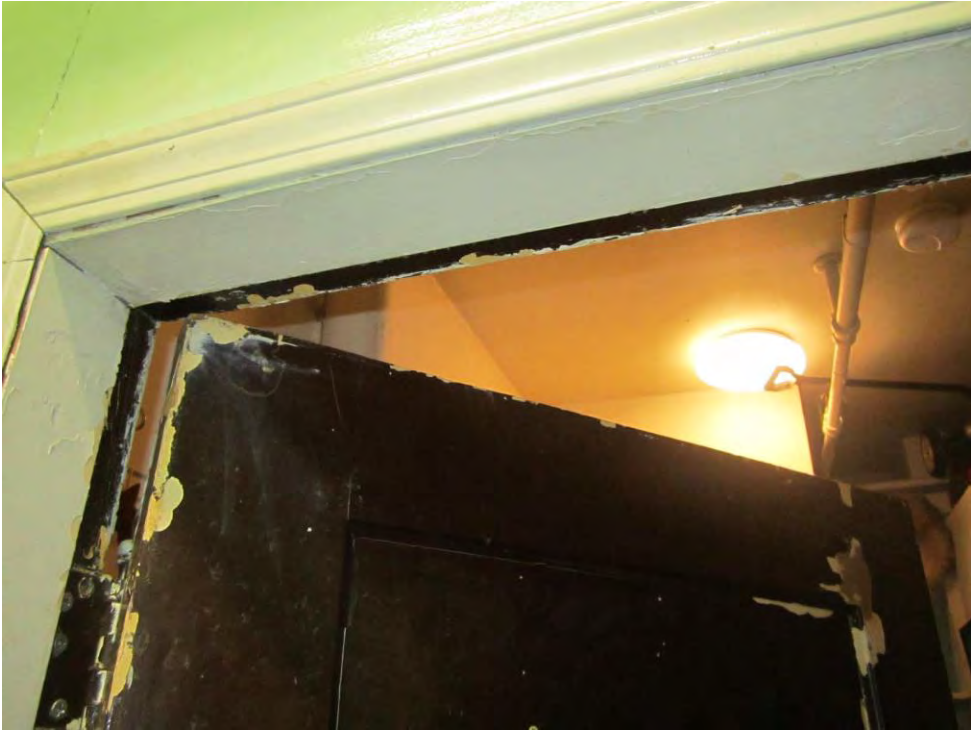
<p>Violation 143 Photo 142</p>
Photo	Description

- 142. Room 416 - Locking hasp installed at the exterior of the door - Section 15.1 (1) - Photo 142
- 143. Room 417 - No self-closer - Section 15.1 (1) - Photo 143

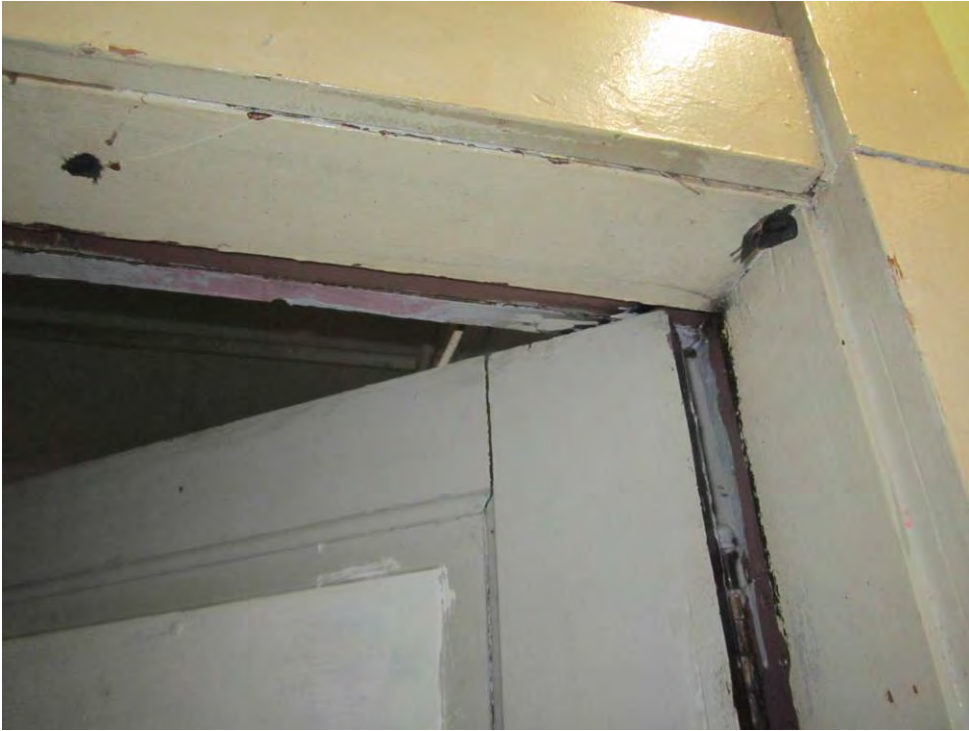
<p>Violation 145 Photo 144</p>
Photo	Description

- 144. Room 419 - self-closer does not shut the door completely - Section 15.1 (1) - Photo 144

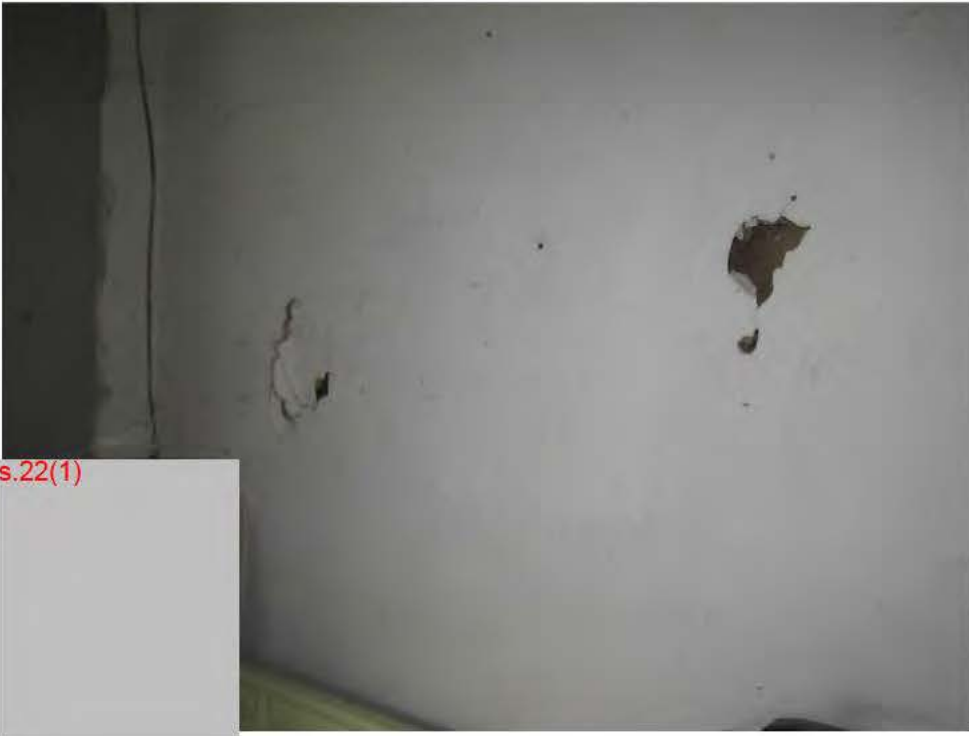
<p>s.22(1)</p>	Violation 146 Photo 145

- 145. Room 420 - No self-closer - Section 15.1 (1) - Photo 145
- 146. Room 420 - Multiple breaches in the wall throughout the room approx. 6"x6" - Section 14.1 (2) - Photo 146
- 147. Room 420 - No cold water from the sink - Section 21.10 (f) - Photo 147
- 148. Room 420 - The window pane has a hole - Section 21.10 (d) - Photo 148
- 149. Room 420 - Light fixture does not turn on - Section 21.10 (c) - Photo 149
- 150. Room 421- No self-closer - Section 15.1 (1) - Photo 150
- 151. Room 421- Wall insufficiently repaired (Duct tape) - Section 14.1 (2) - Photo 151
- 152. Room 422- Flooring insufficiently repaired - 13.1 (2) - Photo 152
- 153. Room 423 - No cold water from the sink - Section 21.10 (f) - Photo 153
- 154. Room 423 - Breach in the wall approx. 8"x8" - Section 14.1 (2) - Photo 154
- 155. Room 424- No self-closer - Section 15.1 (1) - Photo 155
