Re: **Request for Access to Records under the Freedom of Information and Protection of Privacy Act (the "Act")**

Record of maintenance of the water/sewer pipe on Hull Street (located under the street), from November 24, 2017 to March 7, 2019.

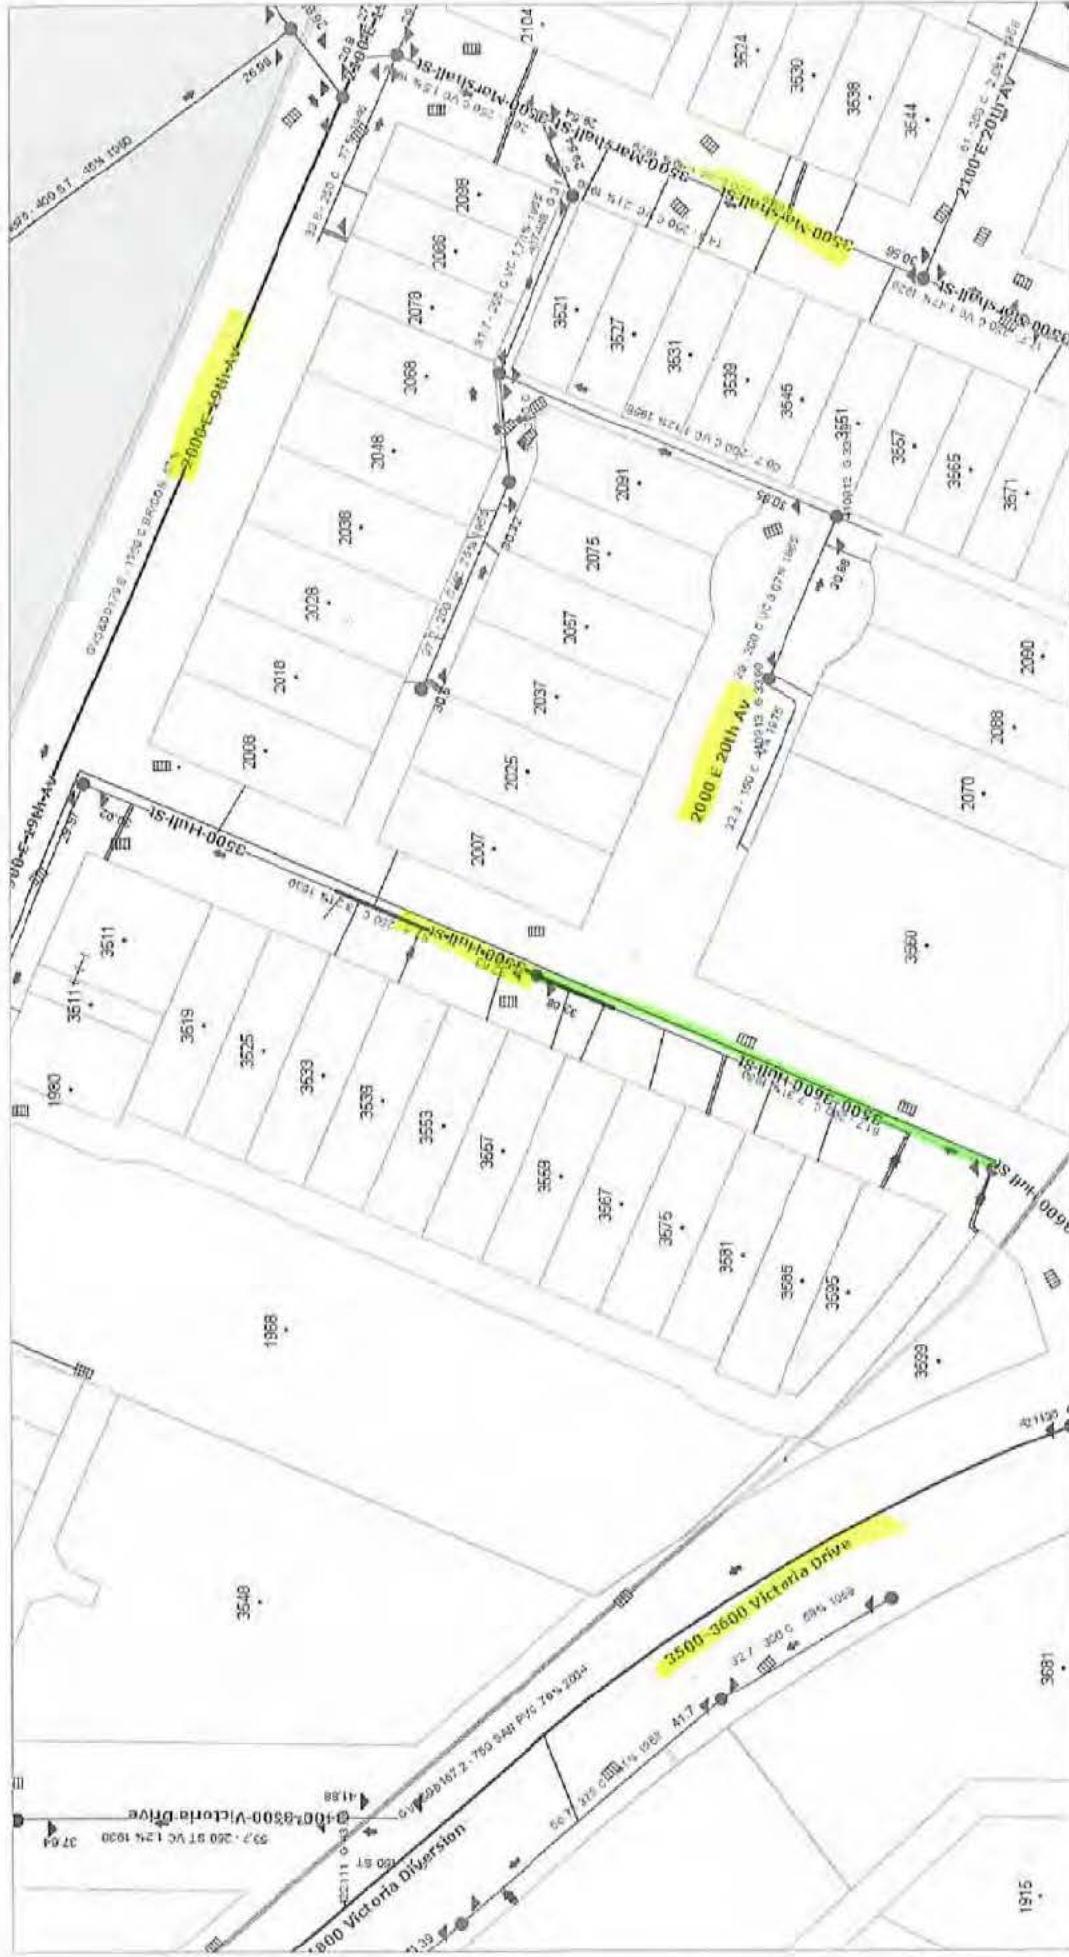
SAP Charge #	Address & Location: 3500 - 3699 HULL ST COVAV				Responsible	
EES1047639					Sewer Operations	
Work Order #	Work Order Activity				Created Date	
1047639	Maintenance(SCUT)				2019/01/11	
Group Project #	Problem	Sub Activity	Assigned To		Crew ID	
		SCUT	LAWRENCE HARMON			
Work Order Comments: Rootcut Main on 6 month schedule per B. Todd - From plugged main November 2017 - Area CB Map C10 Facet Map T15 3500 - 3699 Hull St 200 Comb (81.68m run) - Maintain current schedule/EES970992 CCTV completed 05/04/18 NTF 2019/01/03 Acoustic Inspection found Poor Result (3) maintain current schedule						
Reference #1	1020046				Billable?	
Reference #2					N	
Collection Agency		Collection Method		Zone	Beat	
Service Request #						
Contact Name			Contact Phone		Contact Type	
Asset Type	Asset ID #	B.U.N	Status	Asset Area	Map # (Facet)	District
Main (C)	410914		IN_SERVICE	CBC10	T15	1
Asset Details: C 200 Millimeter VC 81.68 Meters 7.31% [81.68-200.0 C VC 7.31% 1930];[81.7 - 200 C 7.31% 1930]:

Safety & Asset Notes:						
PM Sched.	Maint. Sched.	Due Date	Zone	Last Completed Work Order		
6 MONTHS	25411	2019-01-03	SO_CBC10	2019/01/03; 1020046; Maintenance (SACOUS)		
Crew Comments						
ROOT CUT MAIN, <u>HEAVY</u> ROOTS FOUND. JOB COMPLETE. ✓

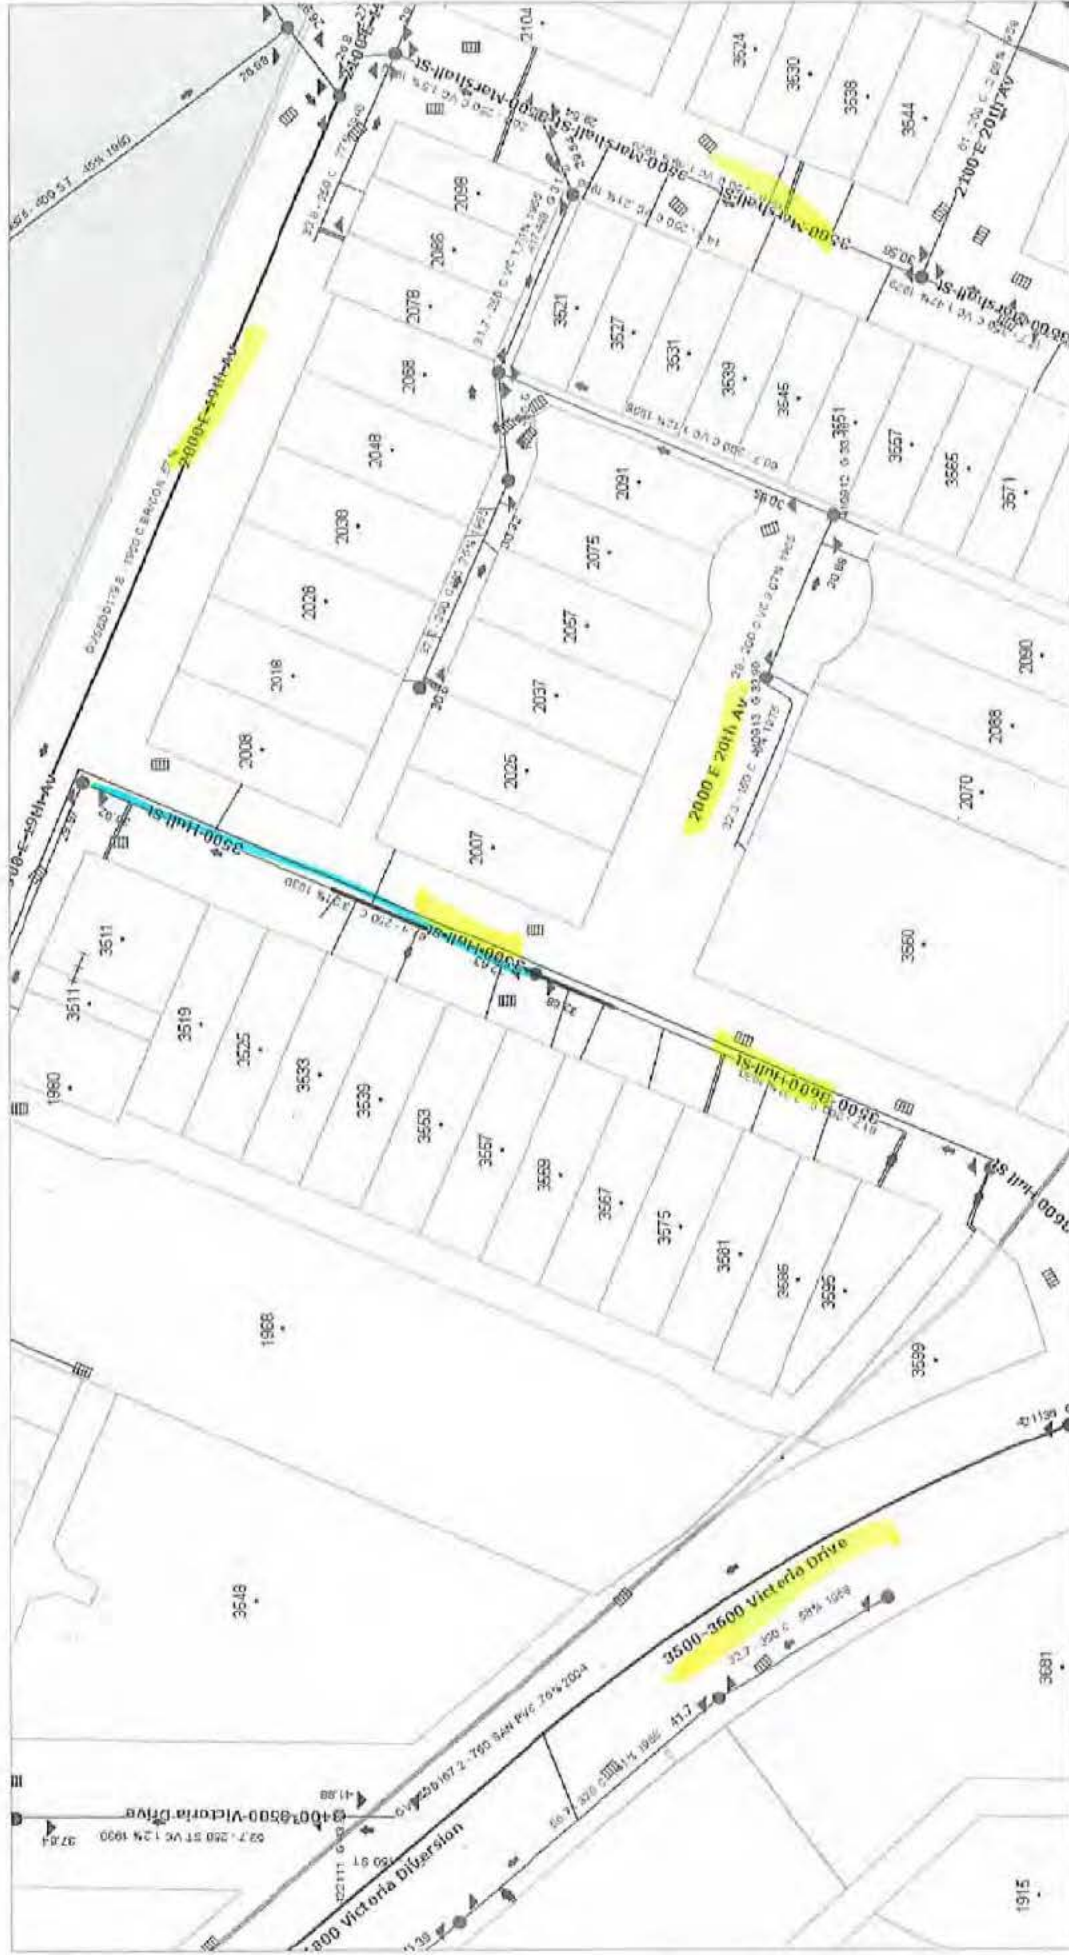
SAP Charge #	Address & Location: 3500 - 3599 HULL ST COVAV				Responsible	
EES1047322 <i>Complete</i>					Sewer Operations	
Work Order #	Work Order Activity				Created Date	
1047322	Maintenance(SCUT)				2019/01/11	
Group Project #	Problem	Sub Activity	Assigned To		Crew ID	
		SCUT	LAWRENCE HARMON			
Work Order Comments: Rootcut main on annual schedule per R. Foster 2017 Area CB Map C10 Facet Map T15 3500-3599 Hull - 250 Comb (81.38m run) / EES970993 CCTV completed 05/04/18 NTF 2019/01/04 Acoustic Inspection found Poor Result (1) - maintain current schedule						
Reference #1					Billable?	
Reference #2					N	
Collection Agency		Collection Method		Zone	Beat	
Service Request #						
Contact Name			Contact Phone		Contact Type	
Asset Type	Asset ID #	B.U.N	Status	Asset Area	Map # (Facet)	District
Main (C)	422026		IN_SERVICE	CBC10	T15	1
Asset Details: C 250 Millimeter VC 81.38 Meters 3.21% [81.38-250.0 C VC 3.21% 1930]

Safety & Asset Notes:						
PM Sched.	Maint. Sched.	Due Date	Zone	Last Completed Work Order		
6 MONTHS	25431	2019-01-04	SO_CBC10	2019/01/04; 1020047; Maintenance (SACOUS)		
Crew Comments						
<p><i>Rootcut main, Light roots found. Job complete.</i></p> <p><i>DA</i></p>						
Work Completed Date: JAN-14/19		Print Name: CURRIE/ANSTEY			Crew ID: RENT35
