RE: Request for Access to Records under the Freedom of Information and Protection of Privacy Act (the "Act")

1. **Records of inspections of 439 Powell Street, between January 1, 2011 and March 31, 2015, including annual SRO inspections, and inspections related to enforcement actions or structural integrity;**

1. what caused the brick veneer on the east elevation of the building located at 439 Powell Street to separate and fall into the building located at 451 Powell Street on or around July 24th, 2013; and,
2. what is the condition of the brick veneer and wood frame exterior wall on the west elevation of 439 Powell Street.

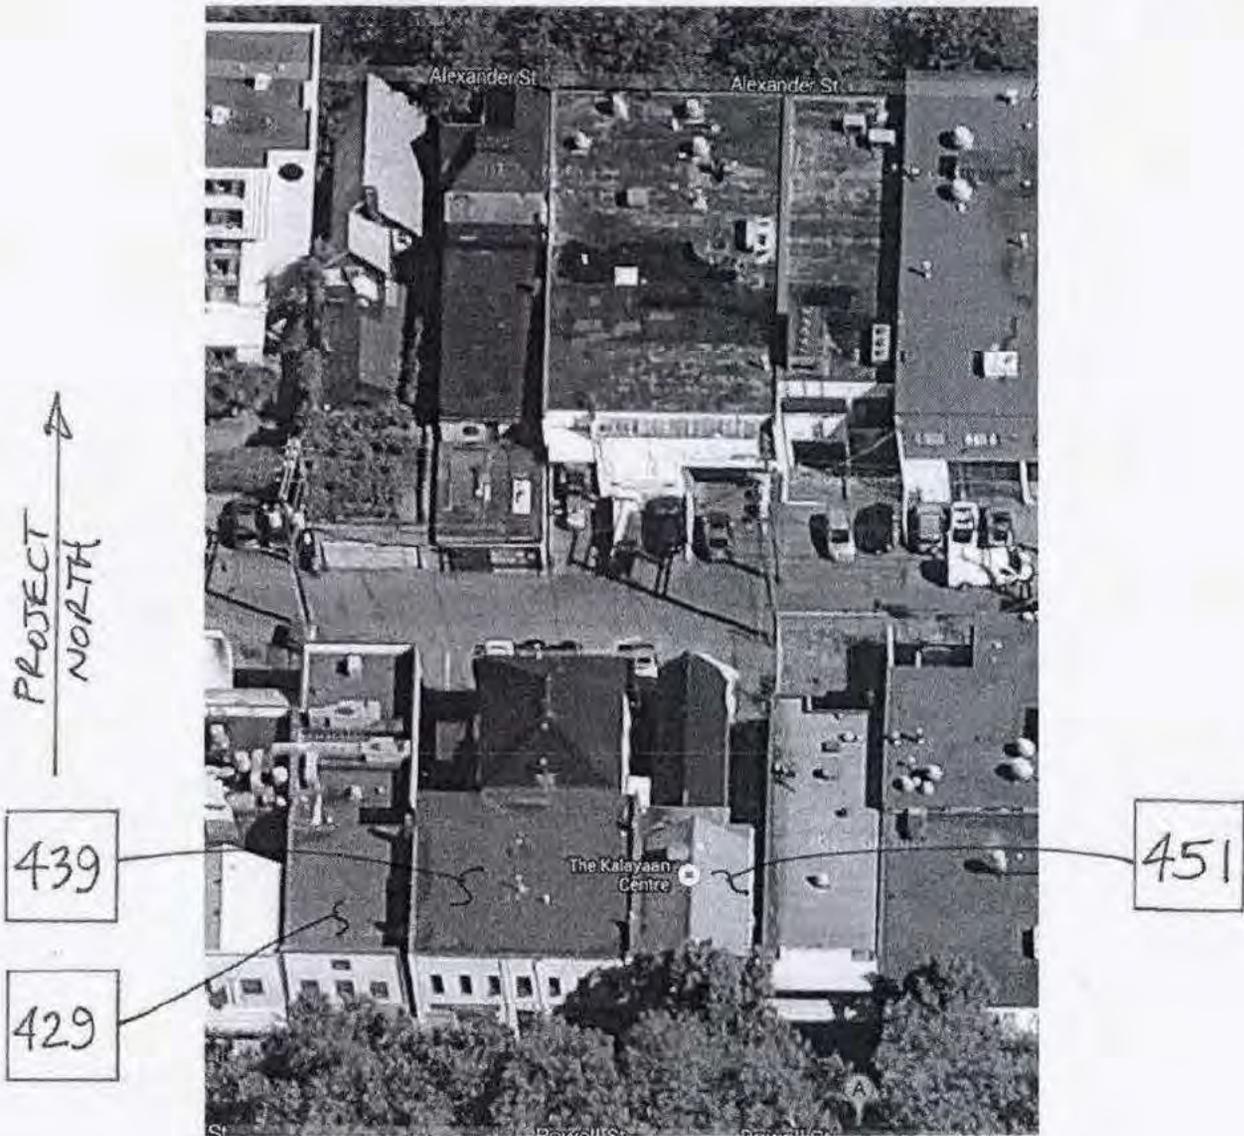
Figure 1: Aerial View of 429, 439 and 451 Powell Street, Vancouver

The existing building located at 439 Powell Street is actually comprised of two buildings (see Figures 1, 2 and 3). The south or front building that faces Powell Street appears to be the original building erected on the site and is a two-story wood frame structure supported on stone and mortar foundation walls. The main floor level is constructed from 2x10 floor joists at 16 inches on center over a crawlspace. The exterior walls are constructed from 2x4 wall studs at 16 inches on center and the walls are sheathed with horizontal 1x10 wood siding.

My description of the building located at 451 Powell Street is based entirely on photographs supplied by yourself because the building had been completely demolished and removed at the time of my site visit on October 3rd, 2013 (see Figures 1, 4 and 5).

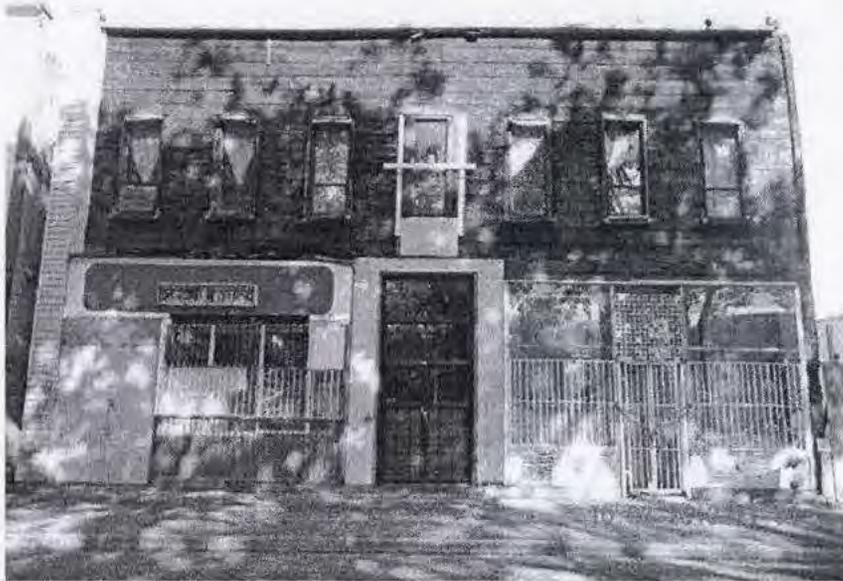
Figure 2: South Elevation of 439 Powell Street, Vancouver

A brick veneer may have been installed on the south elevation of the south building as part of the original construction but at the time of my site visit, the south elevation was stripped of all building finishes down to the horizontal 1x10 wood siding on 2x4 wall studs (see Figure 2).

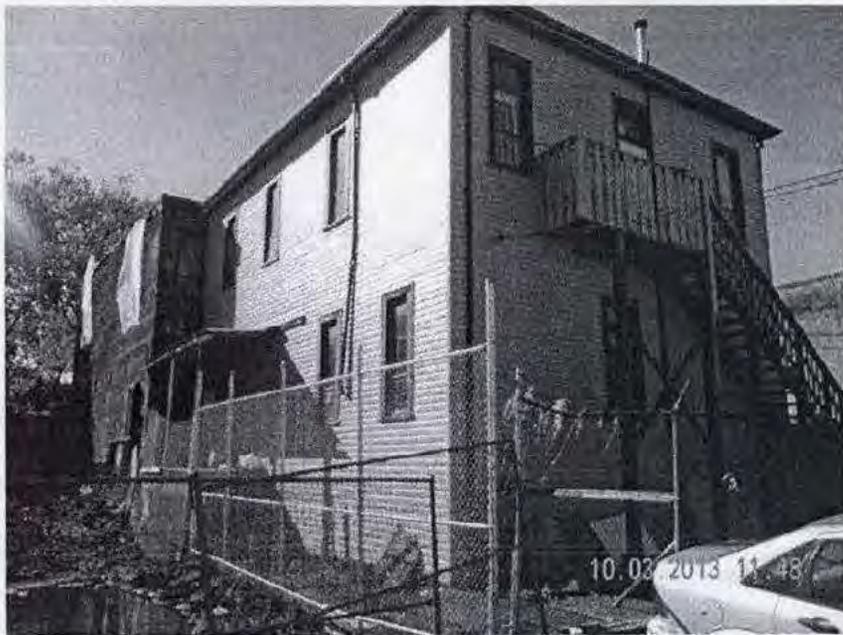
Figure 3: North Elevation of 439 Powell Street, Vancouver

A newer two-story plus possible basement building was constructed immediately to the north of the south building and a brick veneer was noted on the north elevation of the south building. I did not have access to the interior of the north building but in my opinion it is a wood frame structure supported on concrete foundations (see Figure 3).

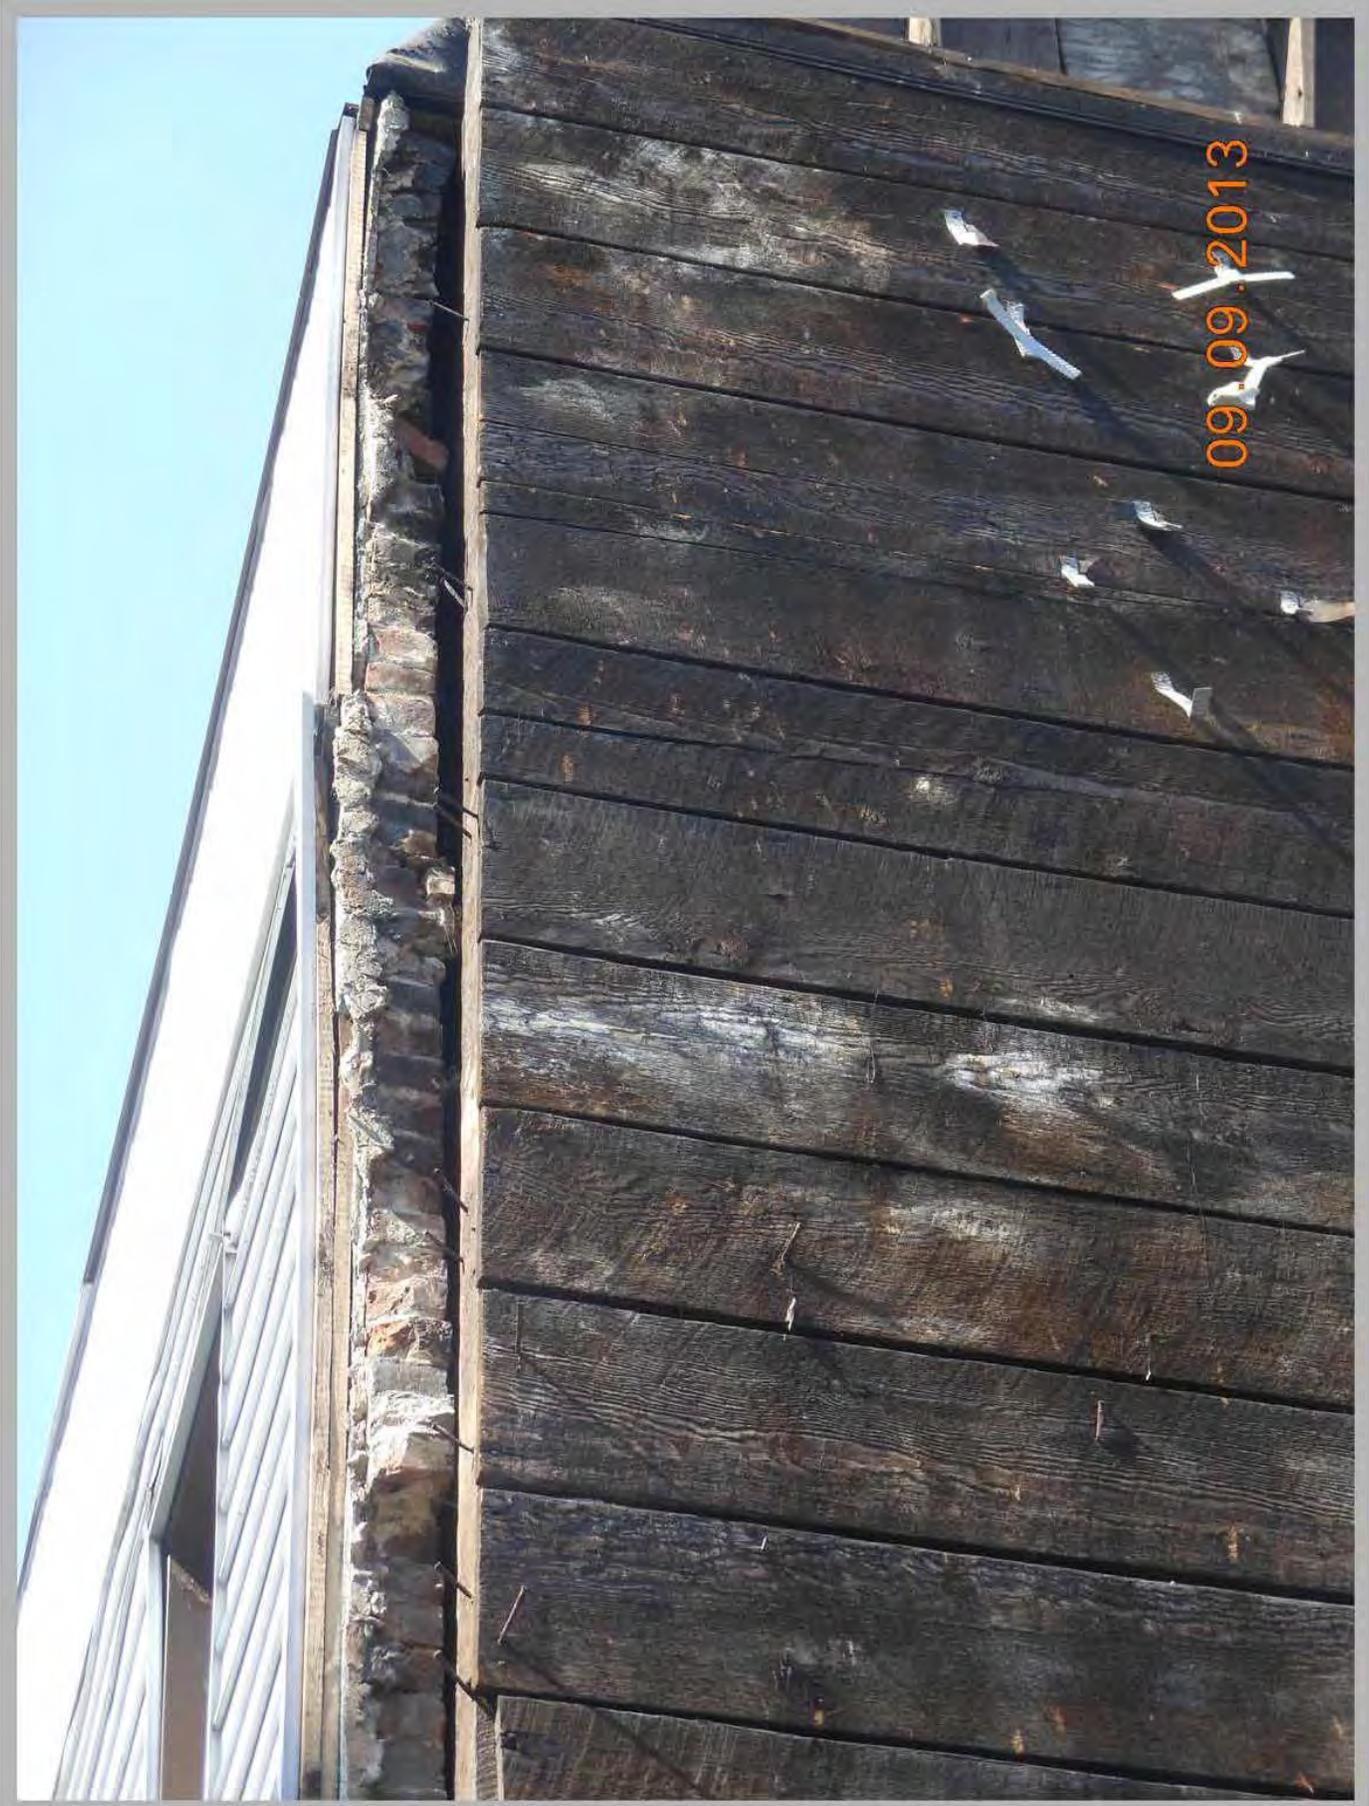
Filename: 01.jpg \\ © City of Vancouver \\

Photo #1 Bulging brick façade

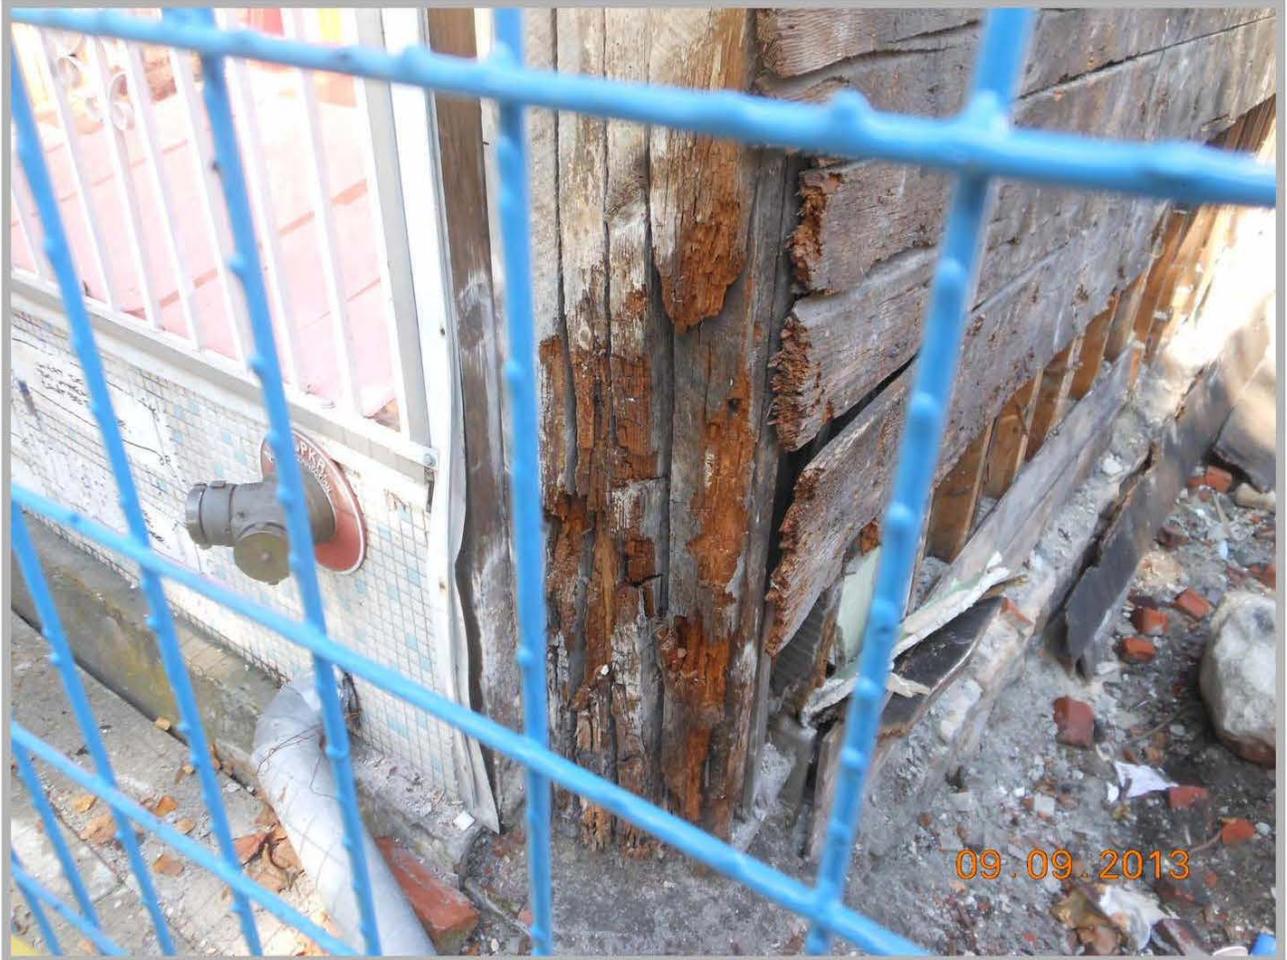
Filename: 02.jpg \ \ © City of Vancouver \ \

Photo #2 Rotting built up post at the SE corner of building at ground level

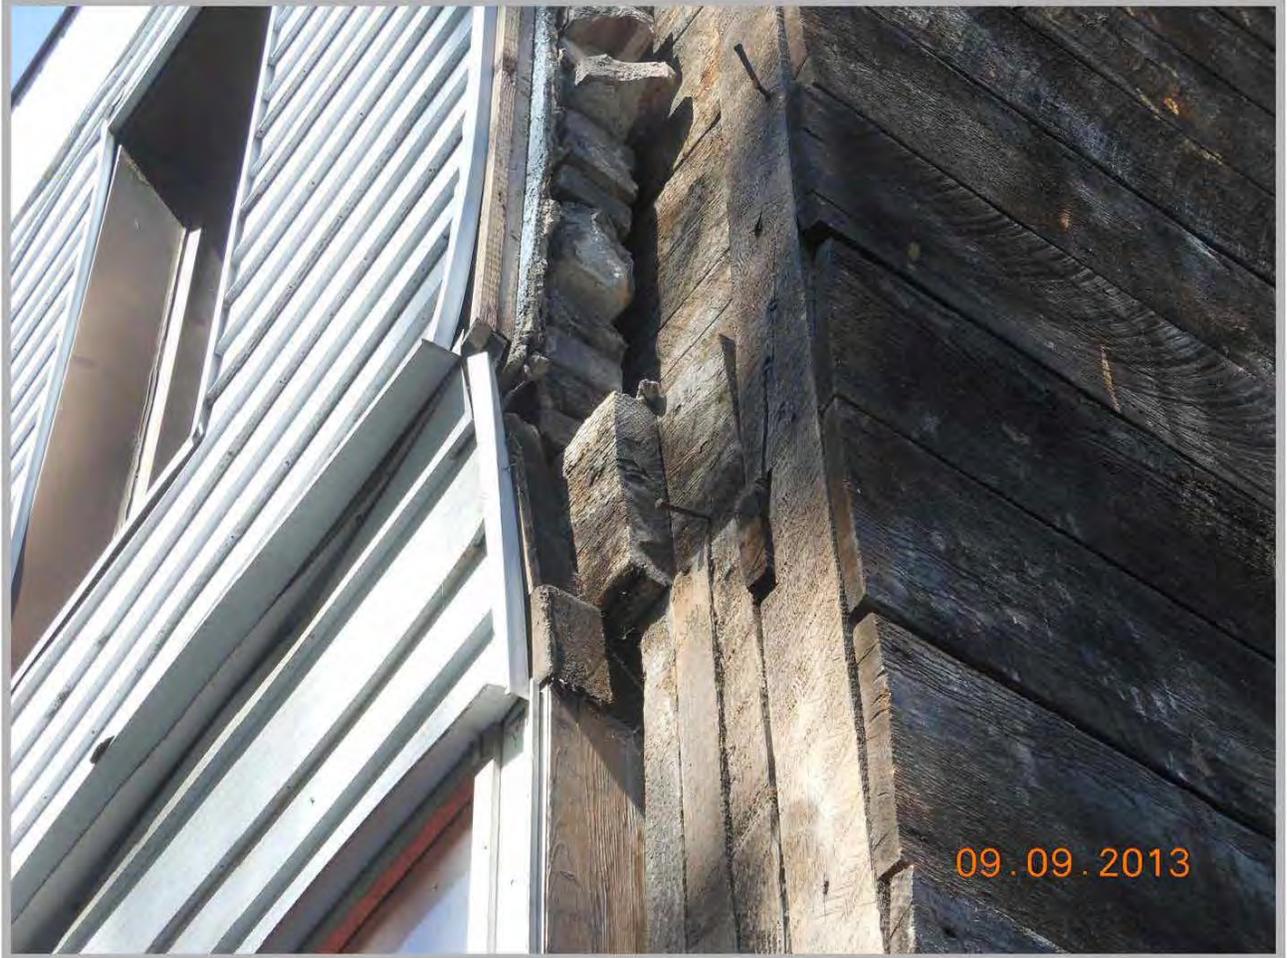
Filename: 03.jpg \\ © City of Vancouver \\

Photo #3 Buckling header over ground floor commercial store front windows.
