Arborist Report for Development Permit Application (DP-2021-00545) at 2120 West 10th Avenue. Date Range: June 1, 2021 to August 24, 2021.

TREE MANAGEMENT REPORT: **FOR PROPOSED DEVELOPMENT**

Site Address: **2120 West 10th Avenue, Vancouver**Project: **Application for Proposed Rezoning Development**

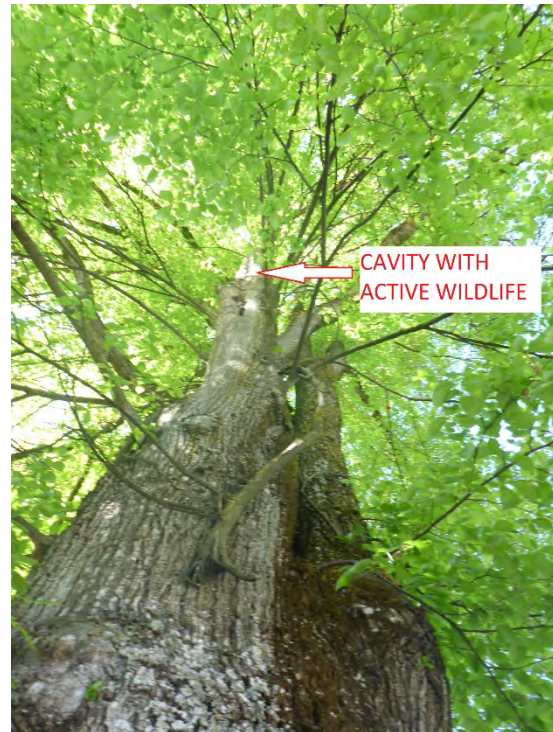
Tree #C02

Tag/ID	# of Trees	Loc	Common name, (Botanical)	Dbh	Ht	Spr	Suitability	Contribution	Priority	Assessment Findings	Action	Rationale	CPZ	RPZ
C02	1	City	English elm (Ulmus procera)	134	35	10.0	U	H	N/A	<ul style="list-style-type: none"> • Sidewalk recently replaced adjacent to the tree so root impacts are expected to have been incurred. • Root and trunk rot diseases (i.e. Armillaria and Ganoderma) fruiting bodies observed at the base of trunk and on ground adjacent to the base of the tree. • Sounding revealed the presence of internal decay in the buttress roots and within thne lower bole. • Historical trunk injury observed on the north side of the trunk resulting in a large open wound. Internal trunk decay behind the injury was detected by sounding. • Failure of this tree is probable in any direction via either stem failure or root failure and target ratings are constant. • Due to the severity of the defects, pruning is not an applicable treatment for mitigation and removal is strongly recommended. • This tree is HIGH-RISK (see TRAQ findings in accompanying report). • Park Board will be notified by this office for their consideration and action. 	Protect - Refer to Parks	Possible High Risk Tree	11.0	see dwg

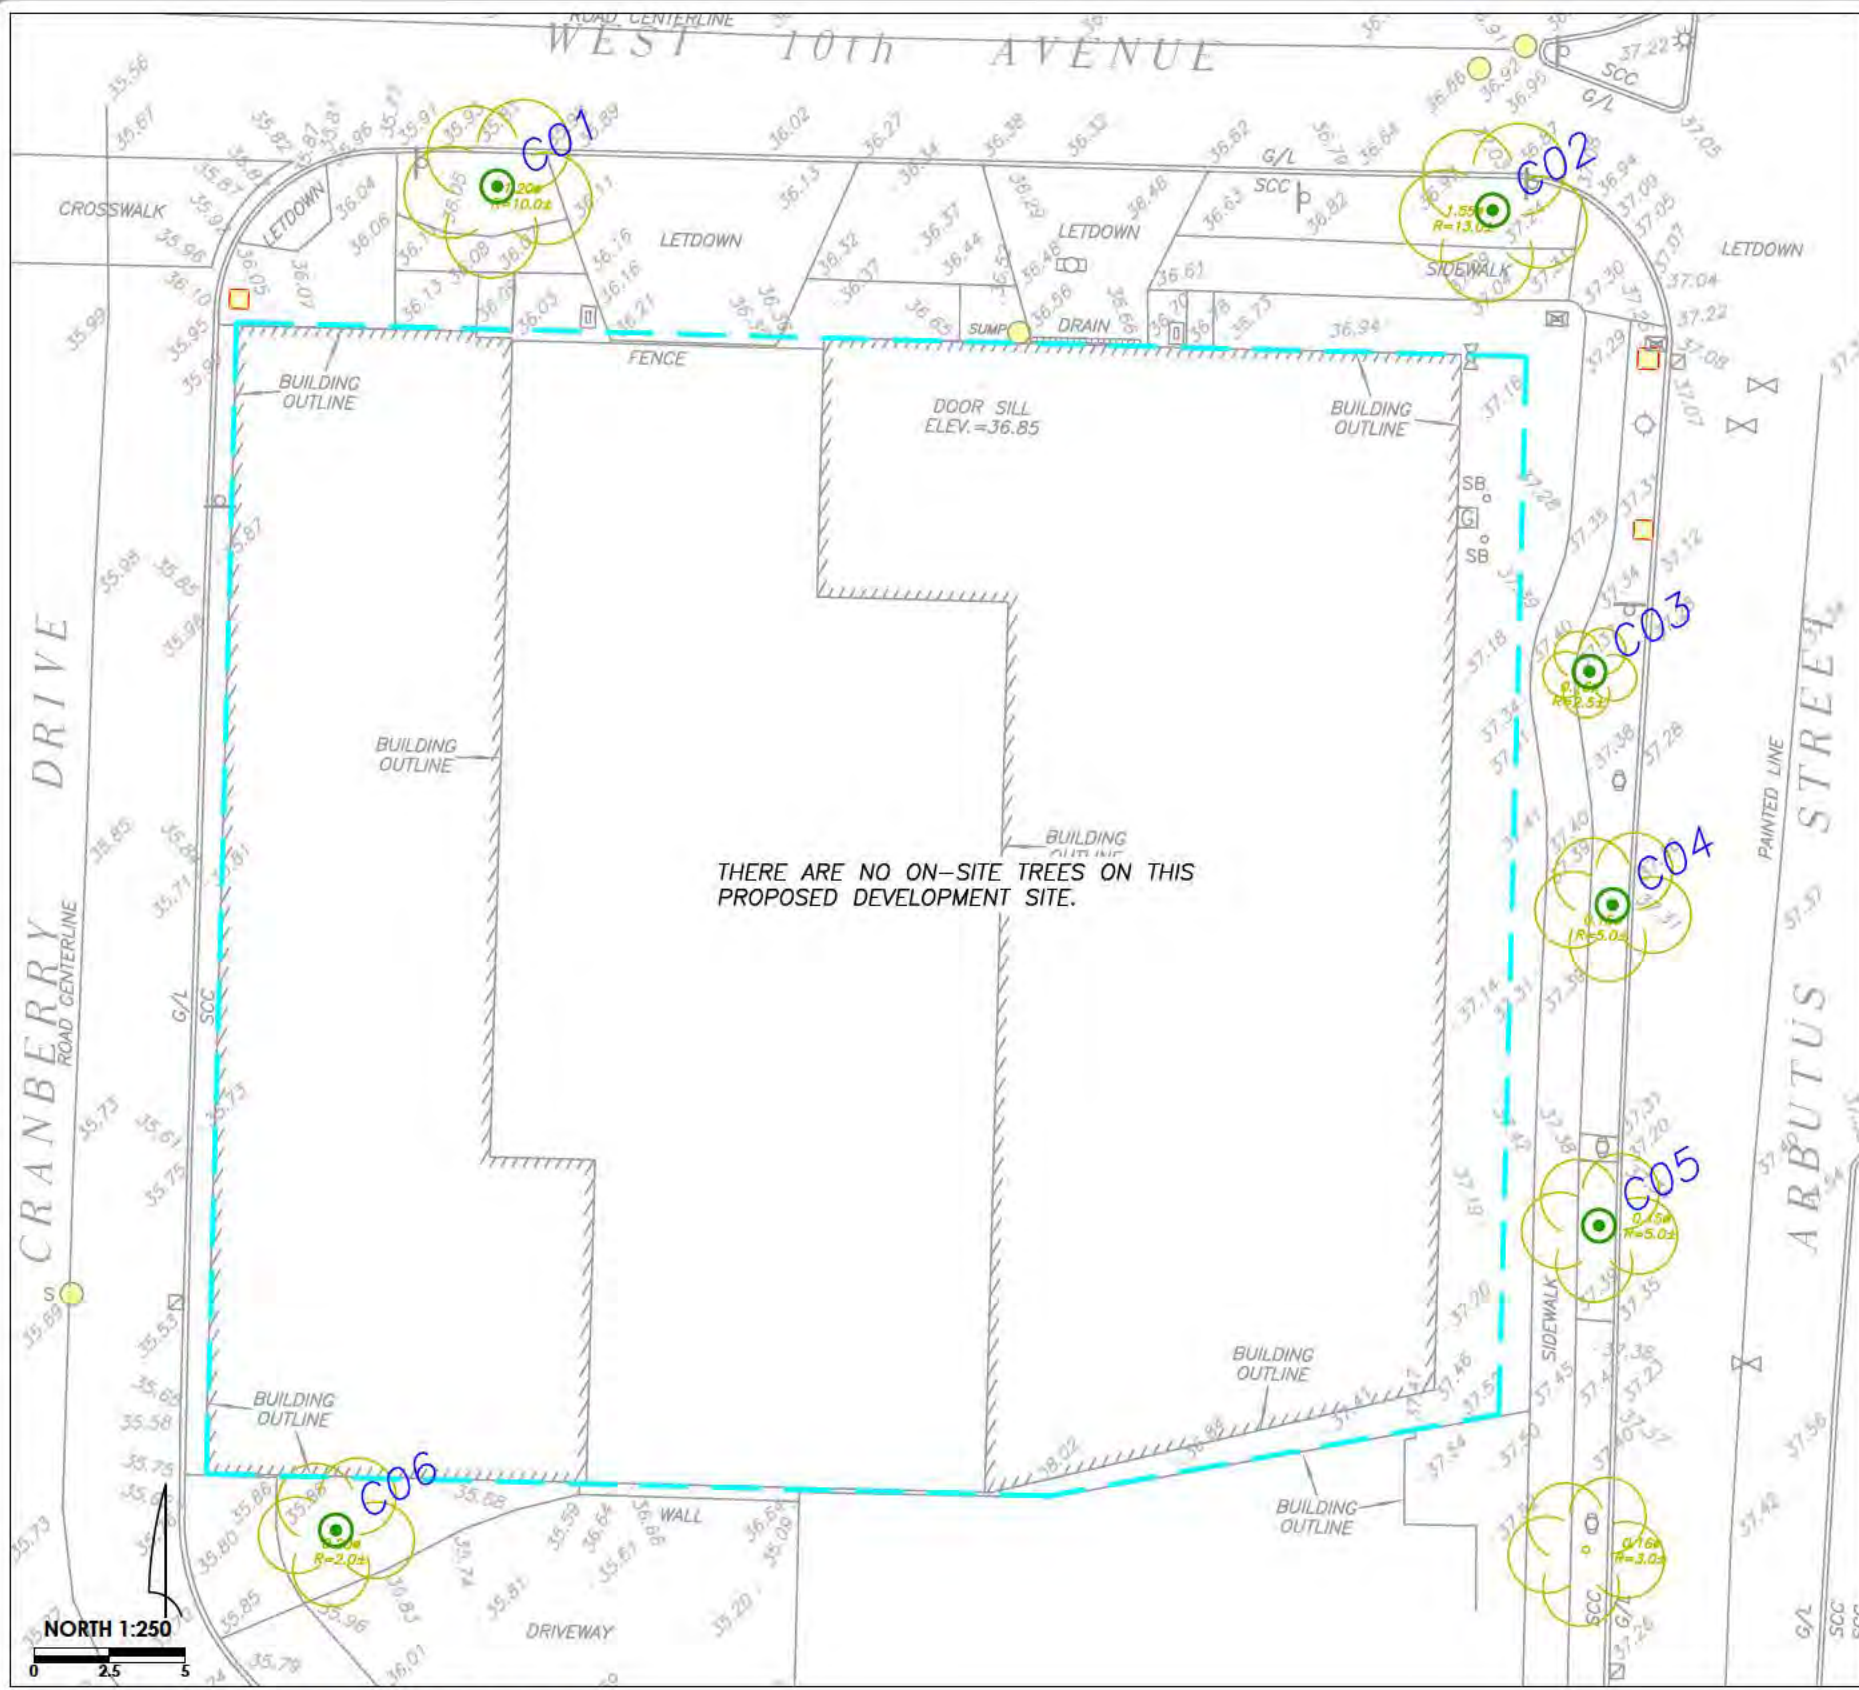
TREE ASSESSMENT DETAIL

TagID	# of trees	Loc	Common name, (Botanical)	DBH	Ht	Spr	LCR	Suitability	Contribution	Priority	Assessment Findings	Action	Rationale	CPZ	RPZ
C01	1	City	Scotch elm (Ulmus glabra)	107	35	8.0	C	H	N/A	4	Cavity observed on the westmost scaffold branch, and proactive pruning to reduce the crown spread to 4.5m on the west side of the tree. The overall scope of pruning is well within tolerance and it will not impact the health, stability, nor aesthetics of the tree.	Protect	Possible High Risk	9.0 N	see dag
C02	1	City	English elm (Ulmus procera)	134	35	10.0	U	H	N/A	4	Side-scan recently replaced adjacent to the tree so root impacts are expected to have been incurred. Root and trunk rot diseases (i.e. Armillaria and Ganoderma) fruiting bodies observed at the base of trunk and on ground adjacent to the base of the tree. Sounding revealed the presence of internal decay in the buttress roots and within the lower bole. Historical trunk injury observed on the north side of the trunk resulting in a large open wound. Internal trunk decay behind the injury was detected by sounding. Failure of this tree is probable in any direction via either stem failure or root failure and target ratings are constant. Due to the severity of the defects, pruning is not an applicable treatment for mitigation and removal is strongly recommended. This tree is HIGH RISK (see TRM2 findings in accompanying report). Park Board will be notified by this office for their consideration and action.	Protect - Refer to Tree Parks	Possible High Risk	11.0 N	see dag

C03	1	City	Star magnolia (Magnolia stellata)	18	8	4.0	S	H	N/A	4	No significant defect observed.	Protect	Low	5.0 E	2.5
C04	1	City	European beech (Fagus sylvatica)	7	4	1.0	S	H	N/A	4	No significant defect observed.	Protect	Low	2.0	1.5
C05	1	City	European beech (Fagus sylvatica)	15	9	1.5	S	H	N/A	4	No significant defect observed.	Protect	Low	2.5	2.5
C06	1	City	Japanese maple (Acer palmatum)	20	15	3.0	U	M	N/A	4	The tree is growing within 1m of the existing building and it appears to rely on the existing foundation for tree root anchoring and soil stability. Removal of the existing foundation, required to accommodate construction of new building, will de-stabilize the tree and make it high risk for failure. This tree should be removed proactively prior to demolition commencing.	REMOVE - Subject to Parks Approval	High	4.0	2.0
