File No.: 04-1000-20-2021-531 - Phased Release 1 of 2

## **TREE MANAGEMENT REPORT:** **FOR PROPOSED DEVELOPMENT**

Report Date: **July 4, 2018**

Site Address: **2120 West 10<sup>th</sup> Avenue, Vancouver**

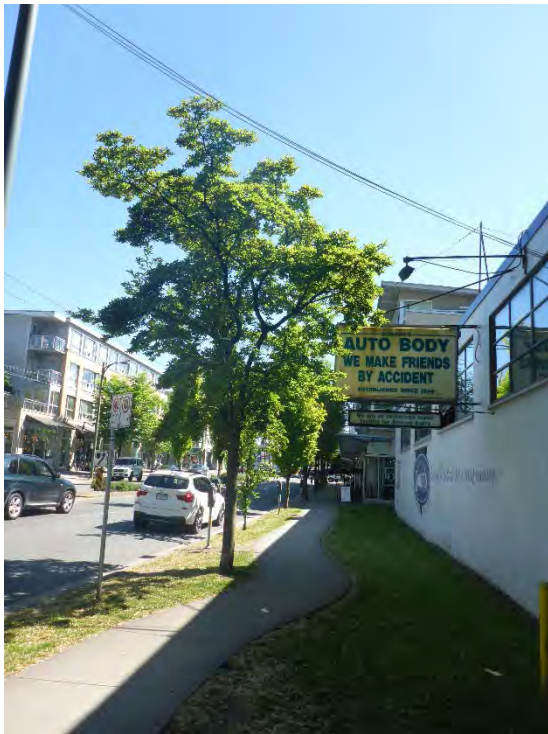
Tree #C03

C03	1	City	Star magnolia (Magnolia stellata)	18	8	4.0	S	H	N/A	• No significant defect observed.	Protect	5.0 E	2.5	2.5 W	2.0	1.5	2.5
C04	1	City	European beech (Fagus sylvatica)	7	4	1.0	S	H	N/A	• No significant defect observed.	Protect	2.0	1.5				
C05	1	City	European beech (Fagus sylvatica)	15	9	1.5	S	H	N/A	• No significant defect observed.	Protect	2.5	2.5				
C06	1	City	Japanese maple (Acer palmatum)	20	15	3.0	U	M	N/A	• The tree is growing within approximately 1m of the existing building at the subject site, and it appears to likely rely on the existing foundation for tree root anchoring and soil stability. Removal of the existing foundation, required to accommodate construction of new building, is expected to destabilize the tree and make it high risk for failure. This tree is recommended to be removed proactively prior to demolition commencing.	REMOVE -	Subject to Parks Approval

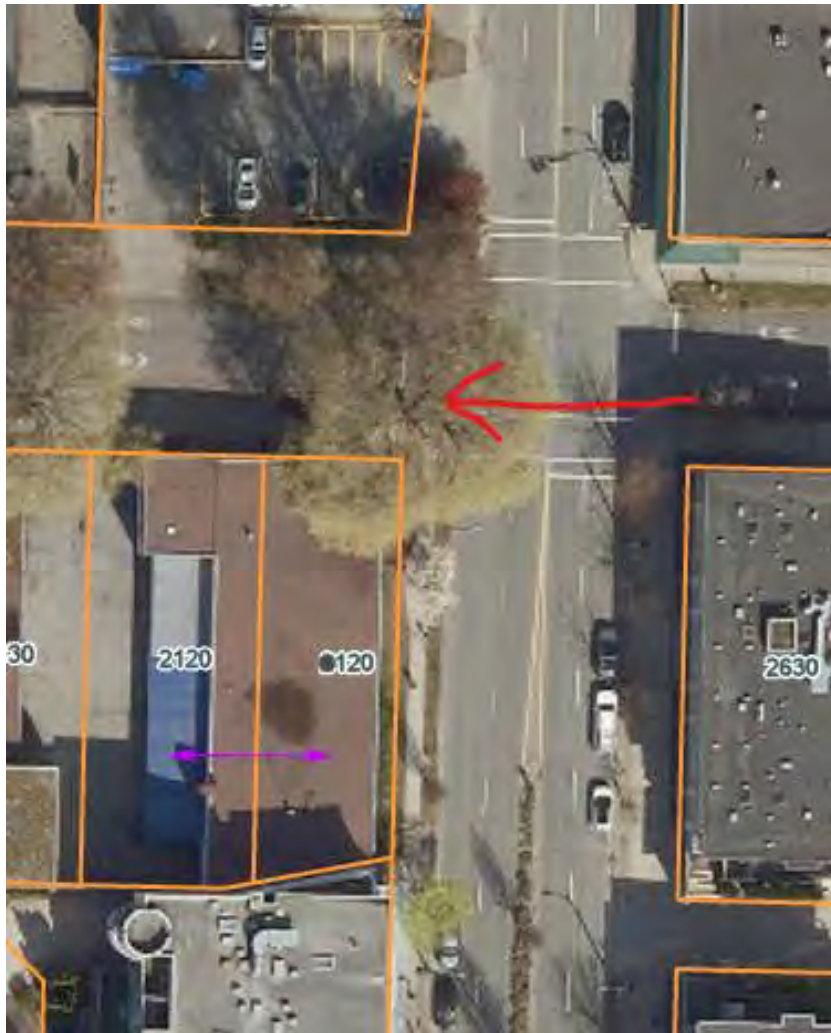
The subject tree is an English elm (*Ulmus procera*) and is growing on the southwest corner of 10<sup>th</sup> and Arbutus, Vancouver, in the sidewalk median. The targets in this area include, the buildings to the south and east, the hydro lines and bus electrified lines, people in vehicles and pedestrians below. This is a densely populated area and arbutus at this intersection has a lot of vehicle and bike traffic. tree is predominantly exposed to winds from the south and is partly sheltered from winds coming from other directions.

Figure 1. The subject tree in context of the surrounding landscape and infrastructure.

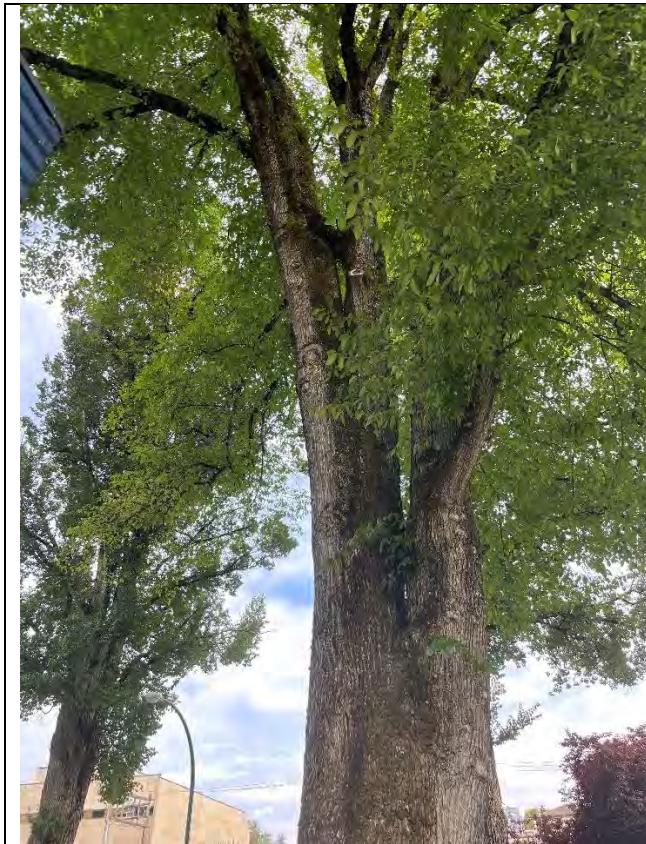
Photo 1. Looking up into the crown of the tree from its south side.

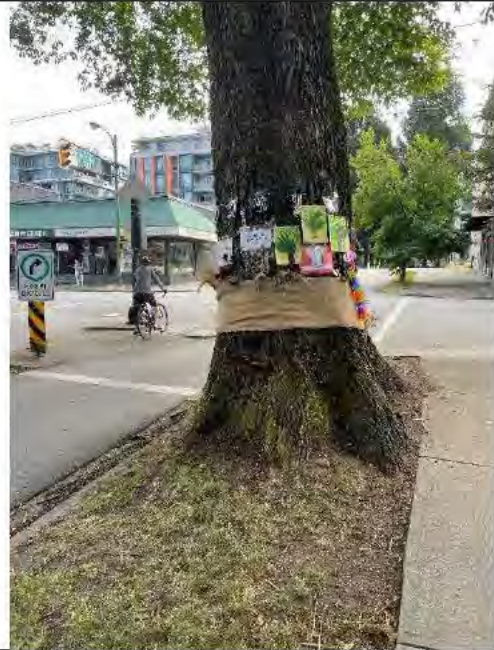
Photo 4. Looking east at the tree.

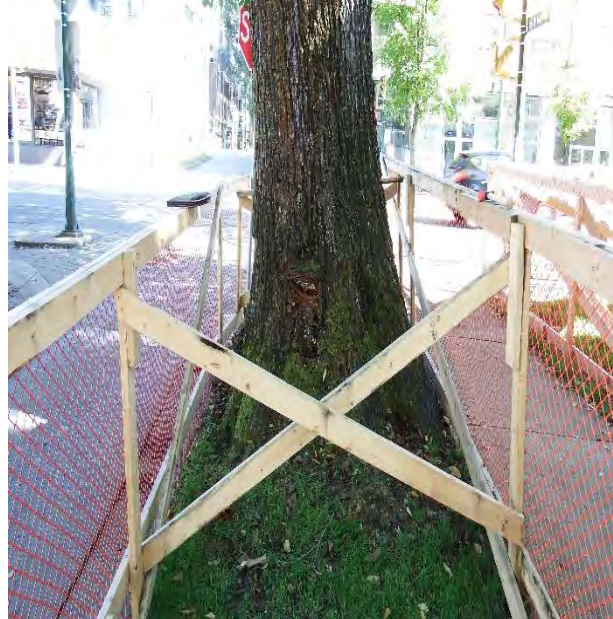
Restricted root growing conditions	The exact root architecture of the tree is unknown, but it is unlikely that the roots are strictly constrained to the interior of the boulevard. A tree of this size would not have enough CRZ to survive if that were the case. Assuming the roots are not restricted to the boulevard, the nearest barriers to root growth are: <ul style="list-style-type: none"> <li>• a concrete building approximately 2 m south of tree</li> <li>• West 10<sup>th</sup> Avenue approximately 1 m north of tree</li> <li>• Arbutus Street approximately 4 m east of tree.</li> </ul>
General forest characteristics (species, age, class, general health)	The subject tree is an American elm and is the dominant tree in the landscape. It is the only tree on the boulevard at the address. The tree is 137 DBH, mature and in good general health.

Figure 4 - Site Rooting Habitat Available

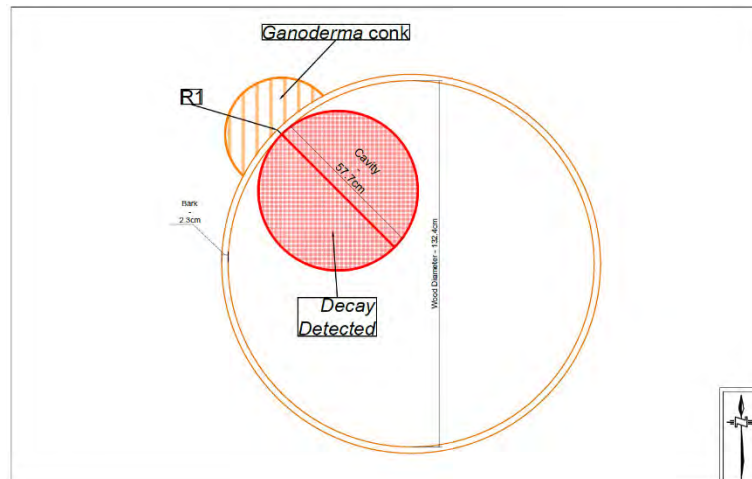
Figure 12 - Map of Resistograph® Test 1

This test showed a thin layer of bark followed by an atypical resistance profile for the species. Both the rotational and feed resistance were low. The profile showed likely signs of incipient decay and advanced white rot throughout.

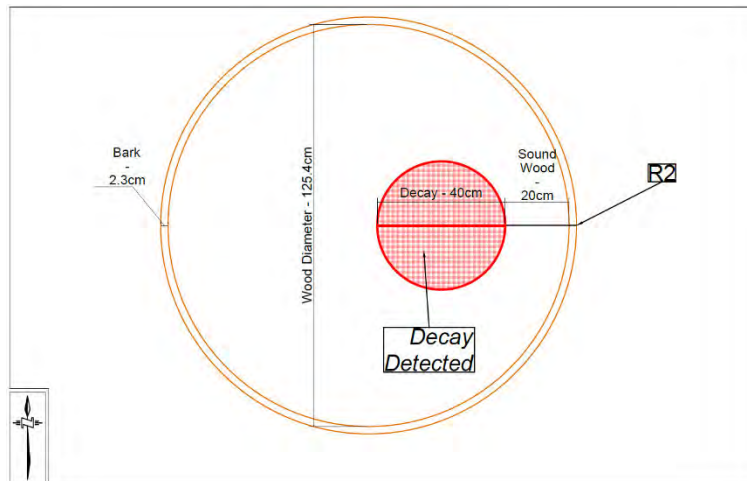
Figure 14 - Map of Resistograph® Test 2

This test showed a lower resistance than typical for the species. 20cm of sound wood was measured, and decay throughout the remaining of the profile. This measurement was taken opposite to conk and 70cm higher. It suggests the decay is progressing out of the root collar and into the basal area of the tree.

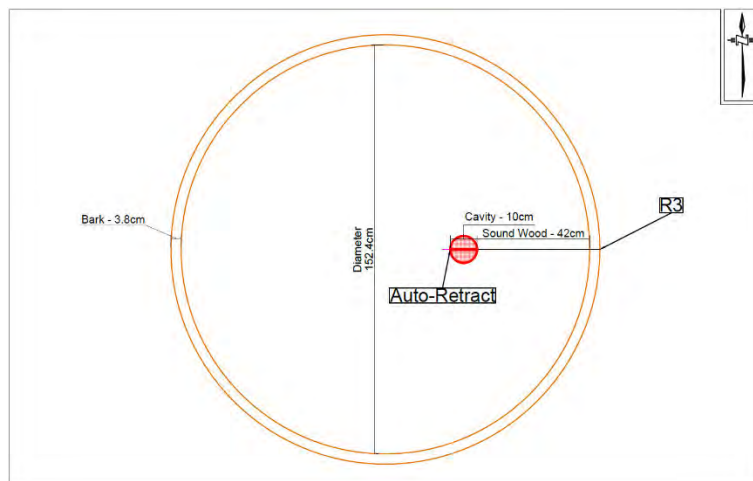
The test was taken in a large buttress with substantial reaction wood to explore the presence of soundwood columns. It showed stronger rotational and feed resistance as compared to the other profiles. The wood was structurally sound up to 46 cm, where a cavity was found.

This is an indicator that the decay is moving outwards and upwards from the observed conk on the west side of the tree.
