Re: Request for Access to Records under the Freedom of Information and Protection of Privacy Act (the "Act")

Records regarding the St. Paul's Medical Campus development, specifically:

### **PRE-DEMOLITION HAZARDOUS MATERIALS REPORT**

### 310 PRIOR STREET, VANCOUVER, BRITISH COLUMBIA

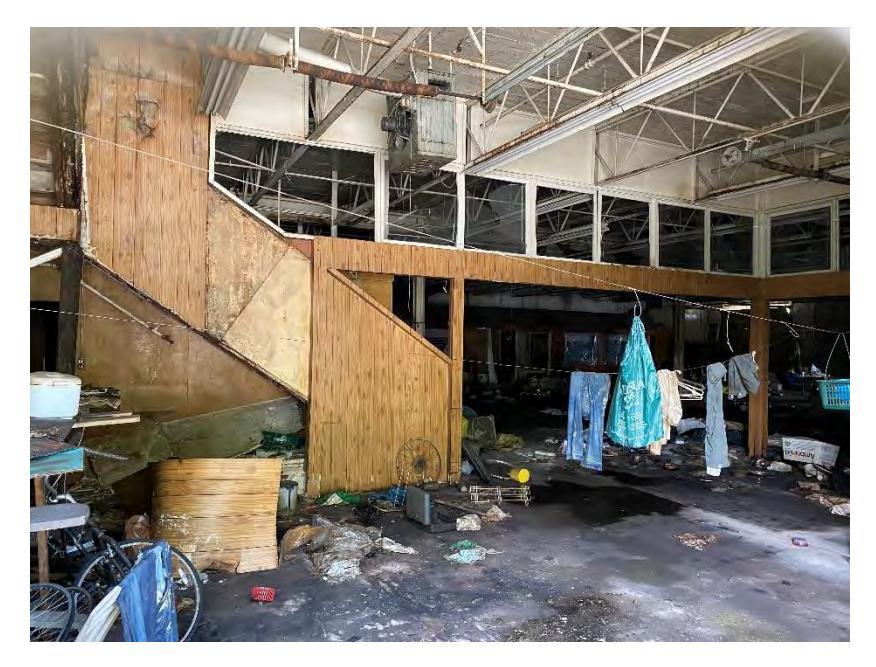
**Description**: View of collapsed roof within interior of 2<sup>nd</sup> Floor North Center Office.

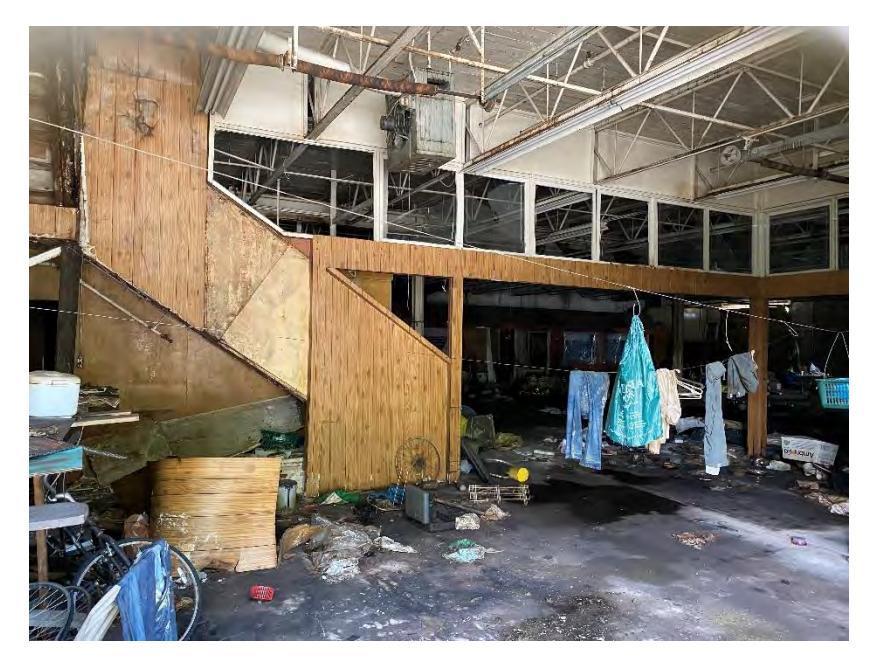
**Description**: View of collapsed roof within interior of 2<sup>nd</sup> Floor North Center Office.

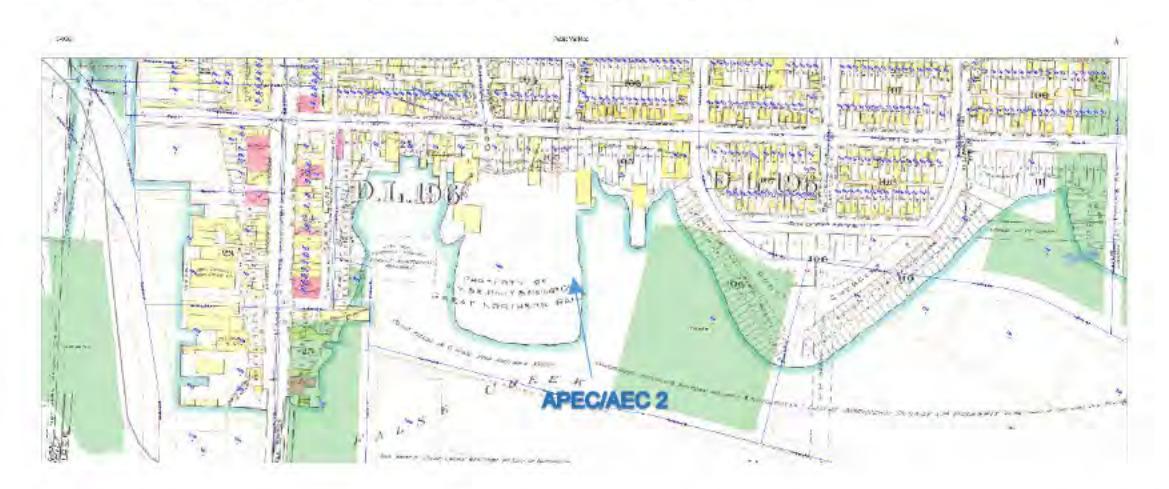
#### Figure D: Imported Fill Shown on 1912 Fire Insurance Plan

AEC 2 is defined by surrounding boreholes that meet applicable standards and by the boundaries of the Site. The boundaries of AEC 2 are somewhat fuzzy owing to larger spacing between boreholes especially toward the southwest portion of the APEC. For this report we assume that the area of AEC 2 corresponds to the area of fill imported before 1912 according to fire insurance maps (Figure D). This is supported by qualitative observations of the fill during drilling and that most soil exceedances associated with fill (particularly in deeper soil) are in this area.

Soil results from BH141 and BH142 (inside APEC 2) are below standards and show stratigraphy like APEC 1 (silty sand over medium sand), which might suggest that the southwest portion of the APEC 2 is better quality than the rest of the APEC. However, given the heterogeneous nature of fill, more characterization would be needed to conclude this. For now, we assume that all soil in APEC 2 is part of AEC 2, but we differentiate between the confirmed and possible extent of AEC 2 (Figure 20).

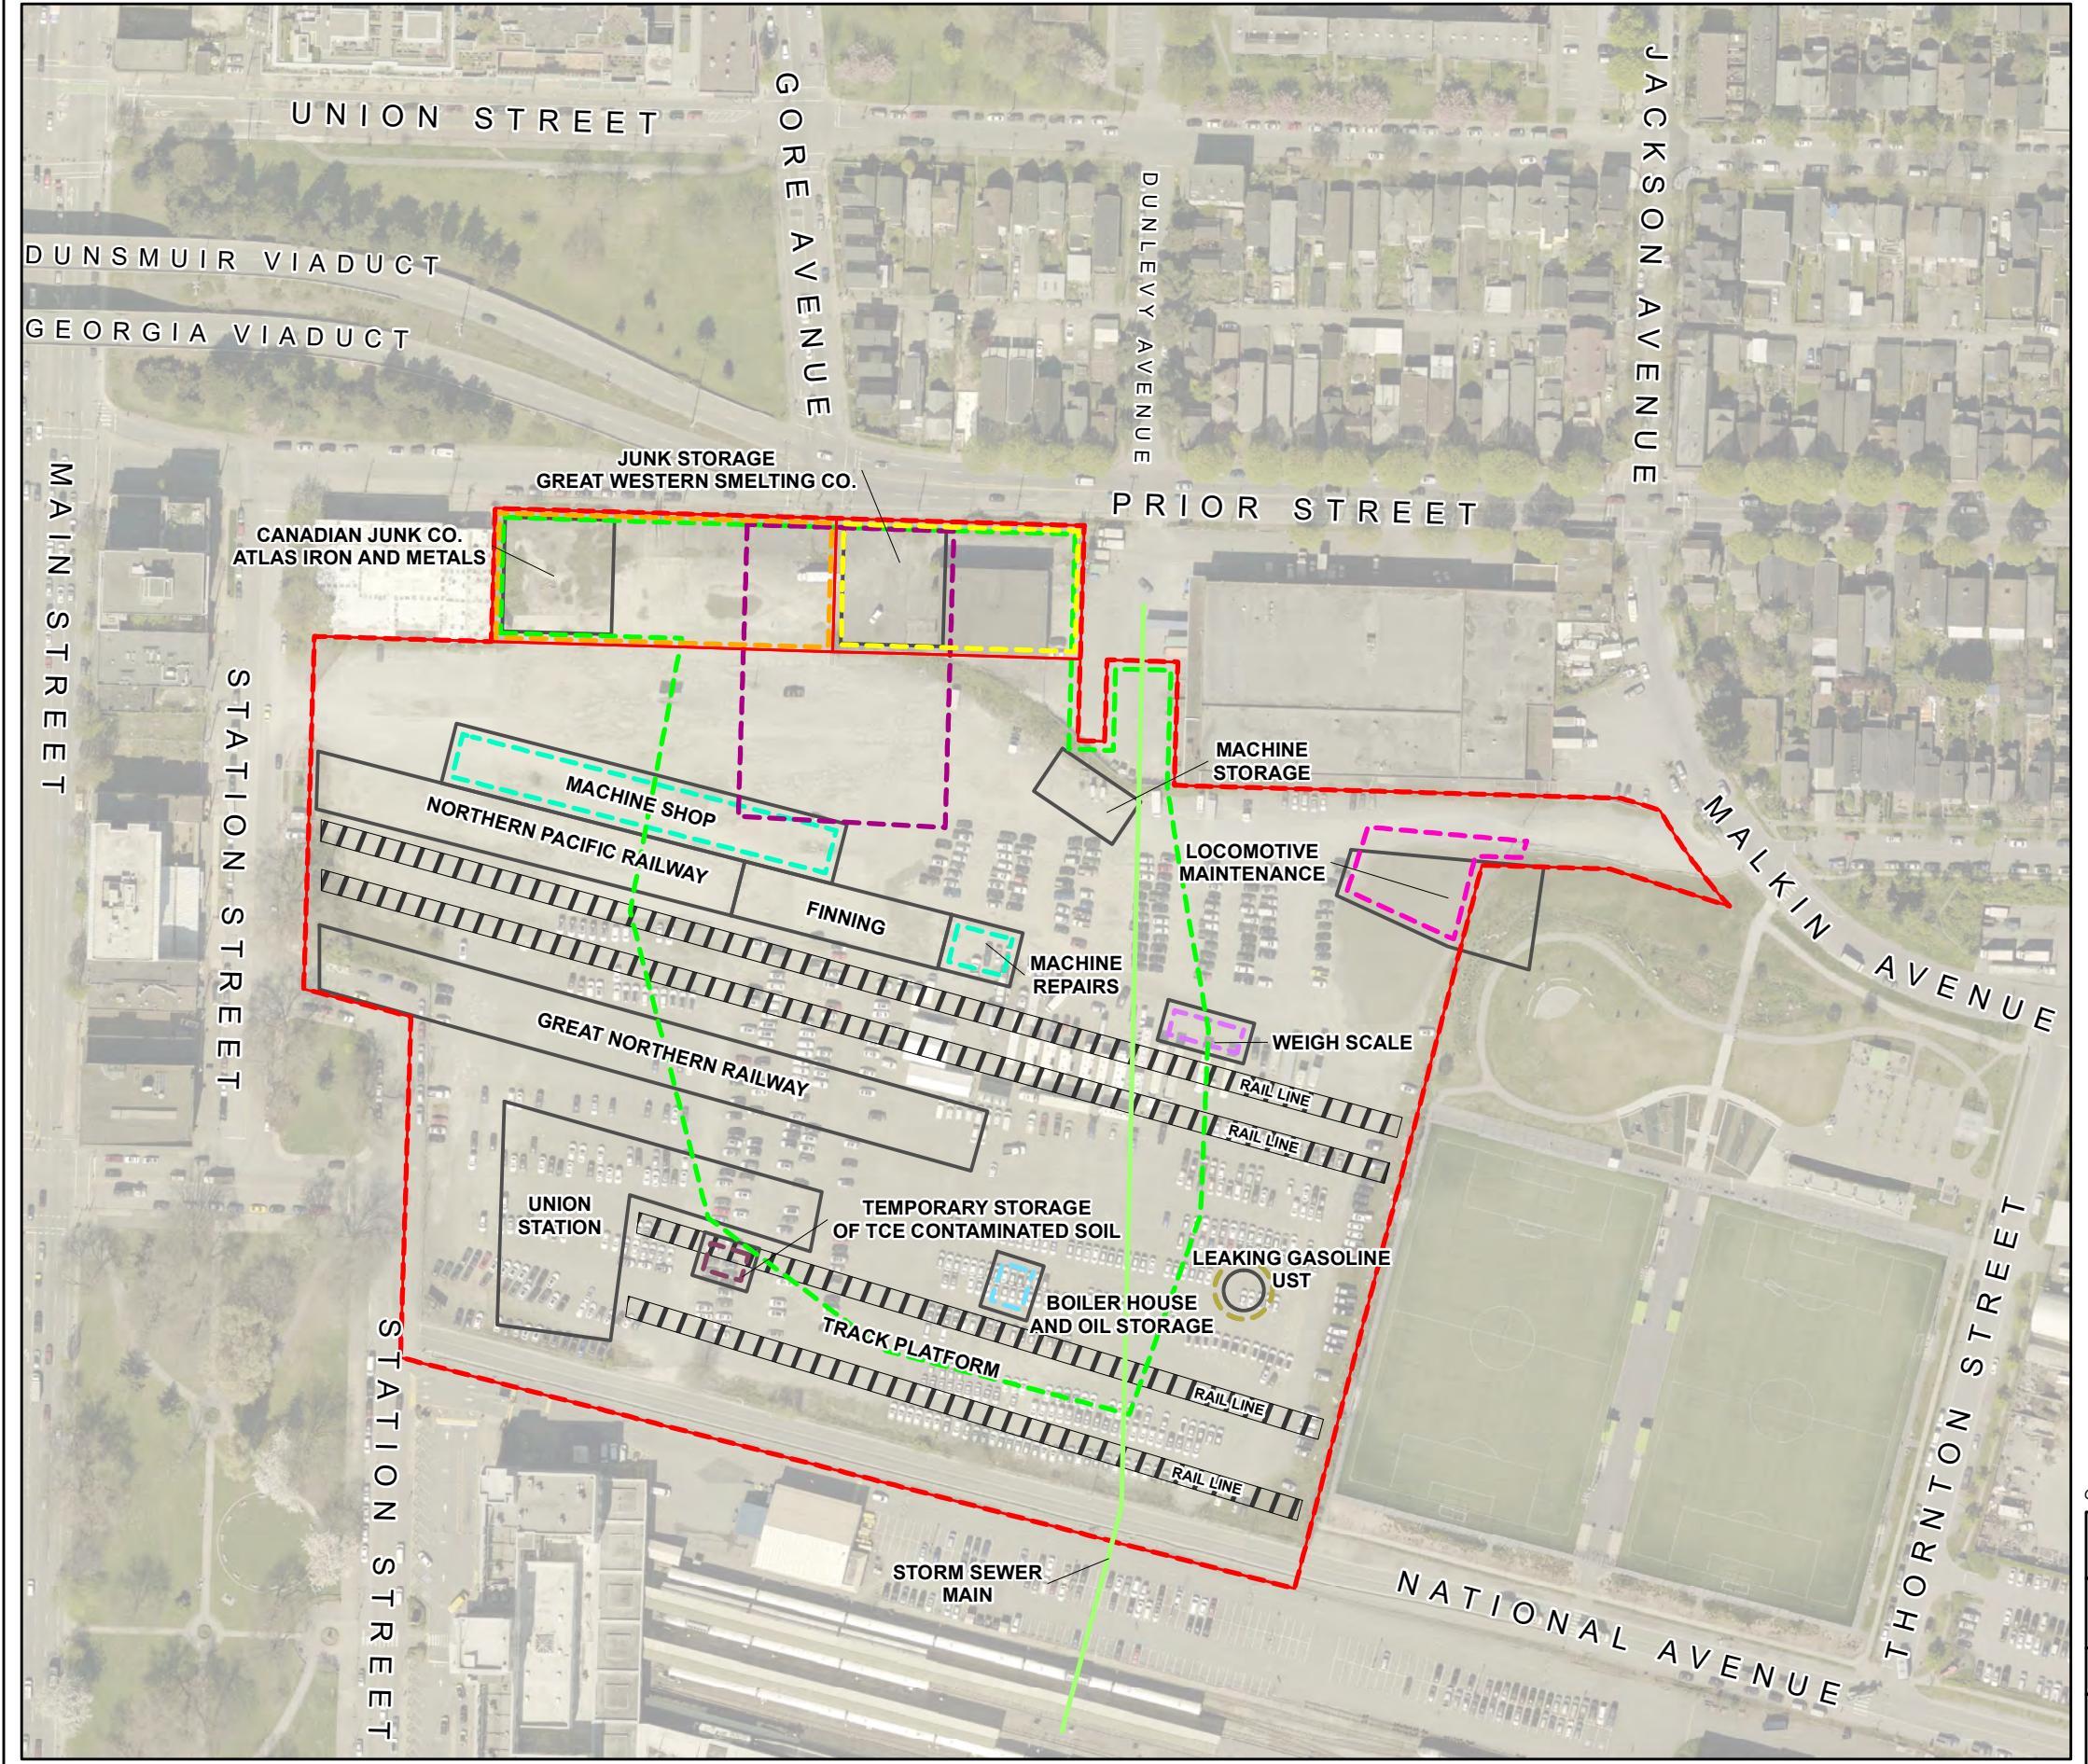
Oite Devenden: (Annewingto)
Site Boundary (Approximate) APEC 1 - Imported fill (post-1912)
APEC 2 - Metals and hydrocarbon impacts in
I imported fill (pre-1912)
APEC 3 - Historical repair and maintenance shops
APEC 4 - Historical locomotive maintenace
APEC 5 - Historical weigh scale
APEC 6 - Historical boiler house and fuel oil
APEC 7 - Historical leaking gasoline UST
APEC 8 - Historical temporary storage of TCE
APEC 9 - Former Beam Manufacturing Co.
APEC 10 - Former Canadian Junk Co. Ltd.
APEC 11 - Former Great Western Smelter and
N 0 20 40 80 m
Ortho Image and Parcel Boundary from The City of Vancouver's Open Data Catalogue
ONSITE AREAS OF POTENTIAL ENVIRONMENTAL CONCERN
250 and 310 Prior Street and 1002 Station Street, Vancouver, BC
PROVIDENCE HEALTHCARE
FIGURE FIE No.: Date: Dwg No.: Drawn by: FIGURE 3355-01.01 MAR 2019 53550101-F31 DPL 3
Original in colour

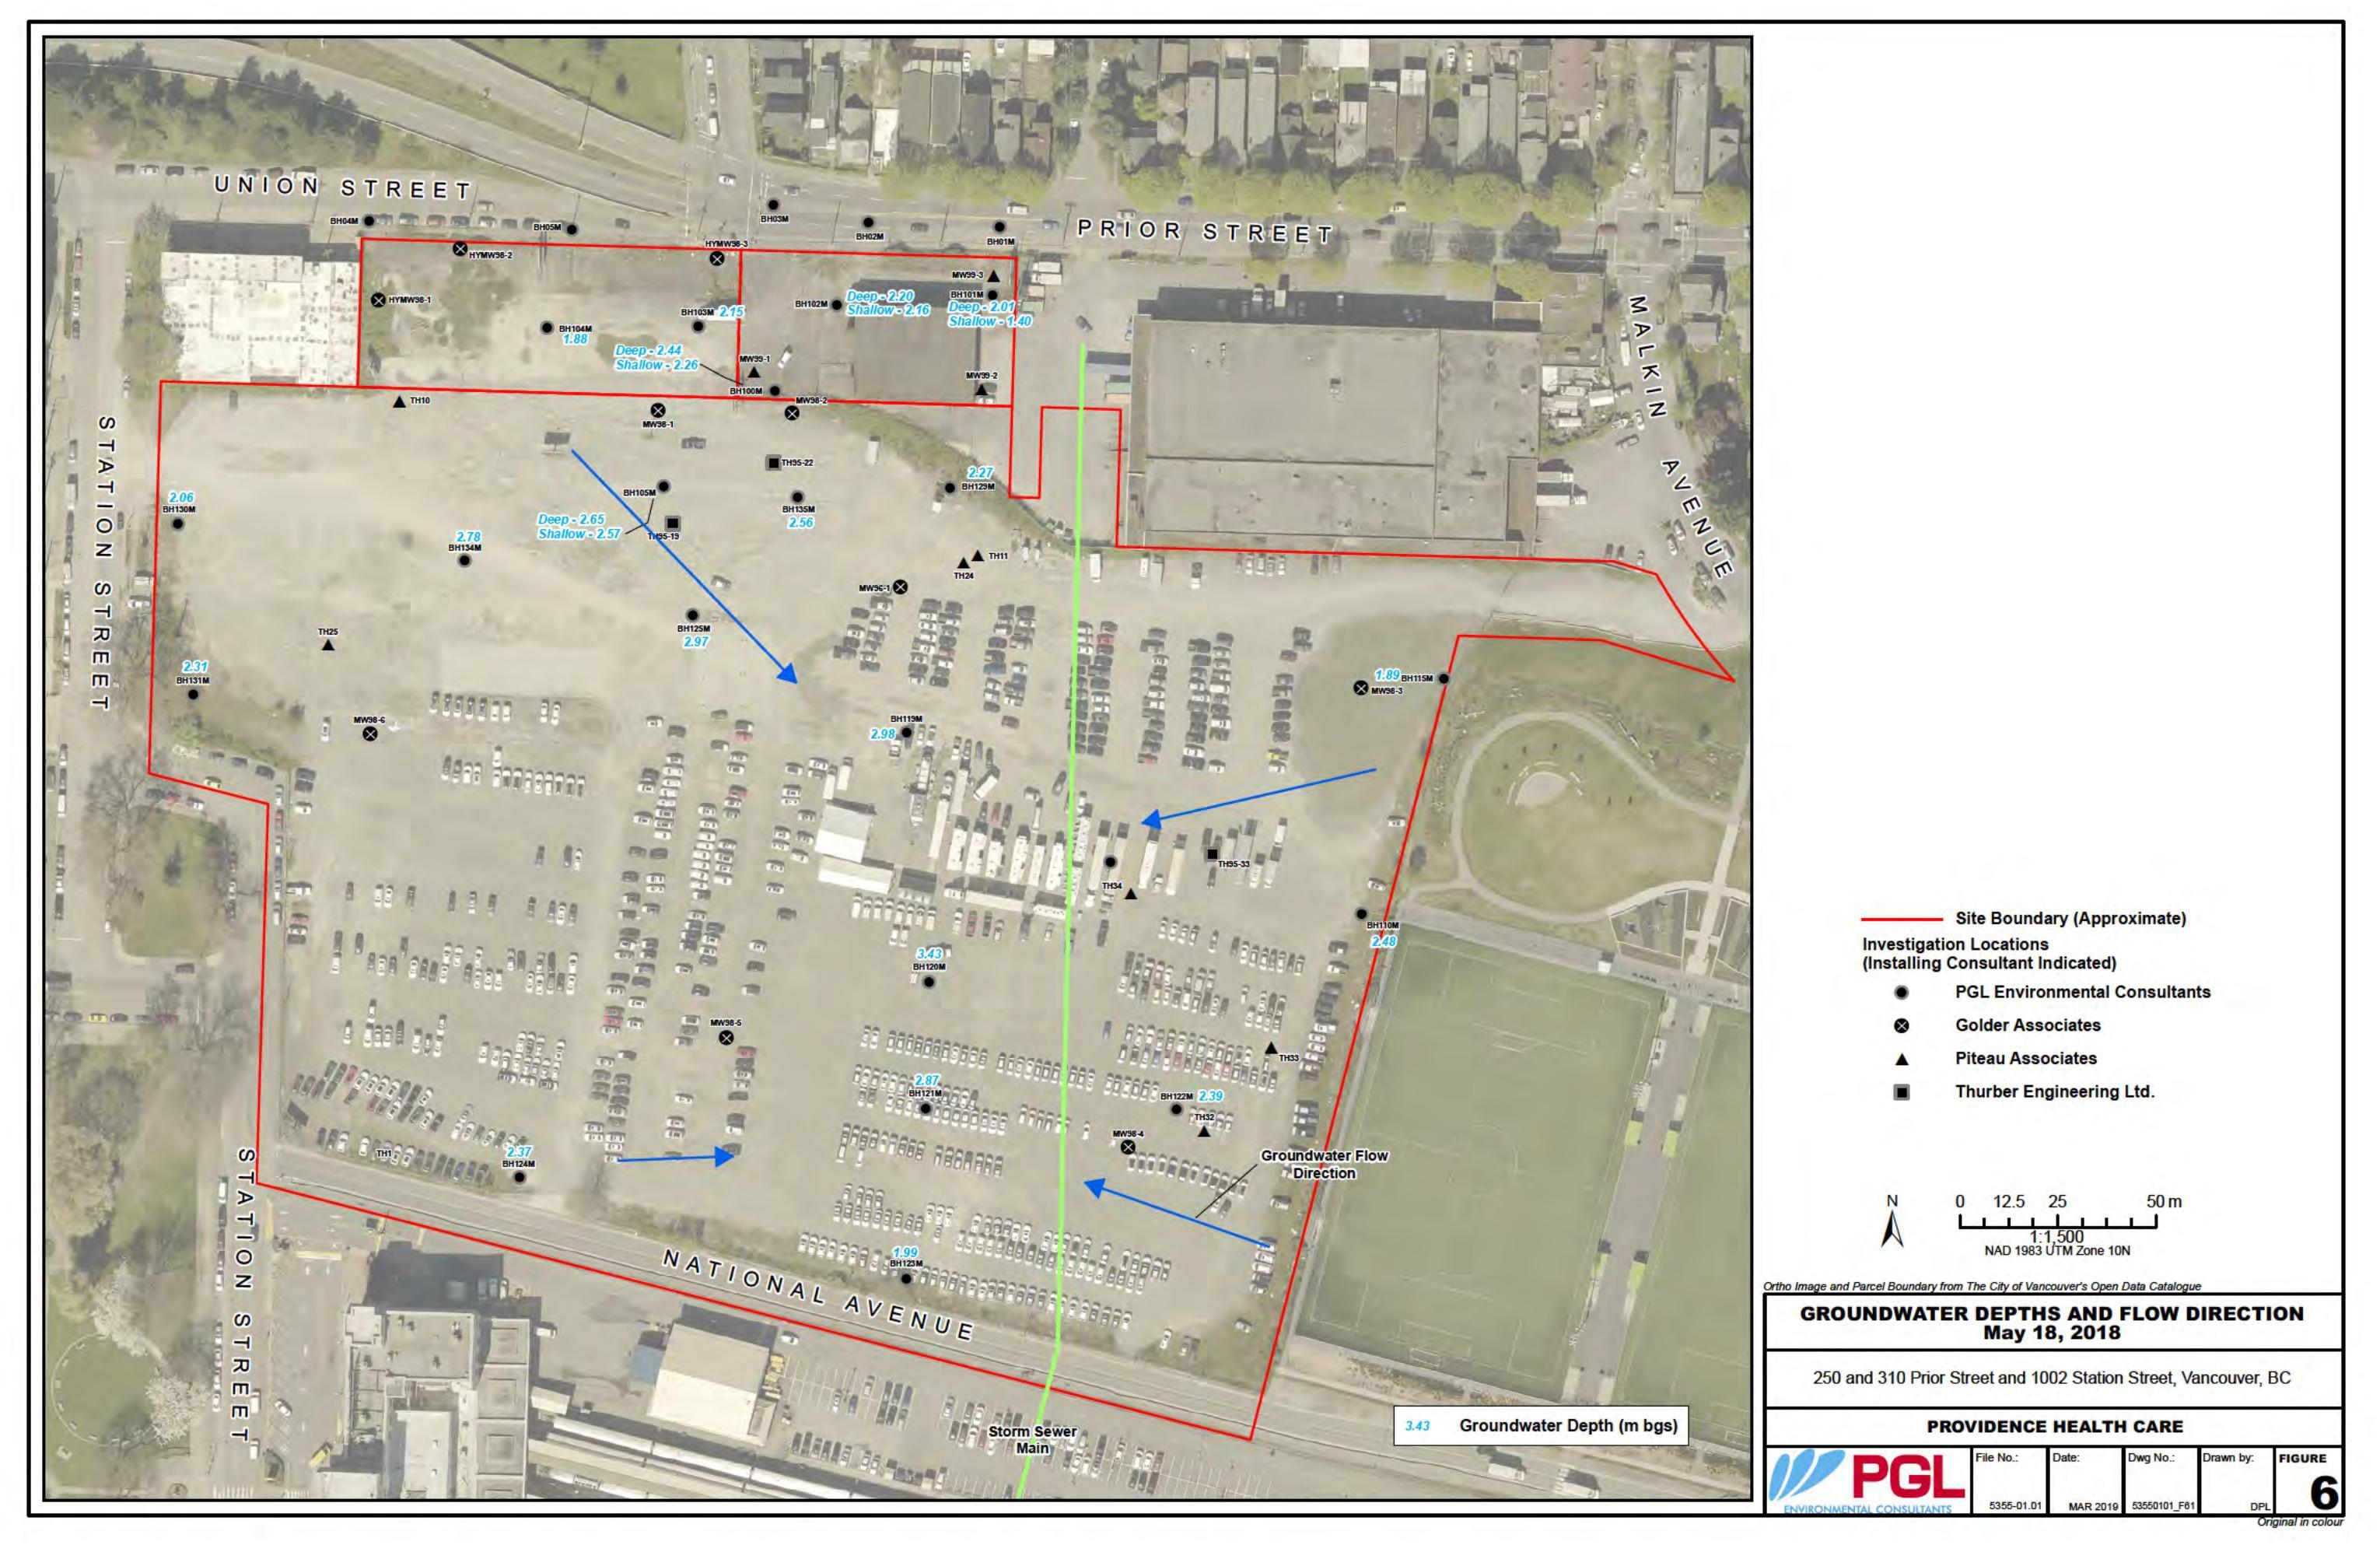
Groundwater elevations were measured at groundwater-monitoring wells on the Site (Figure 6 and associated table). Measurements indicate a static water table around 2m below grade. Relative water table elevations indicate that shallow groundwater is drawn towards the storm sewer running through the centre-east of the Site. Generally, groundwater is expected to flow south through the infilled area of the False Creek Flats around the denser glacial till formation to the west, then move west and discharge into False Creek. Hydraulic gradients in the filled area of the False Creek Flats are very low unless they are locally influenced by utility trenches.

We monitored groundwater levels in May 2018 and February 2019 (Table for Figure 6). Groundwater levels were similar with February levels being slightly higher. We reviewed Golder's monitoring data from 2001 through 2014 (Appendix 5). Groundwater levels were like those observed by PGL, with levels being lower in the summer and higher in the winter.
