GEOTECHNICAL COMMENTS ON CAUSES AND FACTORS CONTRIBUTING TO COLLAPSE OF WEST EXCAVATION SHORING

Proposed Development
138 East 8th Avenue
Vancouver, BC

Our File: 120-4694

March 31, 2020

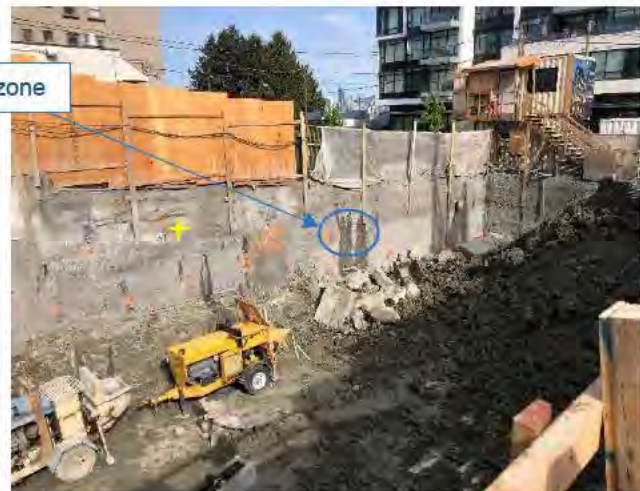
Photo 4B: West Elevation seepage - May 9, 2019

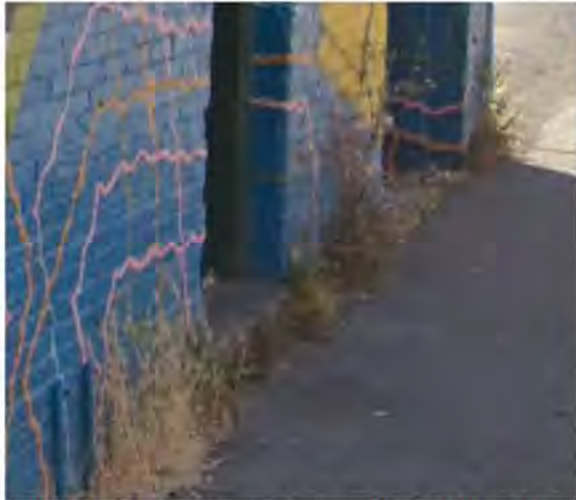
In plan, based on the video referenced in Section 2.2.16, for which select still shots are provided (Photos 11 to 13, Page 14), the collapse initiated at the mid portion of the north-south length of shoring. It is noted that this same north-south mid-point is the location of maximum deformation in the lane to the east of the site, as evidenced by a comparison between 2018 Google Imagery and 2020 conditions.

Photo 19: Google street view, July 2018 east side of lane east of Development Site

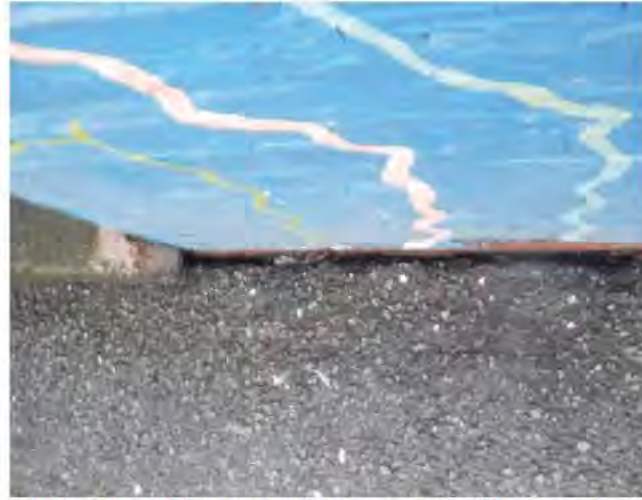
Photo 20: February 6, 2020 east side of lane east of Development Site

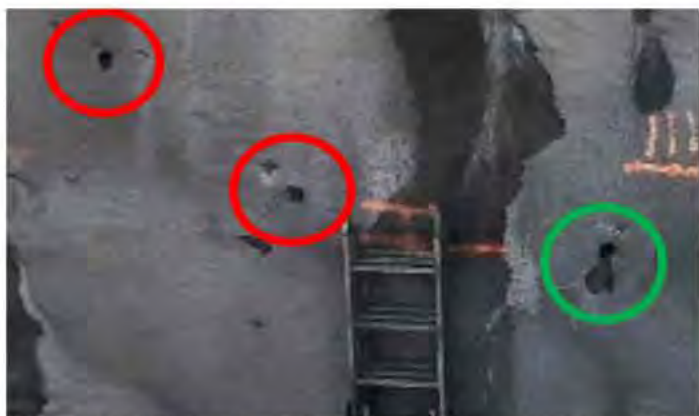
Photo 4: Zoomed Photo 2, showing non functional weepholes versus a weephole showing signs of seepage

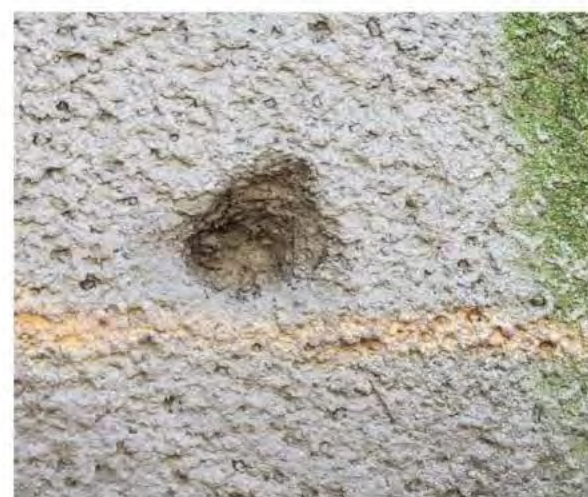
Photo 5: Example of non functional weephole (weephole located on North Elevation)
