ENVIRONMENTAL REVIEW AT EVERETT CROWLEY PARK

(FORMER KERR STREET LANDFILL)

October 22, 2014

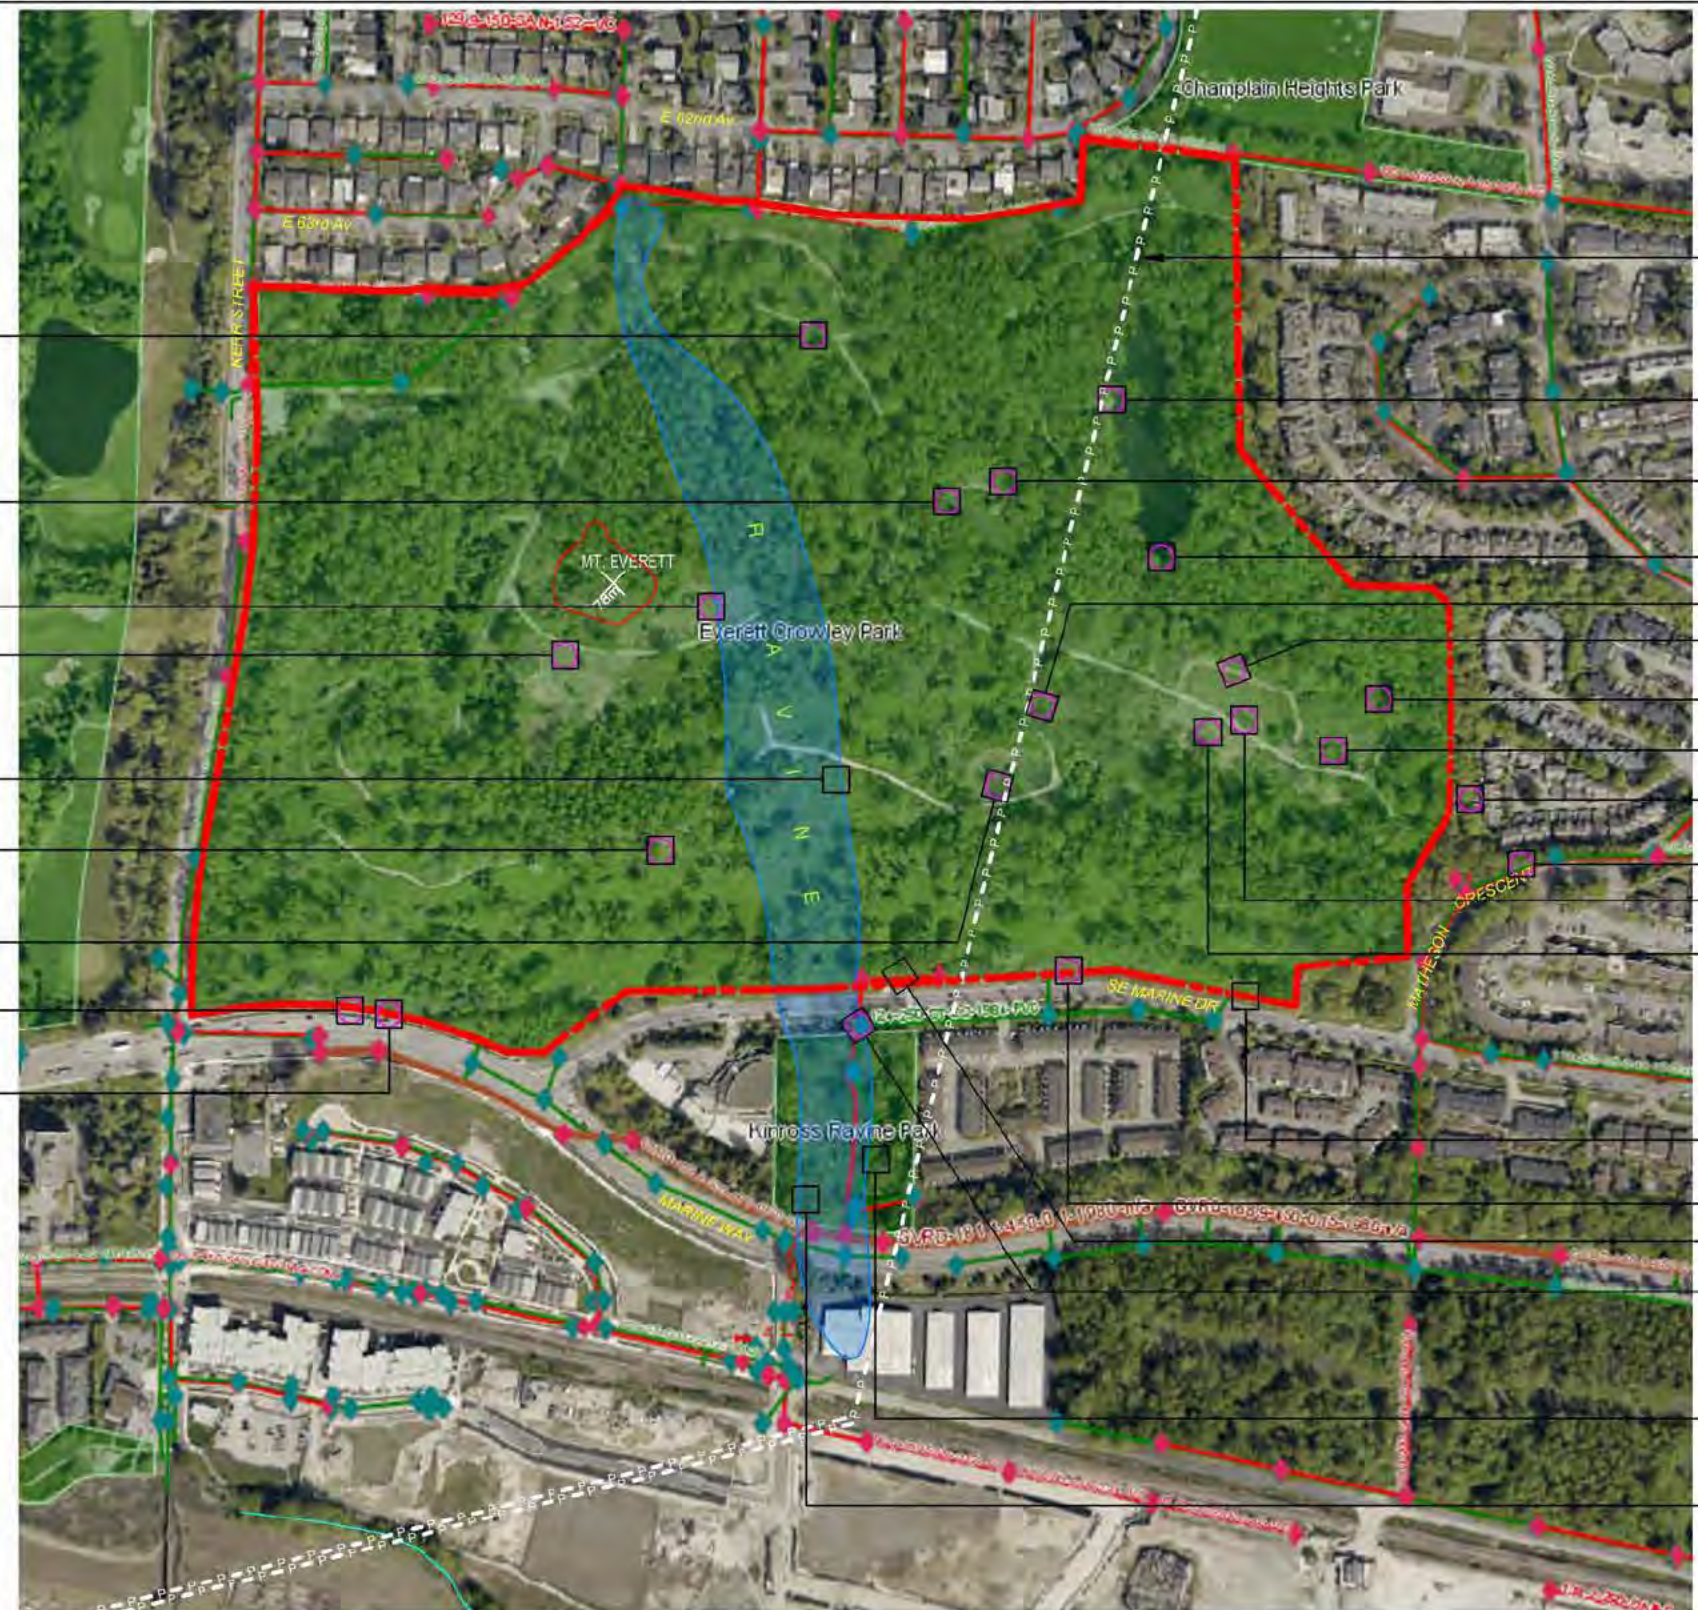
SITE LOCATION: 8200 Kerr Street Vancouver, BC	DATE: 2014-07-31	SCALE: 1:5,000	DWG. No: 002
---	------------------	----------------	--------------

Groundwater seeps were not readily visible in the areas walked throughout the Site. However, several were observed along Marine Drive at four (4) locations. An intermittent swale was also observed along Marine Drive with standing water observed within. The seeps and swale (with water) locations are noted on Drawing VAN6044-14-002 and are as follows:

A: - a 2 m length of steel culvert (poor condition) was observed with stagnant water.

B: - an area of cattails and swale was observed east of former Kinross Creek Ravine.

C: - swale area was observed adjacent to bus stop within area of former Kinross Creek Ravine.

D: - an area of approximately 50 m in length adjacent to sidewalk on the north side of Marine Drive was observed including what appears to be an interception drain based on gravel at surface and a number of catch basins.

Seeps B to E were rust coloured indicating iron precipitate, typically common of leachate impacts.

A number of potential gas venting areas in the eastern portion of the Site (presented on Drawing VAN6044-14-002) were observed. These areas were targeted based on the report review, anecdotal information, field visit and the park map located at the Kerr Street and the Matheson entrances. Of note:

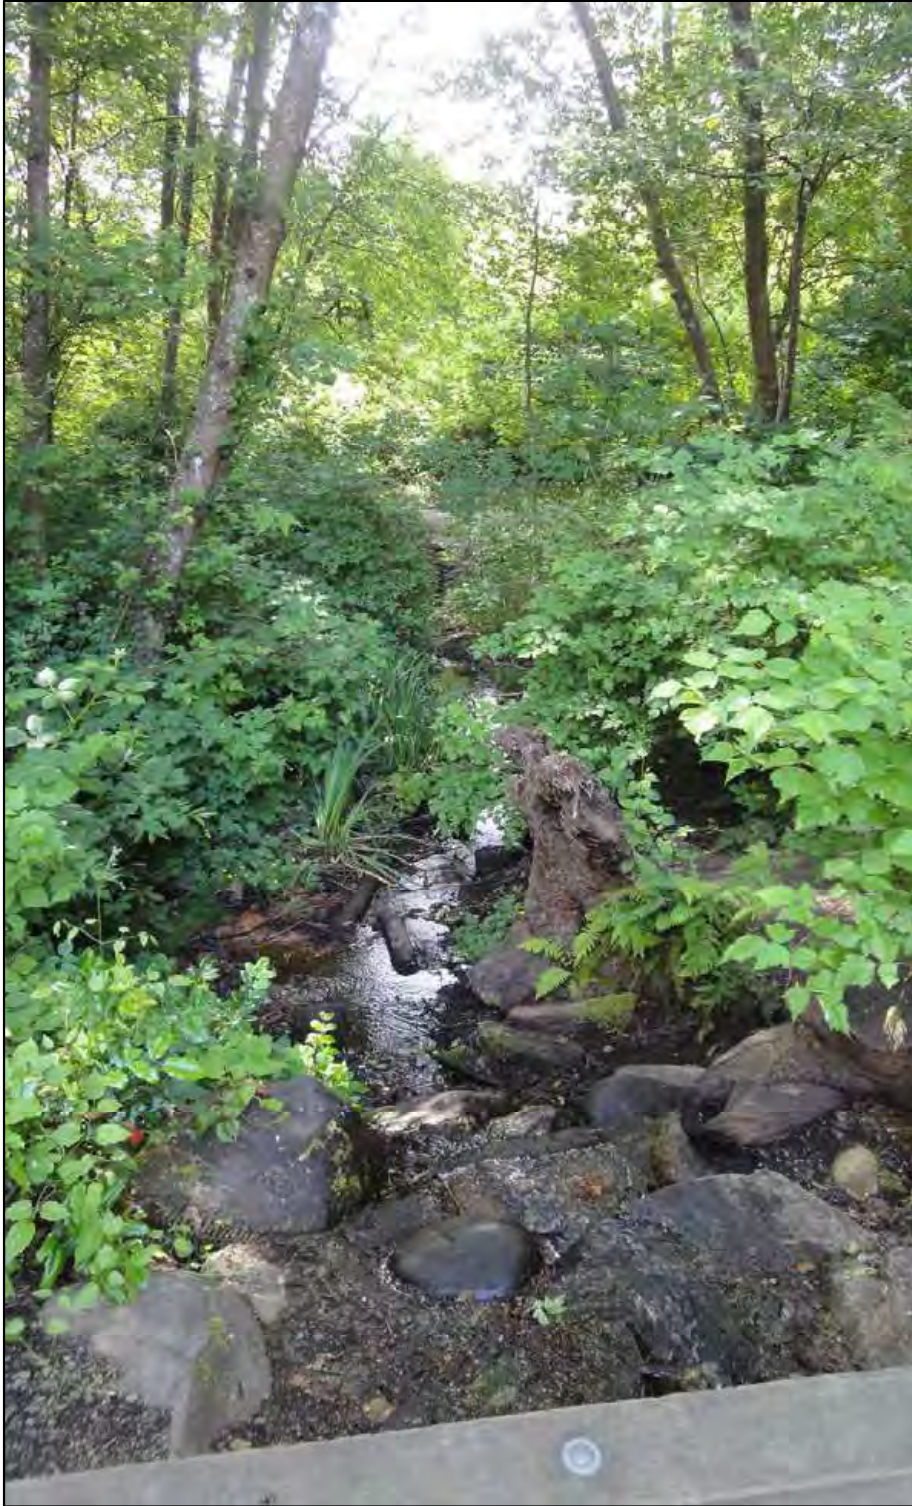
PHOTO 8: Looking downstream from foot bridge at southern discharge end of Avalon pond.
(June 12, 2014)

- At the discharge point from Avalon pond, minor iron staining was observed along the creek bank (photograph 9)
- Approximately 170 m downstream of Avalon pond, the creek was inspected and landfill garbage (concrete, old tubing, refuse) was visible along the exposed face of the western creek bank. No garbage

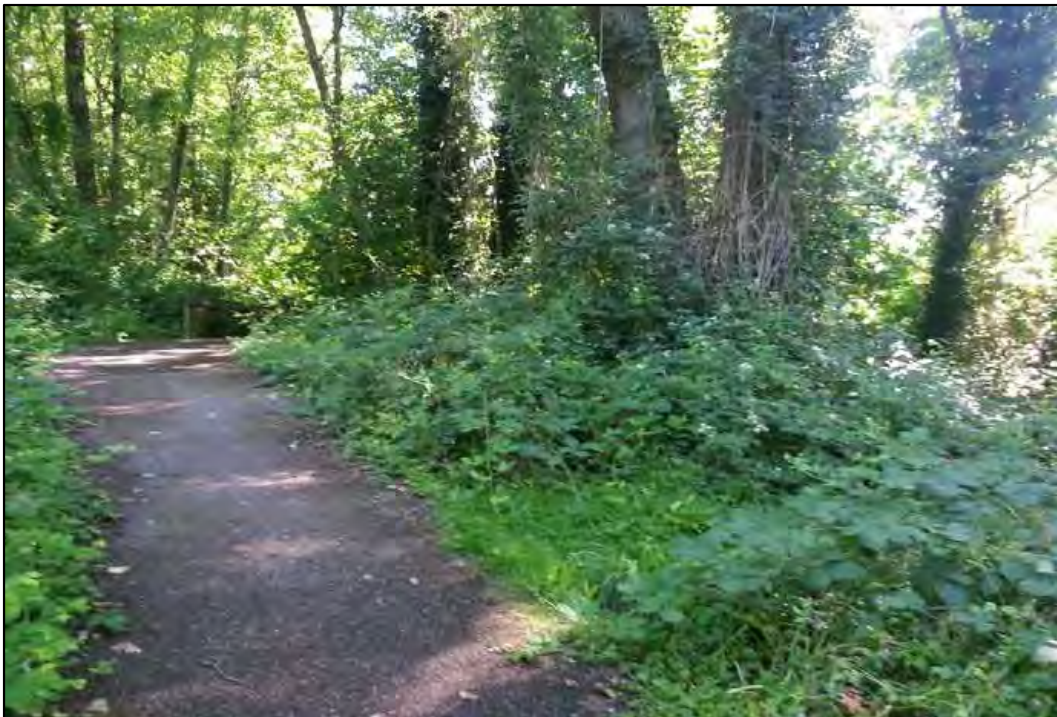
PHOTO 37: Location of storm drain in reference to footbridge over New Kinross Creek. (June 30, 2014)

E: - A seep was noted on Matheson Crescent (Photographs 34 and 35) in close proximity to where New Kinross Creek discharges into a storm catchment drain (Photograph 36) and then likely into the City storm sewer system.
