**Record of City studies regarding a building condition assessment of 2294 W 10<sup>th</sup> Avenue (completed approximately April 2020), including:**

## CA Report

### SOCL\_6485\_2294 W 10th Av

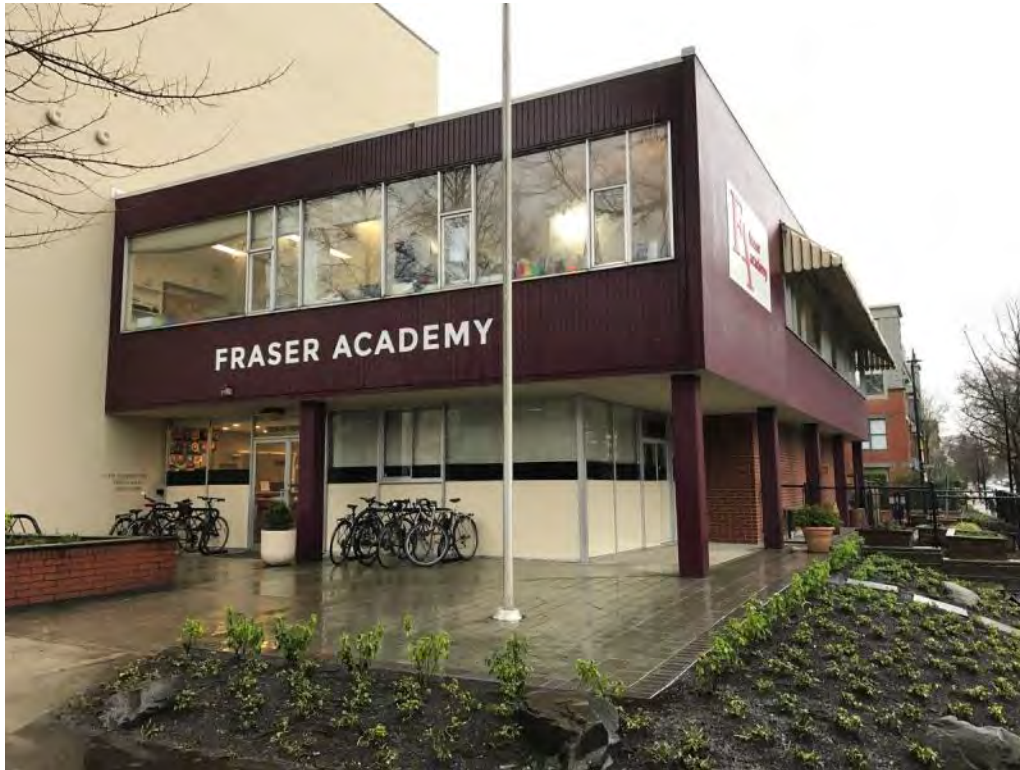
<b>Facility Portfolio</b>	Yes
<b>Address</b>	2294 W 10th Av
<b>ModelType</b>	Building
<b>Size</b>	25,000 Sq.Ft.
<b>Site Size</b>	0.00 Sq.Ft.
<b>Construction Year</b>	1955
<b>Template</b>	Office
<b>Replacement Cost</b>	\$6,065,000
<b>Floor Above Grade</b>	4
<b>Divisional Units</b>	0
<b>Description</b>	The building is an approximately 25,000sf, five storey building with a basement (East Wing) and two story building (West Wing) constructed circa 1955. The building is primarily used as a school.

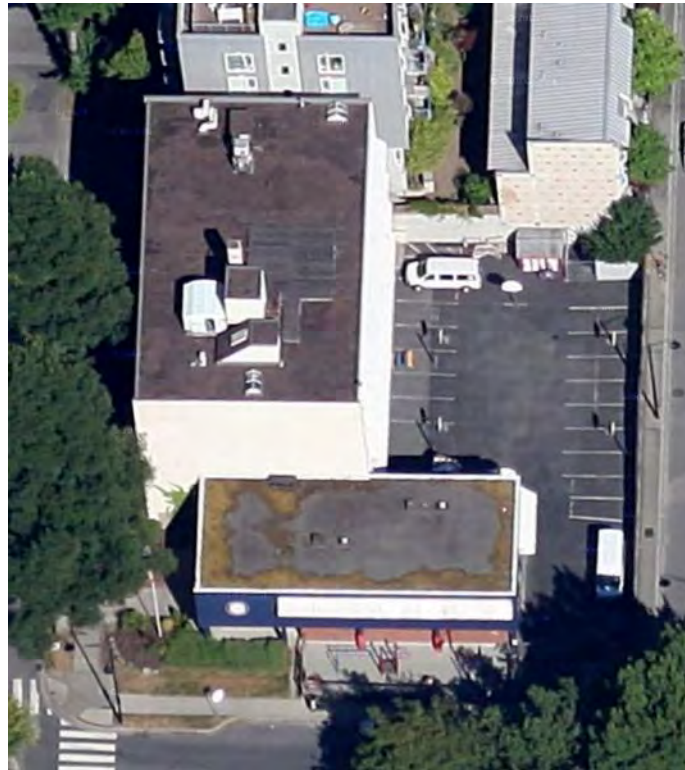
### SOCL\_6485\_2294 W 10th Av - Site

<b>Facility Portfolio</b>	Yes
<b>Address</b>	2294 W 10th Av
<b>ModelType</b>	Site
<b>Size</b>	18,544 Sq.Ft.
<b>Site Size</b>	0.00 Sq.Ft.
<b>Construction Year</b>	1955
<b>Template</b>	Fully Developed Site <150k
<b>Replacement Cost</b>	\$403,331
<b>Description</b>	The building is located on an approximately 18,544 sq.ft. site which generally includes an asphalt paved parking area, concrete walkways, trailers, rubber flooring, wood fencing, basketball hoops and chain?link fencing.
