Subject: Update - media reports re debris falling from Granville Bridge

I am writing in follow up to recent media attention to reports regarding concrete debris falling from the Granville Bridge. In brief, Engineering staff and external consultants have determined that the debris identified by David McCann, general manager of Creekhous Industries, did not actually originate from the bridge itself.

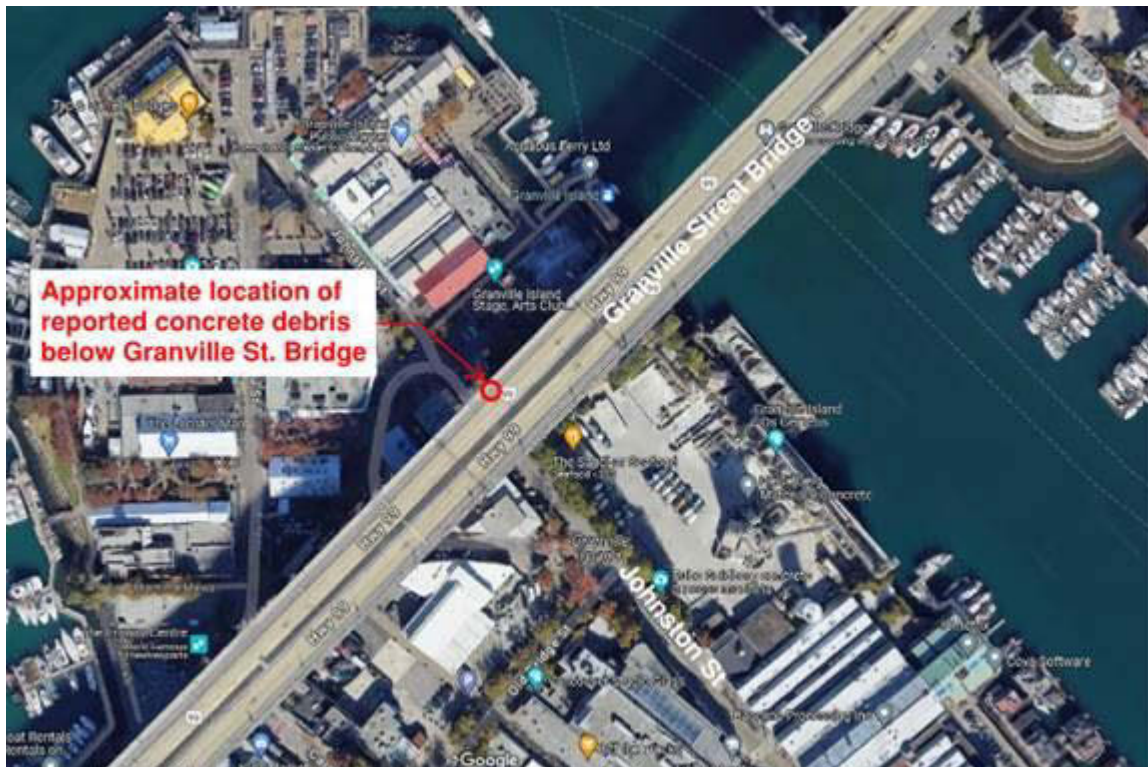
- The approximate location of the concrete debris found by Mr. McCann is shown in Figures 1 & 2 below, west of Creekhous shops (circled in red):

Figure 1 – Map of approximate location of reported debris
