**Regarding the March 29, 2024 derailment of the Stanley Park Train, record of the incident report, repair report and colour photographs of the damage and the incident site.**

**Doc #:** 23-080-MEMO-002

**Re:** 2024-03-29 Incident Response

**TECHNICAL FIELD REPORT****Our File:** V83290**Inspection Date:** 2024-04-09**Purchase Order:** Pay by Visa**City of Vancouver**955 Evans Avenue  
Vancouver, BC V6A 4C8Attention: Ms. Rosemary Yip  
Owner: City of VancouverInspection of Chance Train components  
Location: 250 West 70th, Vancouver

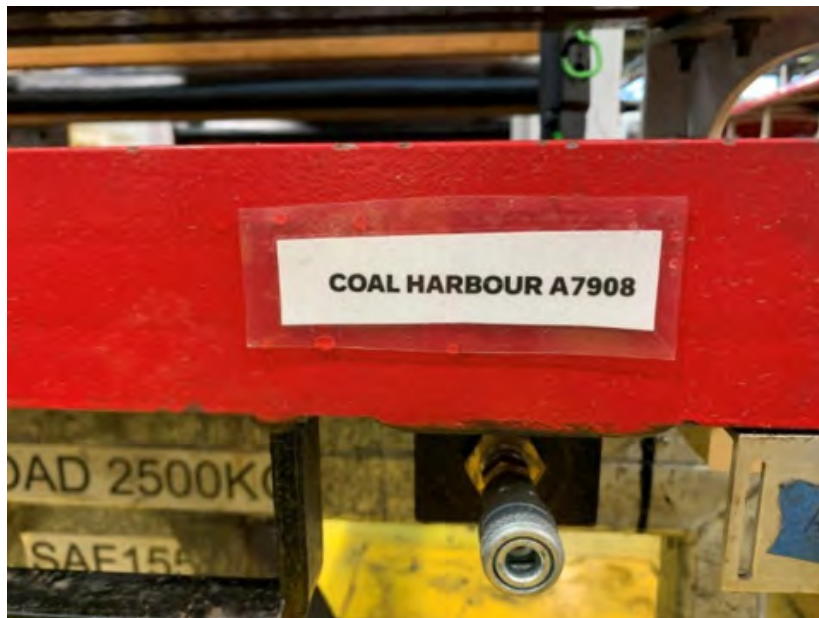
Figure 1: Coal Harbour Carriage ID

1. Carriage Frame & Base Platform (Coal Harbour - A7908) (3.2) - no defects noted.
2. Railing & Roof Support (3.3) - no defects noted.
3. Bogie #4:
  - Fasteners (3.4) - no defects noted.

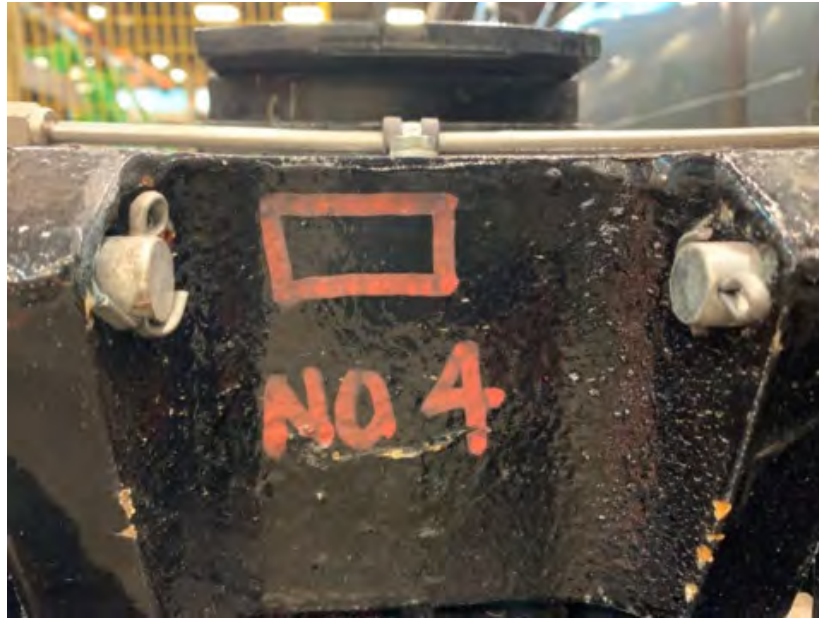
Figure 3: Bogie #4 ID

- Truck Structure (3.5) - no defects noted.
  - Wheels (3.6) - no defects noted.
  - Axels/Shafts (3.7) - no defects noted.
  - Suspension (3.8) - no defects noted.

- Wheels & Suspension Hardware (3.9) - no defects noted.
  - Brake Lever Arms & Links (3.10) - no defects noted.
4. Bogie #6:
  - Fasteners (3.4) - no defects noted.

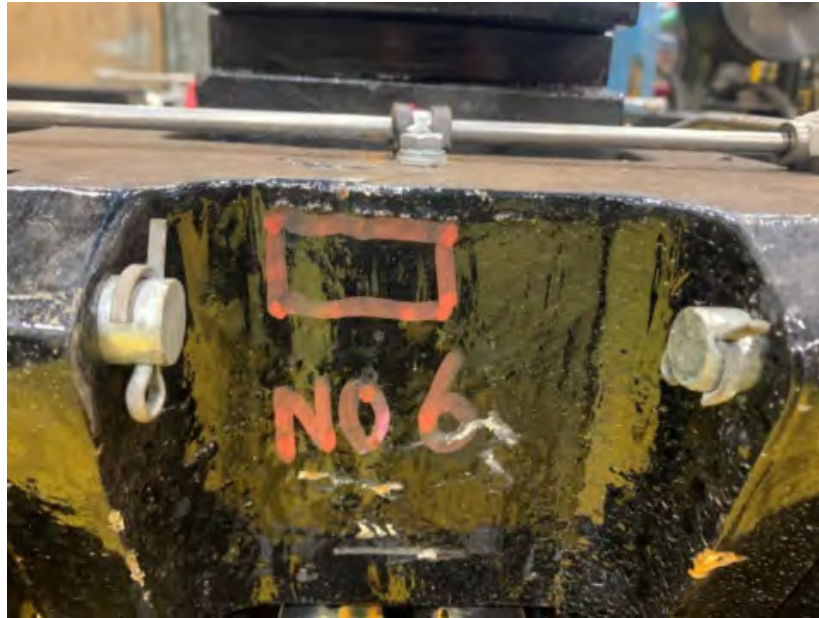
Figure 5: Bogie #6 ID

- Truck Structure (3.5) - no defects noted.
  - Wheels (3.6) - no defects noted.
  - Axels/Shafts (3.7) - no defects noted.
  - Suspension (3.8) - no defects noted.

- Wheels & Suspension Hardware (3.9) - no defects noted.
  - Brake Lever Arms & Links (3.10) - no defects noted.
5. Hitch Bars (3.11) - no defects noted.
