File No.: 04-1000-20-2024-328

May 7, 2014

RE: Arborist Report for Henriquez Partners Architects - For property located at 1040 West Georgia St., Vancouver, BC

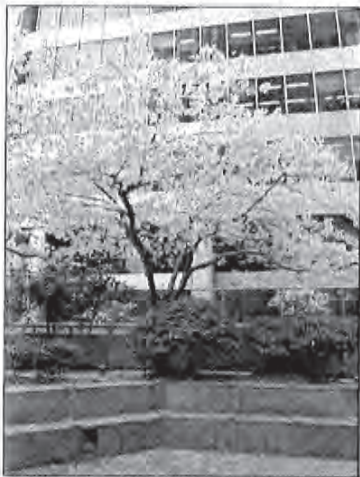
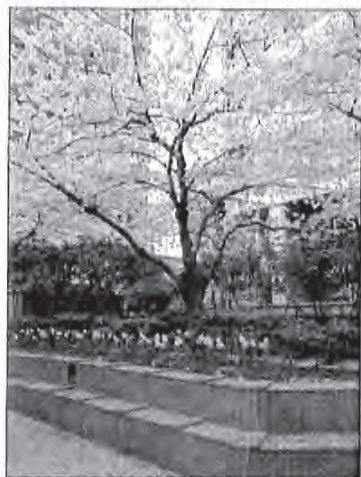
<u>TREE #</u>	<u>SPECIES</u>	<u>DBH</u> (cm)	<u>HEIGHT</u> (m) est.	<u>CRZ</u> radius (ft.)	<u>OBSERVATIONS & RECOMMENDATIONS</u>
1	Cherry <i>(Prunus sp.)</i>	35			<p>These trees all present the same characteristics and issues; they have been previously topped, there is extensive canker on the limbs throughout the canopy, there is evidence of Tortrix borer (especially at the graft site), and there is twig dieback also throughout the canopy. They all have wide-spreading canopies which is typical of the species; trees #1 and #2 have been trimmed back on the west side to reduce the overhang into the ramp for the parking entrance.</p> <p>All of these trees are situated within a raised planter that is reported to be about 3ft deep; the walls of the planter are generally 4ft to 7ft on two sides of each tree, except Tree #5 has less than 2.5ft on two sides.</p> <p>RECOMMENDATIONS: The feasibility of relocating these trees was questioned. Based on their declining health they would not be good candidates for relocation; these trees are over 30 years old and their confined environment has likely contributed to the issues they now present. The wide-spreading canopies would have to be cut back hard in order to relocate them. It is very doubtful they would survive being relocated, due to hard pruning that would be necessary, the inevitable root disturbance that would occur, and due to their obvious declining health; for this reason removal is being recommended. Remove trees to enable the site development or the necessary membrane replacement.</p>
