Expo Deck Deconstruction - Scoping Study

City of Vancouver

30 May 2023

Reference: Science World – City Heavy Deck – Condition Assessment and Options for Rehabilitation

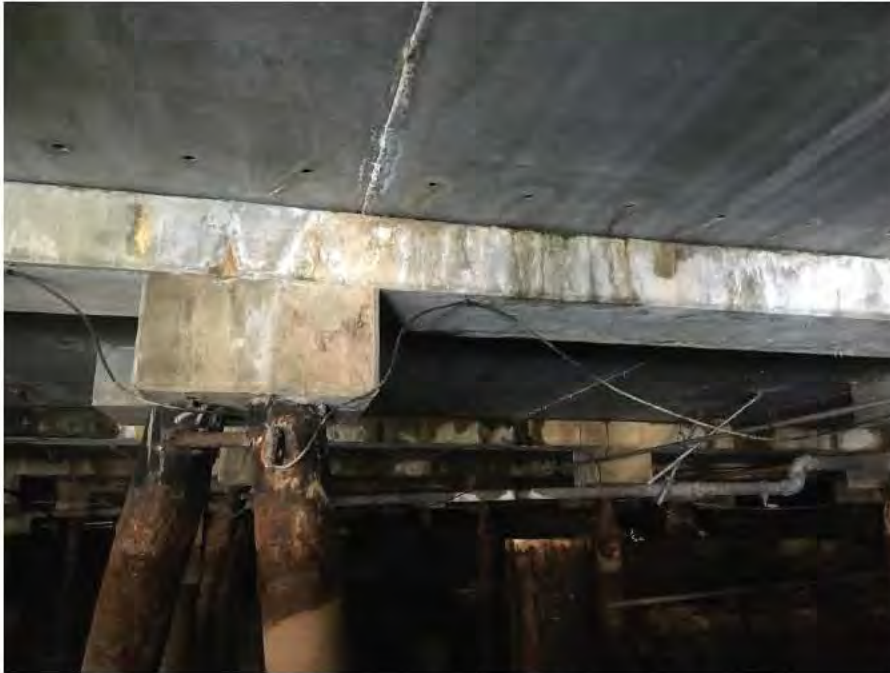
The section of the City Heavy Deck located to the southeast of Science world is supported on steel pipe piles. At this location, there is widespread damage to the pipe coating (Photograph No. 1) with water ingress between the coating and the steel pipe (Photograph No. 2). An impressed current system has been installed to protect the steel pipe piles from corrosion (Photograph No. 3).

Photograph No. 3: Impressed current system installed on steel pipe piles at the City heavy deck to the southeast of Science World
