Title: Pre-Demolition Hazardous Materials Survey (Update)  
David Lloyd George Elementary School, 8370 Cartier Street, Vancouver, BC  
Prepared by: **Alliance EHS Consulting Inc.**  
Dated: April 5, 2022

# PRE-DEMOLITION HAZARDOUS MATERIALS SURVEY (UPDATE)

**David Lloyd George Elementary School  
8370 Cartier Street, Vancouver, BC**

**FINAL**  
**REVISED Hazardous**  
**Building Materials**  
**Assessment**

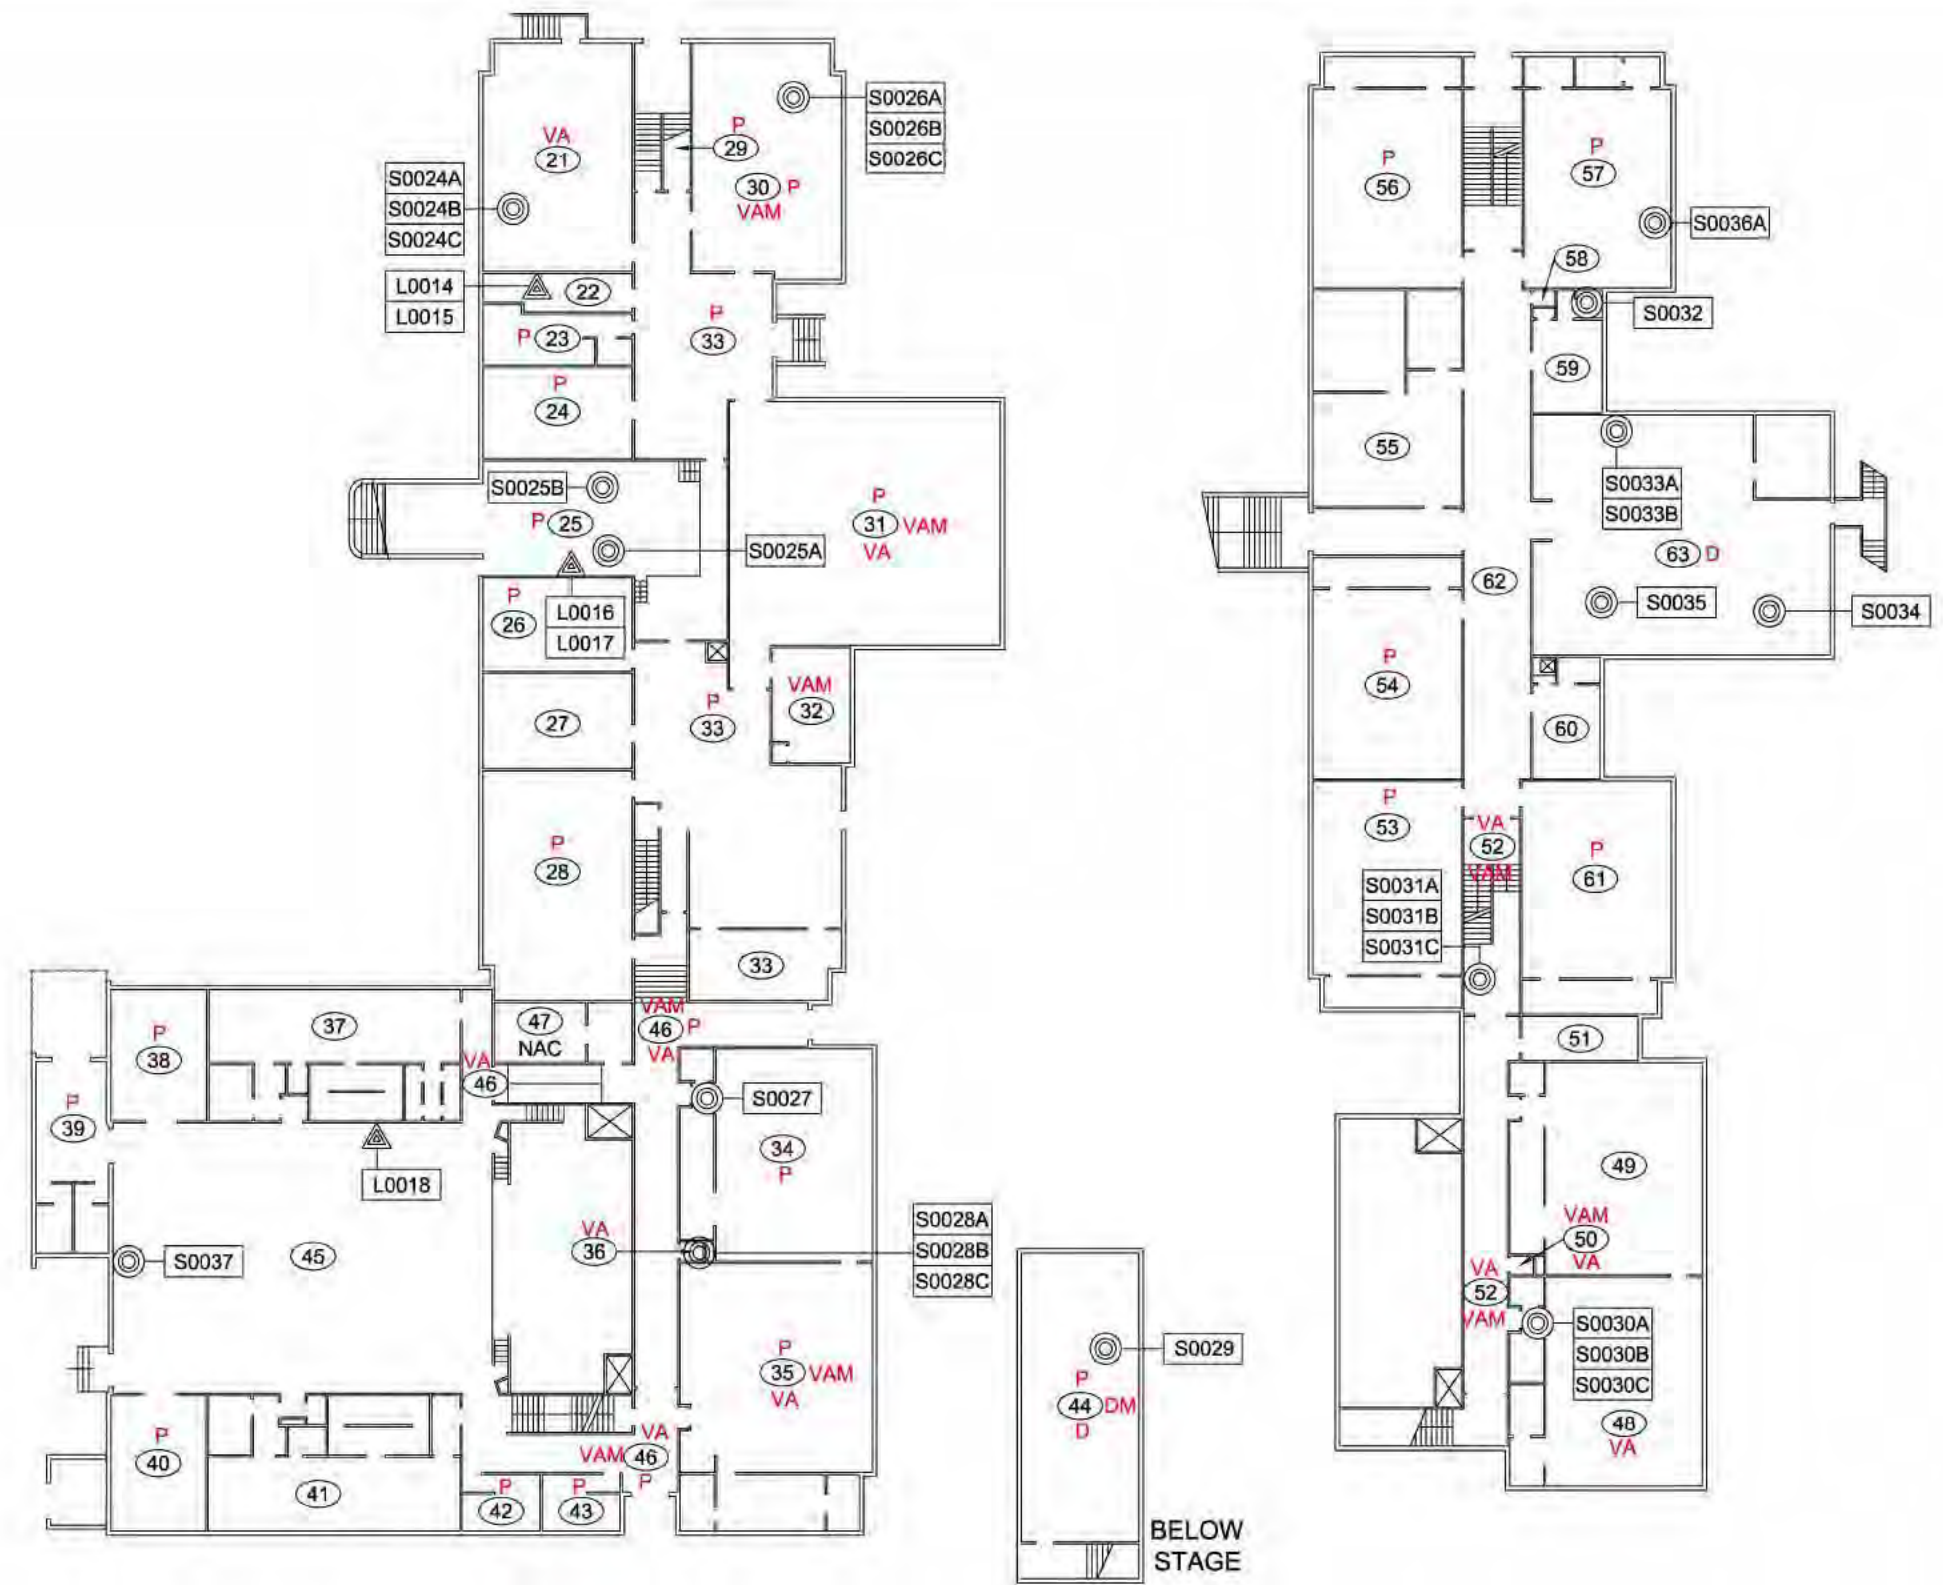
<b>DATE:</b> 2016/05/04	<b>PROJECT #:</b> 12952L
<b>DRAWN BY:</b> PK	<b>DRAWING:</b>  <b>1 OF 2</b>
<b>CHECKED BY:</b> BZ	
<b>SCALE:</b> NTS

- NOTES:**
1. ALL DRAWINGS TO BE REFERENCED WITH THE HAZARDOUS MATERIALS ASSESSMENT REPORT. NOT ALL KNOWN OR SUSPECT HAZARDOUS MATERIALS ARE DEPICTED ON THIS DRAWING. REFER TO THE HAZARDOUS MATERIALS ASSESSMENT REPORT FOR A COMPLETE LIST OF IDENTIFIED HAZARDOUS MATERIALS.
  2. BASEPLAN PROVIDED BY THE CLIENT.
  3. LEGEND IS COLOUR DEPENDENT, PHOTOCOPIES MAY ALTER INTERPRETATION OF FIGURE.
  4. LEAD-BASED PAINT IS PRESENT THROUGHOUT THE BUILDING.
  5. SUSPECT ASBESTOS-CONTAINING TRANSITE CEMENT CHALKBOARDS ARE PRESENT IN CLASSROOMS THROUGHOUT THE BUILDING.
