TITLE:
DAVID LLOYD GEORGE ELEMENTARY
V.S.B. BUILDING No. 17
SECOND & ROOF FLOOR

Project: David Lloyd George Elementary

Project #: 12952L	Site: 8370 Cartier Street, Vancouver, BC	Building Name: David Lloyd George Elementary	Surveyor: Gordon Watkins	Survey Date: 2016-05-02
HAZARDOUS MATERIALS SUMMARY - LEAD (PB) PRODUCTS				
Component	Total Quantity (Estimated)	Location(s)		
LEAD PIPES	30			20

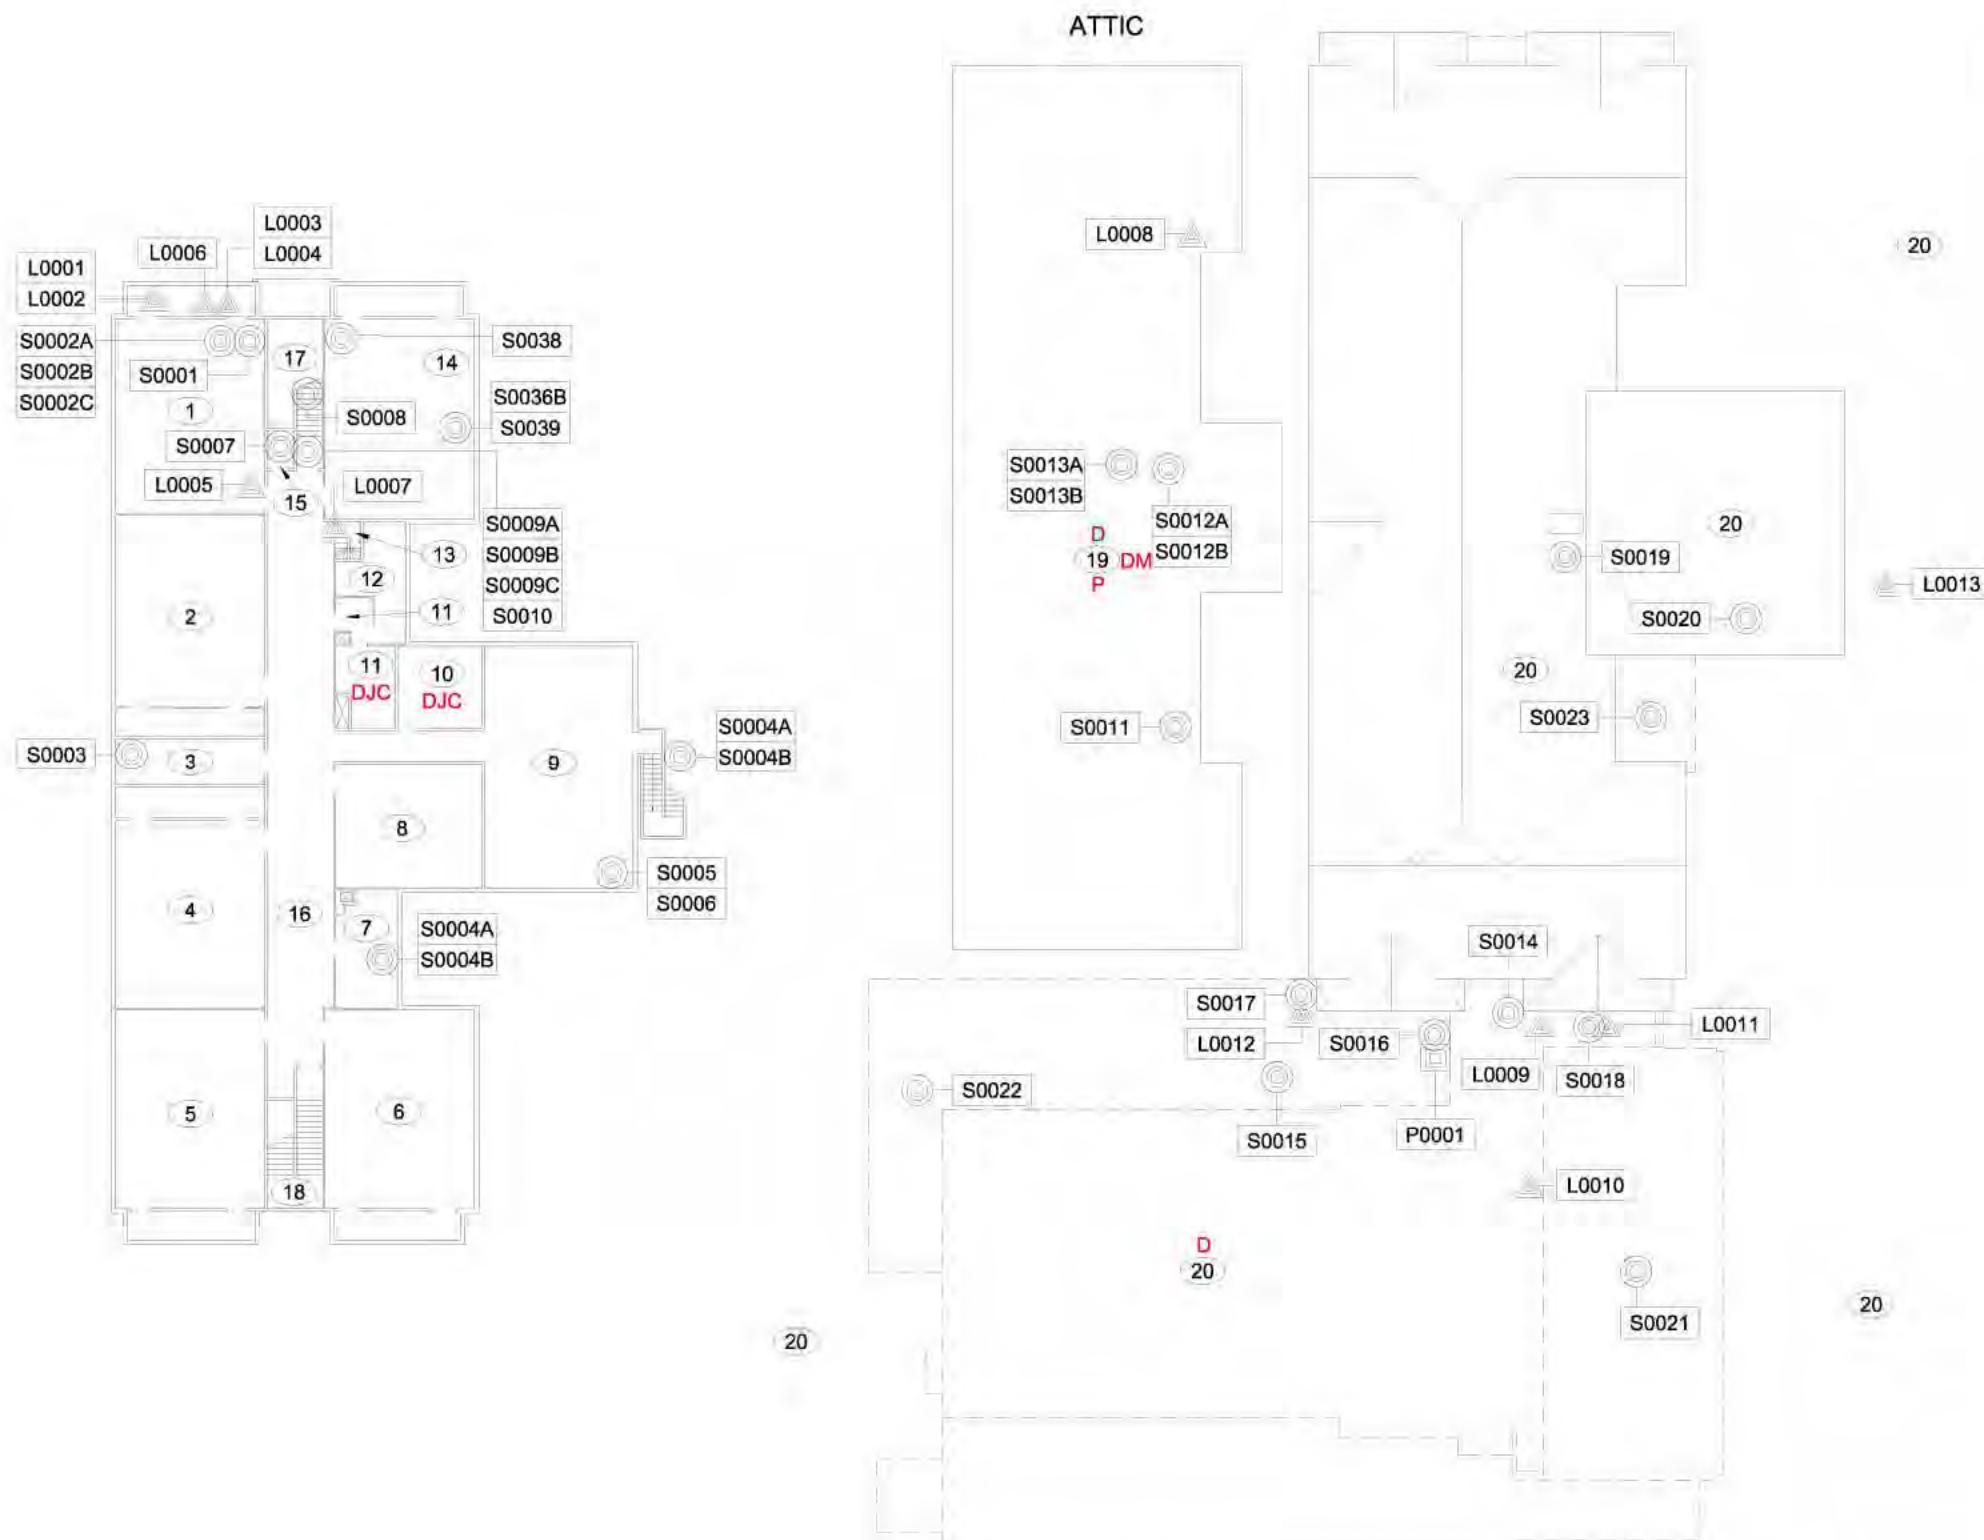
2 OF 2

- ALL DRAWINGS TO BE REFERENCED WITH THE HAZARDOUS MATERIALS ASSESSMENT REPORT. NOT ALL KNOWN OR SUSPECT HAZARDOUS MATERIALS ARE DEPICTED ON THIS DRAWING. REFER TO THE HAZARDOUS MATERIALS ASSESSMENT REPORT FOR A COMPLETE LIST OF IDENTIFIED HAZARDOUS MATERIALS.
- BASEPLAN PROVIDED BY THE CLIENT.
- LEGEND IS COLOR-DEPENDENT. PHOTOCOPIES MAY ALTER INTERPRETATION OF THE DRAWING.
- LEAD BASE PAINT IS PRESENT THROUGHOUT THE BUILDING.
- SUSPECT ASBESTOS-CONTAINING TRANSITE CEMENT CHAUBERBARDS ARE PRESENT IN THE ROOF THROUGHOUT THE BUILDING.
