CITY OF VANCOUVER  
453 West 12th Ave, Vancouver, BC

GEOTECHNICAL ASSESSMENT  
Dunbar Slope, Vancouver, BC

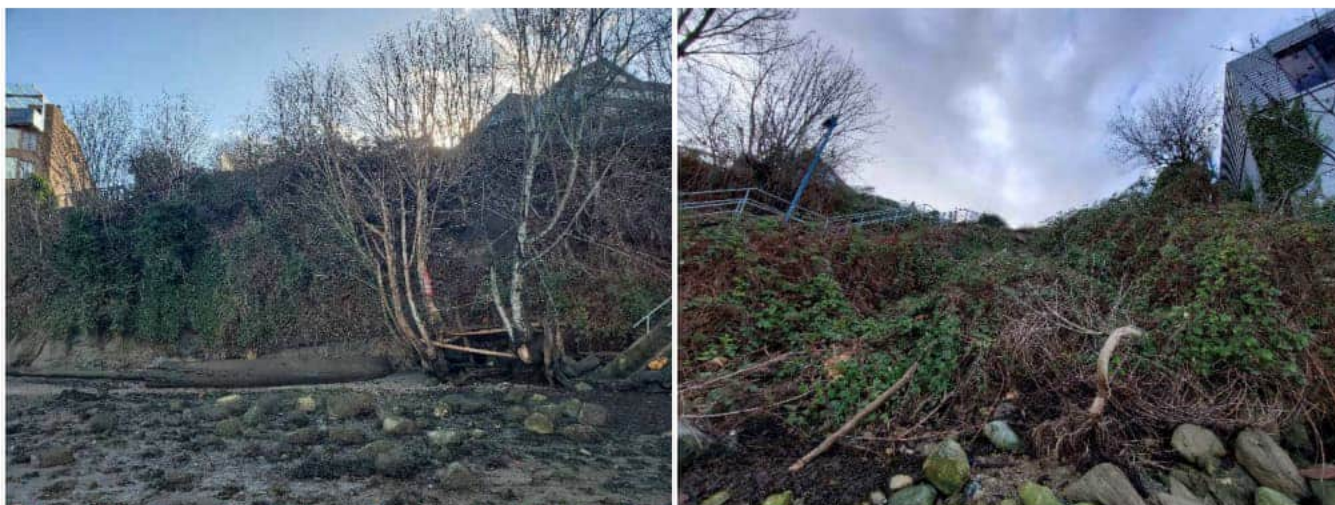
Figure 1. South section (left) and north section (right) of the Subject Area.

The Subject Area is facing northeast and located on a steep slope that leads down from Cameron Ave. to the beach area and is divided by a staircase into north and south sections (Figure 1). Adjacent private properties are 3595 Point Grey Road to the east, 3607 and 3617 Cameron Ave to the north, and 1509 Dunbar St to the southwest. It is located between 0-20m above sea level with a northeast aspect and located within the Coastal Western Hemlock (CWH) Zone of the Biogeoclimatic Ecosystem Classification system of British Columbia (BEC)<sup>3</sup>. The site falls within the Dry Maritime (CWHdm) subzone which is defined by wet winters, relatively dry and mild summers. The site was dominated by red alder (*Alnus rubra*), and bigleaf maple (*Acer macrophyllum*) with some Sycamore maple (*Acer pseudoplatanus*) and beech (*Fagus sp.*). English ivy (*Hedera helix*) and Himalayan blackberry (*Rubus armeniacus*) were the main invasive plant species found throughout the site. Some of the trees are heavily covered by English ivy which would add extra load to the trees on the steep slope.

Trees are mostly on the south section where the slope ranges between 20 (on the crest) to 80%. The soil consists of a thin layer of loamy sand mineral soil mixed with organic matter at different stage of composition over the rock formation (Figure 2, Left). On the north section, adjacent to Cameron Ave, soil profile is thicker (up to 20cm) due to less steep slope which allows the accumulation and development of organic and mineral soil (Figure 2, right). Trees are mostly adapted to the steep slope, low soil content and exposure to wind by growing multiple branches with shorter and well tapered main stem that grows along the slope, as opposed to grow upright (Figure 3, left). A few trees with upright main stem grow on less-steep sites (Figure 3, right). On the north section, there are fewer trees and the ground is covered by invasive plants (Figure 1, right). This section has slightly lower slope (10-65%) compared to the east section.

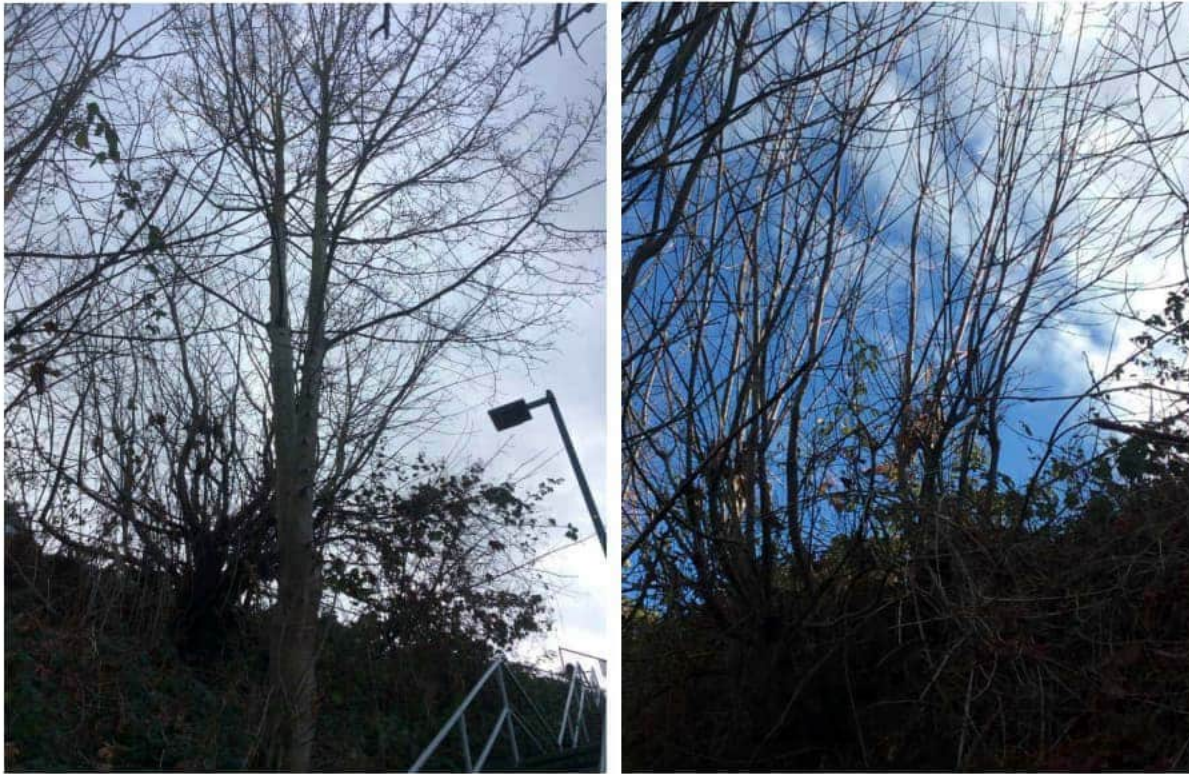
Figure 3. Branchy, short, well-tapered trees on less steep side (left - Tree #11), and steeper side (right – Tree # 12)

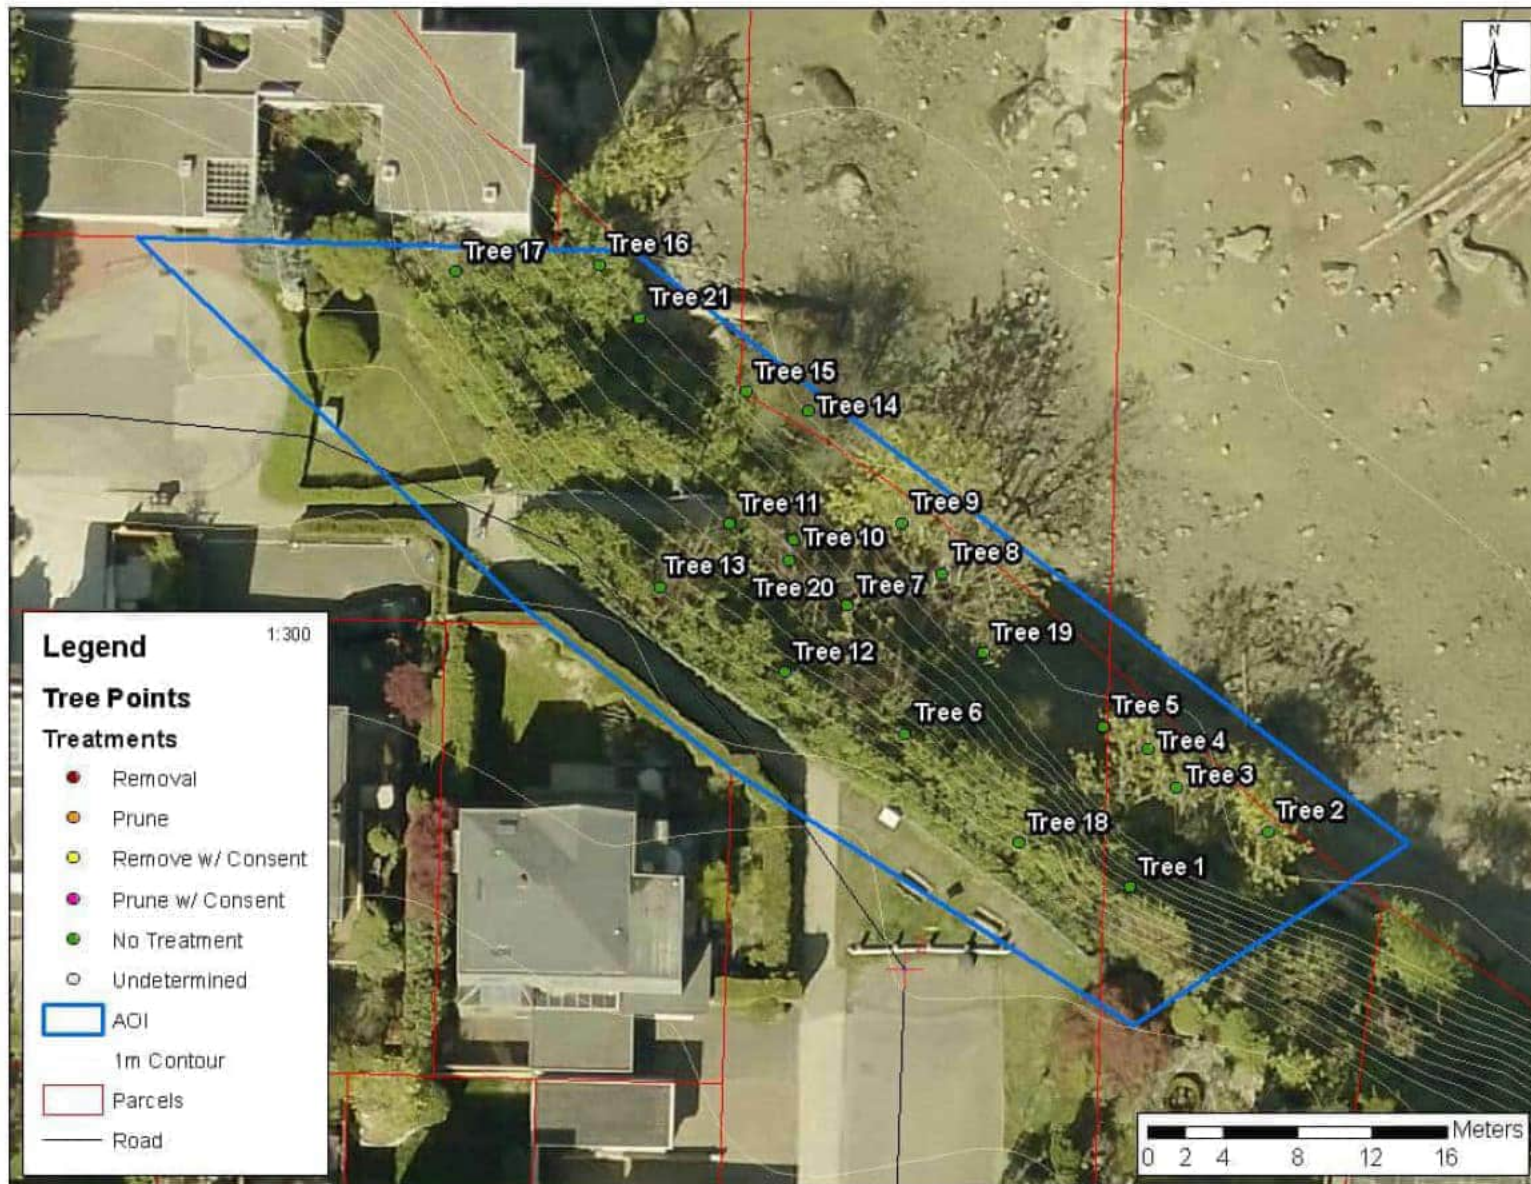
Map 2. Tree Inventory and recommendations

| Tree # | Species<br>(common name) | DBH (cm) | Height (m) | Condition | Comment | Tree Risk Rating | Treatment |
|---|---|---|---|---|---|---|---|
| 14 | Big-leaf maple | 52 | 6 | Poor | 4 stems (28 25 9 8), 1 dead 14cm, exposed roots, bottom of slope | Moderate | Remove one dead stem, re-assess after staircase repair |

Tree# 14 had a rating of “Moderate” as a result of having dead limbs which was recommended for re-assessment after the treatment for the staircase is complete. The risk rating for all inventoried trees within the subject area can be found in the accompanied Tree Risk Assessment Table.
