MAIN POST OFFICE

349 WEST GEORGIA STREET, VANCOUVER, BC

CONSERVATION PLAN

APRIL 23, 2018

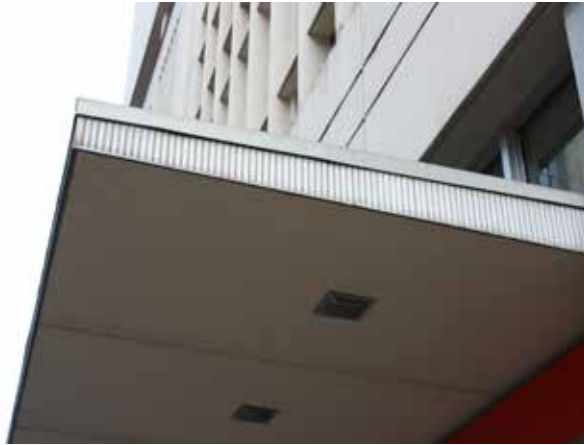
Detail photo of canopy above the secondary storefront entrance on east elevation along Hamilton Street.

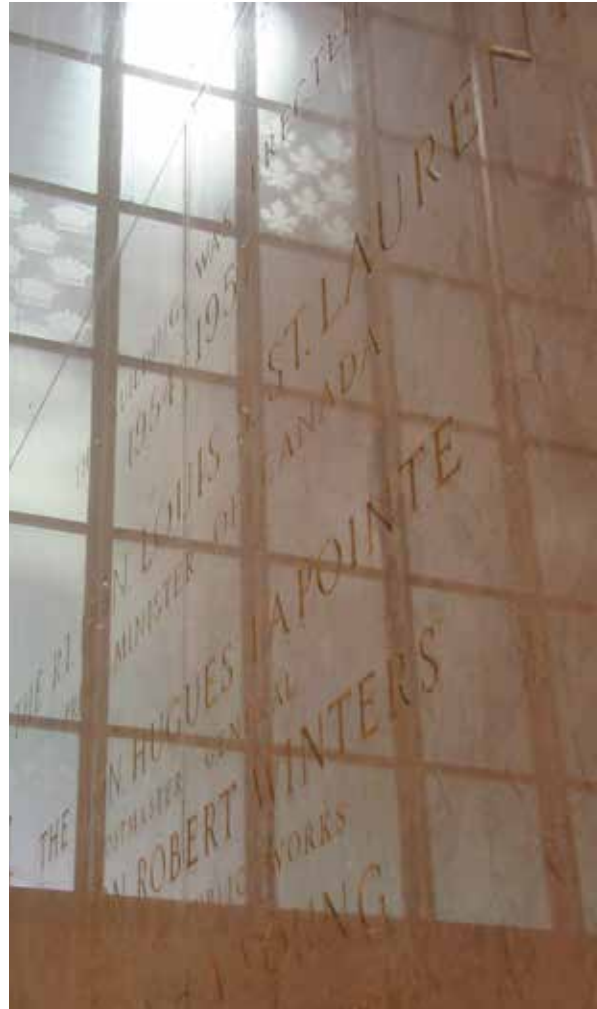
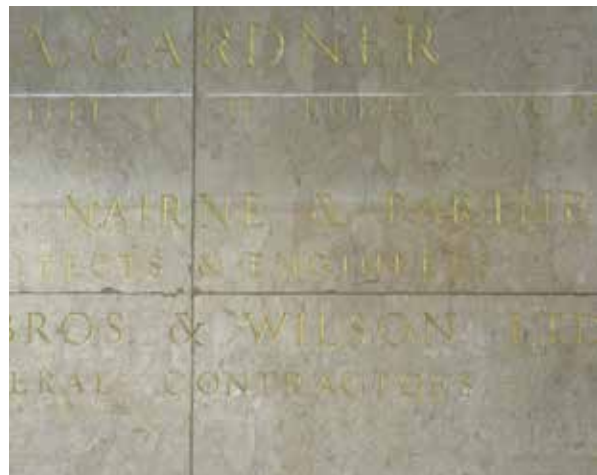
Dedication inscription across four slabs of marble.

- The four slabs of marble bearing the dedication inscription should be relocated to a prominent public area within the new interior space of the Main Post Office.
- The four slabs of marble should not be damaged during removal or relocation, and should be protected from damage for the duration of construction.

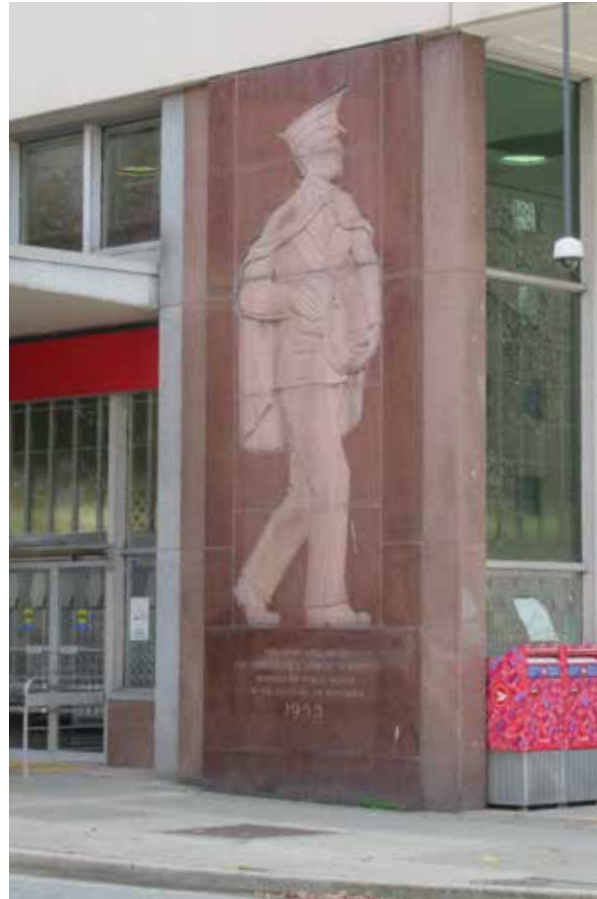
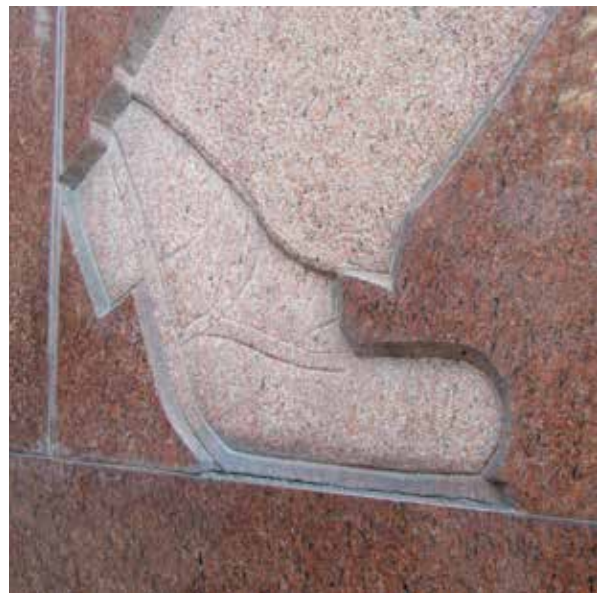
Overall photo (top) of the Postman bas-relief by Paul Huba, and a detail photo (bottom).

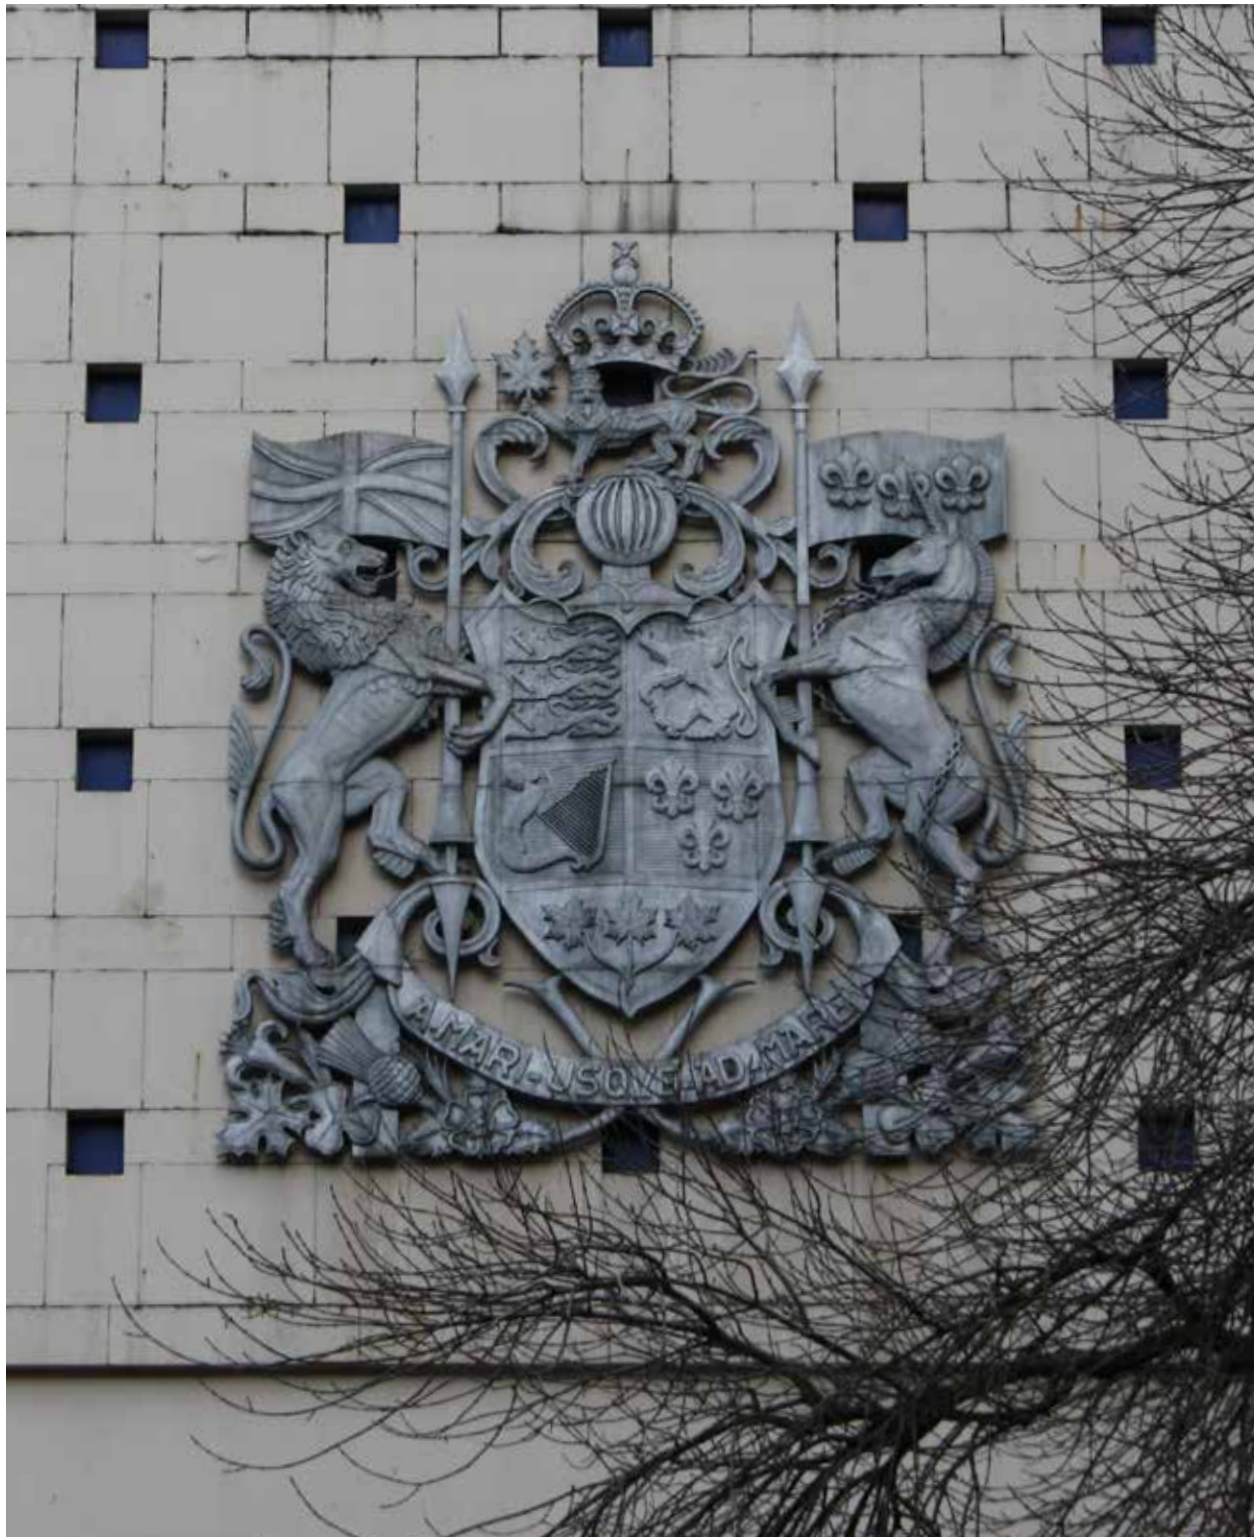
Overall photo of the cast aluminum Arms of Canada cast by Pearson Iron Works on the front facade of the Main Post Office.

- The Arms of Canada should be preserved.
- A professional conservator should be retained to be involved in any conservation work for the Arms.
- The Arms should be cleaned using the gentlest means possible.
- Visually minimal bird control should be implemented to ensure that birds cannot get behind the Arms.
- The Arms should be protected from damage during all stages of construction.
