Subject: 2880 Venables (DP2018-00128) - Review of Lombardy Poplar on West Side of Property

VDZ Project File No.:	PR2016-18
Project Name:	Notre Dame Regional Secondary School
Site Address:	2880 Venables Street, Vancouver, BC
Project Arborist:	Kelly Koome – van der Zalm + associates inc.
Consulting Arborist	Kelly Koome (PN 5962A) Arminder Virk (PN 8443A)

Updated: Arboricultural Opinion
Notre Dame Regional Secondary School
2855 Parker Street, Vancouver

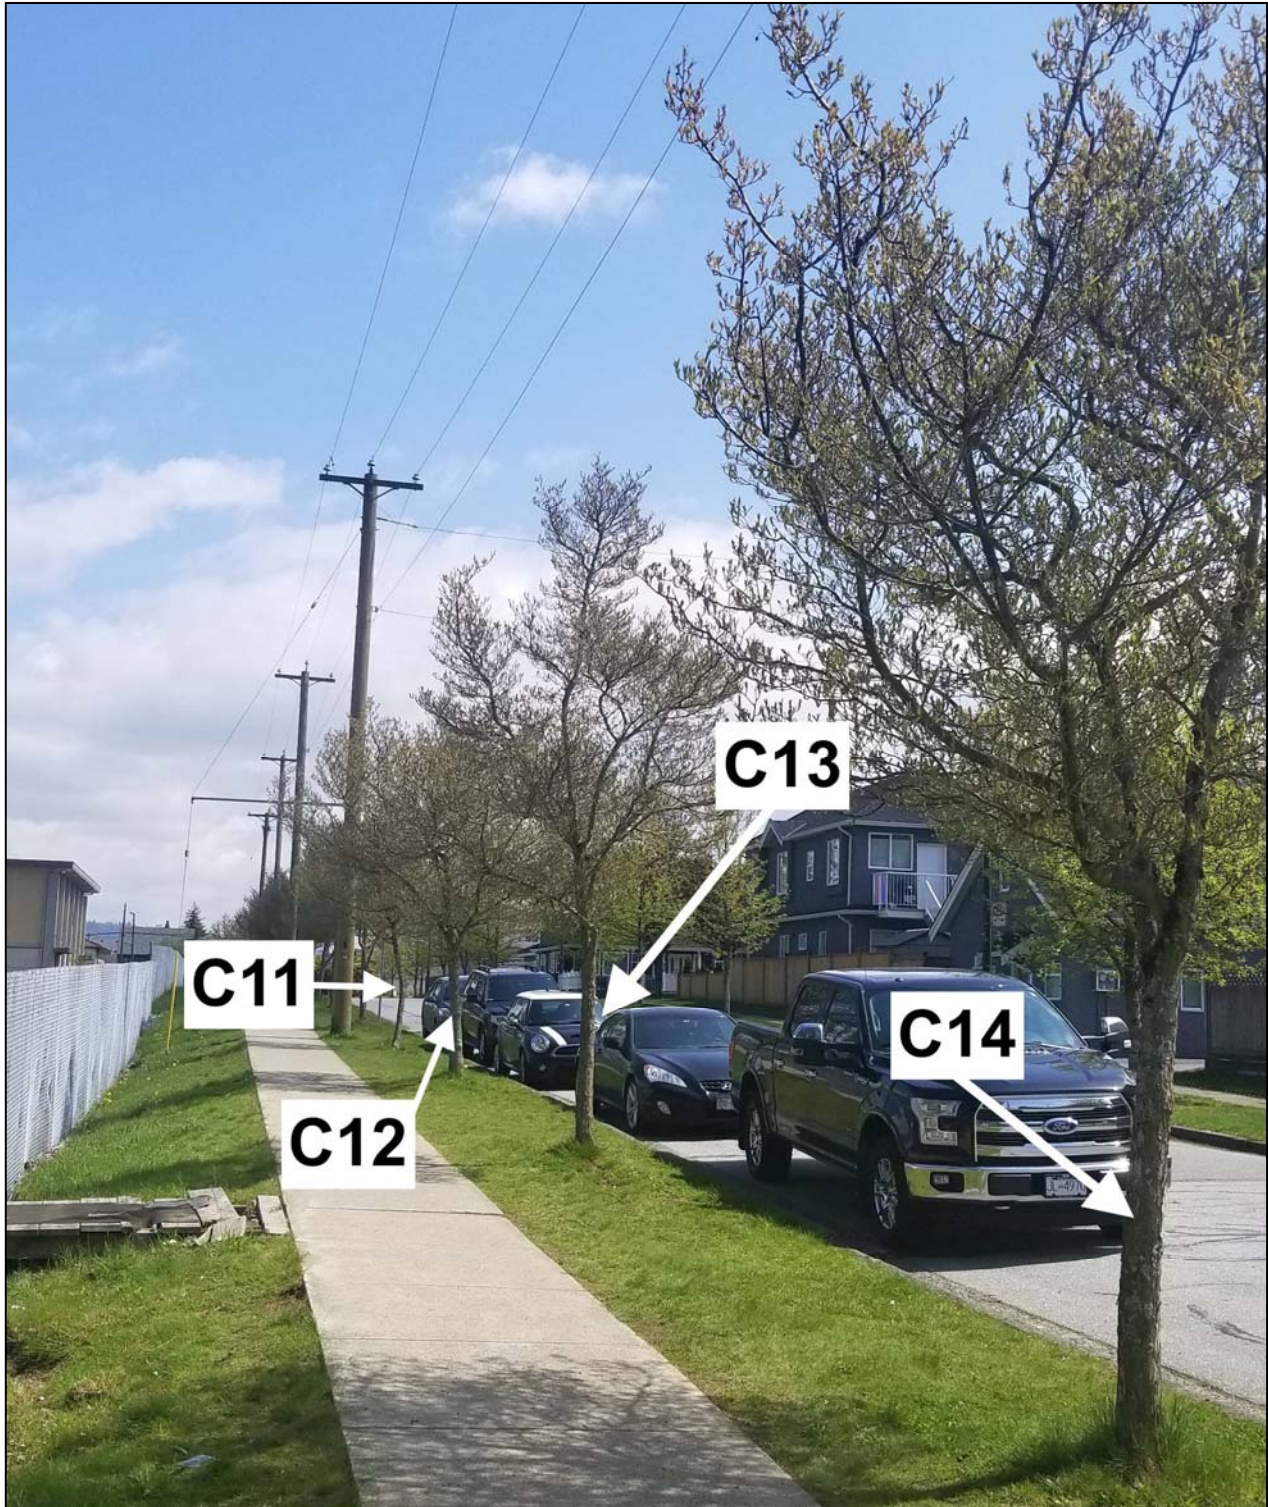
SUITABLE FOR RETENTION –With tree protection fence		
C11	Lavalle Hawthorn <i>Crataegus x lavallei</i>	.10	GOOD	IMAGE 1 DRIP LINE = 2.5 METERS SUITABLE FOR RETENTION –With tree protection fence	RETAIN	N/A
C12	Lavalle Hawthorn <i>Crataegus x lavallei</i>	.14	GOOD	IMAGE 1 DRIP LINE = 2.5 METERS SUITABLE FOR RETENTION –With tree protection fence	RETAIN	N/A
C13	Lavalle Hawthorn <i>Crataegus x lavallei</i>	.12	GOOD	IMAGE 1 DRIP LINE = 2.5 METERS SUITABLE FOR RETENTION –With tree protection fence	RETAIN	N/A
C14	Lavalle Hawthorn <i>Crataegus x lavallei</i>	.12	GOOD	IMAGE 1 DRIP LINE = 2.5 METERS SUITABLE FOR RETENTION –With tree protection fence	RETAIN	N/A

Image 1- City trees situated to the south of the proposed development area along Parker Street.
