**Geotechnical report by Thurber Engineering Ltd. regarding lands at 480 Broughton Street as part of the Coal Harbour Phase II project.  
Date range: January 1, 2017 to December 31, 2017.**

CLIENT	CITY OF VANCOUVER		
	<b>TEST HOLE LOCATION PLAN</b>		
	480 BROUGHTON STREET		
	VANCOUVER B.C.

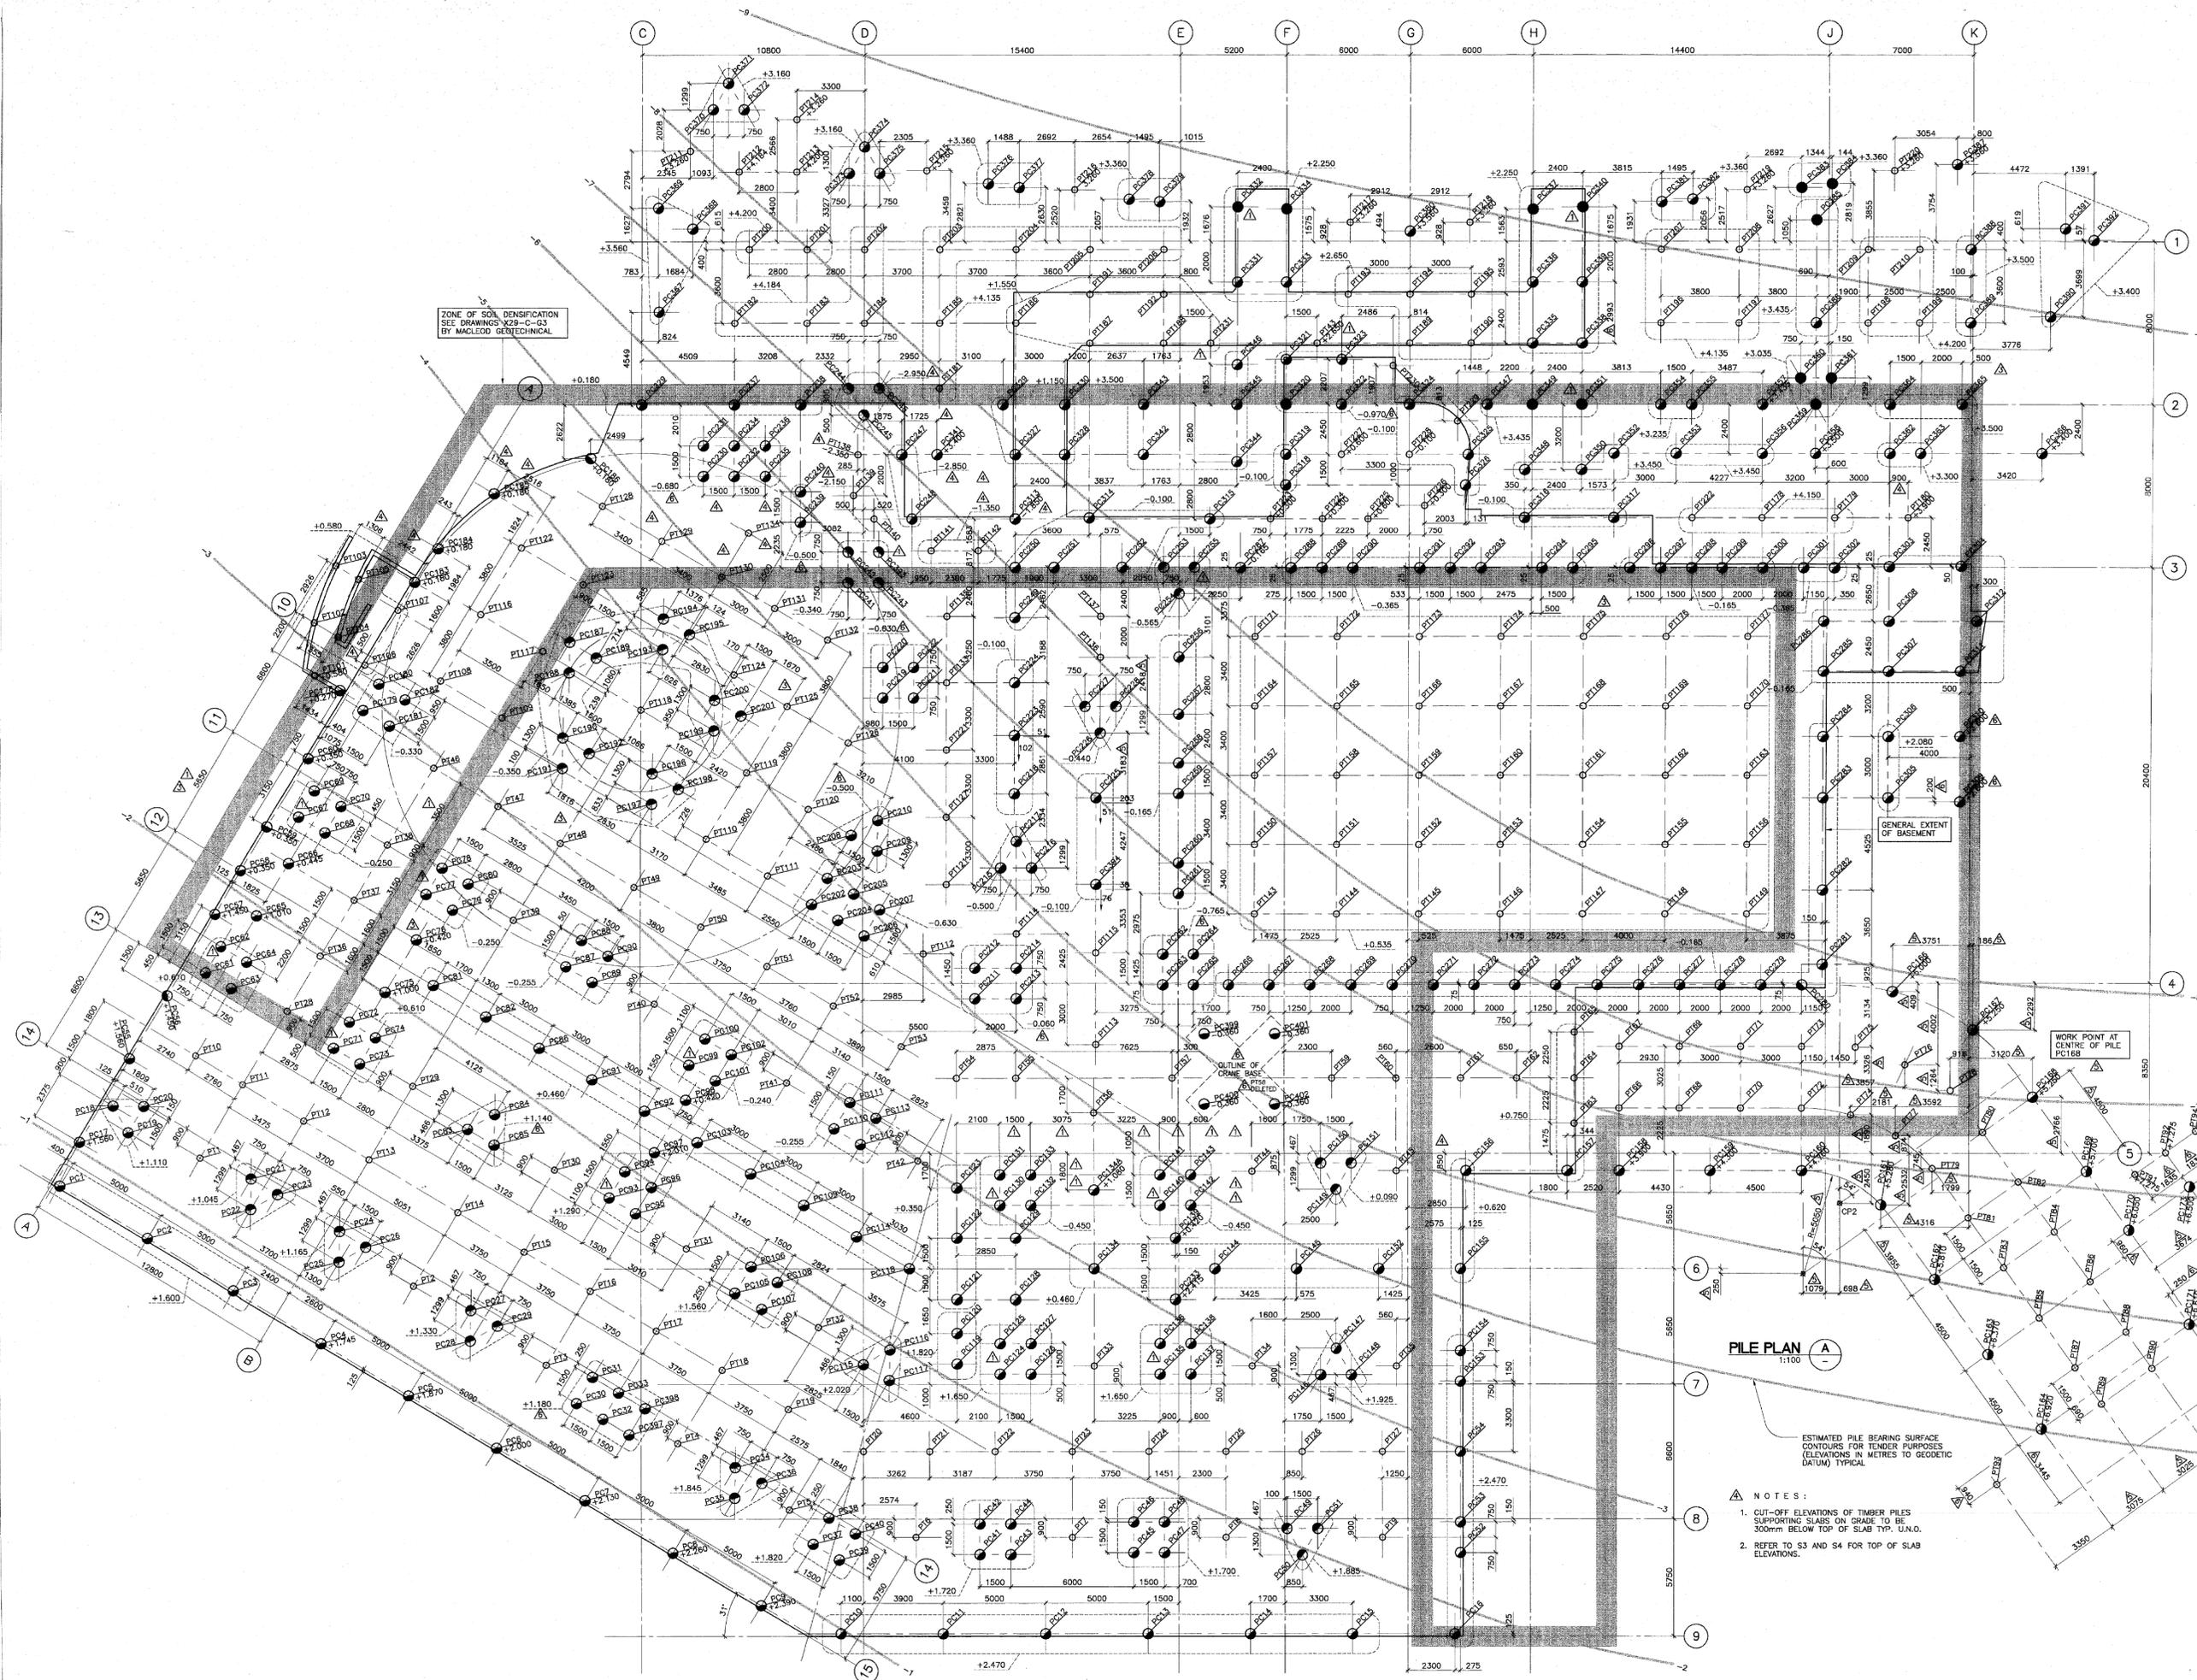
ZONE OF SOIL DENSIFICATION  
SEE DRAWINGS V29-C-G3  
BY MACLEOD GEOTECHNICAL

GENERAL EXTENT OF BASEMENT
