# URBAN systems

Figure 1 – Scenario D Site Plan .....	2
Figure 2 – Proposed Storm Trunks and Servicing .....	4
Figure 3 – Proposed Sanitary Trunks and Servicing .....	6
Figure 4 – Proposed Sanitary IDs .....	8
Figure 5 – Proposed Sanitary Phasing .....	9
Figure 6 – Proposed Water Trunks and Servicing .....	11
Figure 7 – Proposed Electrical.....	13

The conceptual layout of the Scenario D is shown in **Figure 1** below.

# IMP Update

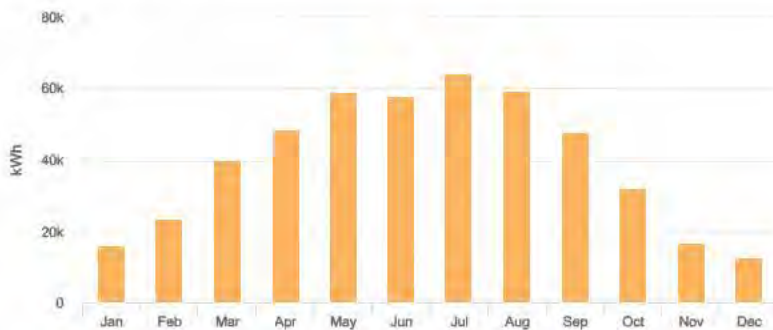
### Monthly Production

Design	Design 1 (inter-row spacing at 34 degrees)
Module DC Nameplate	401.2 kW
Inverter AC Nameplate	375.0 kW Load Ratio: 1.07
Annual Production	479.4 MWh
Performance Ratio	82.9%
kWh/kWp	1,195.0
Weather Dataset	TMY, 10km Grid, meteonorm (meteonorm)
Simulator Version	5b2f7a1471-4b0afd94b7-fa79661d9a-a5360c70c7

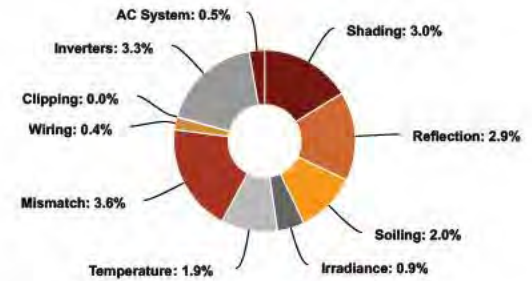
### Sources of System Loss

Description	Output	% Delta
Irradiance (kWh/m <sup>2</sup> )	Annual Global Horizontal Irradiance	1,220.4	
	POA Irradiance	1,441.0	18.1%
	Shaded Irradiance	1,397.7	-3.0%
	Irradiance after Reflection	1,356.6	-2.9%
	Irradiance after Soiling	1,329.5	-2.0%
	<b>Total Collector Irradiance</b>	<b>1,329.5</b>	<b>0.0%</b>
Energy (kWh)	Nameplate	533,616.3	
	Output at Irradiance Levels	528,840.8	-0.9%
	Output at Cell Temperature Derate	519,037.7	-1.9%
	Output After Mismatch	500,573.6	-3.6%
	Optimal DC Output	498,502.9	-0.4%
	Constrained DC Output	498,418.2	0.0%
	Inverter Output	481,855.0	-3.3%
	<b>Energy to Grid</b>	<b>479,446.0</b>	<b>-0.5%</b>
Temperature Metrics			
	Avg. Operating Ambient Temp		12.2 °C
	Avg. Operating Cell Temp		20.1 °C
Simulation Metrics			
	Operating Hours	4589	
	Solved Hours	4589

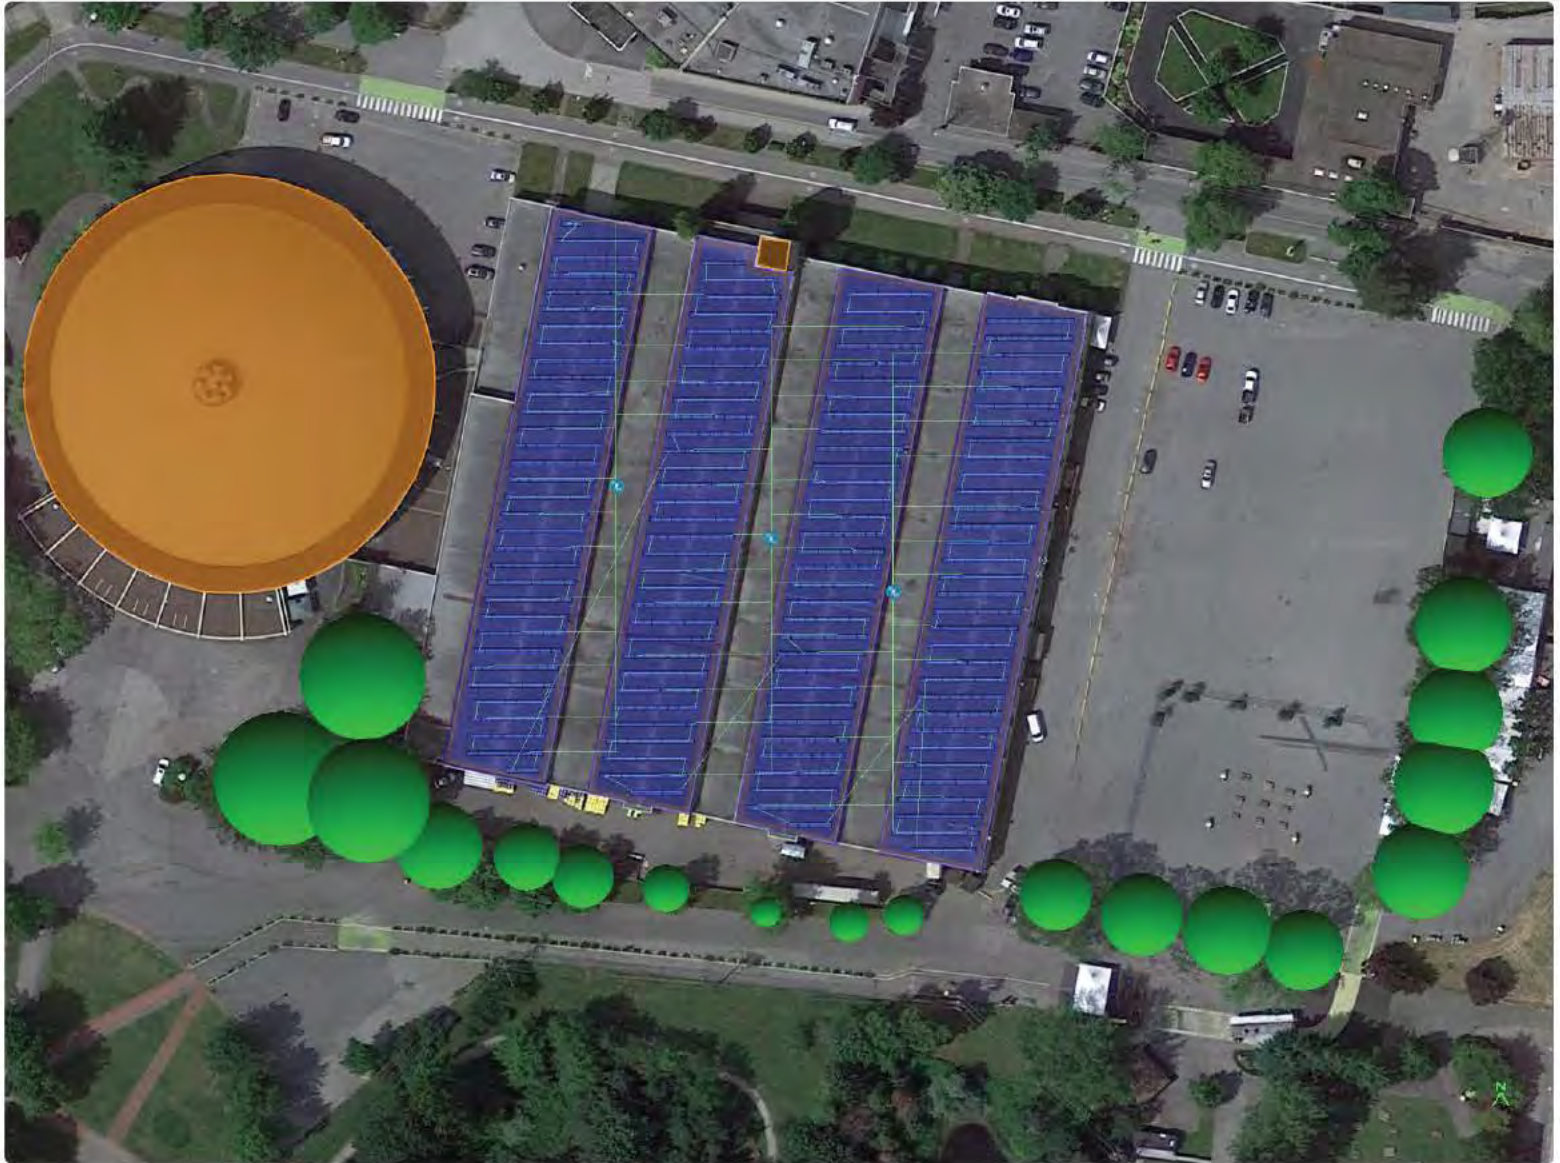
Detailed Layout

Description	Racking	Orientation	Tilt	Azimuth	Intrarow Spacing	Frame Size	Frames	Modules	Power
Field Segment 1	Fixed Tilt	Landscape (Horizontal)	34°	180°	2.4 m	1x1	249	249	99.6 kW
Field Segment 2	Fixed Tilt	Landscape (Horizontal)	34°	180°	2.4 m	1x1	248	248	99.2 kW
Field Segment 3	Fixed Tilt	Landscape (Horizontal)	34°	180°	2.4 m	1x1	252	252	100.8 kW
Field Segment 4	Fixed Tilt	Landscape (Horizontal)	34°	180°	2.4 m	1x1	254	254	101.6 kW

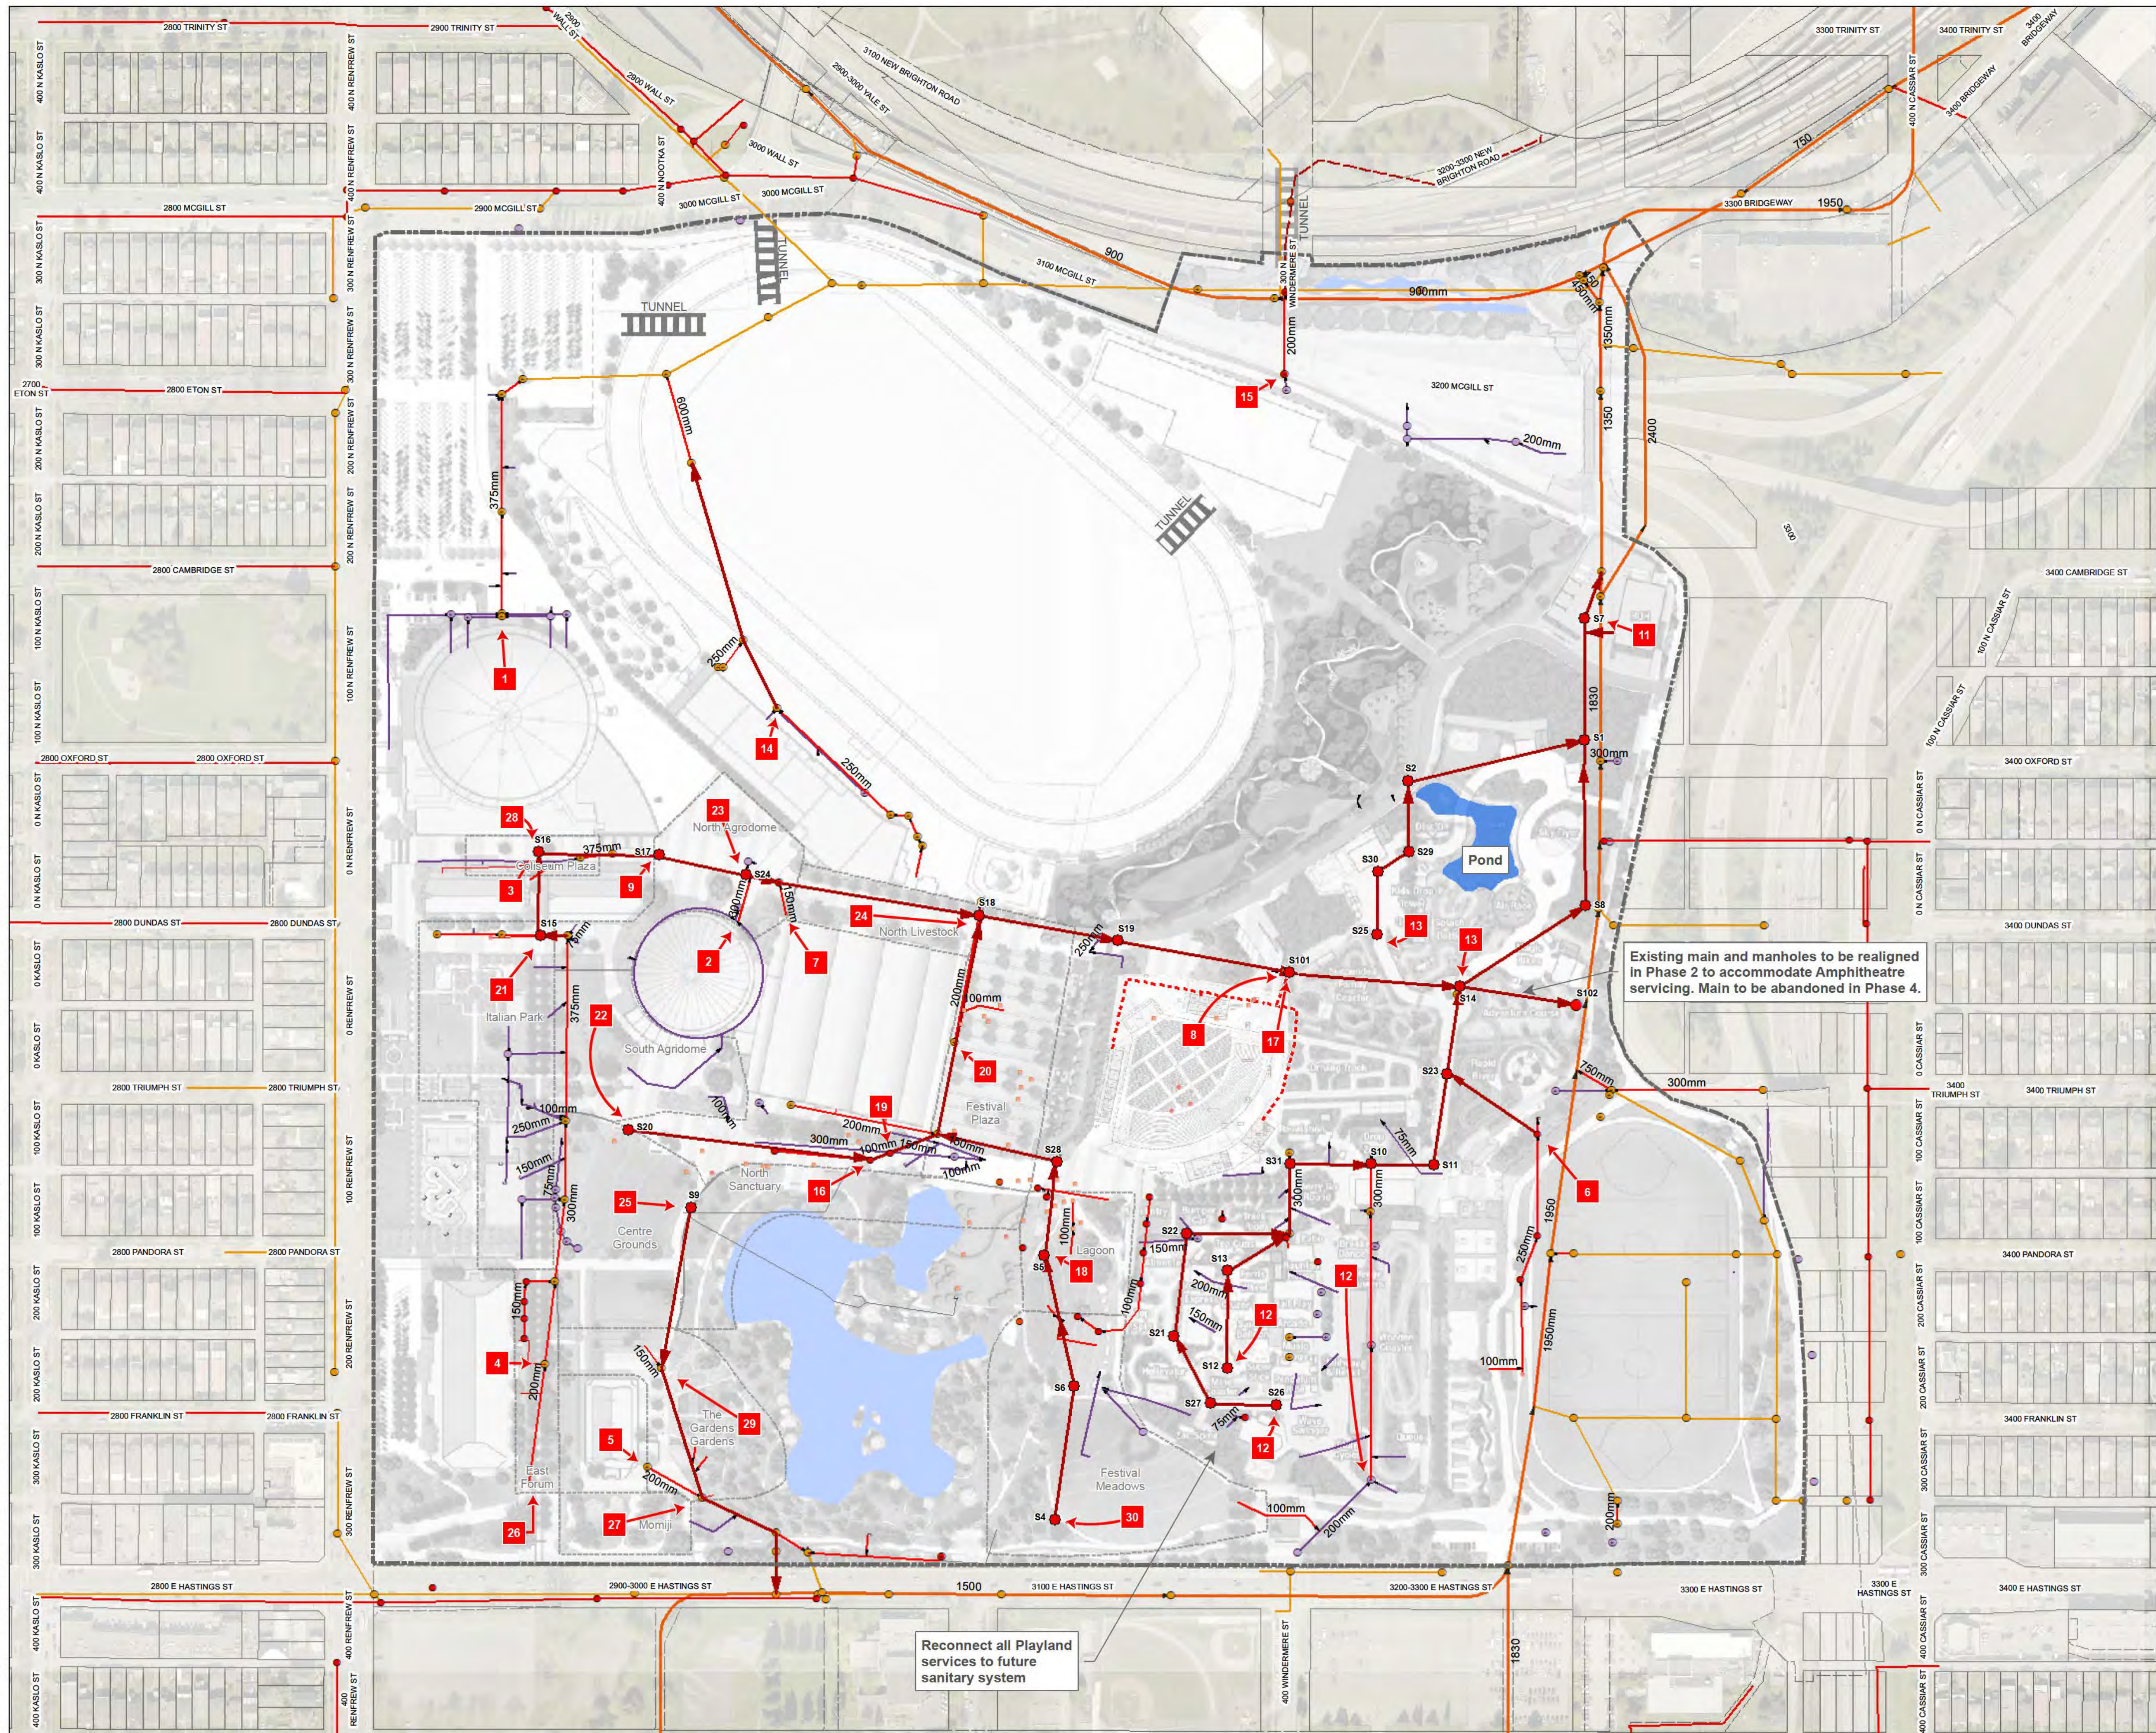
FIGURE 4

# IMP Update Amphitheatre Renewal Future Sanitary Loading

Loading calculations from the IMP have been applied with Scenario D attendance projections and produced an 11 L/s increase from 41 L/s to 52 L/s under existing conditions, which is a negligible addition compared to the total calculated flow in the pipe of 800 L/s. Despite the minimal flow increase that would result from the Amphitheatre, Metro Vancouver has stated this connection may be subject to further review.

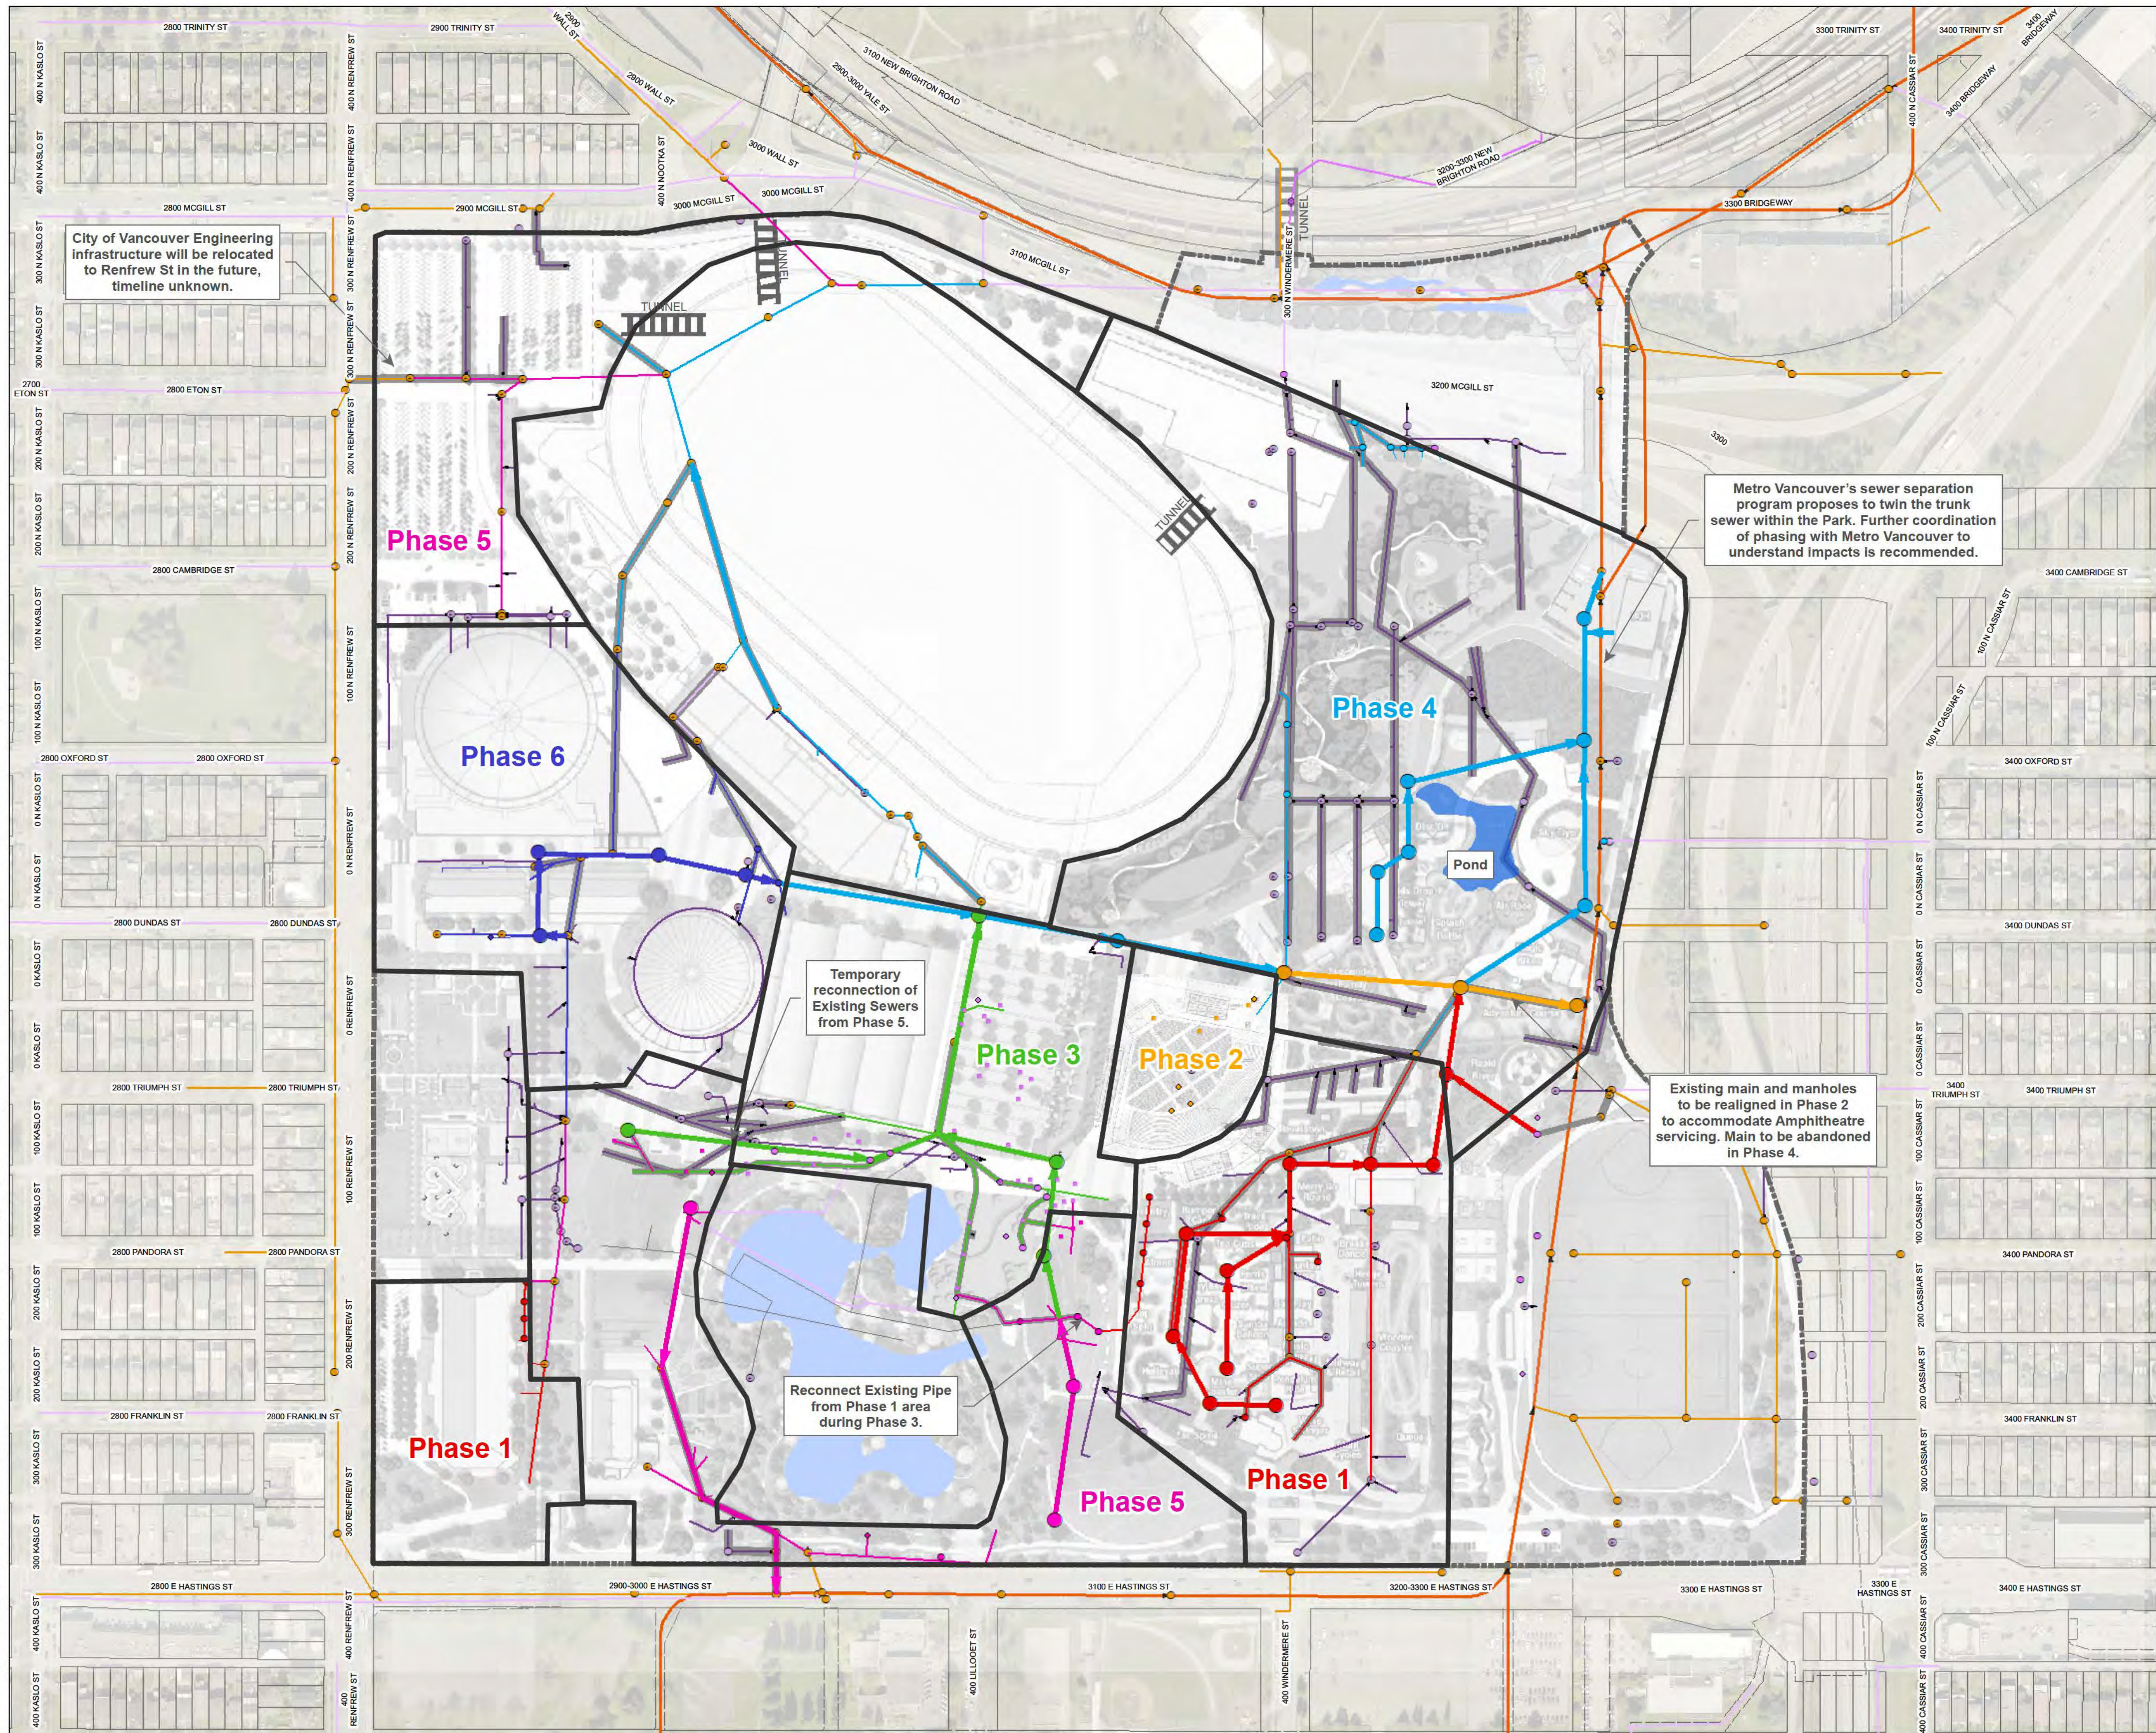
FIGURE 5

# IMP Update Amphitheatre Renewal Future Sanitary Implementation Strategy

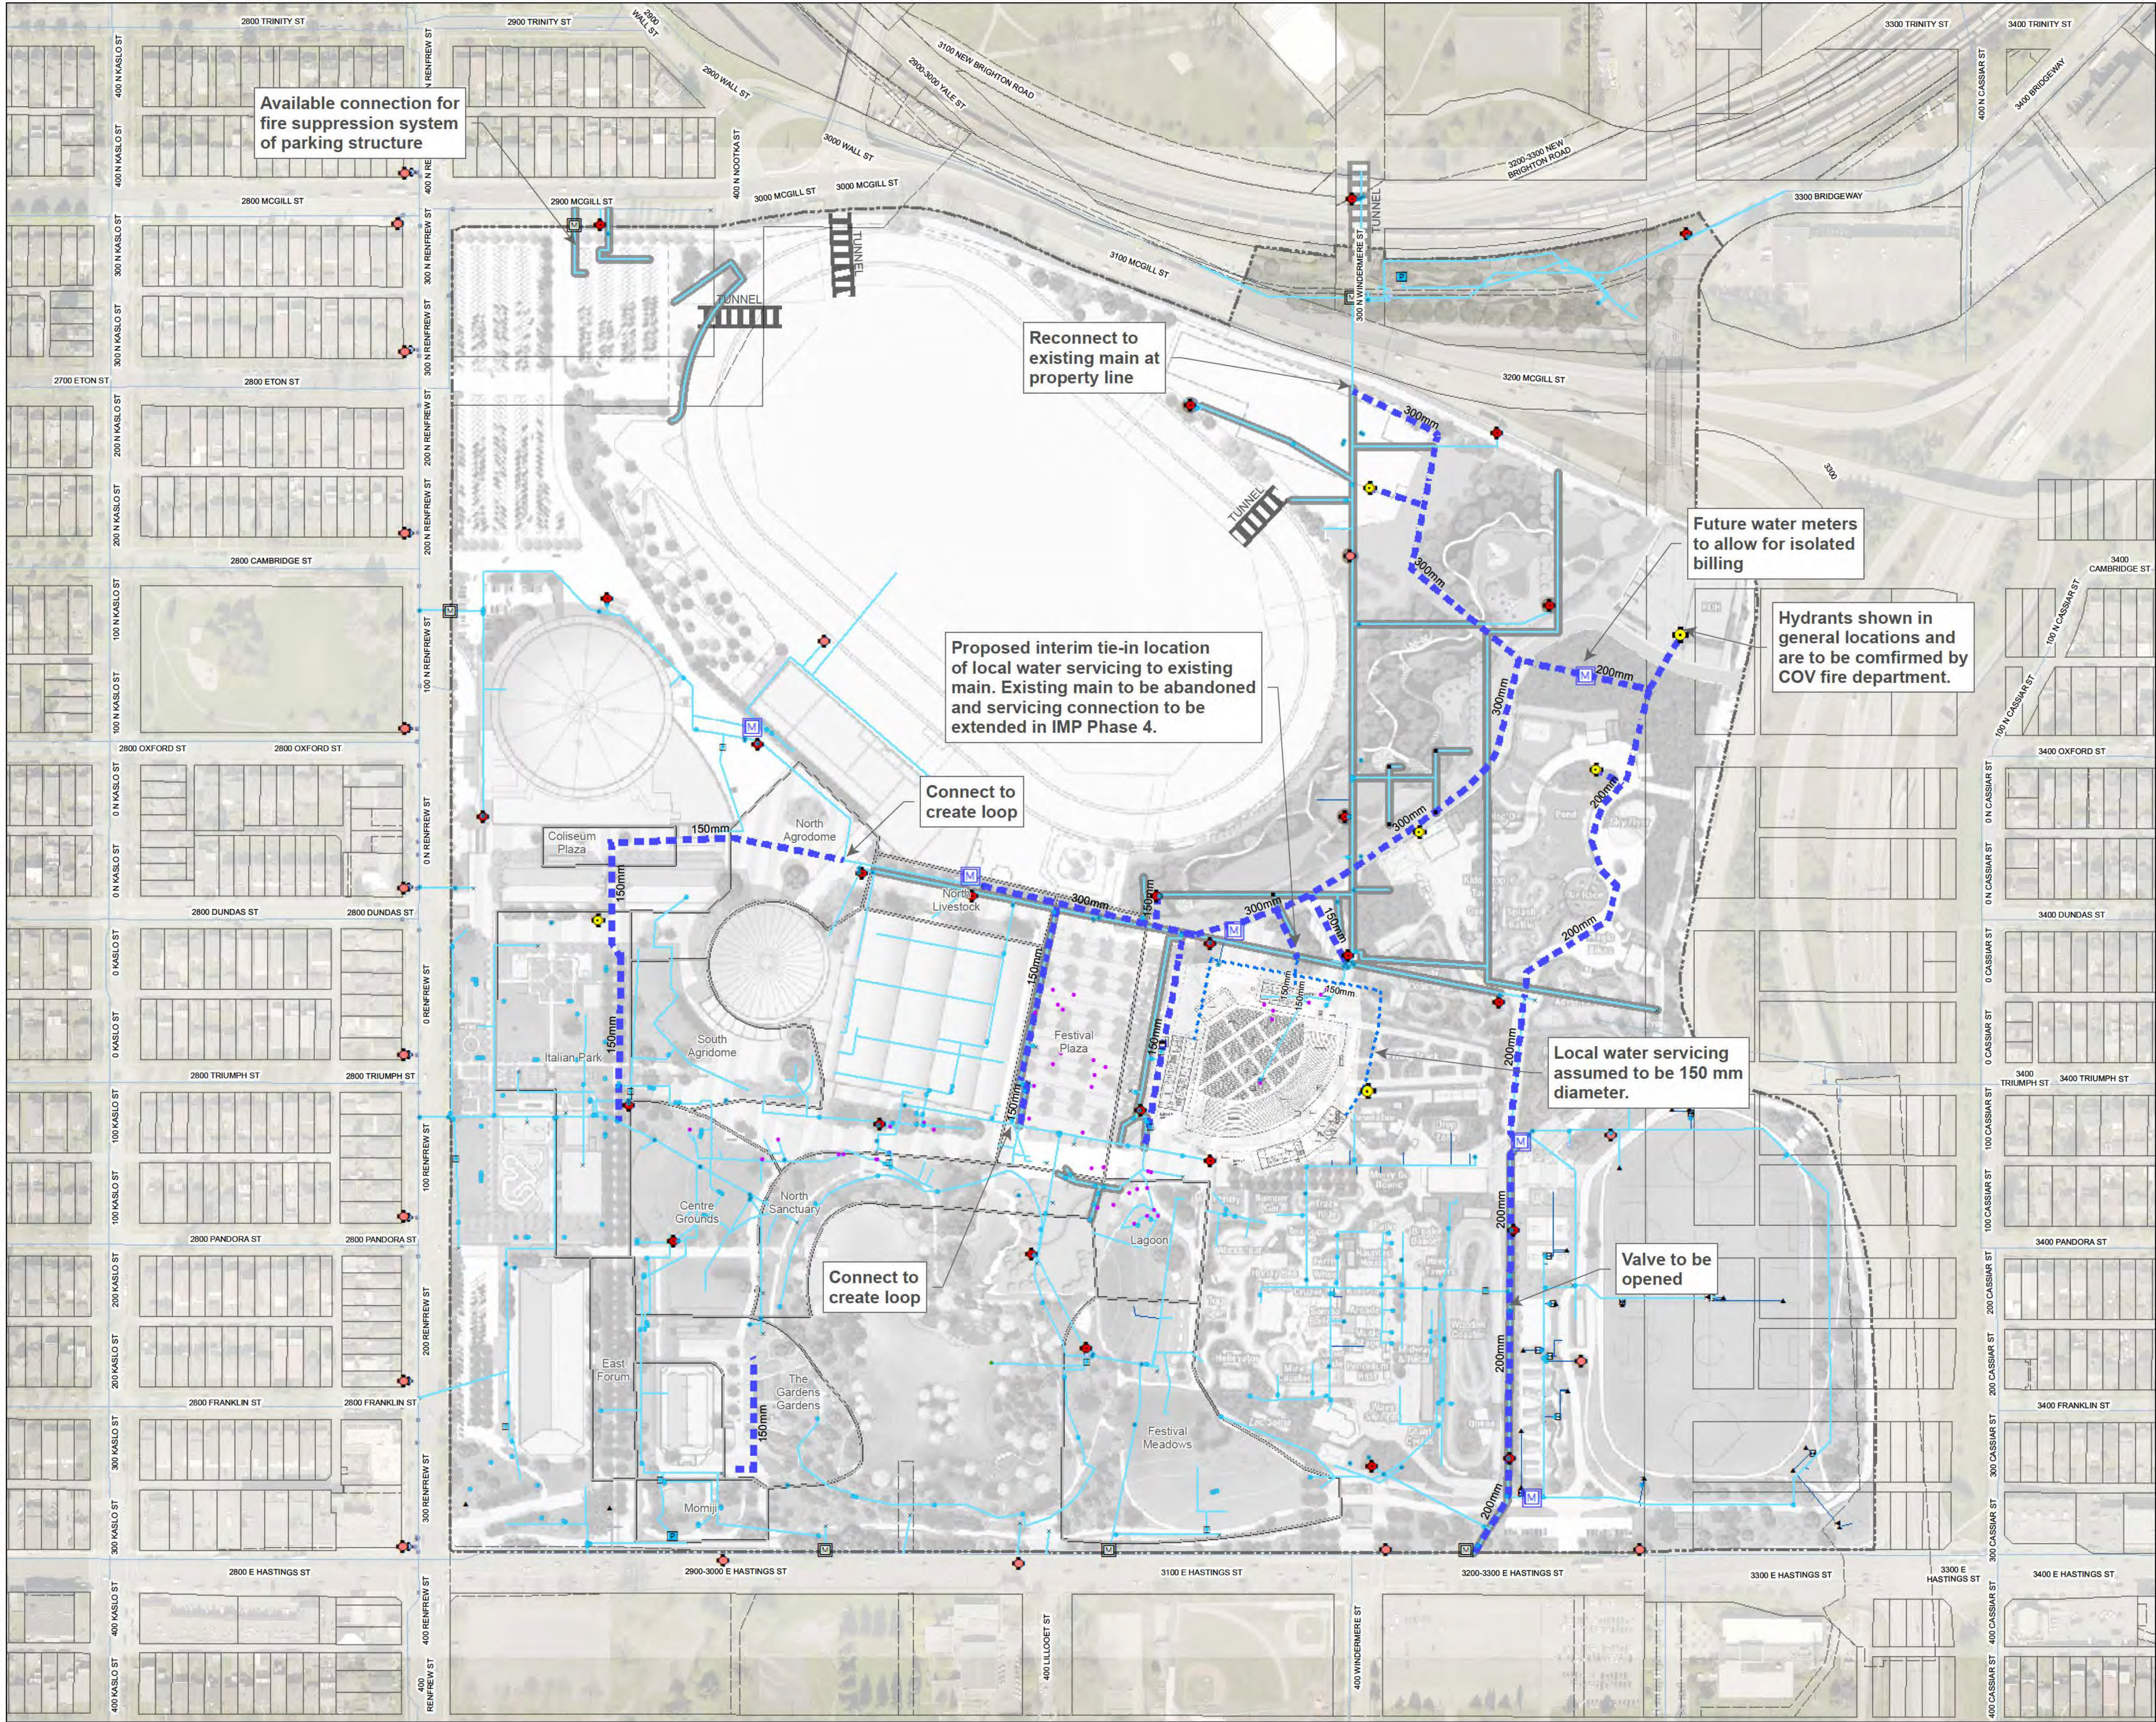
FIGURE 6

The modelling details and infrastructure recommendations are presented in the technical memo “Amphitheatre Update Water System Analysis” in **Appendix B**. Our analysis indicated that fire flow demands for buildings B can be satisfied by accessing the existing fire hydrant near the southwest lower level Amphitheatre entrance, in conjunction with a new proposed hydrant which would be located near building B to Miller Drive as shown in **Figure 6**.

## IMP Update Amphitheatre Renewal Future Water Servicing Schematic

Although the existing hydrant adjacent to the Lowerline building appears to be a convenient source for building B fire flows, the hydrant’s elevation and location within the network did not produce sufficient residual pressure when used in tandem with other hydrants for building B fire flows. Furthermore, the valve located on the 150mm main running east of Playland will need to be opened as previously recommended in the IMP in order to create a looped system. The proposed water servicing strategy and fire fighting approach should be reviewed with the City’s fire department and emergency responders prior to design advancement.

- **Water** – The updated water servicing strategy included the addition of a new hydrant near building B in design Scenario D to provide sufficient flow flows in conjunction with an existing hydrant to the southwest of the Amphitheatre. Prior to or during detailed design these recommendation hydrant locations should be reviewed in consultation with the Vancouver Fire Department in consideration of the emergency response plan for the Park and access to hydrants.

This analysis focuses on changes specific to the Amphitheatre design Scenario D, which is outlined in the Hastings Park Infrastructure Master Plan – Amphitheatre Update Technical Memo. The revised future water system with the Scenario D Amphitheatre site plan is shown in **Figure 6** of the Amphitheatre memo.

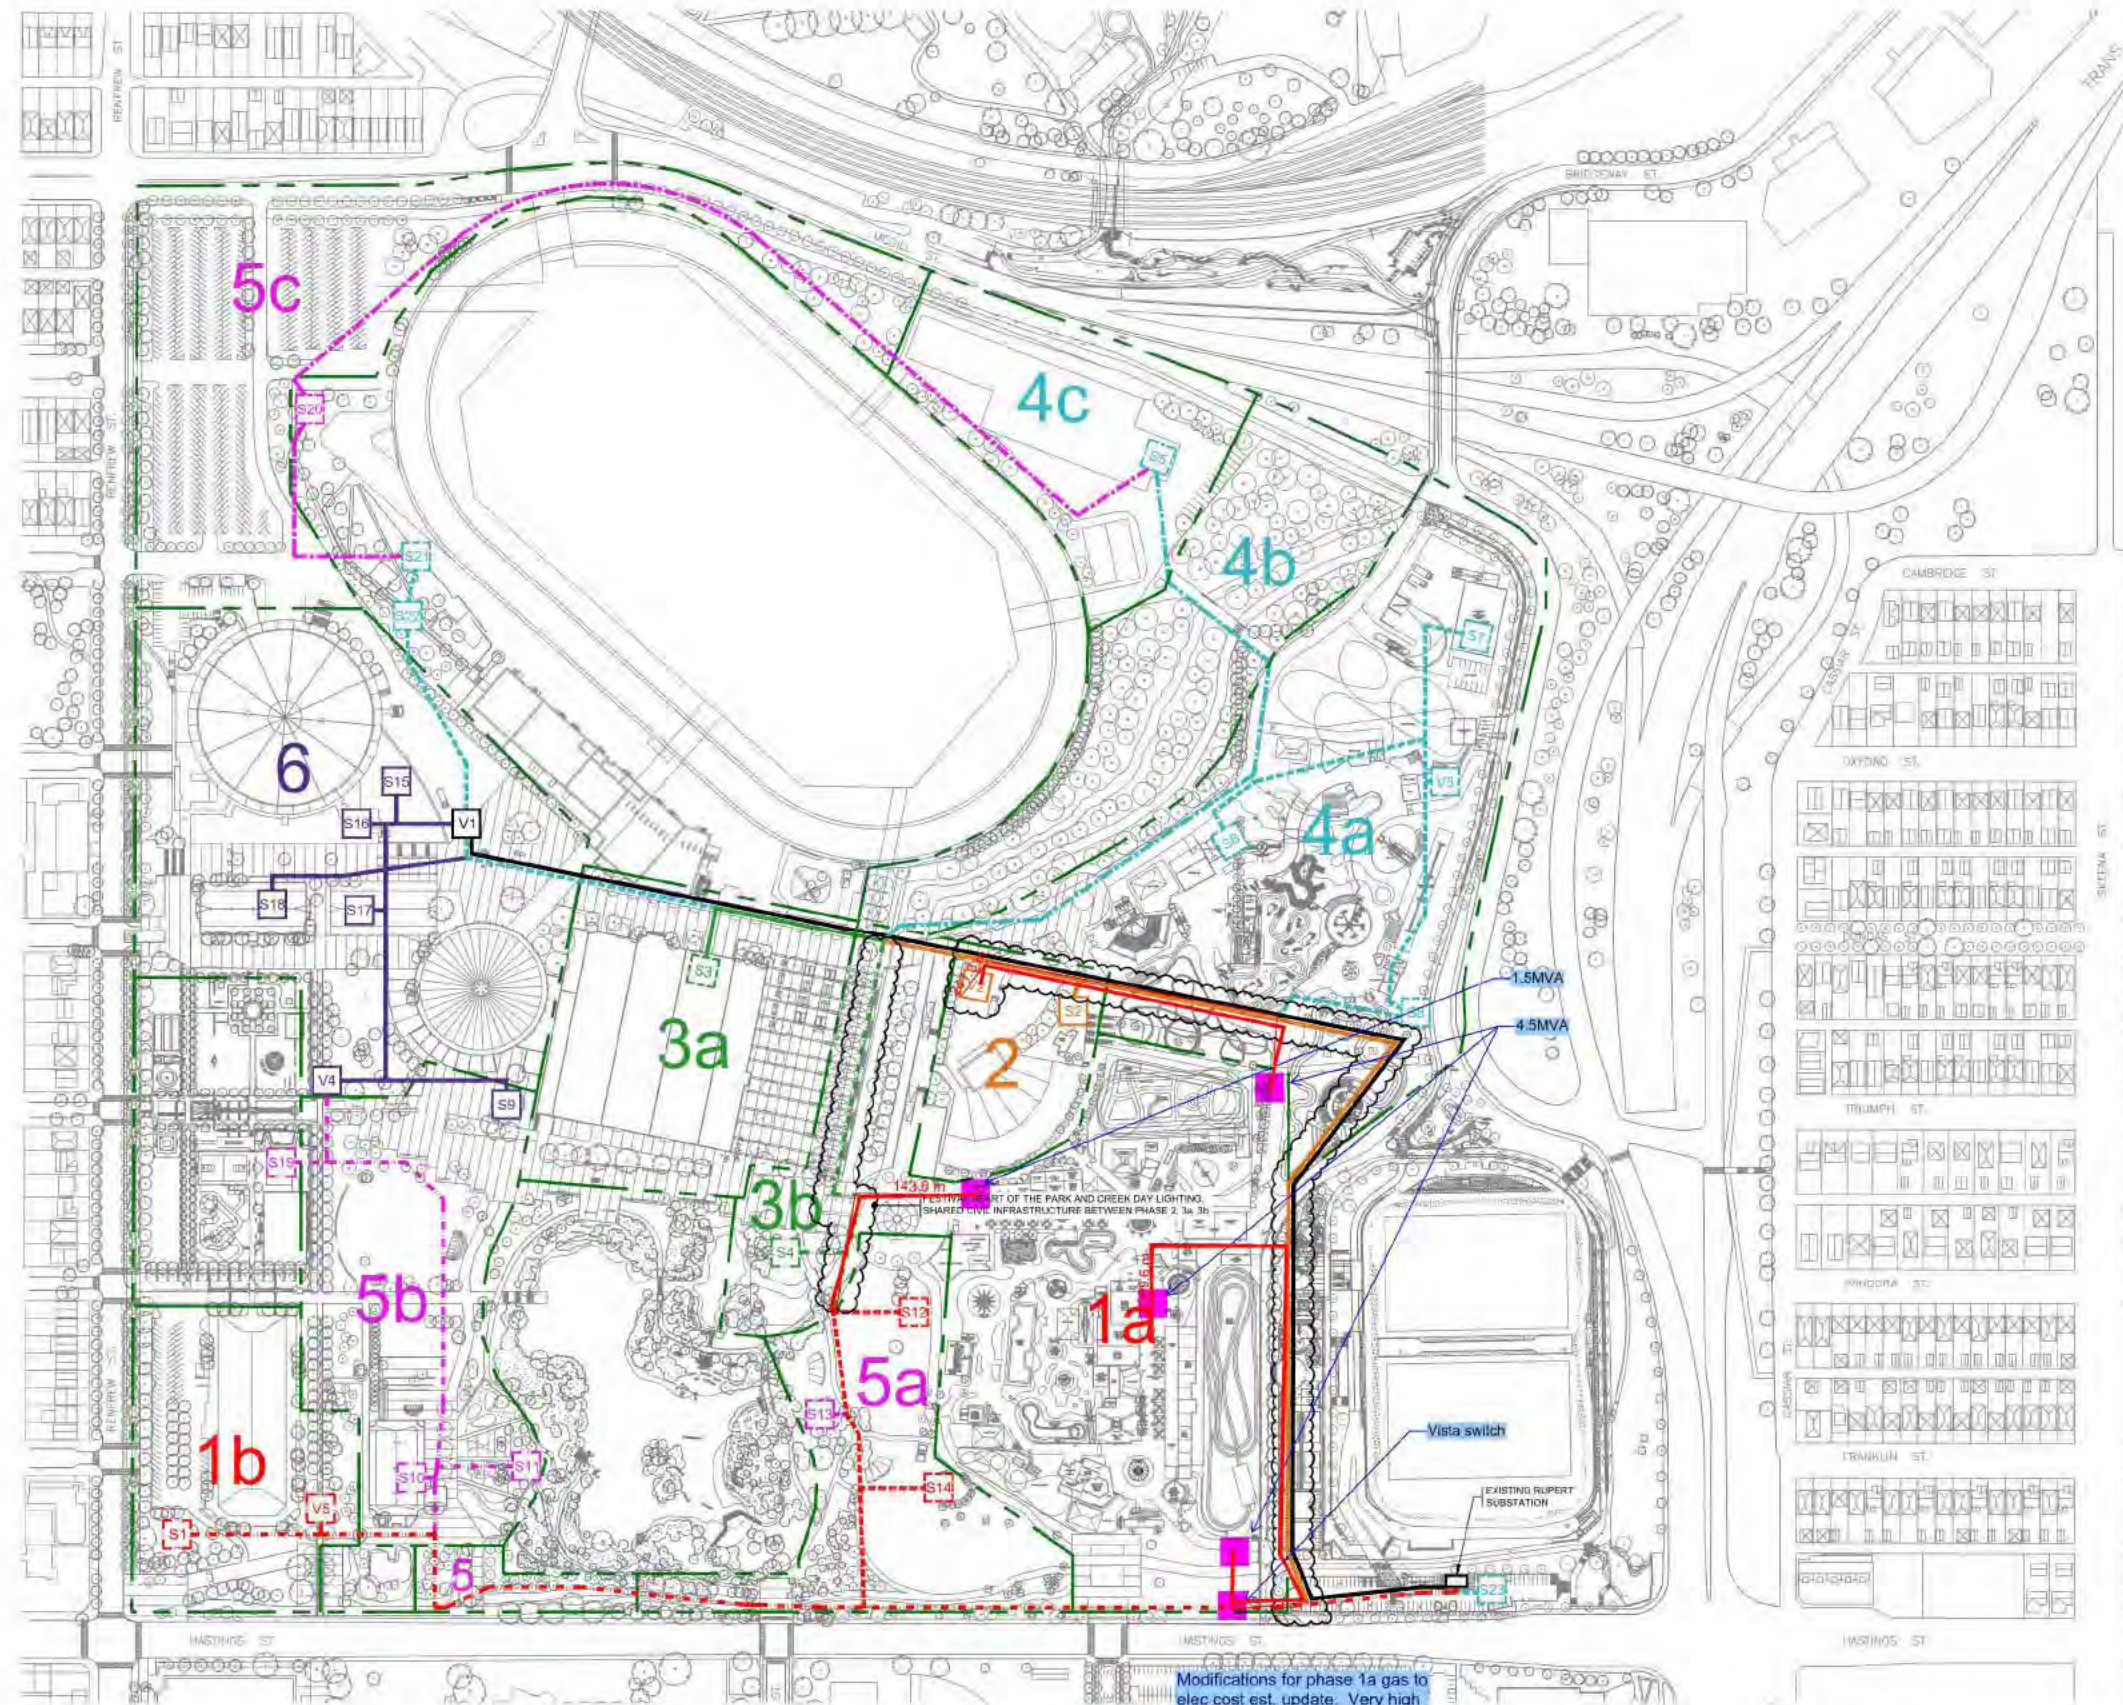
- LEGEND:**
- S1 OUTDOOR UNIT SUBSTATION (No. INDICATES LOCATION)
  - V1 VISTA TYPE PRIMARY SWITCHGEAR (No. INDICATES LOCATION)
  - DUCTBANKS (TRENCH)

- IMPLEMENTATION TIMELINE:**
- EXISTING
  - PHASE 1a (1 TO 5 YEARS)
  - PHASE 1b (1 TO 5 YEARS)
  - PHASE 2 AMPHITHEATER SCENARIO D (TO OCCUR FIRST)
  - PHASE 3a (5 TO 8 YEARS)
  - PHASE 3b (5 TO 8 YEARS)
  - PHASE 4a (8 TO 12 YEARS)
  - PHASE 4b (8 TO 12 YEARS)
  - PHASE 4c (8 TO 12 YEARS)
  - PHASE 5a (12 TO 15 YEARS)
  - PHASE 5b (12 TO 15 YEARS)
  - PHASE 5c (12 TO 15 YEARS)
  - PHASE 6 (15 TO 20 YEARS)

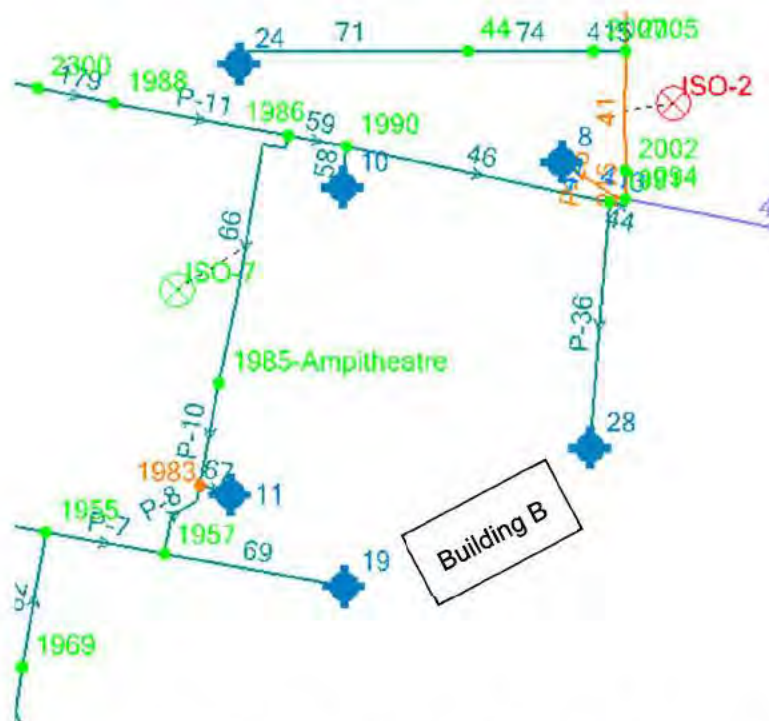
**Figure 1 – Model Amphitheatre Update Trunk Water System**

In order to achieve fire flow and residual pressure criteria, an additional hydrant at the east side of the Amphitheatre was added to the existing system model, shown as hydrant “28” on the model schematic in **Figure 1** below. This hydrant would be connected to the 150mm local service to building B as shown on **Figure 6** in the Amphitheatre Update Technical Memo and will serve as long-term Amphitheatre fire protection in the IMP’s future water system.

As shown in **Figure 1**, hydrant 28 is proposed adjacent to future building B and is serviced from the north side of the Amphitheatre. In conjunction with hydrant 11, the required fire flow of 120 L/s for building B is satisfied while maintaining residual pressures of 140 kPa as presented in **Table 3**. It is also required that hydrants are located within 80m of each facility, with building B located near the edge of hydrant 11's coverage radius. **Figure 2** below presents an updated map of the fire hydrant coverage following implementation of the Amphitheatre Update servicing strategy. These recommendations and hydrant locations should be confirmed in consultation with the Vancouver Fire Department in consideration of the emergency response plan for the Park and access to hydrants.

Hydrant ID	Elevation	Fire Flow Demand	Residual Pressure
<b>11 (Existing)</b>	27.0 m	75 L/s	249 kPa
<b>28 (Proposed)</b>	34.0 m <sup>1</sup>	45 L/s	182 kPa

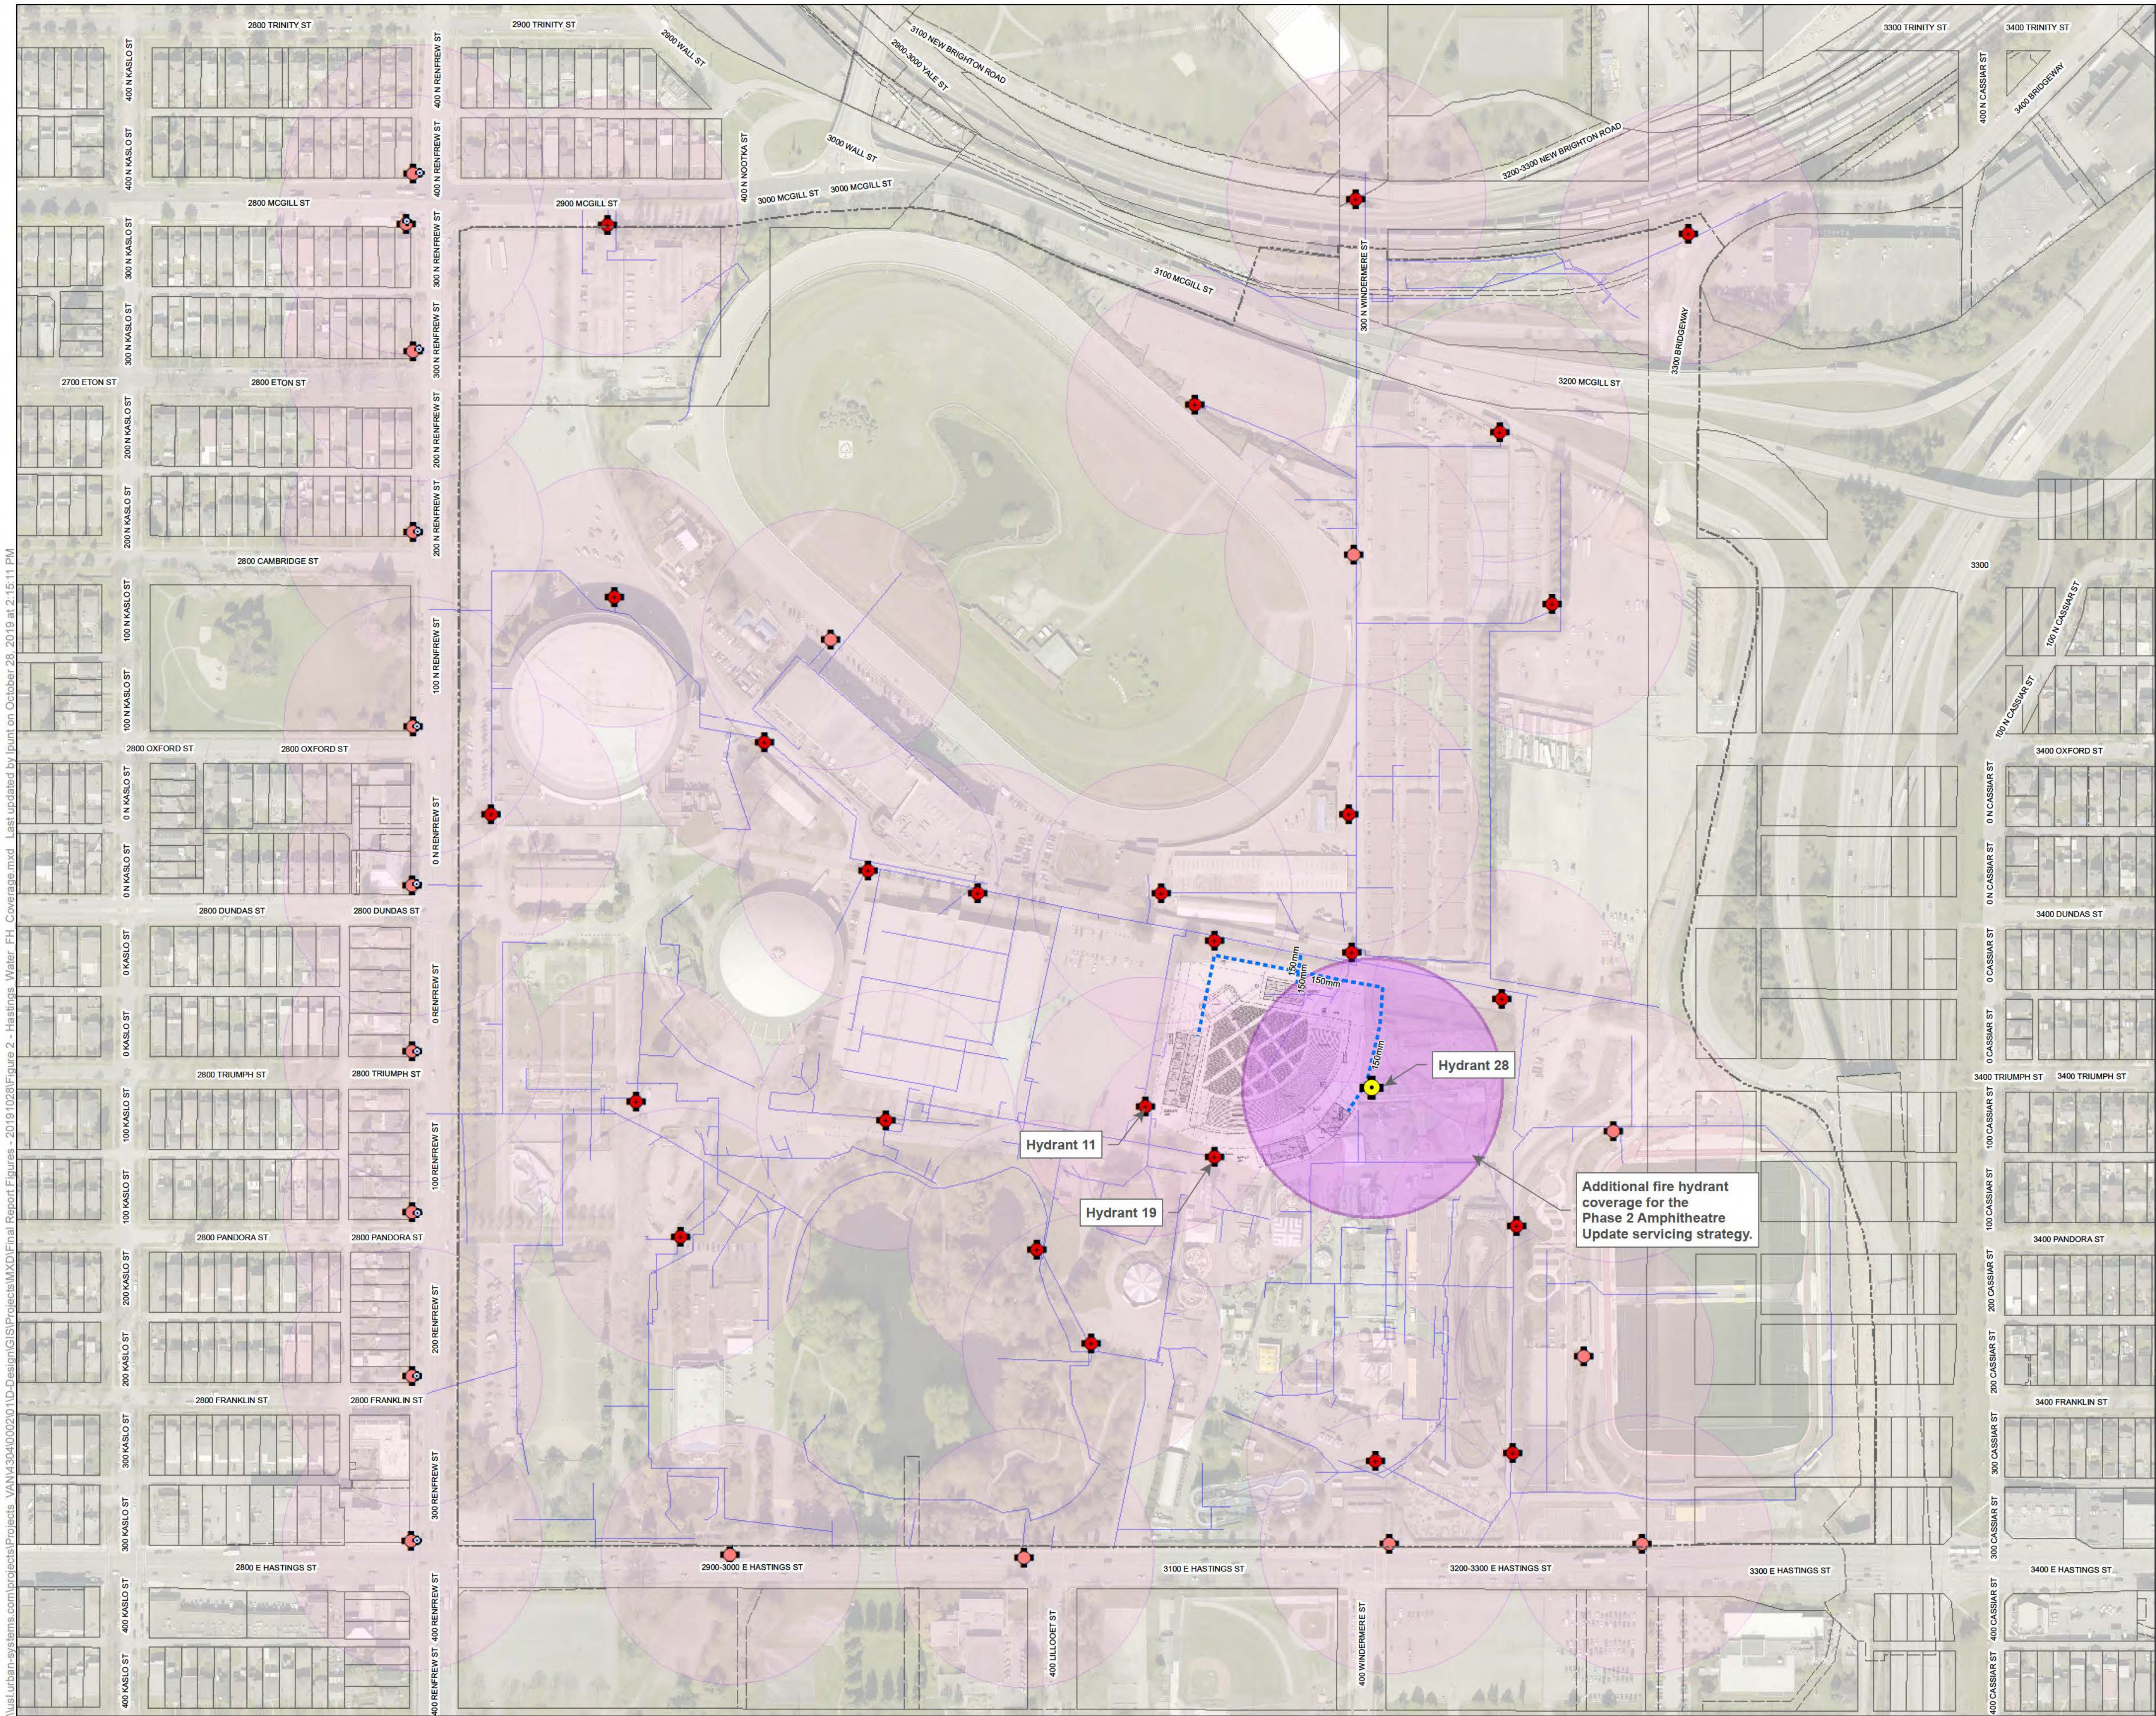
# IMP Update Amphitheatre Renewal

## Existing Fire Hydrant Coverage
