# URBAN systems

Figure 1 – Scenario D Site Plan .....	2
Figure 2 – Proposed Storm Trunks and Servicing .....	4
Figure 3 – Proposed Sanitary Trunks and Servicing .....	6
Figure 4 – Proposed Sanitary IDs .....	8
Figure 5 – Proposed Sanitary Phasing .....	9
Figure 6 – Proposed Water Trunks and Servicing .....	11
Figure 7 – Proposed Electrical.....	13

The conceptual layout of the Scenario D is shown in **Figure 1** below.

# IMP Update

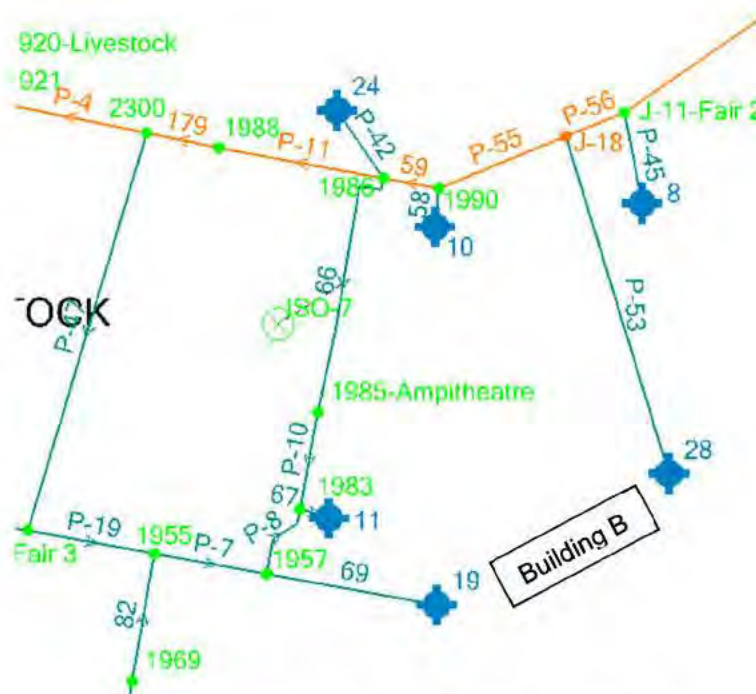
**Figure 3 – Model Future Trunk Water System**

The recommended future servicing upgrades greatly improve the potential hydraulic capacity of the Hastings Parks water system. The future system model outlined in the Future Potable Water System Analysis was reanalyzed with focus on the Amphitheatre fire flows, as shown in **Figure 3**. Using the same multi-hydrant approach discussed in the existing Amphitheatre analysis, it was determined that hydrant 19 could be used in conjunction with hydrant 11 to deliver a combined 120 L/s fire flow while maintaining sufficient residual pressure within the future system. Hydrant 28, recommended for the existing system to meet fire flow requirements, would offer additional protection after local Amphitheatre servicing is reconnected to the reconfigured future system. Refer to the Future Potable Water System Analysis in Appendix J of the IMP for further discussion and analysis of the entire future water system.

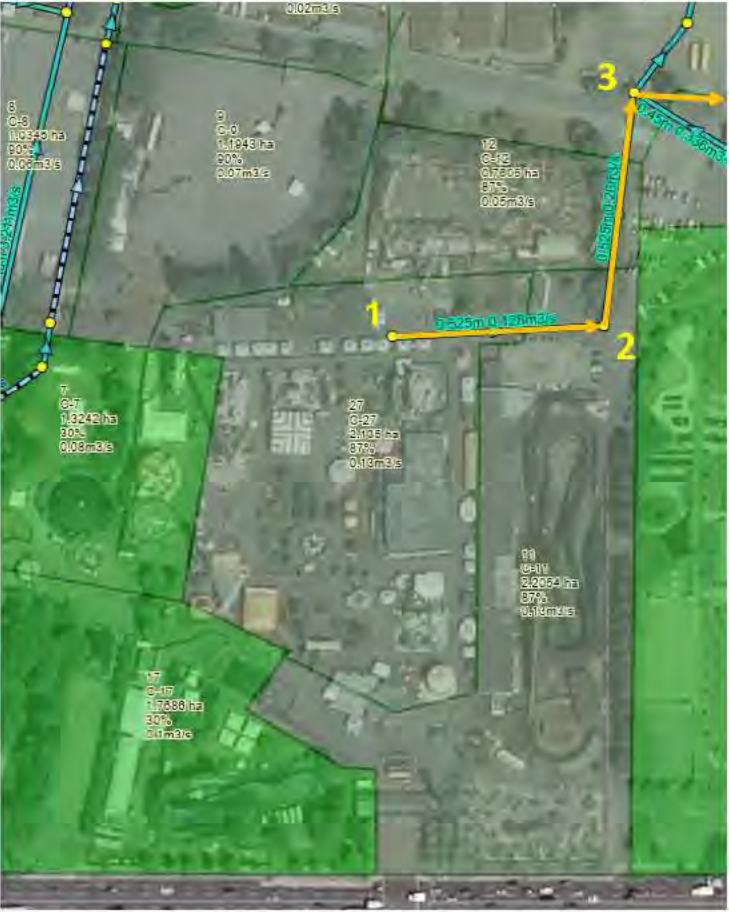
Approximate location of existing combined  
main to Metro Vancouver sewer

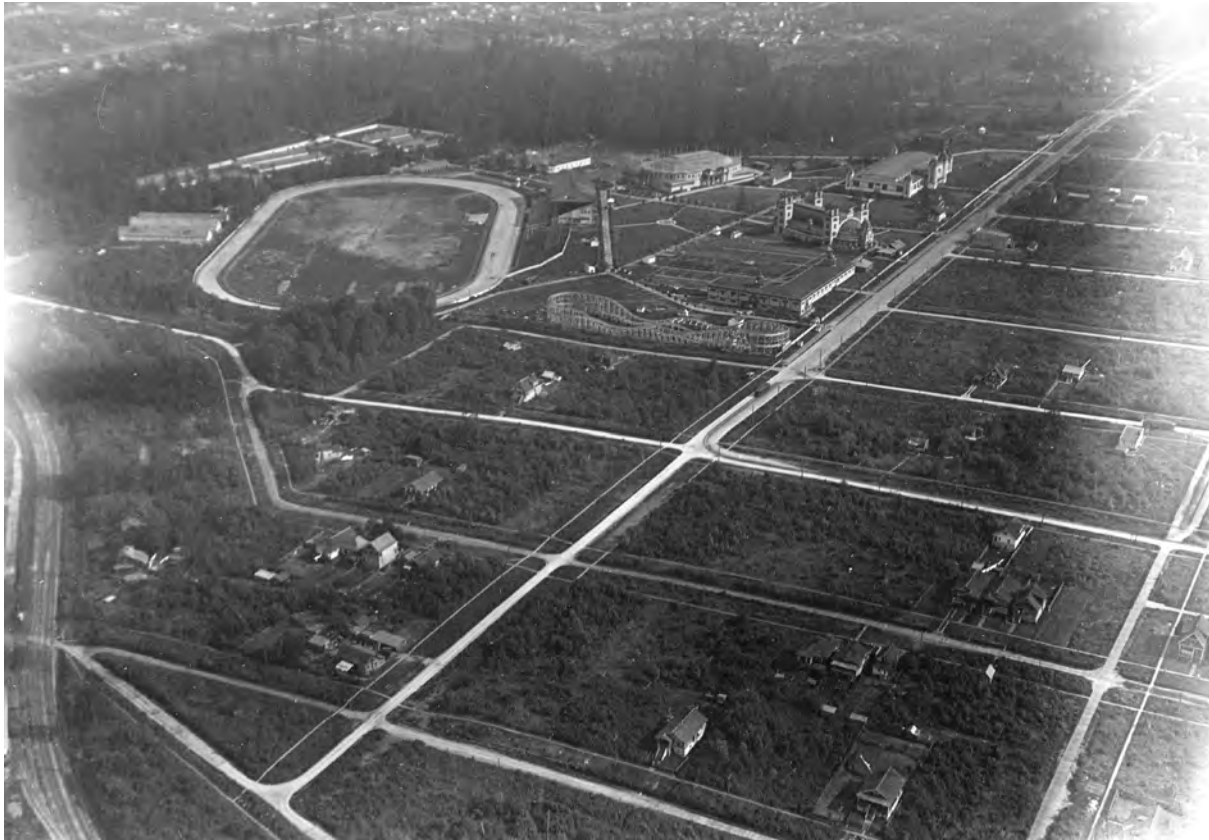
**Figure 8. Hastings Park 27 May 1919. Oblique view looking southeast along Renfrew Street towards Hastings Street, with parts of Wall Street, Trinity Street, McGill Street, the northern section of Hastings Park, the first roller coaster, the Manufacturing/Industrial Building and the Exhibition Building on the Exhibition Grounds (City of Vancouver Archives AM1535-S1: CVA 1123-1).**

The Exhibition Building was constructed in Hastings Park in 1909, and in 1910 the first Vancouver Exhibition was held (Figure 7). At this time much of Hastings Park was likely forested as a tree line is evident in the background of a plan drawn in 1915 (Figure 6), just beyond the exhibition hall to the south and beyond the athletic field grandstands to the east. The Vancouver Exhibition grounds would eventually expand to claim all the forested areas that once covered Hastings Park. The 1915 planning map (Figure 6) shows some of the early expansion plans of the Park grounds, and Renfrew Creek is shown labelled as a ravine, with another small stream to the east. Windermere Street is shown traversing the Park and connecting to McGill Street near where it crosses Renfrew Creek. The map indicates that the eastern and southern portions of Hastings Park are forested. The forested areas are still extant in a 1919 air photo of the Park (Figure 8).

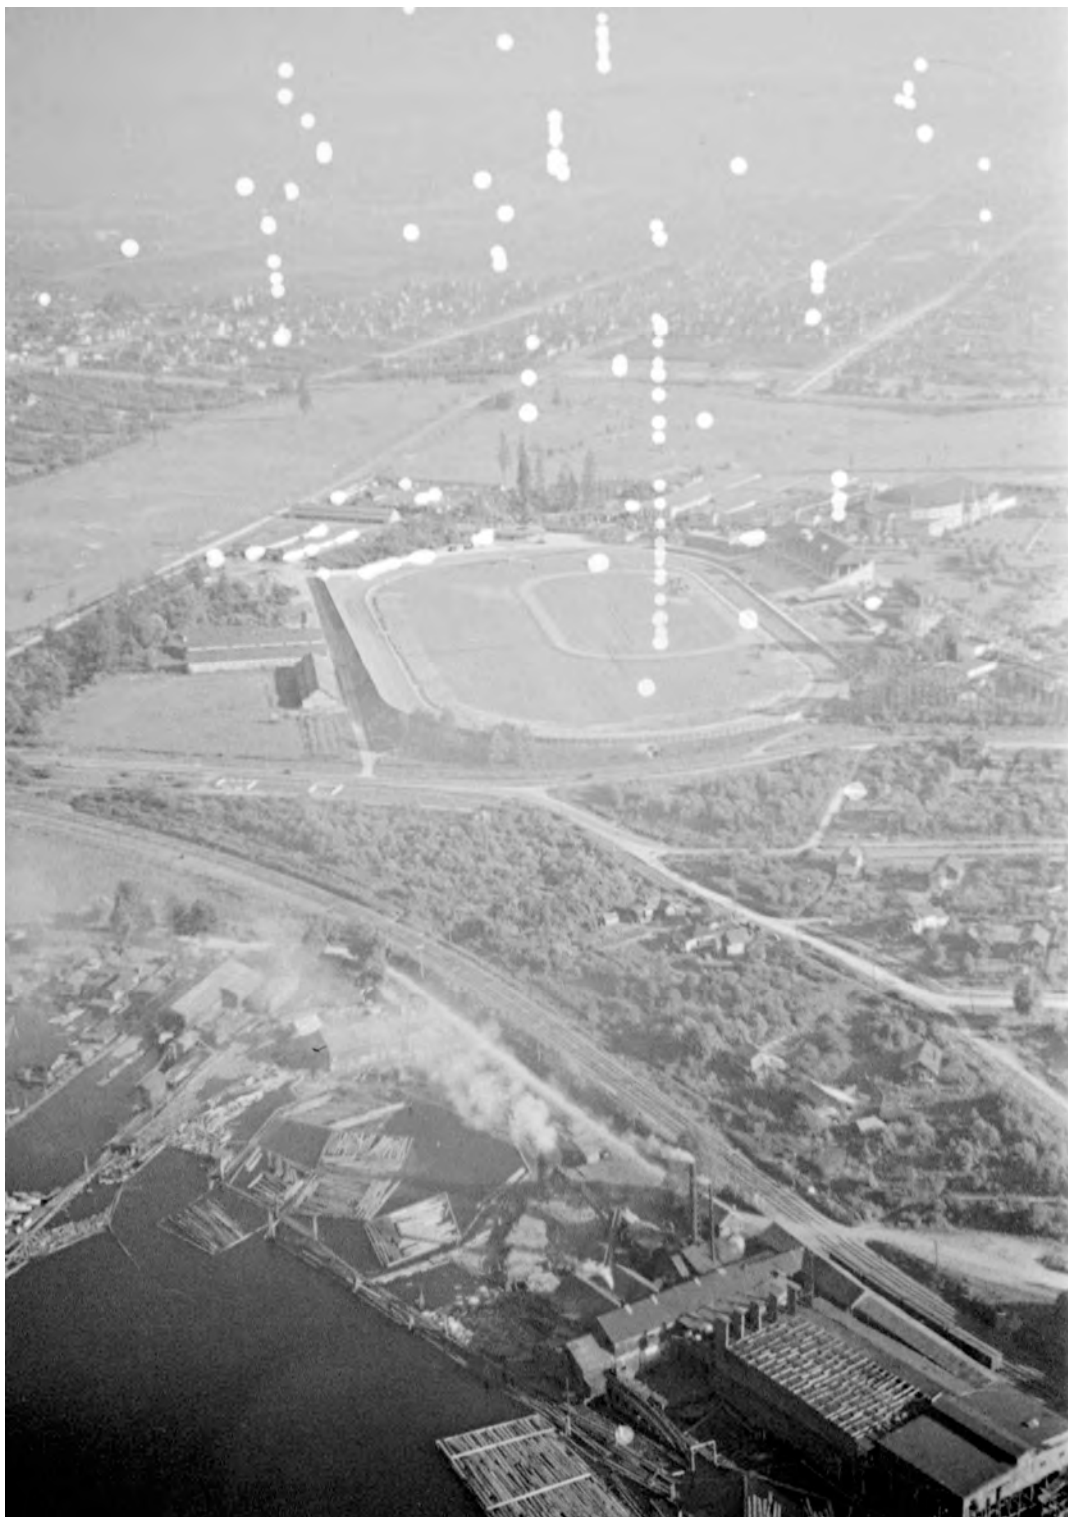
**Figure 9. Aerial view 1936 of Hastings Park looking east with log booms on south shore of Burrard Inlet (City of Vancouver Archives AM1376-: CVA 94-28).**

The progression of developments within Hastings Park since 1910 over the next 50 years is seen through a series of air photos (Figure 9, 10, 11). In the 1936 air photo (Figure 9) the forested areas in the eastern and southern portions of the Park are shown to be cleared, however a narrow forested strip on the western side of Windermere Street is still visible, indicating that Renfrew Creek had not yet been covered over. By 1947 (Figure 10) the narrow forested strip is gone, Windermere Street is still visible, and a bare ravine at the north end of the Park is all that remains of Renfrew Creek. A later photo from c. 1964 (Figure 11), after the construction of empire stadium a decade earlier, shows Renfrew Creek now completely covered over with no remnant visible on the surface.

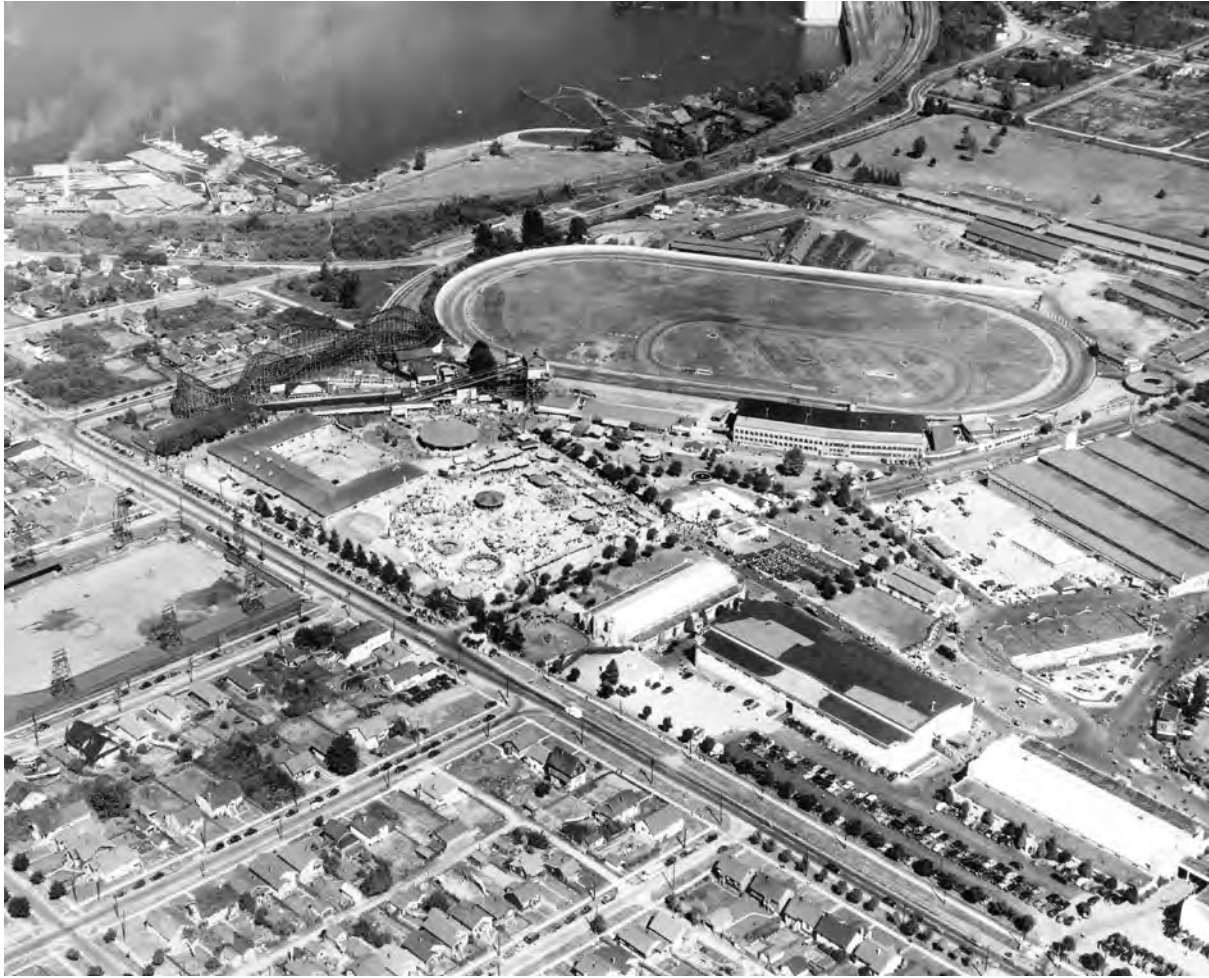
**Figure 10. Aerial view 1947 looking northeast over Hastings Park. The oblique view shows the Burrard Inlet shoreline, Renfrew Street, the Hastings Park race track, the amusement park including an enlarged roller coaster at its original location, and exhibition buildings (City of Vancouver Archives: AM281-S8-: CVA 180-1468).**

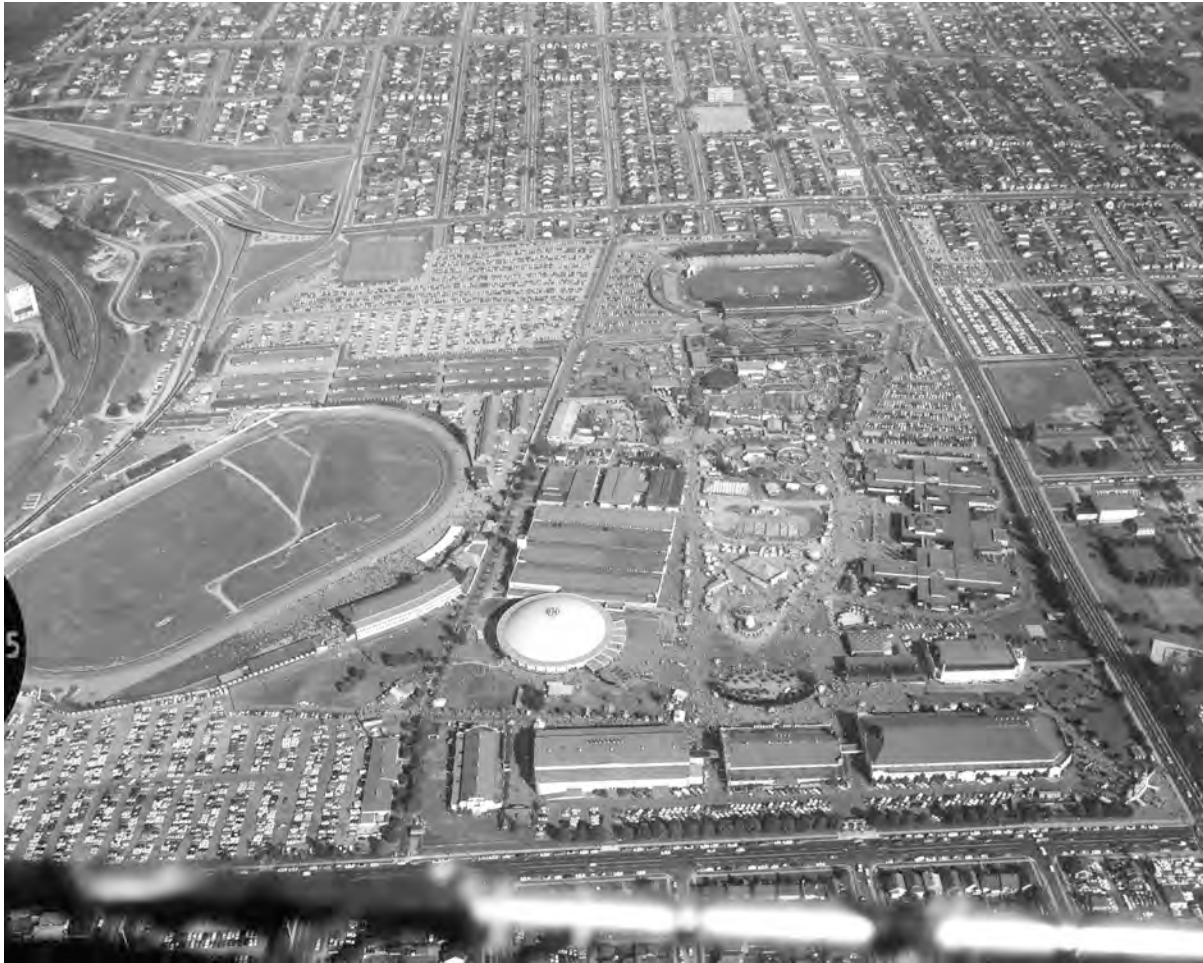
**Figure 11. Aerial view ca. 1964 looking east of PNE grounds and surrounding area where the roller coaster is shown in its new location after it was moved in 1958 to the southeast portion of Hastings Park (City of Vancouver Archives AM281-S8-: CVA 180-5256.4).**

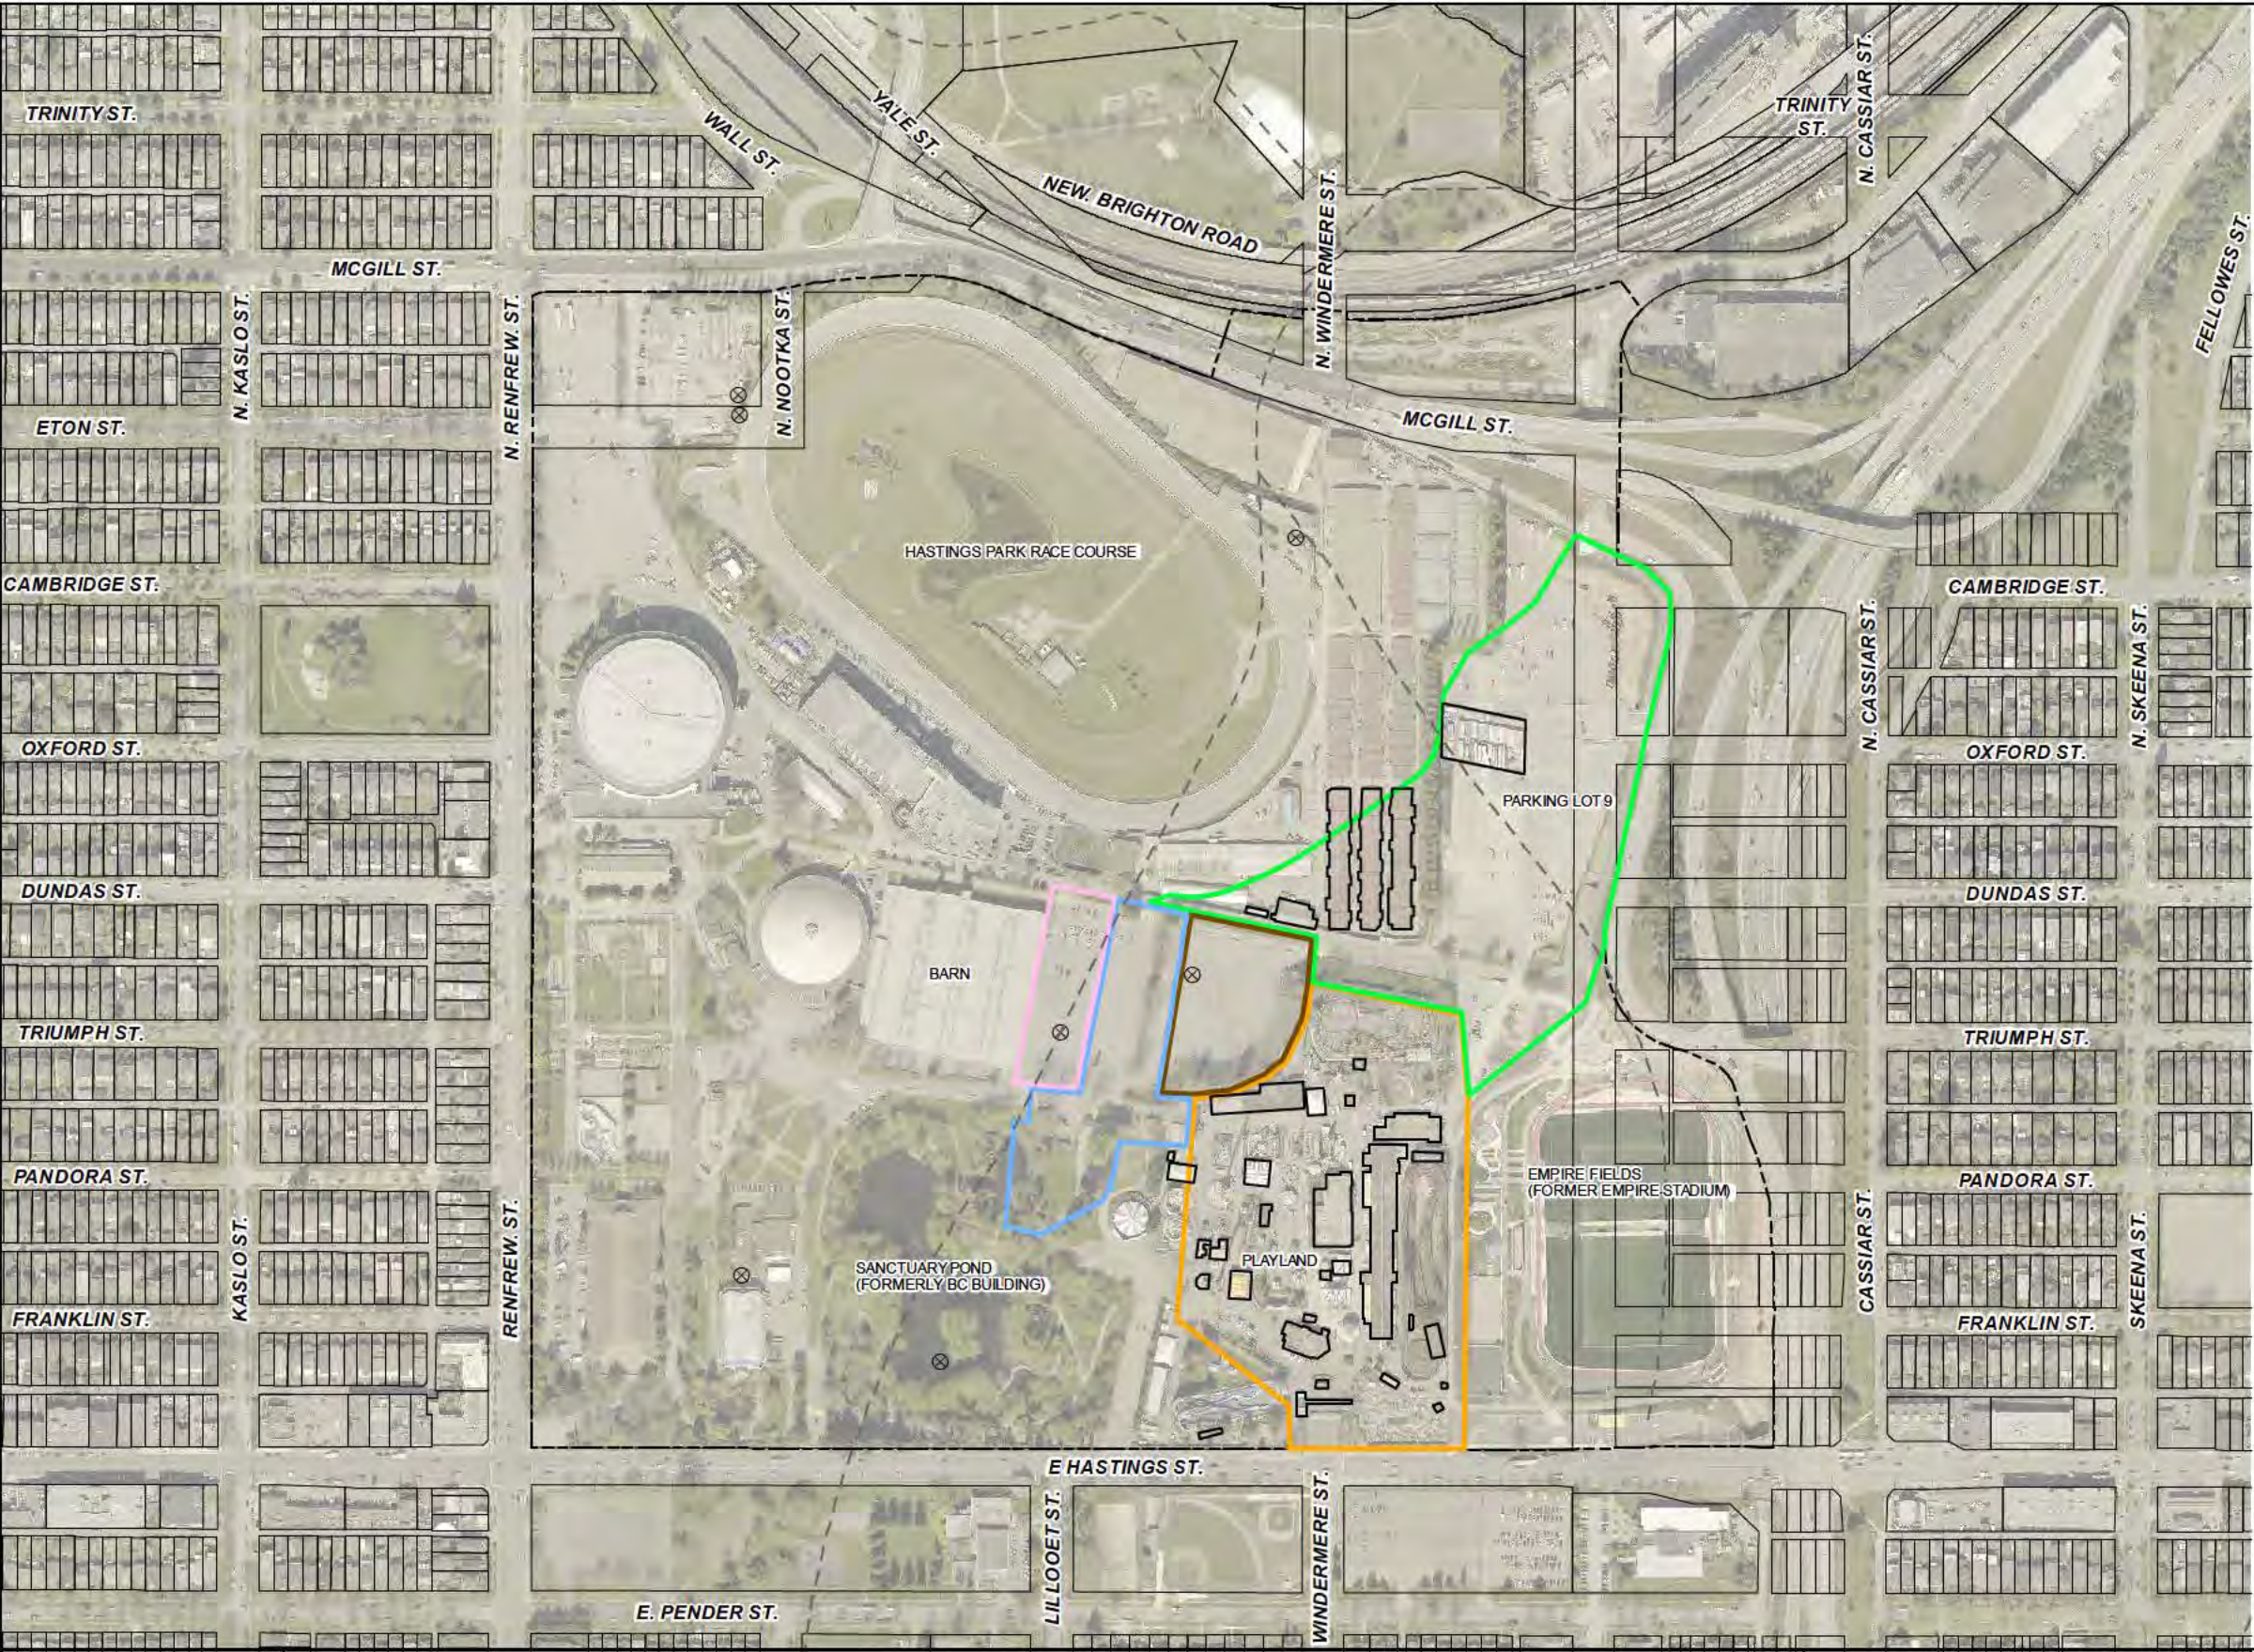
Figure 3  
Site & Surrounding  
Land Use Plan

LOCAL  
GROUNDWATER  
FLOW DIRECTION
