Re: Request for Access to Records under the Freedom of Information and Protection of Privacy Act (the "Act")

Any available geotechnical report and excavation and shoring drawings for the following properties:

HORIZON BC Housing 1338 Seymour Street, Vancouver, BC ENGINEERING INC Geotechnical Report

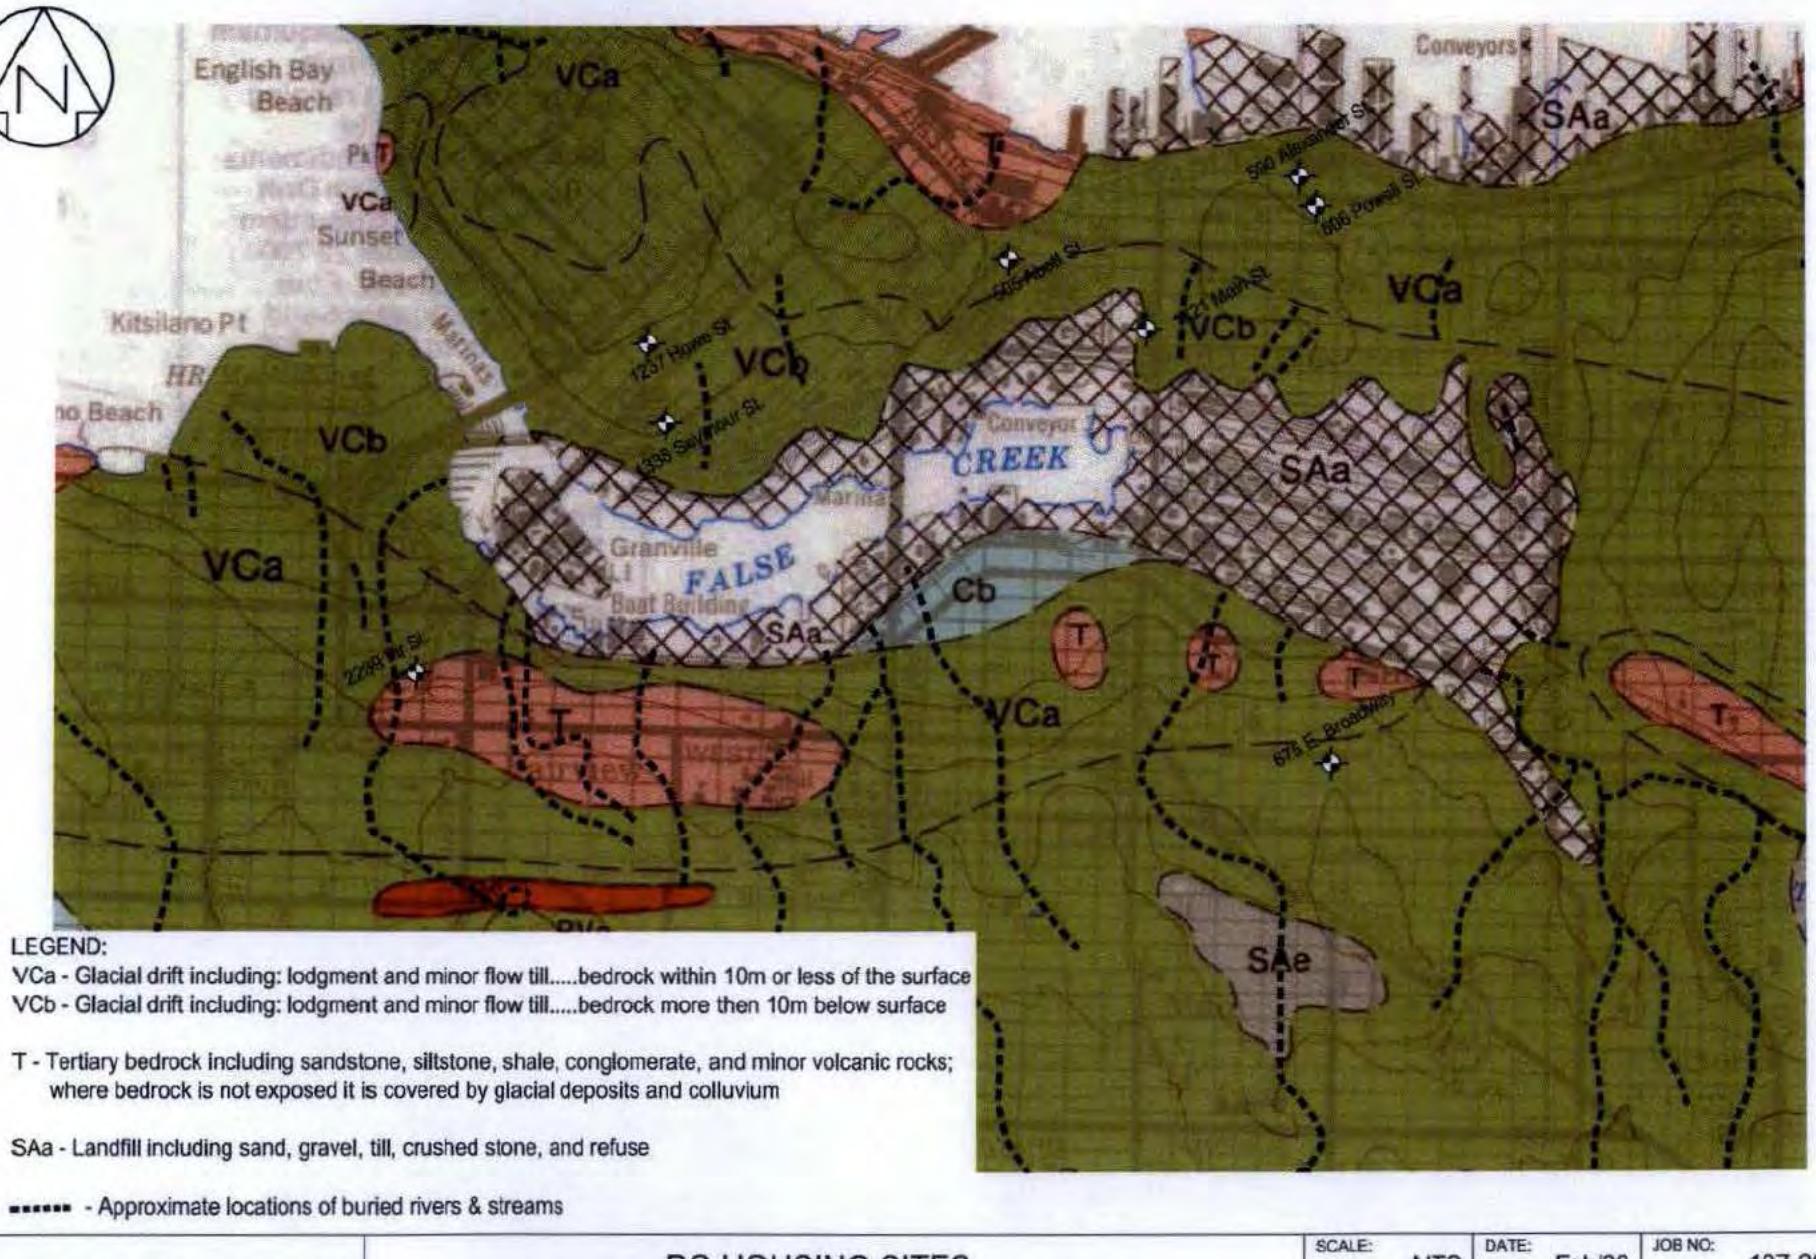
BC HOUSING SITES
LOCATED ON SURFICIAL GEOLOGY MAP
(Map 1468A, Surficial Geology Vancouver)

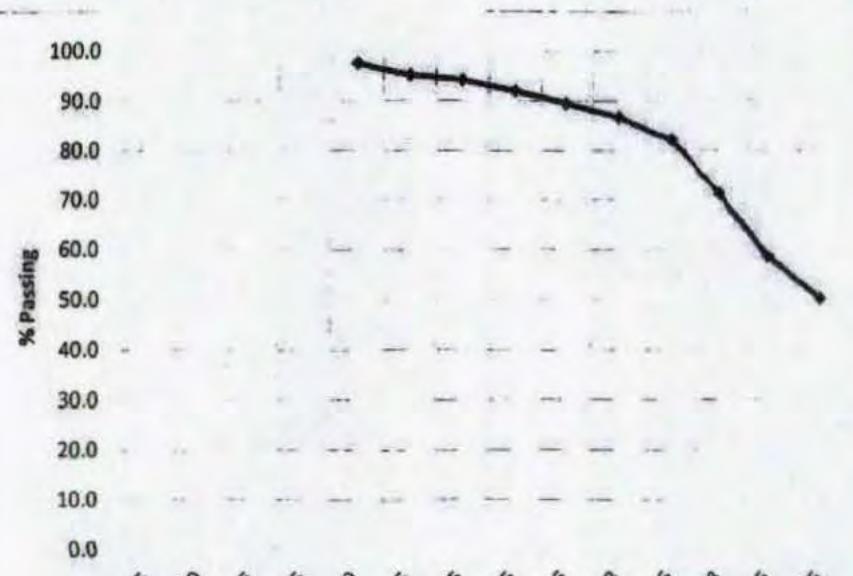
# SIEVE ANALYSIS REPORT (ASTM C136)

CLIENT:	WALL FINANCIAL	PROJECT #	9760
PROJECT NAME:	MIXED USE DEVELOPMENT		
PROJECT LOCATION:	1300 RICHARDS STREET, VANCOUVER	Contraction of the	
SPECIFICATION:	MMCD	TEST #:	TH11-01 16'
TYPE OF SAMPLE:	SAND AND GRAVEL	METHOD:	Wash
SOURCE:		DATE SAMPLED:	6-Sep-11
COLOUR:	GREY	DATE TESTED:	9-Sep-11

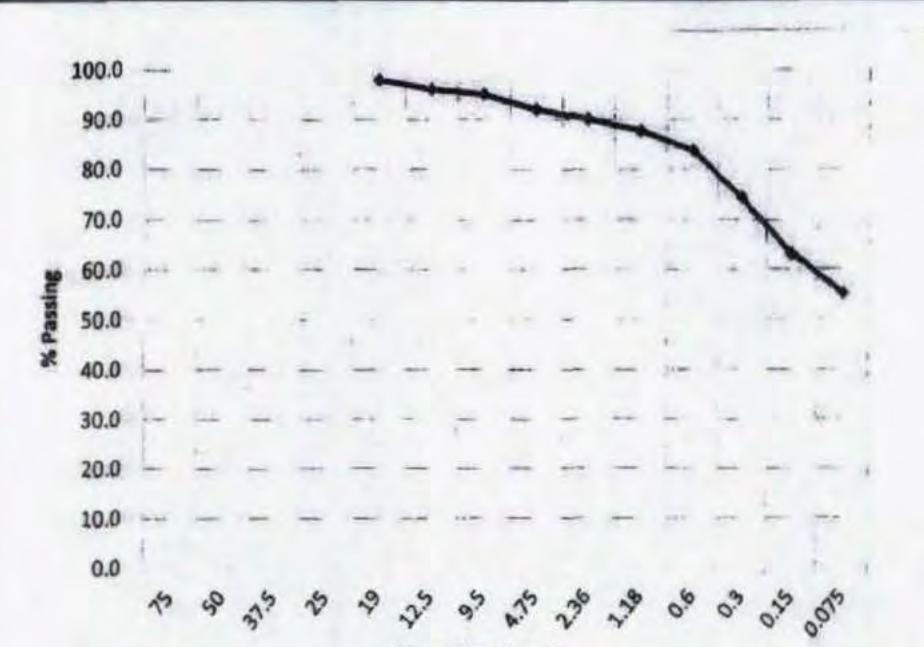
CLIENT:	WALL FINANCIAL	PROJECT #	9760
PROJECT NAME:	0		
PROJECT LOCATION:	1300 RICHARDS STREET, VANCOUVER		
SPECIFICATION:	MMCD	TEST #:	TH11-01 50'
TYPE OF SAMPLE:	SAND AND GRAVEL	METHOD:	Wash
SOURCE:		DATE SAMPLED:	6-Sep-11
COLOUR:	GREY	DATE TESTED:	9-Sep-11

GRAVE	L SIZES	% PASSING	GRADATION	SAND SIZES		%PASSING	GRADATION
(inch)	(mm)		LIMITS	(No.)	(mm)		LIMITS
3	75			4	4.75	92.0	1
2	50			8	2.36	90.0	
1.5	37.5			16	1.18	87.7	
1	25			30	0.8	83.7	
0.75	19	97.9		50	0.3	74.4	
0.5	12.5	96.1		100	0.15	63.2	
0.375	9.5	95.1		200	0.075	55.2

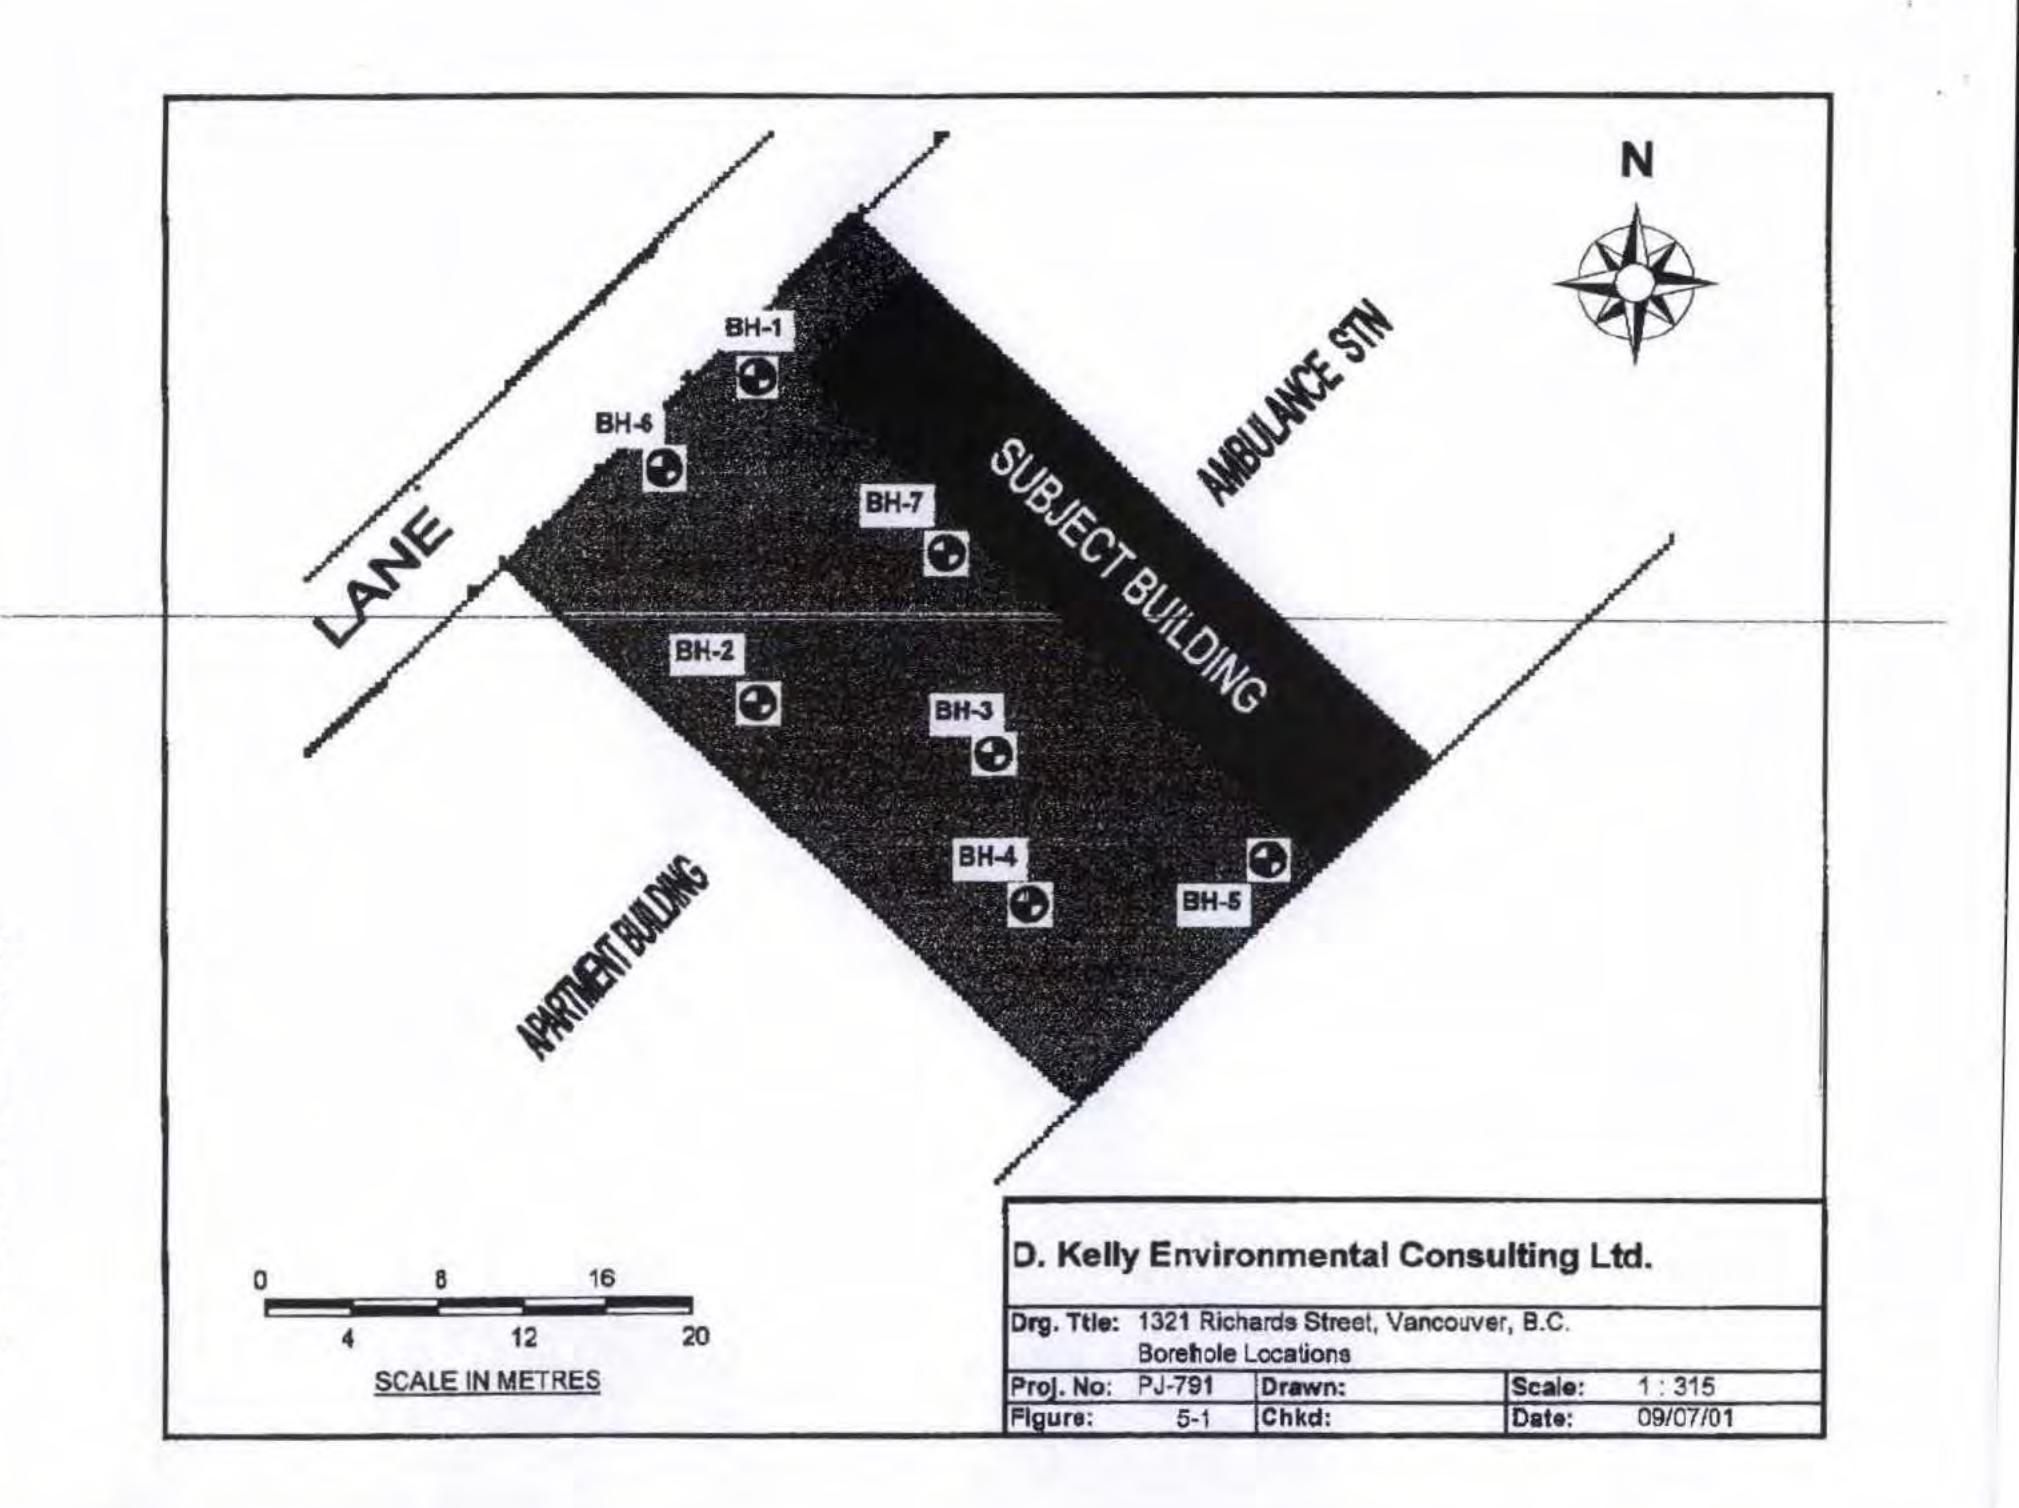
Borehole No.: BH-1 Project No.: PJ-791			Sheet 1 of 1				
Site Location: 1321 Richards Street, Vancouver, B.C. Driller: Downrite Drilling Date Drilled: 25 Drilling Method: Solid Stem Auger MONITORING WELL DATA Pipe: 50 mm Screen: # 10 Slot Other Monitors:	/06/01		Well Screen Bentonite Scol Filter Sand	SS - Split S WA - Wash AU - Auger CN - Contin RX - Rock ( GS - Grab )	mple Ty poon Sample Sample nuous Core Sample	<u>pe</u>	
		Denth		Samp	le	Soil	
SOIL DESCRIPTION	Strat Plot	Scale (m)	Monitoring Well Details	Number & Depth (m)	Type	Vapour Conc. (ppm)	
0 – 0.1 m Sand/Gravel 0.1 – 1.5 m Medium dense, dark to light brown, medium to coarse SAND 1.5 – 2.1 m Stiff, light brown, slightly clayey SILT with trace gravel, sandy from 2 m 2.1 – 3.8 m Dense to very dense, light brown to gray, slightly silty fine to coarse SAND with occasional cobbles				01 @ 0.7 02 @ 2.1	AU		
<ul> <li>Soil samples (01) &amp; (02) submitted for laboratory analysis</li> </ul>

Borehole No.: BH-2 Project No.: P	J-791		She	ət 1 of	1	
Site Location: 1321 Richards Street, Vancouver, B.C. Driller: Downrite Drilling Date Drilled: 25 Drilling Method: Solid Stem Auger MONITORING WELL DATA Pipe: 50 mm Screen: # 10 Slot Other Monitors:	:. :/06/01		Well Screen Bentonite Seal Filter Sand	SS - Split S WA - Wash AU - Auger CN - Contin RX - Rock ( GS - Grab 3	mple Ty poon Sample Sample Jore Sample	<u>Pe</u>
		Denth		Samp	8	Soil
SOIL DESCRIPTION	Strat Plot	Scale (m)	Monitoring Well Details	Number å Dapth (m)	Type	Vapour Conc. (ppm)
0 – 0.6 m Mainly SAND with gravel				03 @ 0.3	AU
