Record of the most recent and full City Inspection Report for the Flint Hotel at 1516 Powell Street as per the Standards of Maintenance Bylaw (Bylaw #5462). Date Range: January 1, 2020 - June 11, 2021.

Standards of Maintenance By-law No. 5462

Reason for Inspection Planned Annual Inspection of Common Areas Only

RE: 1516 POWELL STREET – FLINT HOTEL

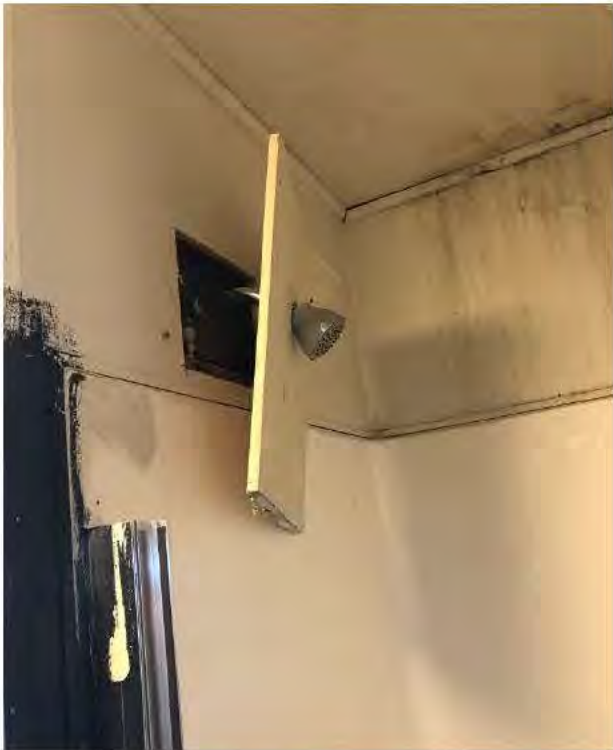
7. 3rd Floor Bathroom @Room - Walls - drywall damaged - S/M Bylaw 5462 Section 21.10(d) - Photo 3
8. 3rd Floor Bathroom @Room - Electrical switch - cover plate missing - S/M Bylaw 5462 Section 21.10(c) - Photo 4

<p>Photo 3 - Violation 7</p> <p>3rd Floor Bathroom @Room § 22(1)</p> <p>Walls - drywall damaged</p>

Therefore, in accordance with Section 23.2 of the By-law, you are ordered to correct the above-noted deficiencies (item nos. 1 thru 22) **within 30 days of the date of this order.**

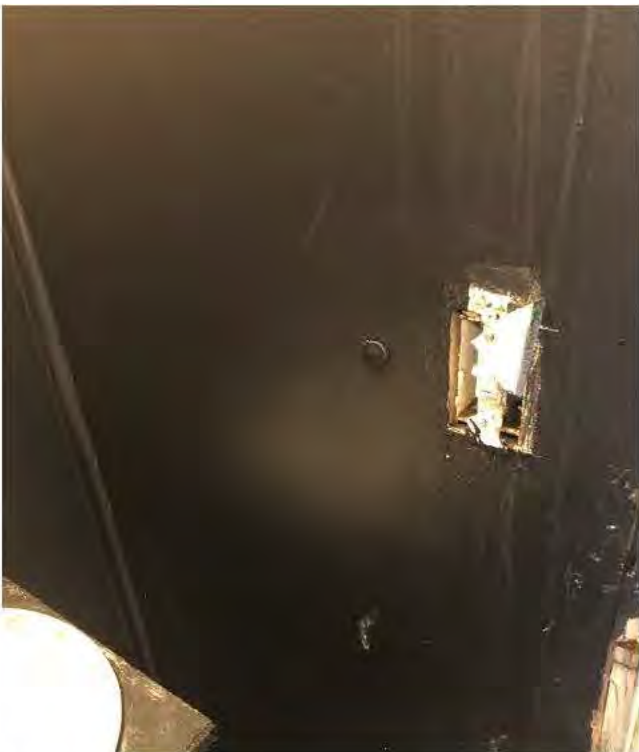
<p>Photo 4 - Violation 8</p> <p>3rd Floor Bathroom @Room § 22(1)</p> <p>Electrical switch - cover plate missing</p>

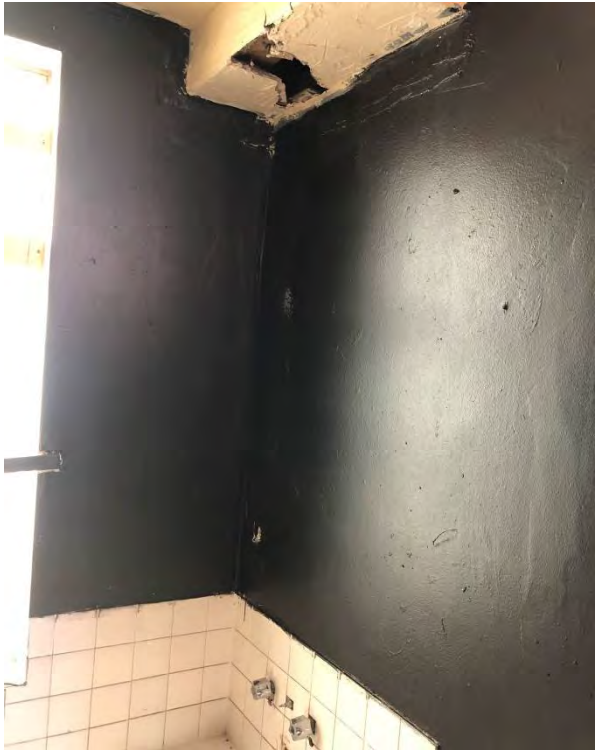
13. 2nd Floor Bathroom @Room - Ceiling - damaged drywall - S/M Bylaw 5462 Section 21.10(d) - Photo 7
14. 2nd Floor Bathroom @Room - Sink - tap missing - S/M Bylaw 5462 Section 21.10(f) - Photo 8

A photograph showing a corner of a bathroom. The ceiling is dark and appears to be made of drywall, with a significant portion missing or crumbling away, revealing the underlying structure. The walls are also dark, and the floor is covered in light-colored tiles. A door handle is visible on the left side of the frame.	<p>Photo 7 - Violation 13</p> <p>2nd Floor Bathroom @Room s.22(1)</p> <p>Ceiling - damaged drywall</p>

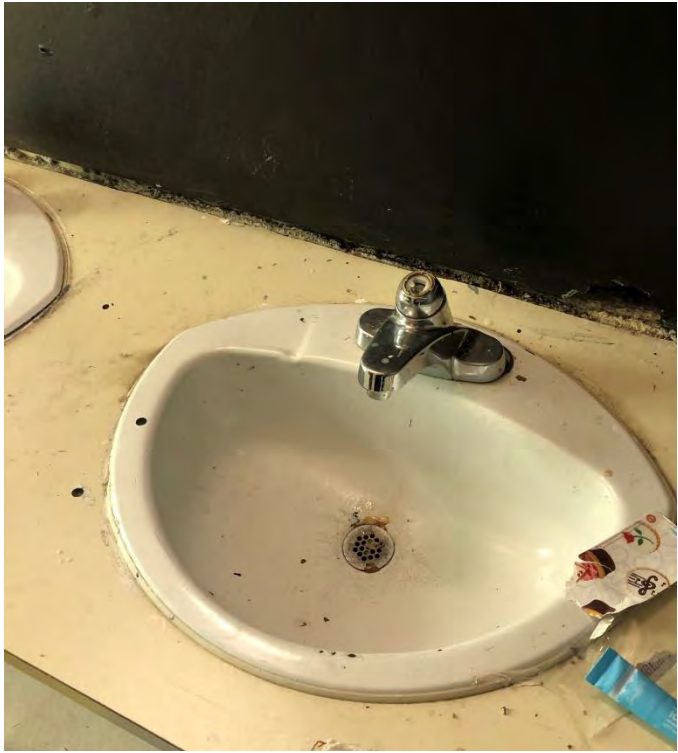
A photograph of a white, oval-shaped sink set into a light-colored countertop. The sink has a single-lever chrome faucet. The countertop is cluttered with various items, including a small box and some debris. The background wall is dark and appears to be made of drywall.	<p>Photo 8 - Violation 14</p> <p>2nd Floor Bathroom @Room s.22(1)</p> <p>Sink - tap missing</p>

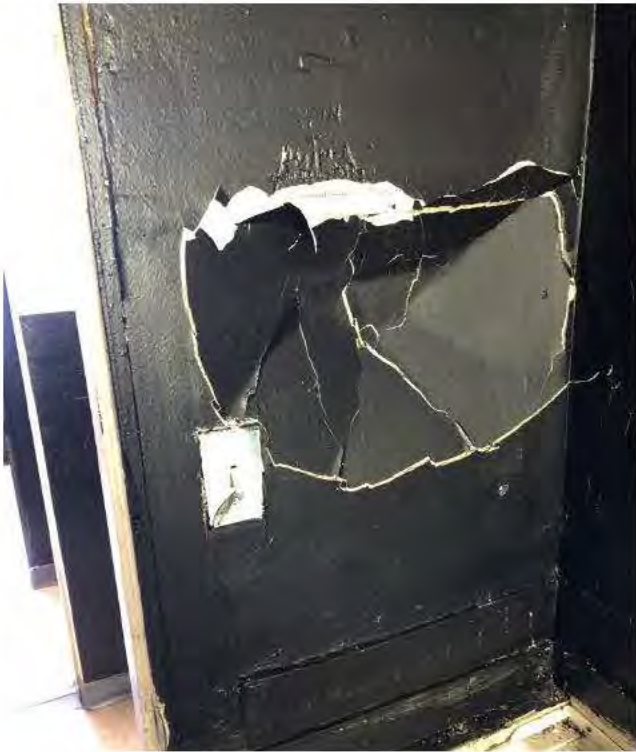
16. 2nd Floor Bathroom @Room §22(1) - Walls - drywall damaged - S/M Bylaw 5462 Section 21.10(d) - Photo 9
17. 2nd Floor Bathroom @Room - Sink - plugged - S/M Bylaw 5462 Section 21.10(f) - Photo 10
18. 2nd Floor Bathroom @Room - Ceiling - damaged drywall - S/M Bylaw 5462 Section 21.10(d) - Photo 11
19. 1st Floor Bathroom @Room - Sink - tap missing - S/M Bylaw 5462 Section 21.10(f) - Photo 12
20. 1st Floor Bathroom @Room - Walls - drywall damaged - S/M Bylaw 5462 Section 21.10(d) - Photo 13
21. 1st Floor Bathroom @Room - Sink and Bathtub - taps missing - S/M Bylaw 5462 Section 21.10(f) - Photo 14
22. 1st Floor Hallway @Bathrooms - Walls - drywall damaged at baseboards - S/M Bylaw 5462 Section 21.10(d) - No Photo

<p>Photo 9 - Violation 16</p> <p>2nd Floor Bathroom @Room § 22(1)</p> <p>Walls - drywall damaged</p>

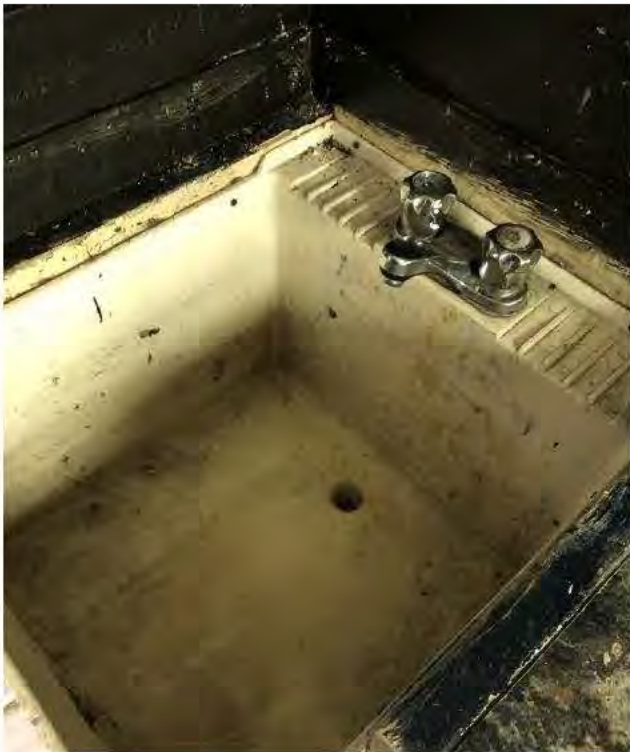
<p>Photo 10 - Violation 17</p> <p>2nd Floor Bathroom @Room § 22(1)</p> <p>Sink - plugged</p>

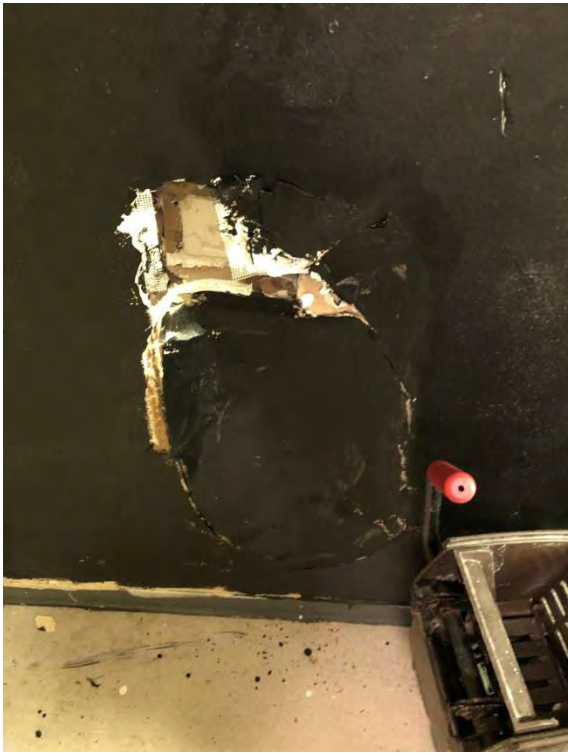
<p>Photo 13 - Violation 20</p> <p>1st Floor Bathroom @Room s.22(1)</p> <p>Walls - drywall damaged</p>

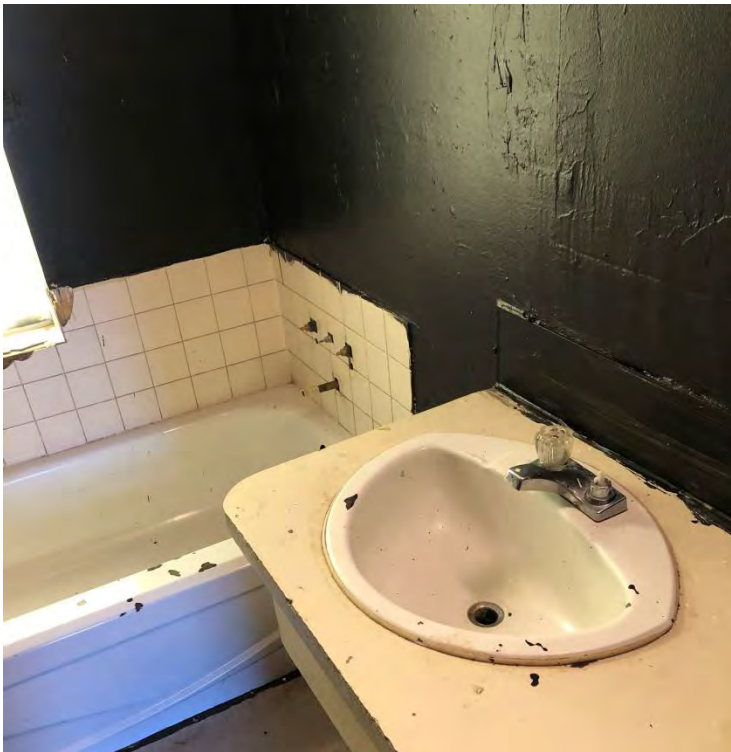
<p>Photo 14 - Violation 21</p> <p>1st Floor Bathroom @Room s.22(1)</p> <p>Sink and Bathtub - taps missing</p>
