City of Vancouver

Bridge Engineering Services

Task C1 - Detailed Visual Inspections

Our Ref: 2068-016-RPT-GEN-001-0

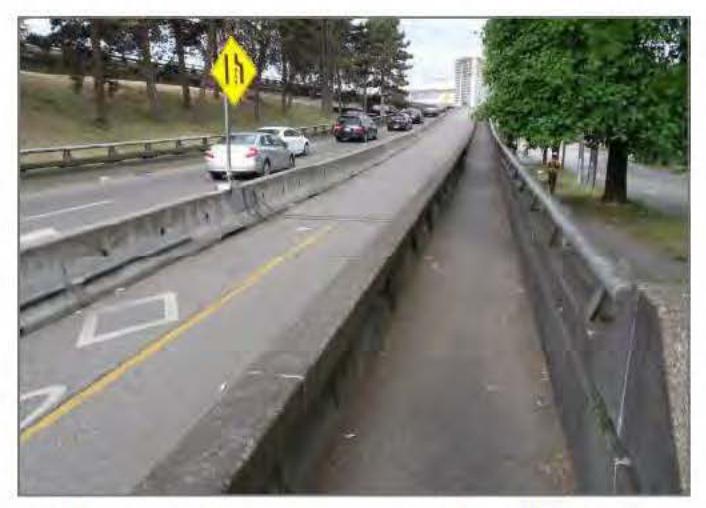
G1. View west along on-ramp approach from Main Street.

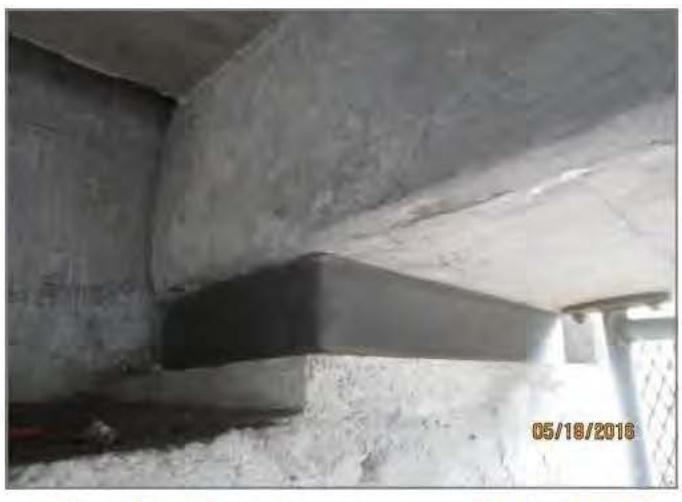
G2. Typical bearing condition at on-ramp abutment (DM2).

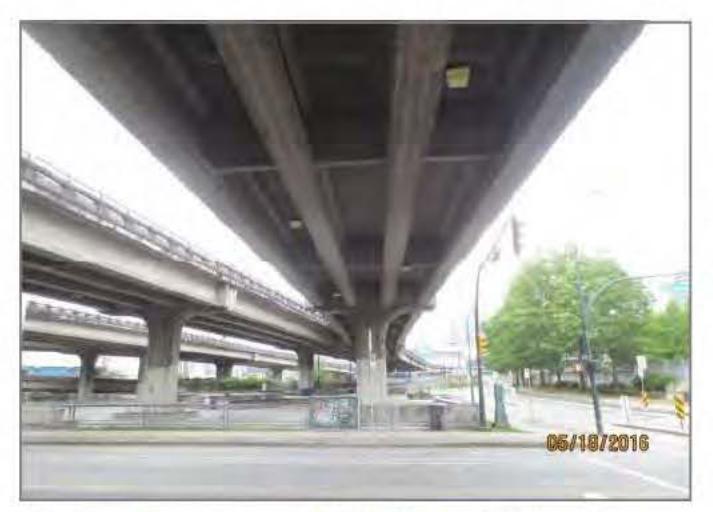
G3. View of on-ramp span DM4-DM5 over Quebec St.

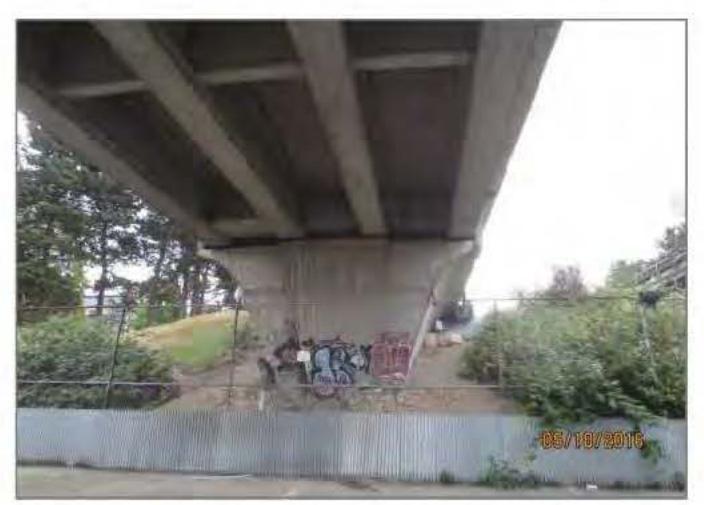
G4. General view of east abutment at D2.

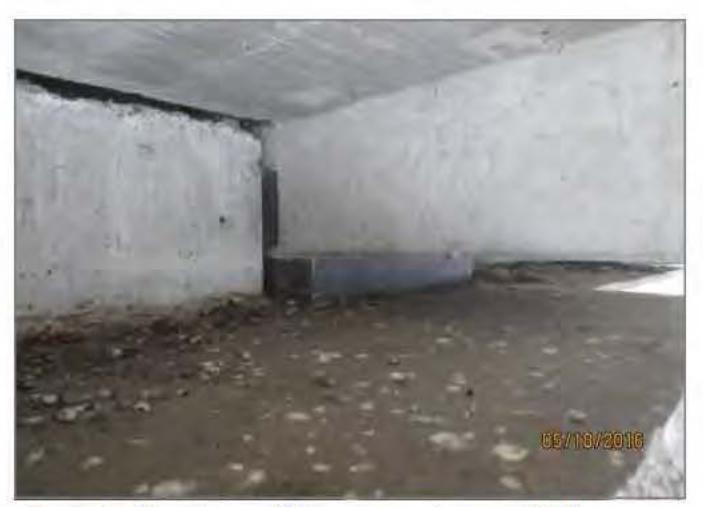
G5. Typical bearing condition at east abutment (D2).

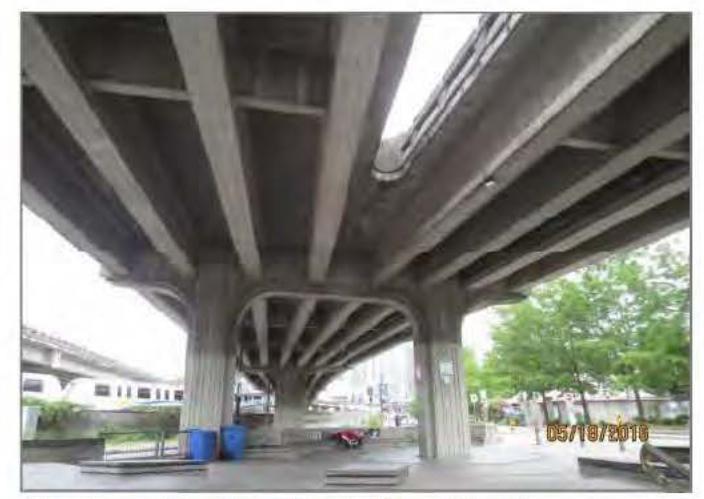
G6. On-ramp junction with mainline at Pier D6.

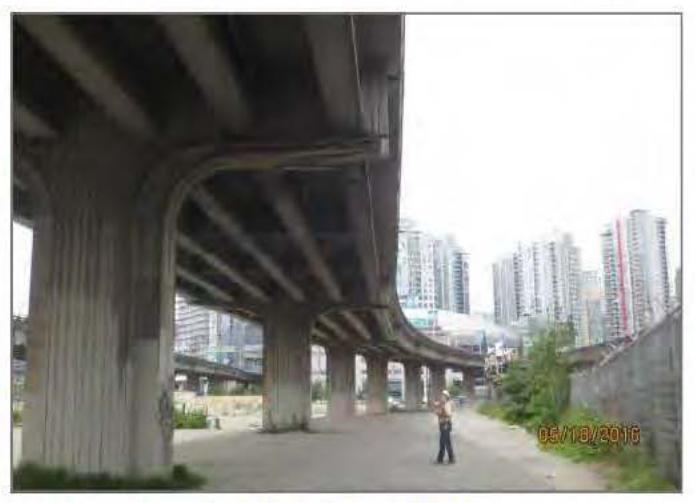
G7. General view looking west from Pier D8.

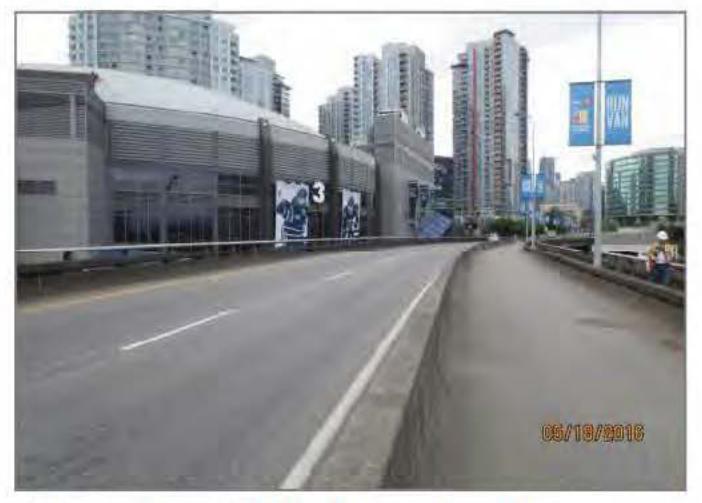
G9. General view of deck looking west from D14.

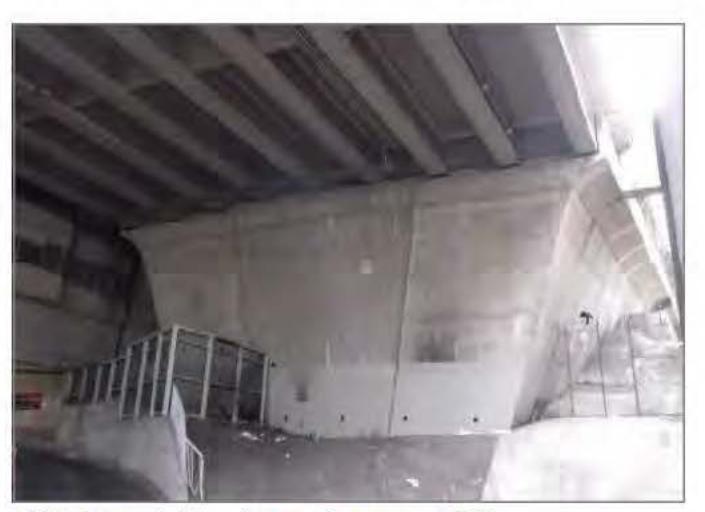
G11. General view of west abutment at D23.

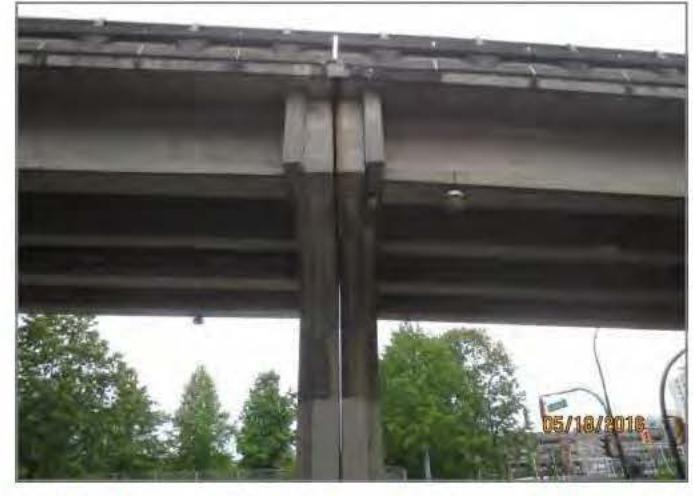
G8. Gap between piers at expansion joint; Pier DM5 shown.

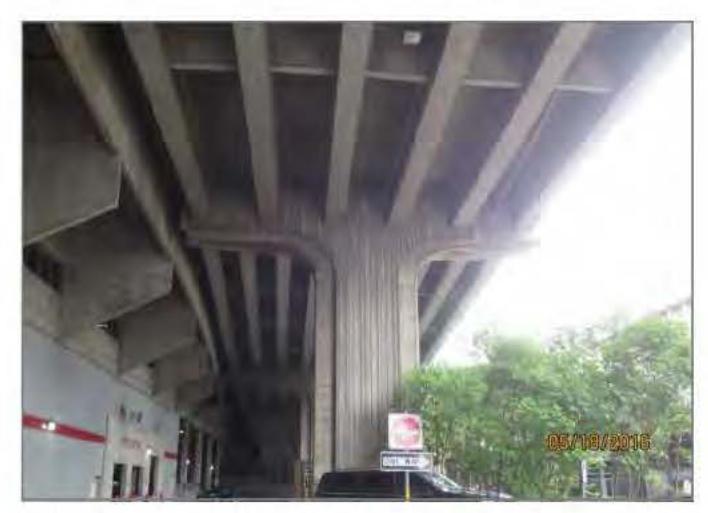
G10. East face of Pier D21 north of the Costco building.

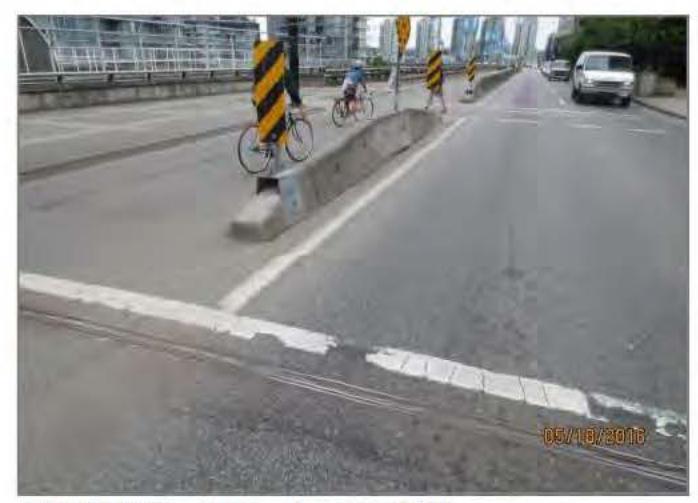
G12. Deck joint at west abutment (D23).

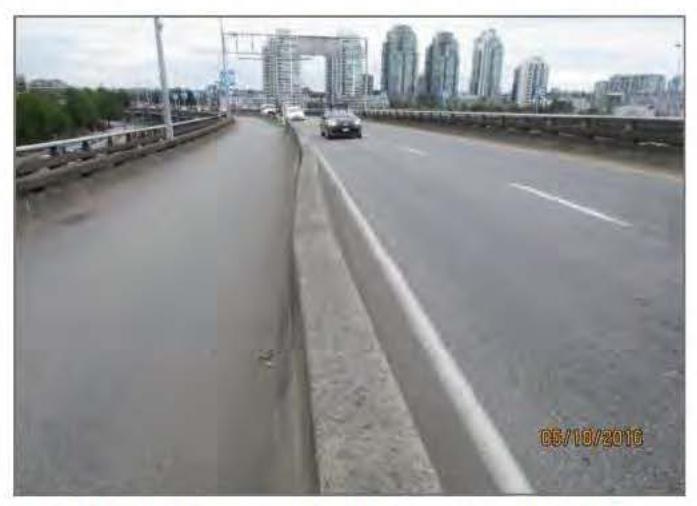
D19. Slight misalignment of traffic barrier near Pier D15.

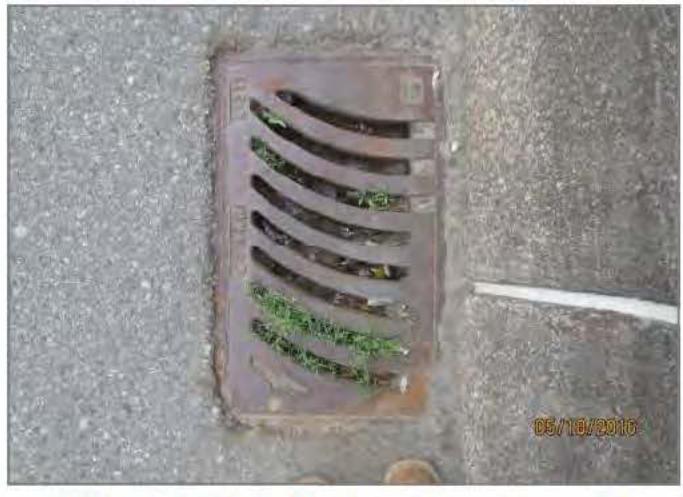
D20. Drain basin filled with debris and vegetation at DM5.

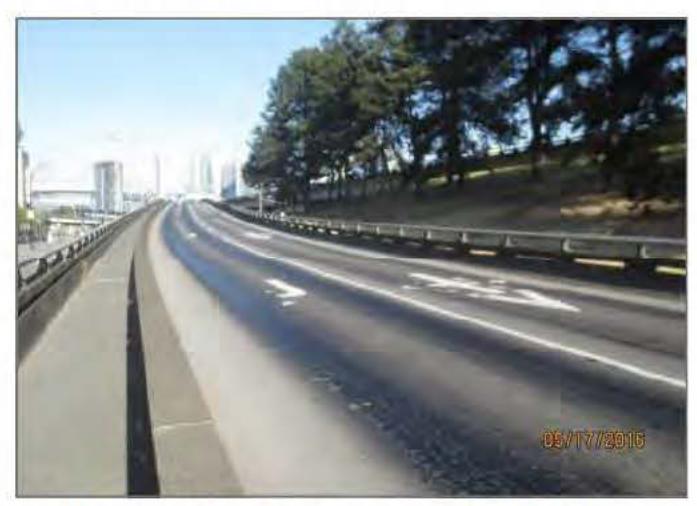
G1. View west along off-ramp approach from Main Street.

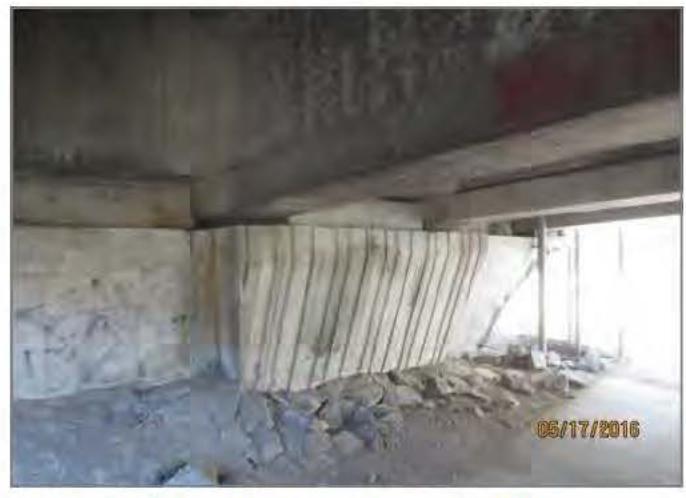
G2. General view of off-ramp abutment at GM2.

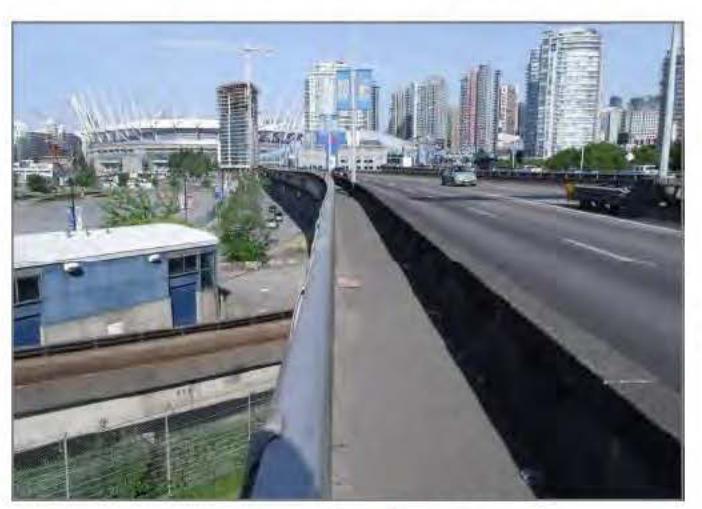
G3. View west near off-ramp junction with mainline.

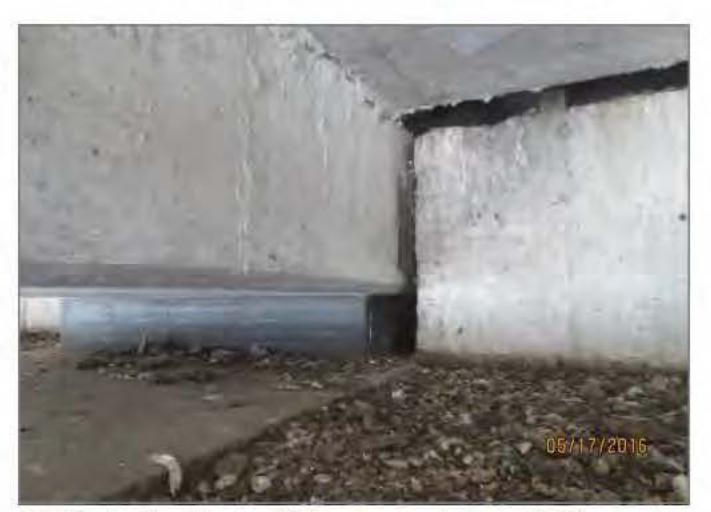
G5. Typical bearing condition at east abutment (G2).

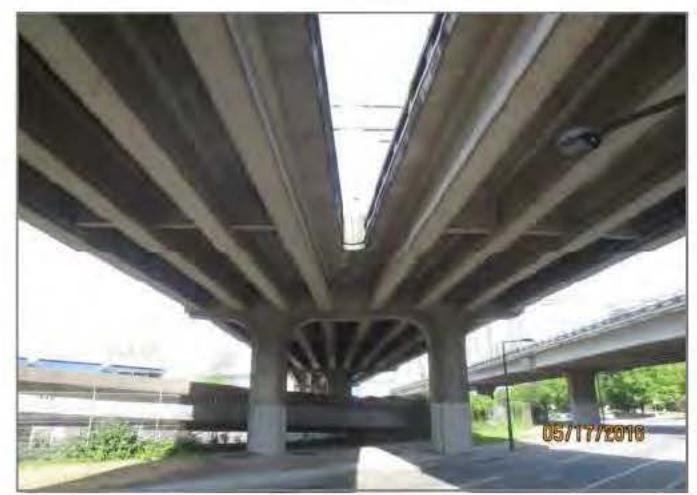
G6. Off-ramp junction with mainline at Pier G6.

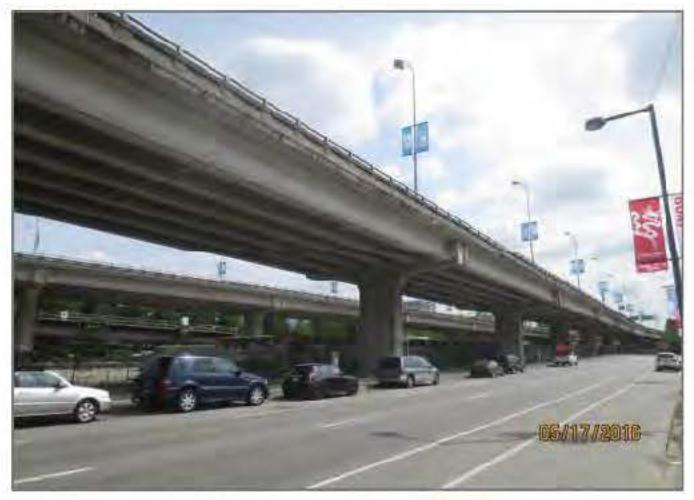
G7. General view looking west from Pier G13.

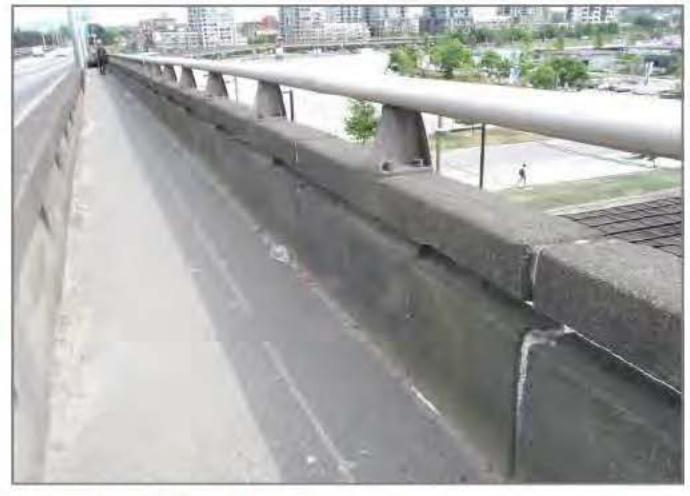
G8. General view of south parapet.

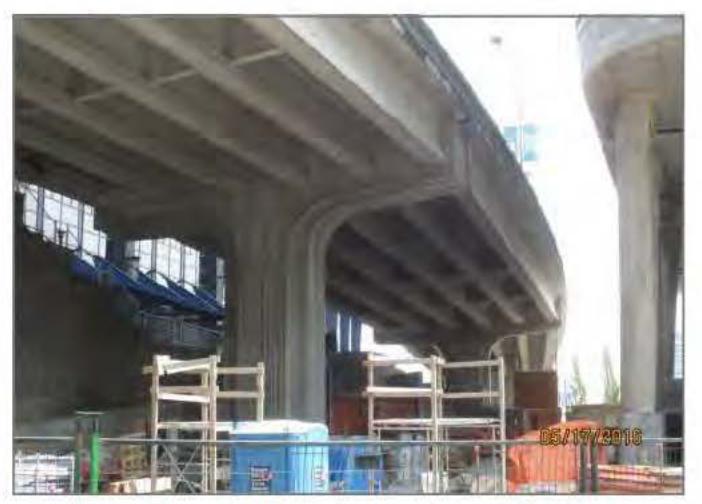
G9. Pier G19 fenced off due to construction activities.

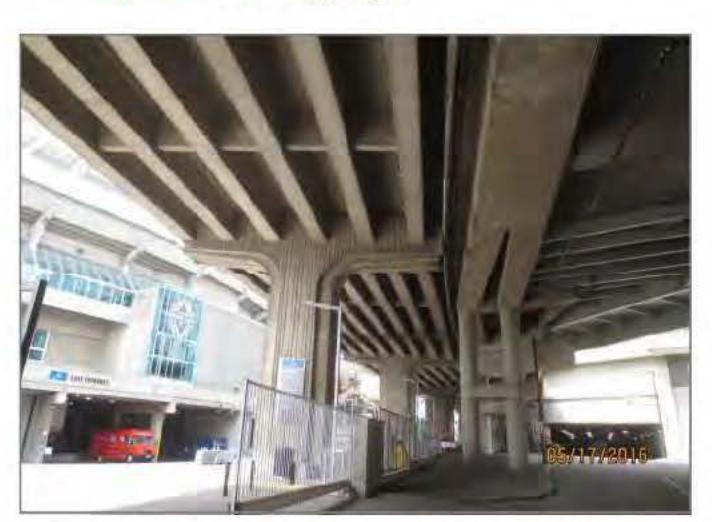
G10. Pier G21 between Rogers Arena and BC Place Stadium.

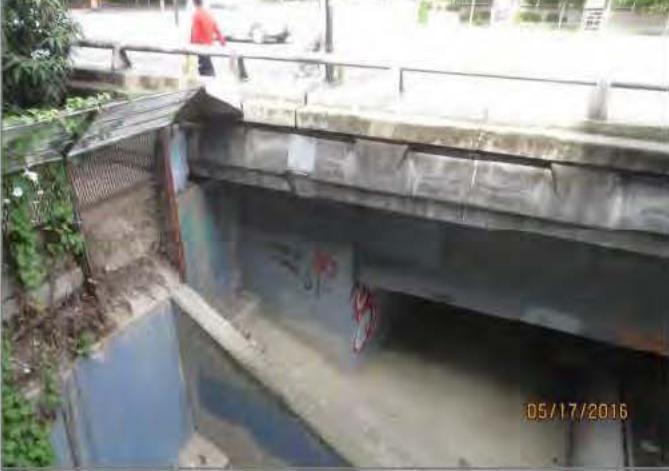
G12. South end of west abutment at G27.

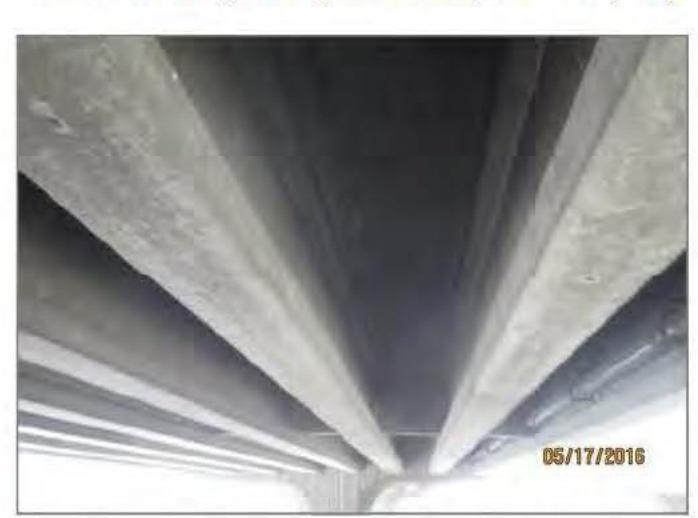
D9. Deck soffit spall with exposed rebar at Pier G6.

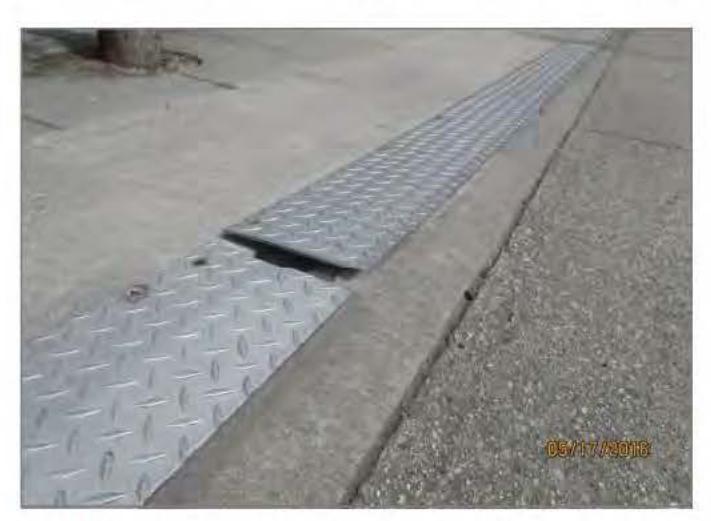
D20. Deck joint steel at Pier G20 which rattles with live load.

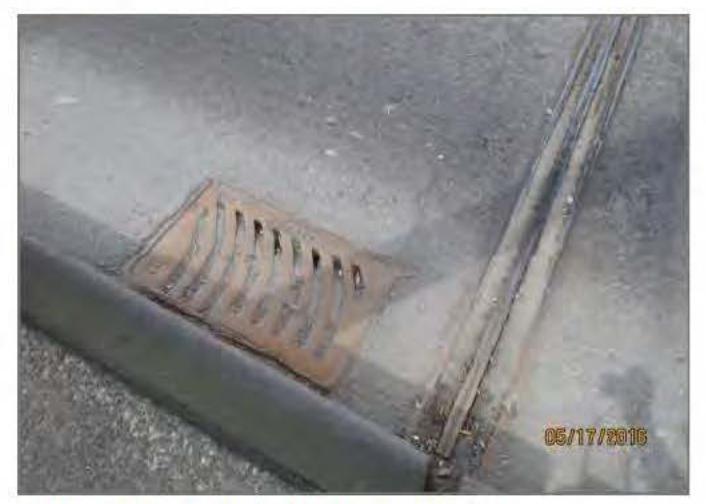
D25. Drain basin filled with debris at Pier G9.

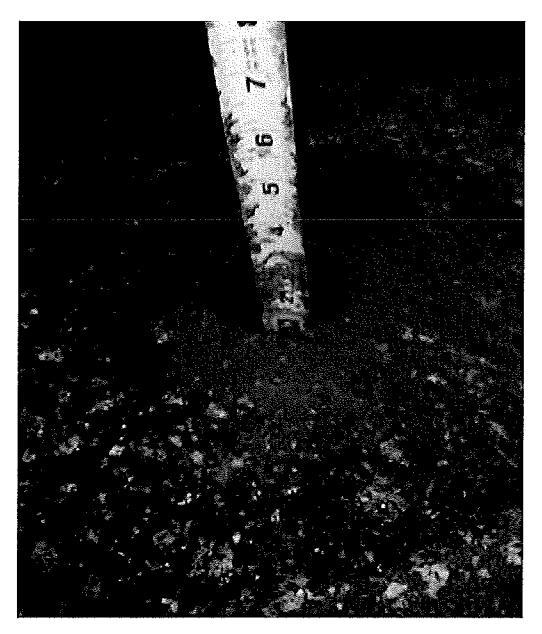
Photo 1 – Asbestos-containing asphalt – Core sample Approx 3" Depth

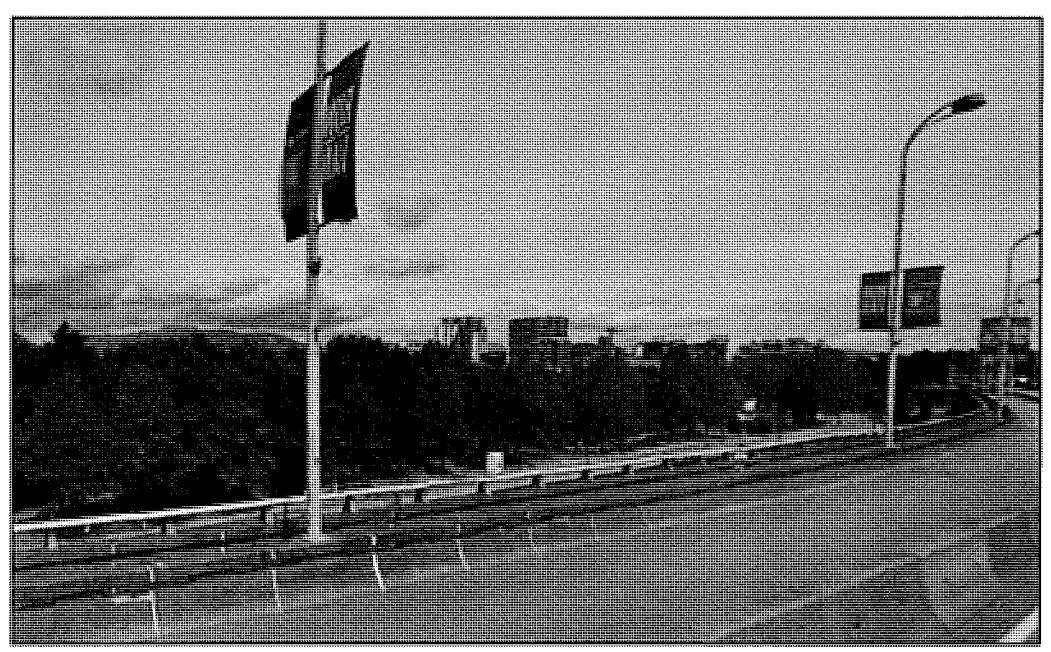
Photo 2 – Lead-based painted lamp post& galvanised railing

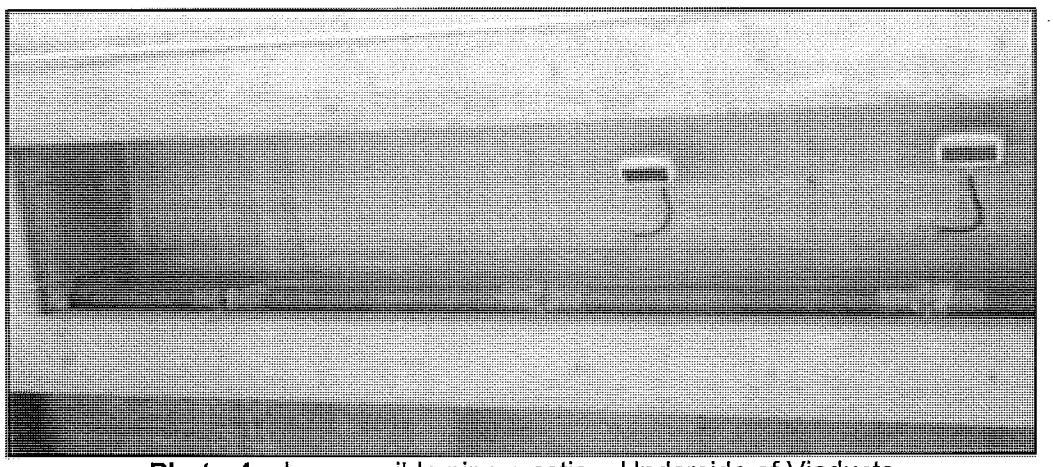
Photo 4 – Inaccessible pipe mastic – Underside of Viaducts

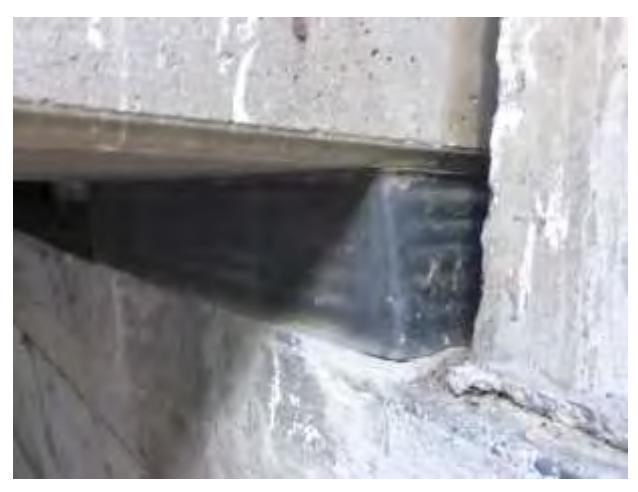
The bearings had typical outward bulging between reinforcing plates (Figure 14), as expected under vertical loading. Slight transverse deformation (10 to 15 mm) towards the south was observed in some bearings (Figure 15), but this is well within the pad's

Figure 15. Slight transverse deformation of bearings (girder A bearing shown)

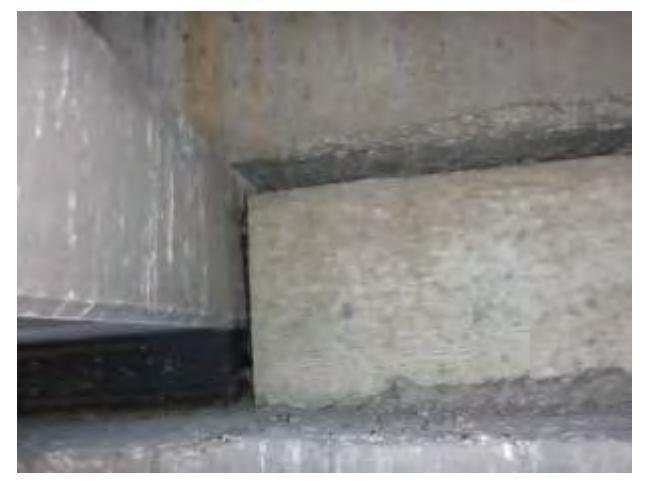
The concrete shear key between the bottom flanges of girders E and F was in good condition with no signs of cracking or damage (Figure 16). The gaps between the shear key and the bottom flanges of adjacent girders E (north of shear key) and F (south of shear key) were 15 and 30 mm, respectively. If the girders were equidistant from the shear key at time of installation, they have moved 7.5 mm to the south. This is consistent with the southwards deformation of the bearings mentioned above. There was no distress observed as a result of this transverse displacement.

Figure 16. Shear key at interface with girder F (sixth girder from north)

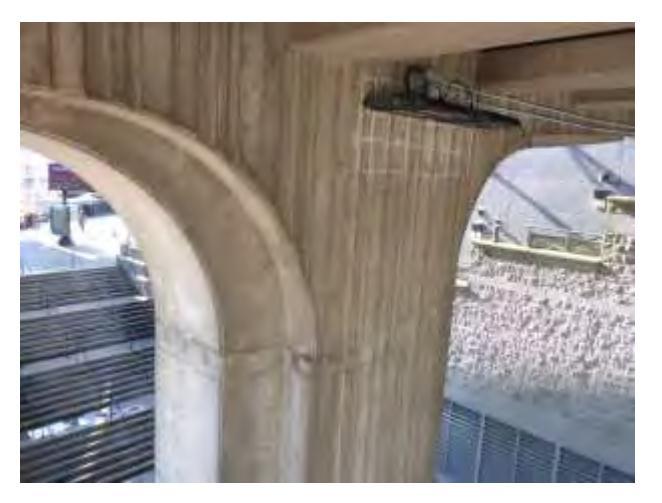
Horizontal construction joints were observed on all columns (Figure 18, Figure 20), which are attributed to staged pours during construction. Localized concrete repairs were noted on the margins of these joints where previous delamination, spalling and forming defects were previously addressed.

Figure 20. Pier D18 : Typical diagonal construction joint

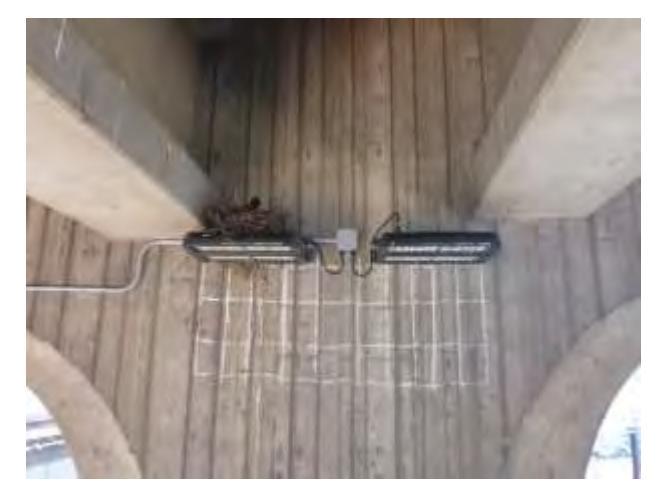
Bird's nests were observed above some lamps mounted on piers (Figure 21). This is considered a fire hazard and should be removed. We recommend installing bird spikes or other deterrent devices above these lamps to discourage nesting.

Figure 21. Bird's nest at pier D17

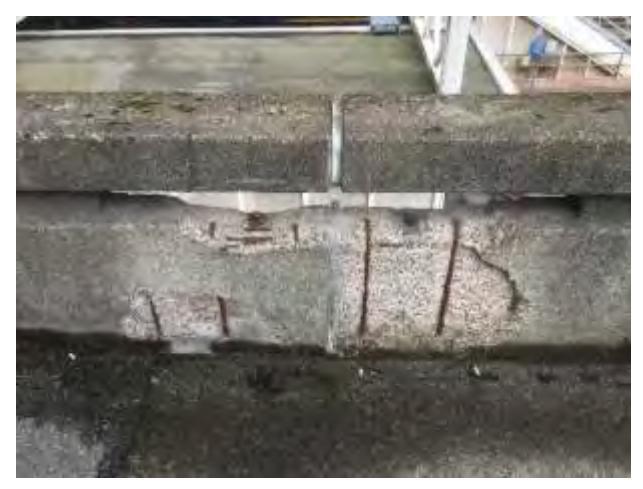
Figure 24 through Figure 28 show the precast guardrails, handrails and median barriers on the bridge. Past inspection reports have highlighted extensive spalling and rebar corrosion in the existing handrails and guardrails. Our inspection identified consistent defects in the handrails and guardrails.

Figure 25. Precast north handrails: Concrete spalling and rebar corrosion on south face

Once the new Georgia Ramp is completed, spans D17 to D23 of the Dunsmuir Viaduct will either be rehabilitated or demolished. If the City of Vancouver decides to rehabilitate them, as part of the general rehabilitation design and for compatibility with the New Dunsmuir Elevated Park, all existing barriers would be removed and replaced with new pedestrian / bicycle barriers. Given the short remaining functional life of these barriers, we do not recommend any repairs.

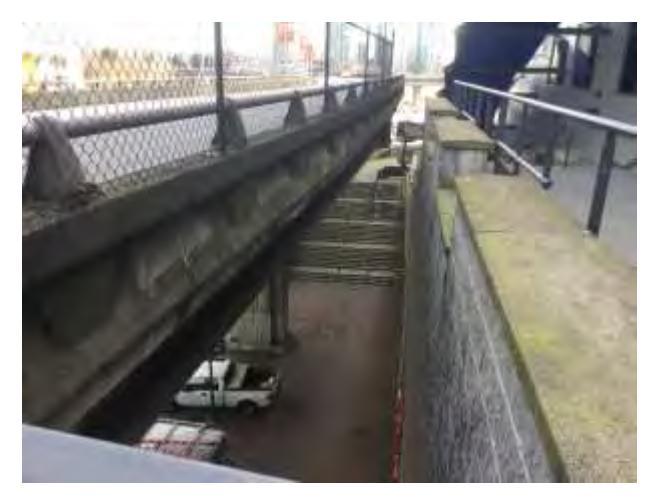
The south side of the south guardrail appears been patched (Figure 29) around the entrance to Rogers Arena. Sounding by hammer of the concrete on the exterior faces of the south guardrail and north handrail did not reveal any delamination. Therefore, these barriers do not pose a safety threat to pedestrians below the bridge.

Figure 29. Looking east: South guardrail, span D18-D19: Previous patches are visible.

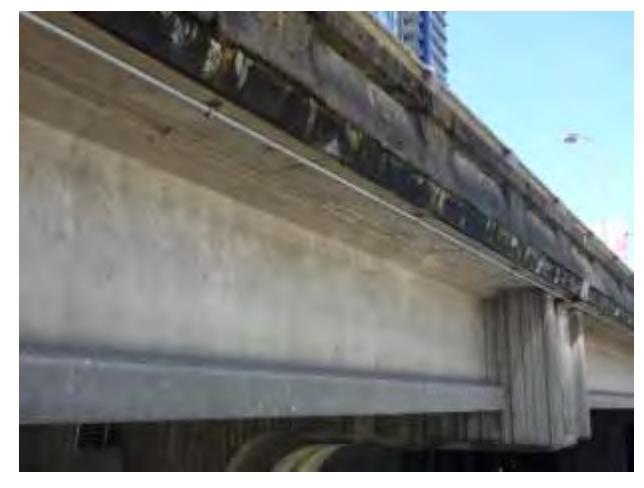
Algal growth and wetness was observed on both the vertical edges of the deck along the entire viaduct (Figure 31). This points to water seepage through the grouted horizontal joint between the precast barriers and the top of the deck. The drip grooves have mostly prevented this water from running down the deck soffit towards the exterior girders (Figure 32).

Figure 32. Drip groove prevented water from running down deck soffit towards exterior girder

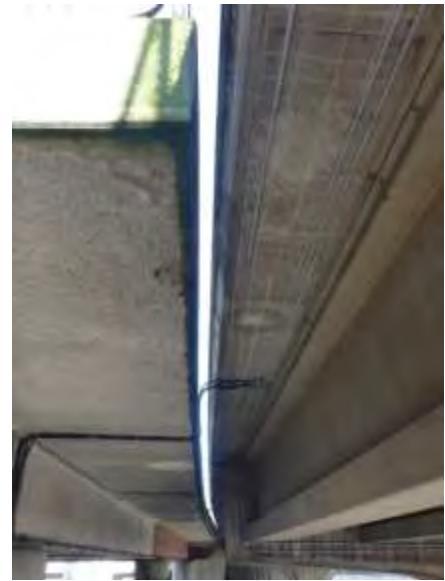
Previous patch repairs and new concrete spalls were found in the deck soffit of the south overhang in span D18-D19 (Figure 33, Figure 34). The concrete in these areas appeared to be robust when struck with a hammer, and there were no signs of deterioration around them. We recommend the new spall be repaired using a repair mortar (e.g. SikaTop 123) for aesthetic reasons.

Figure 33. Deck soffit in south overhang, span D18-D19: Past patch repairs

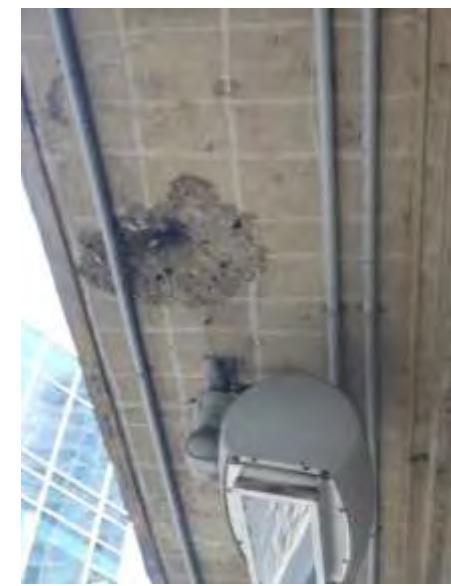
Figure 34. Deck soffit in south overhang, span D18-D19: Concrete spall

- Deck: Repair spalling in south overhang in span D18-D19.
- Joint at Costco building: Repair spalling concrete
- Drainage: Replace seal at leaking PVC pipe connection near D19. Replace waterproofing membrane in catch basin at pier D17.

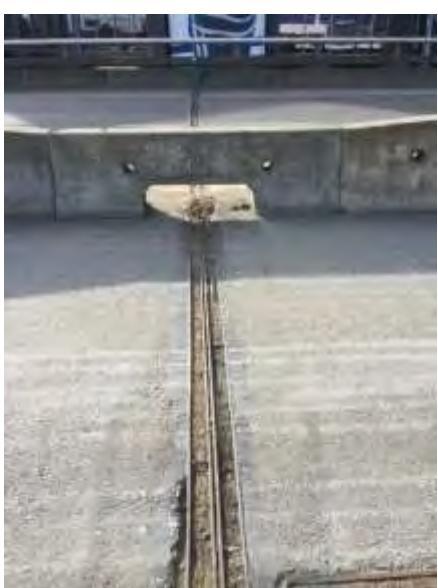
From above, the joints were inspected from the north sidewalk, as lane closures were impractical. All joints were filled with debris, so the seals were hidden from view. The seal at joint D19 was torn in places, while the seal at joint D21 seemed to be missing.

Figure 39. Joint at D17: Filled with debris

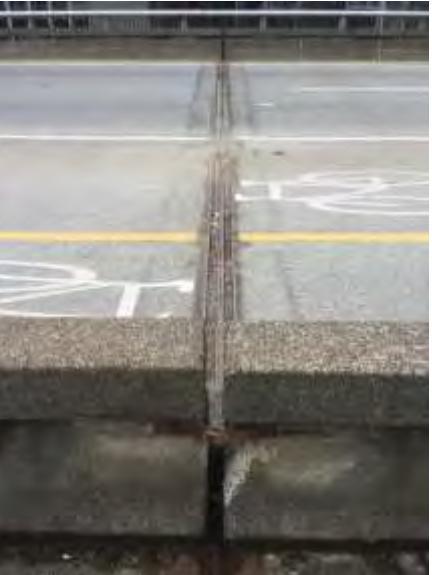
Figure 40. Joint at D19: Filled with debris

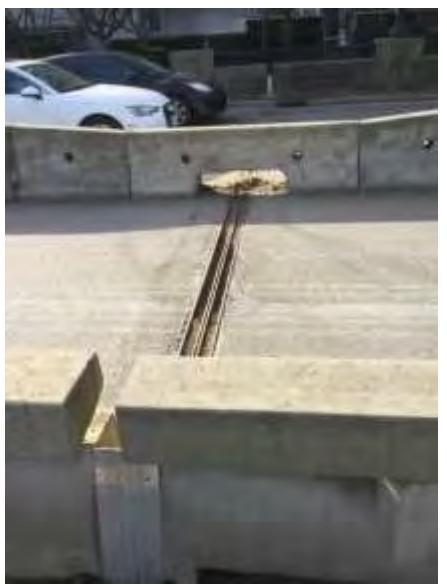
Figure 41. Joint at D21: Filled with debris, seal seems to be missing

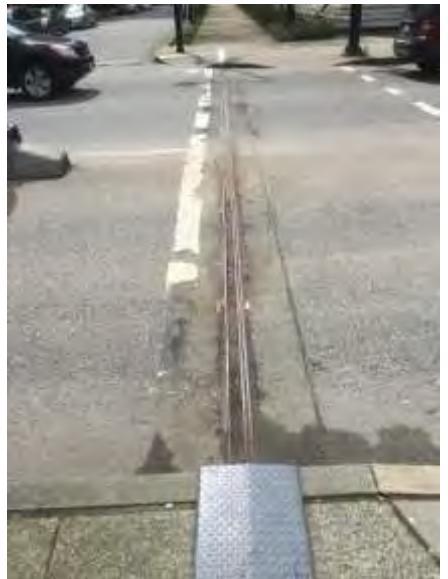
Figure 42. Joint at west abutment D23: Filled with debris

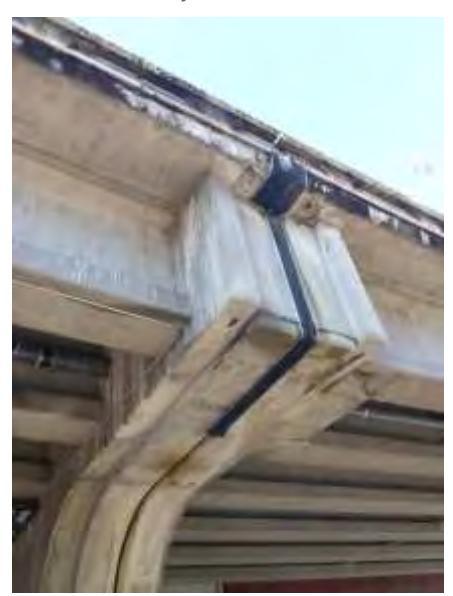
Joints at piers D17, D19, and D21 were leaking. This had led to water and chlorides entering the gap between split piers. The north side of joint D19 had a filter fabric covering the vertical edges of pier caps and part of the underside (Figure 43). On the south side of joint D19, the ingress of chloride-laden water had caused wetness, efflorescence and corrosion stains on pier caps (Figure 44, Figure 45) and columns (Figure 46). A similar pattern was observed on piers D17 (Figure 47) and D21 (Figure 48).

Figure 43. Joint at D19: North side

Areas of suspect concrete were hammer-sounded to detect delaminations which would indicate rebar corrosion due to prolonged exposure to water and chlorides. No such areas were found, but continued exposure could lead to concrete deterioration. Therefore, it is recommended that the joints be rehabilitated.

We recommend replacing existing expansion joints and armouring at D19 and D21 with link slabs to prevent further deterioration of deck, pier caps and columns at split piers. We recommend replacing the existing expansion joints and armouring at D17 and D23 with strip seal expansion joints. This is consistent with the City's intent as outlined in the project RFP. Any deteriorated deck concrete should be replaced during this process.

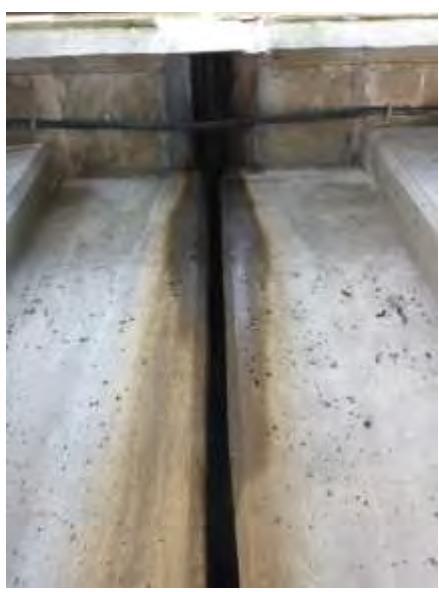
Figure 44. Joint at D19, south side, pier caps

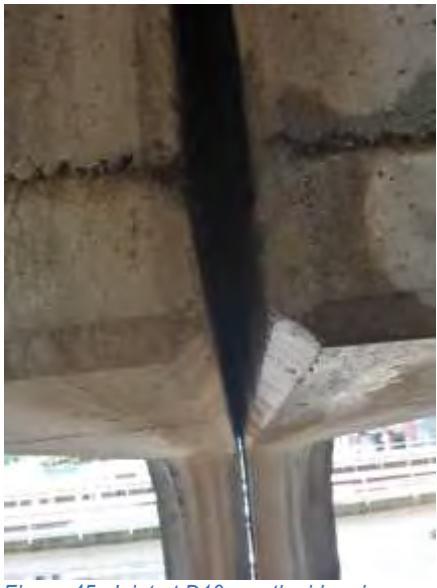
Figure 45. Joint at D19, south side, pier caps

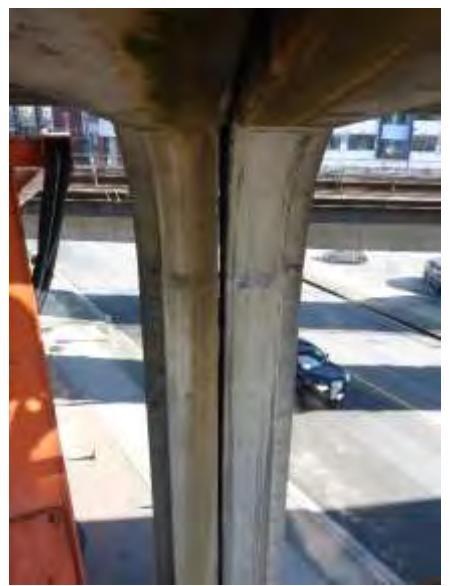
Figure 47. Joint at D17, pier caps and columns

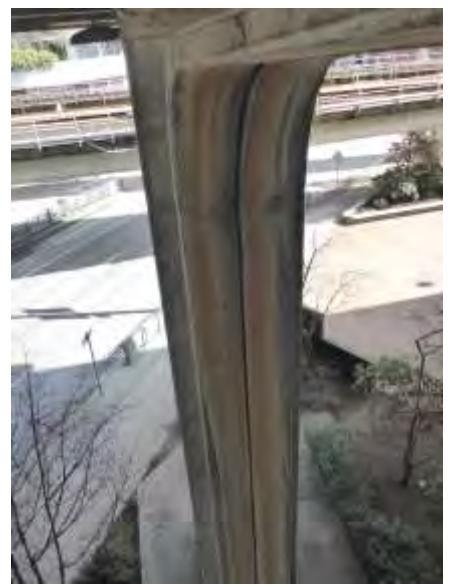
Figure 46. Joint at D19, south side, columns

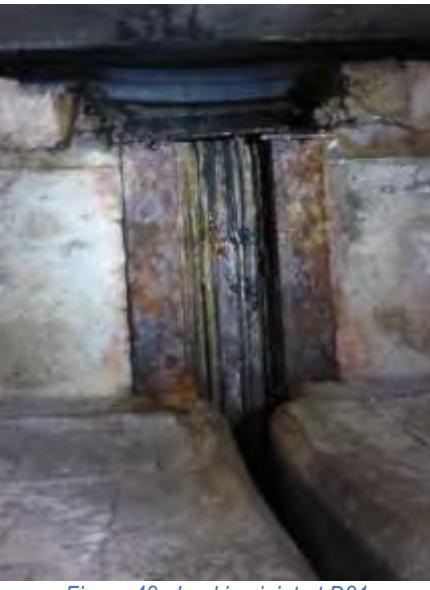
Figure 48. Leaking joint at D21

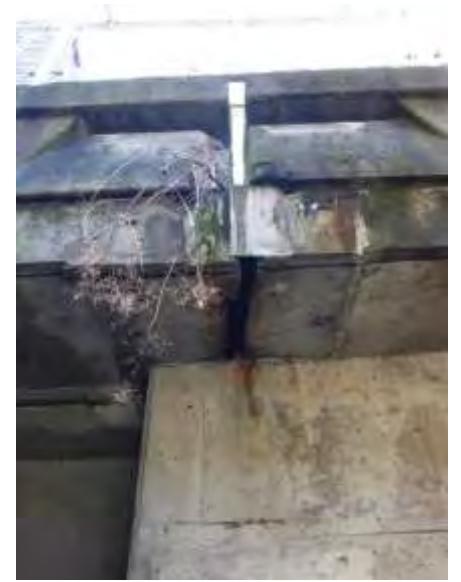
At the west abutment (D23) expansion joint, corrosion staining and spalling of the north overhang soffit was observed (Figure 49). The expansion joint between the exterior girders could not be inspected, as the girder end diaphragm prevents access. The bearing seats were generally dry, with some efflorescence and corrosion staining.

Figure 49. Joint at west abutment (D23): Corrosion stains

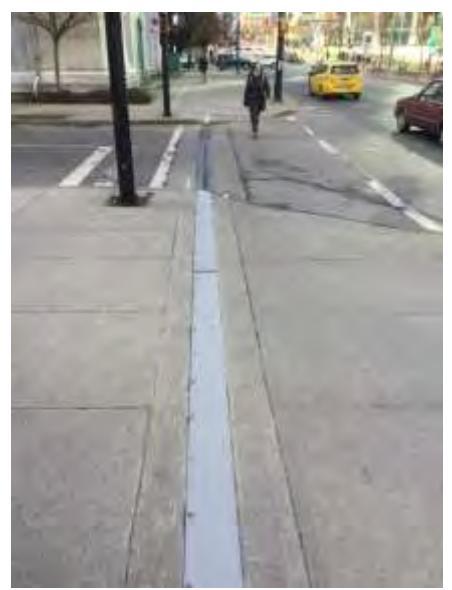
There is a longitudinal joint at deck level along the south edge of the viaduct, beginning at the west end of the south wall of the west abutment D23 (Figure 50), continuing along the roof of the adjacent Costco building (which also serves as the sidewalk south of the viaduct) (Figure 51 and Figure 52), and ending close to pier D20 on the pedestrian bridge connecting the sidewalk to Rogers Arena. East of this point, the Dunsmuir Viaduct deck and pedestrian bridge separate and start to diverge vertically (Figure 53).

Figure 50. Longitudinal joint between viaduct (span D22-D23, right) and sidewalk (left), looking west

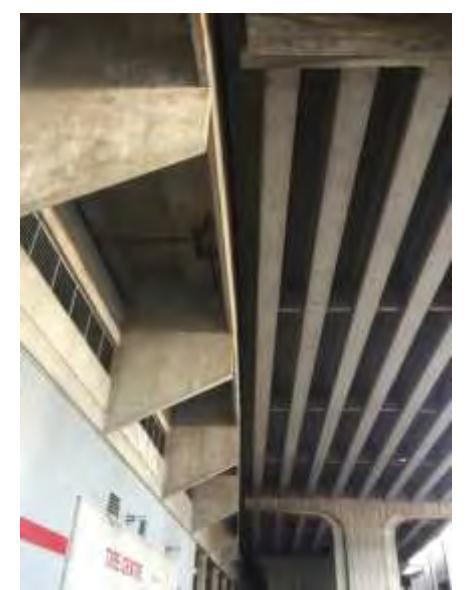
Figure 52. Longitudinal joint between viaduct (spans D21 to D23) and Costco building, looking east

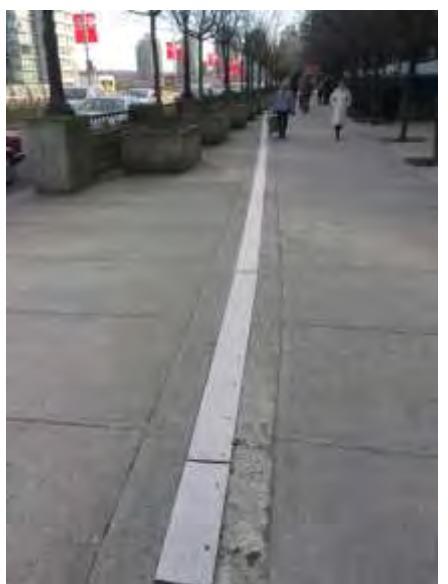
Figure 51. Longitudinal joint between viaduct (span D22-D23, left) and sidewalk (right), looking east

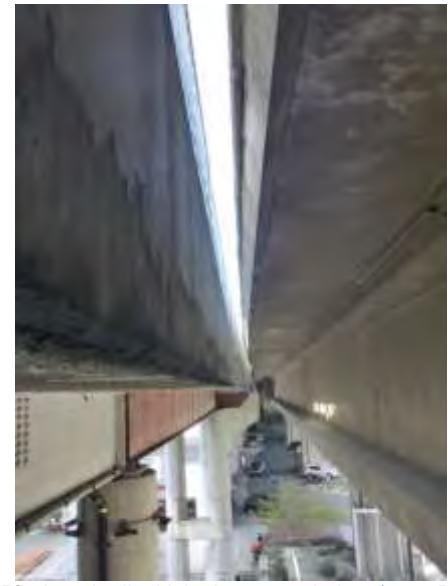
Figure 53. Longitudinal joint between viaduct (span D19-D20, right) and pedestrian bridge connecting sidewalk to Rogers Arena (left), looking east

The existing gap at this expansion joint is 75 mm wide. In a seismic event, transverse movement of the Dunsmuir Viaduct and the adjacent building and pedestrian bridge may result in pounding between these structures. This can lead to structural damage at the contact surfaces and elsewhere in these structures. To prevent this, our seismic retrofit design will consider the use of a wider joint. This joint will be designed during detailed design. This matter is discussed in detail in the Seismic Retrofit Strategy Report (NEFCAP-MMM-S-RPT-017).

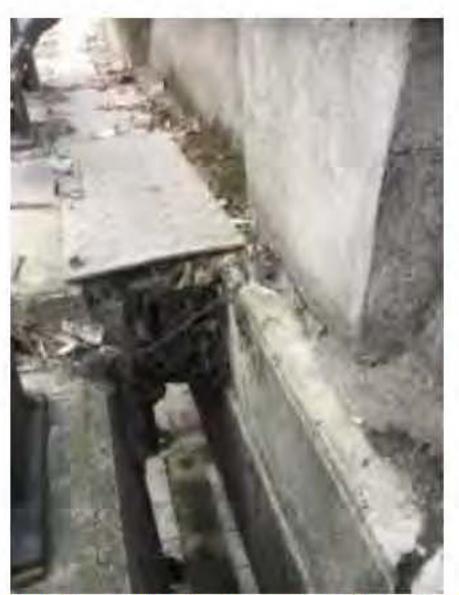
The expansion joint is a compression seal with no armouring and a checkered steel cover plate to reduce the tripping hazard (Figure 54). A 125-150 mm wide concrete infill was poured against the south of the bridge deck to close the gap and minimize joint width (75 mm) (Figure 55). The joint is leaking in some areas (Figure 55) and performing well in other areas (Figure 56).

Figure 54. End of longitudinal joint near pier D20, looking west: Compression seal and cover plate

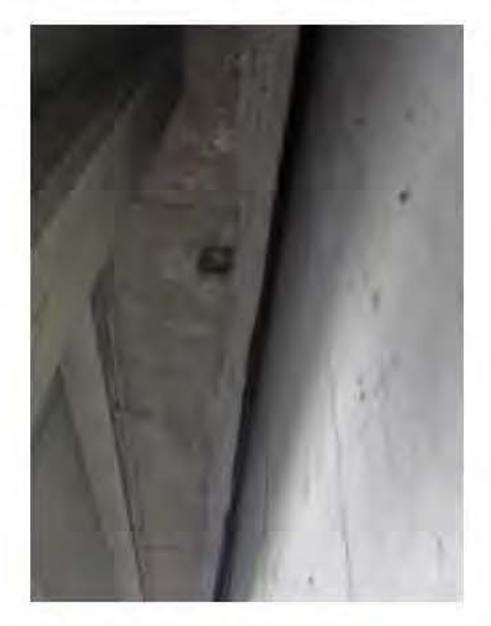
Figure 56. Longitudinal joint, pier D21, looking east: Joint performing well; concrete is dry.

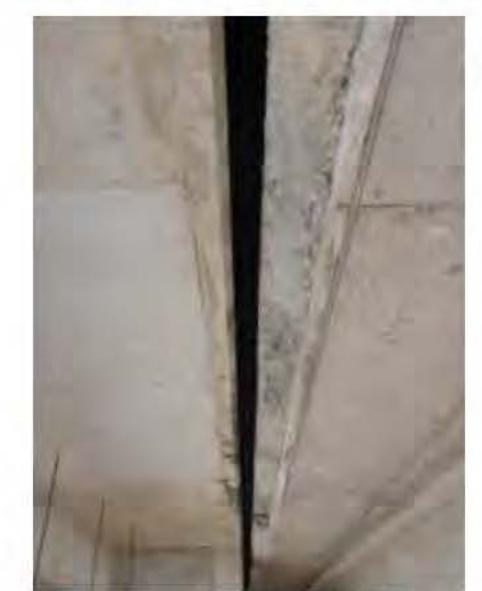
Figure 55. Longitudinal joint, span D20-D21, looking west: Joint leaking. Concrete infill to the right of joint.

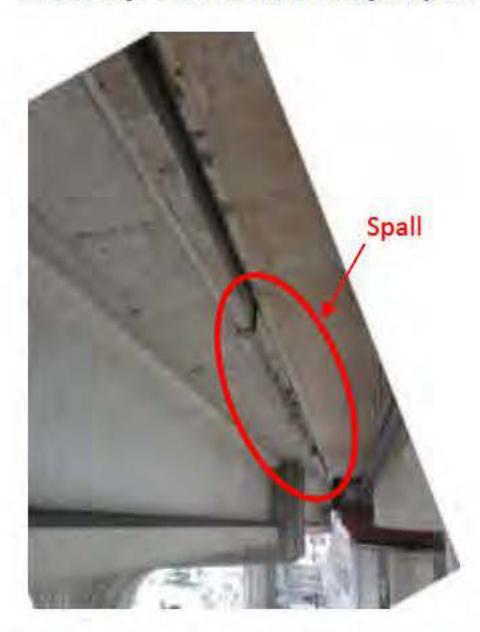
There is a long spall in the concrete infill at the south end of span D20-D21 (Figure 57). This likely occurred because the concrete infill was not attached to the bridge deck using dowels. This spalled concrete should be re-cast and attached to the existing bridge deck using dowels. Hammer-sounding of the remaining concrete infill showed no sign of delamination.

Figure 57. Longitudinal joint, span D20-D21, looking east: Spall in concrete infill. Joint is leaking; concrete is moist.

The infill concrete along the deck soffit between the viaduct and the Costco building appears unstable with evidence of delamination and spalling. As this joint is located directly over a pedestrian area, there is a potential hazard to pedestrians from falling concrete. We recommend removal of any unbonded or otherwise potentially hazardous concrete be considered a high priority.

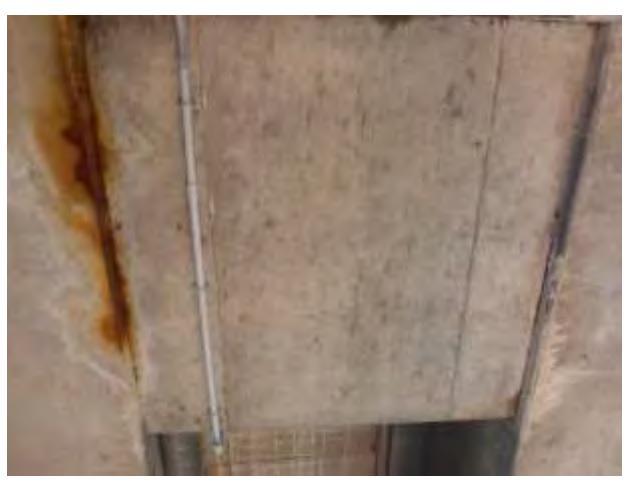
The catch basin at D17 has corrosion stains along its south edge (Figure 60). This may be due to failure of waterproofing membrane. Early signs of similar deterioration were observed at other catch basins. We recommend the waterproofing membrane at D17 be replaced to prevent further deterioration. Access would be from the manhole above.

Figure 60. Catch basin at D17

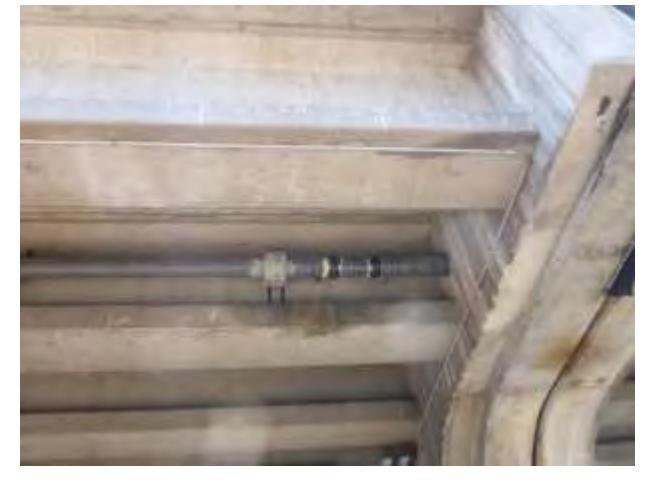
The PVC pipe was leaking at some connections (Figure 63). We recommend the seals on these connections be replaced.

Figure 63. Water stains under PVC pipe fitting, girder B, east of D19
