City of Vancouver

Bridge Engineering Services

Task C1 - Detailed Visual Inspections

Our Ref: 2068-016-RPT-GEN-001-0

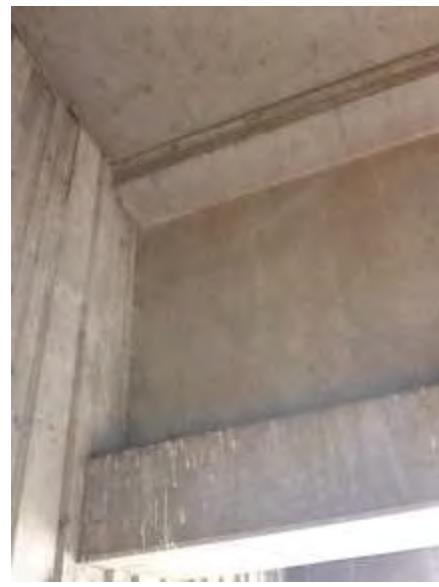
Diagonal cracks were observed at split piers on the east side of D18 and D21 between 0.5 to 1 m from girder ends (Figure 67). Cracks were typically on a 30° angle from the horizon down towards the pier, and extended from 0 to 300 mm from top of web.

Figure 67. Diagonal crack at top of web, east of D21, typical for all girders

These are not shear cracks, as they are closer than the girder depth from the support point (face of pier cap). They may be due to post-tensioning at top of girders at these locations. These cracks are small, stable and not exposed to road spray, and are therefore not of concern. We recommend these cracks be monitored in future inspections, with no remedial action required at this time.

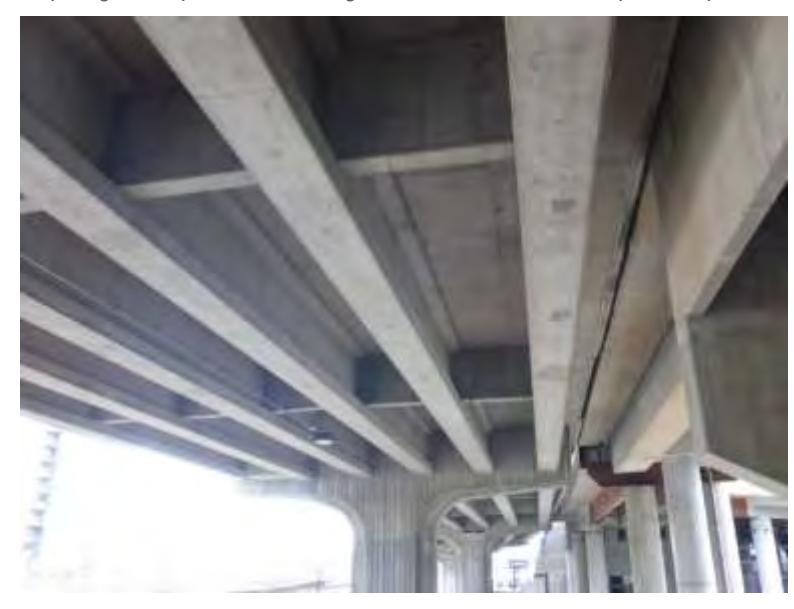
All diaphragms inspected were in good condition, with no repairs required.

Figure 69. Diaphragms in span D20-D21

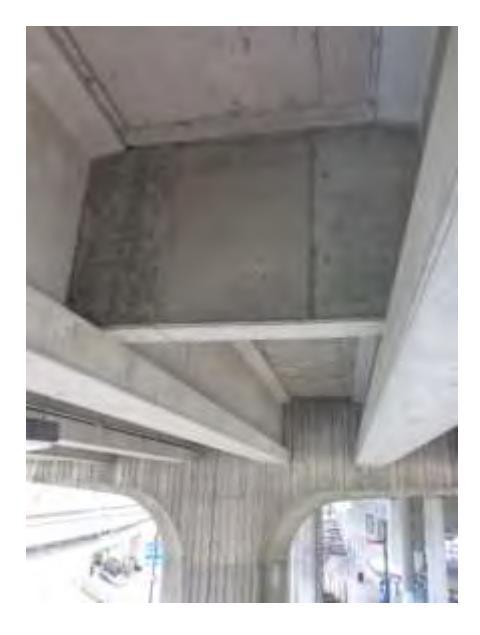
Figure 70. Typical diaphragm
