## **APPENDIX B**

### **Past Condition Inspection Reports**

**Bridge No. D-8**  
**Dunsmuir Viaduct**  
**between**  
**Beatty St. & Main St.**

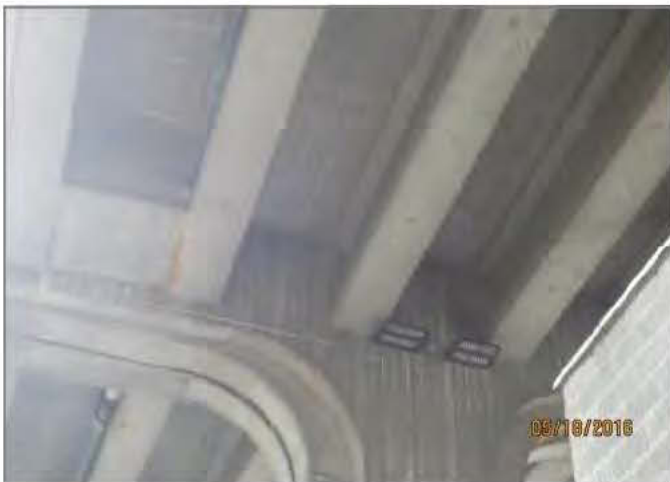
D9. Steel mapping outlines on pier and deck soffit D17-D18,

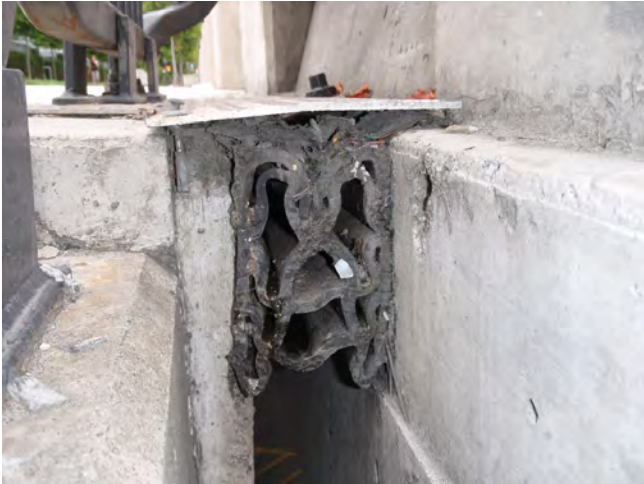
D-8 I-07.jpg

Compression seal in longitudinal joint between deck and sidewalk structure.

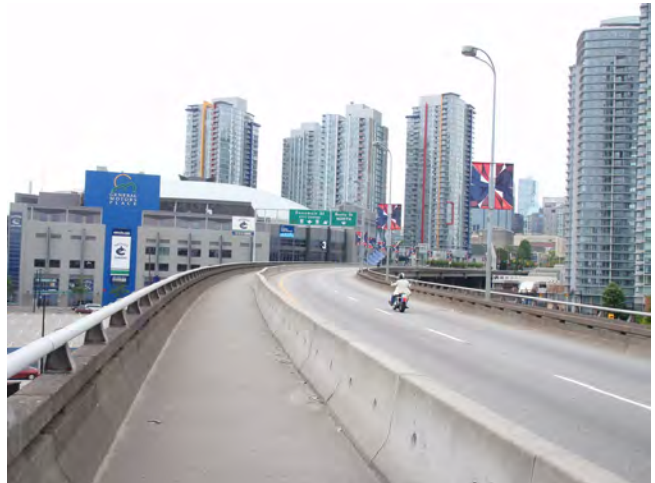
D-8 I-10.jpg

View Looking West, note misaligned No-Post barriers.

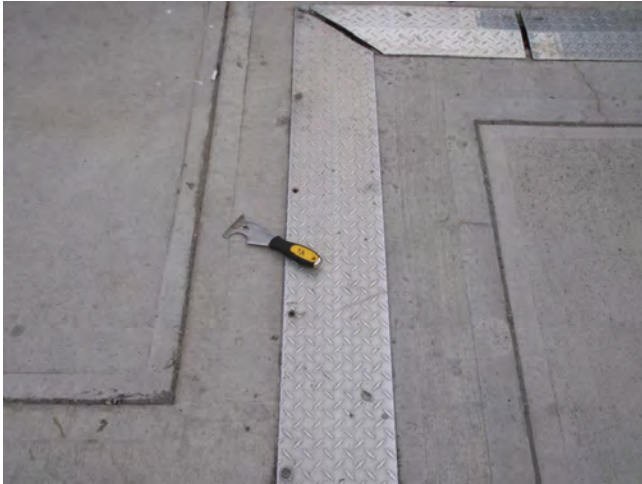
D-8 D-01.jpg

Longitudinal joint in sidewalk, note cover plate hold down screws missing.

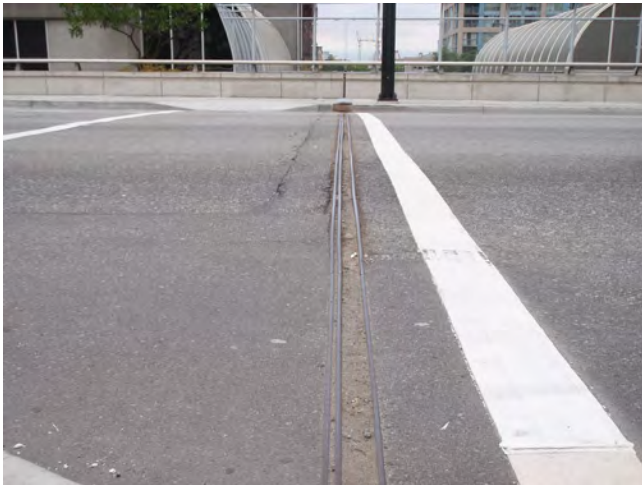
D-8 D-03.jpg

D23 west abutment deck joint.

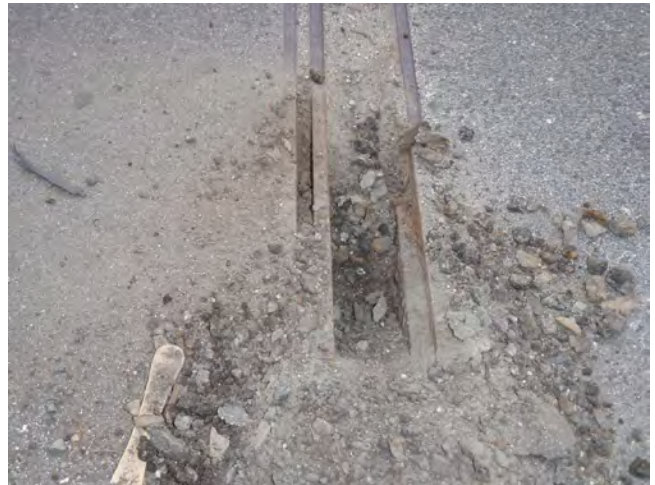
D-8 D-04.jpg

Debris in west abutment deck joint, note no seal at deck level.

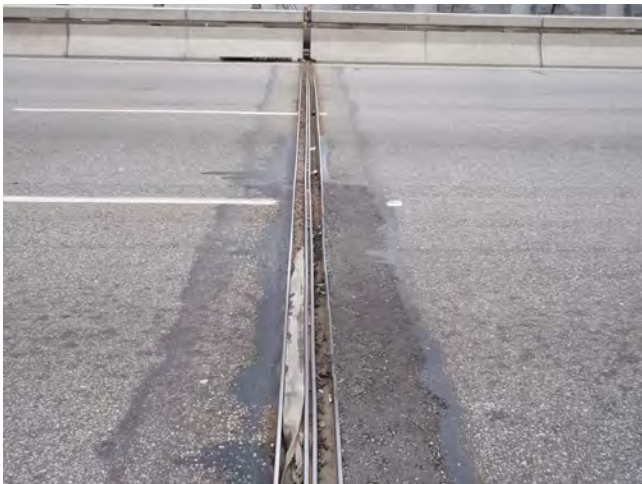
D-8 D-05.jpg

D21 Deck joint, note failed seal element and debris filling joint gap.

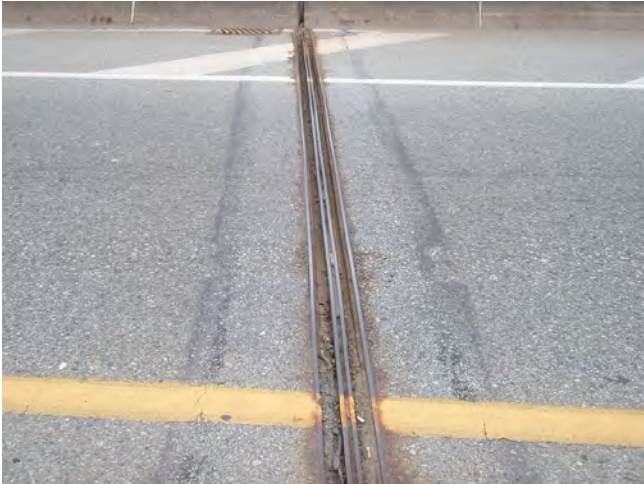
D-8 D-13.jpg

D5 Deck joint, note failed seal element and debris filling joint gap.

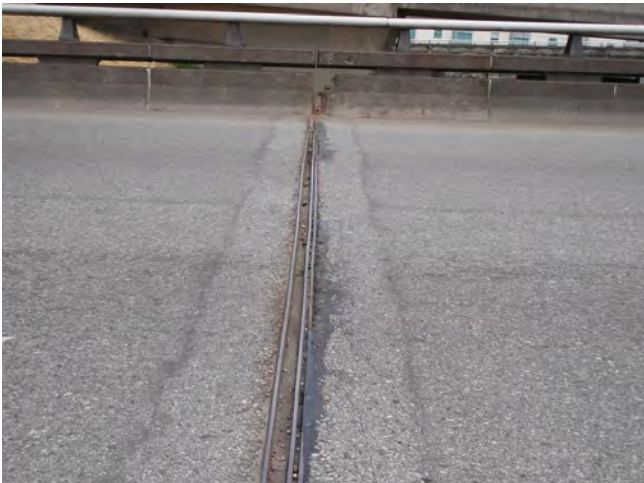
D-8 D-15.jpg

DM2, Ramp, east abutment joint , note missing seal and debris in gap.

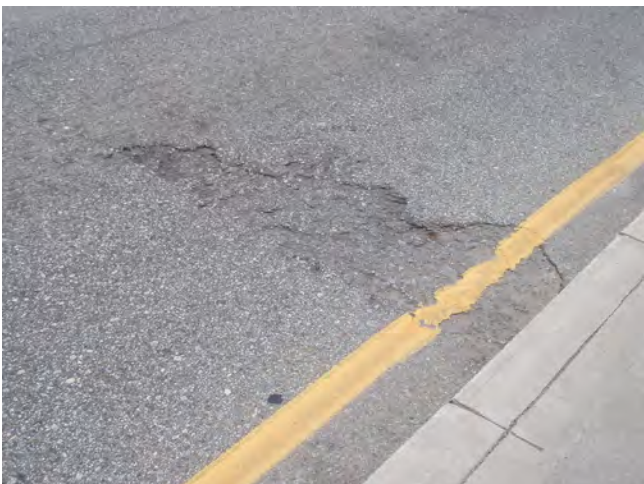
D-8 D-17.jpg

Minor deterioration of asphalt wearing surface in span S18.

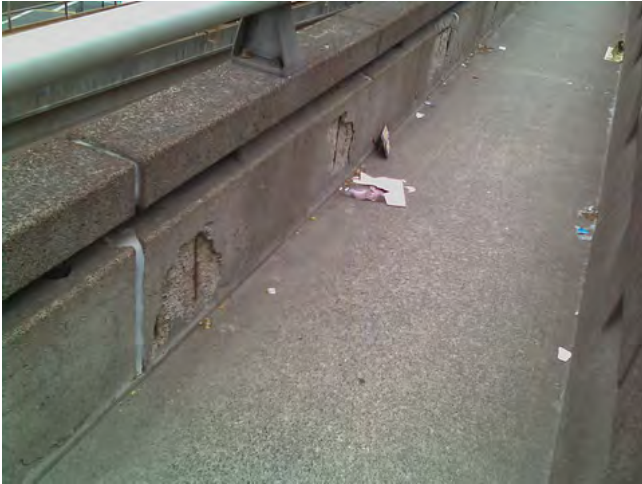
D-8 D-19.jpg

Typical spalls with exposed reinforcement in sidewalk rail.

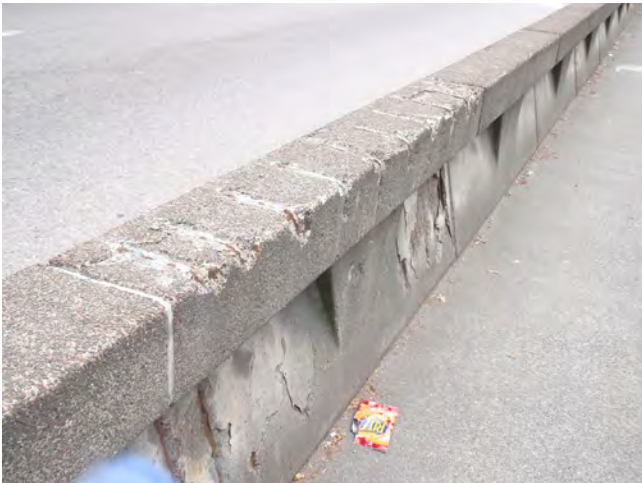
D-8 D-21.jpg

Typical spalling along top of bridge rail.

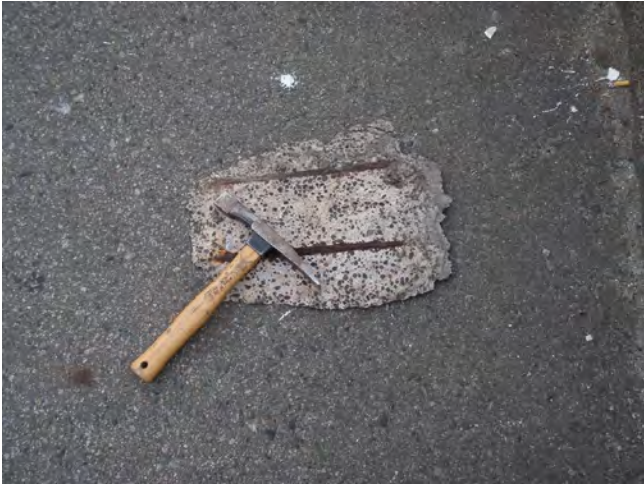
D-8 D-25.jpg

Example of spalling concrete from outside face of bridge rail.

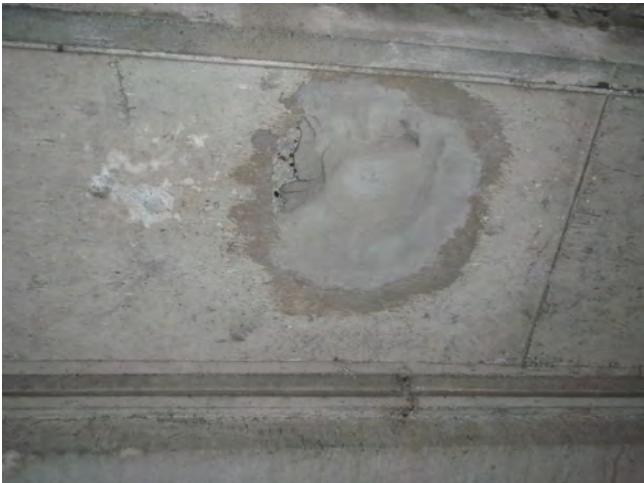
D-8 D-27.jpg

Debonding patch on south deck cantilever above G.M Place concourse.

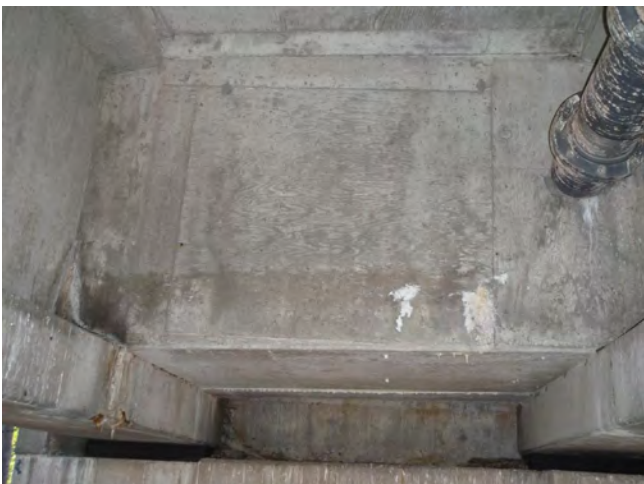
D-8 D-29.jpg

Note cracking and efflorescence in catch basin chamber at east abutment.

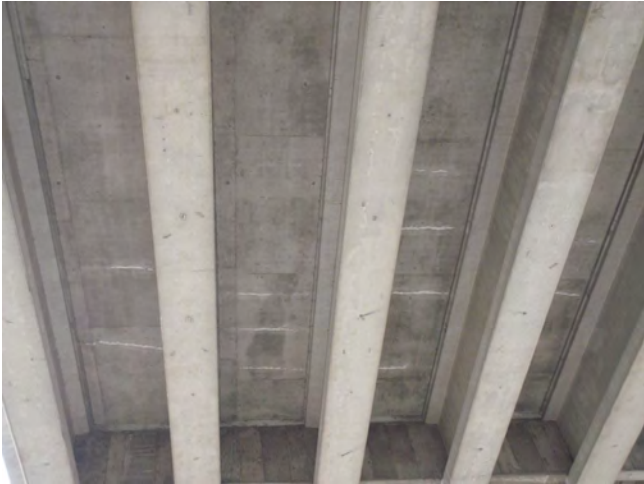
D-8 D-31.jpg

Transverse cracking with efflorescence in subdeck of S5.

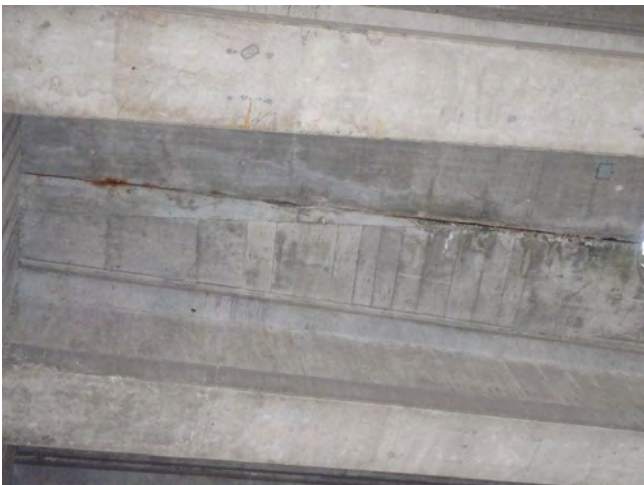
D-8 D-33.jpg

Rust staining at construction joint where ramp and main viaduct diverge.

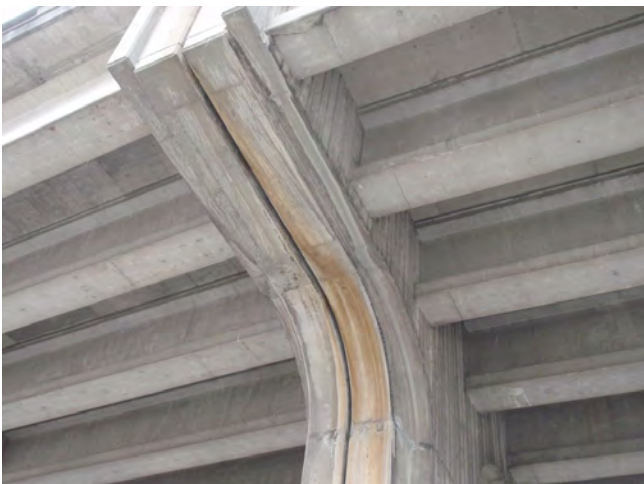
D-8 D-35.jpg

Typical water staining on expansion joint pier.

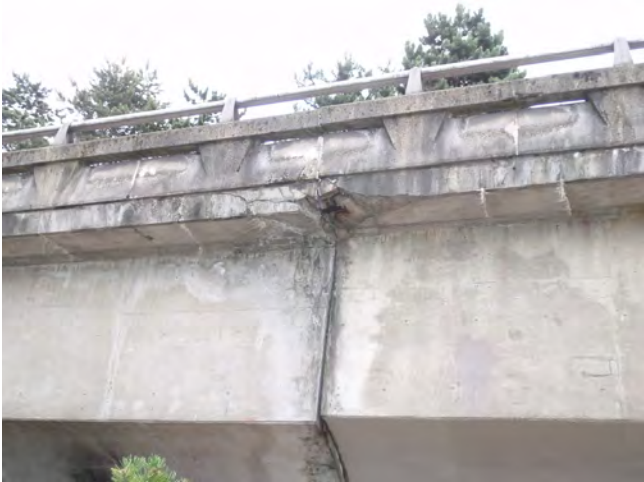
D-8 D-37.jpg

Large concrete spall with exposed reinforcement at back of east abutment of ramp, note settlement at construction joint.

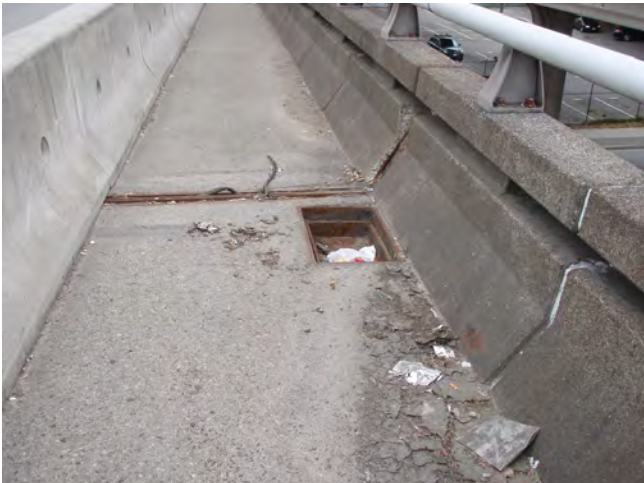
D-8 D-39.jpg

Missing catch basin grid in north shoulder at D7

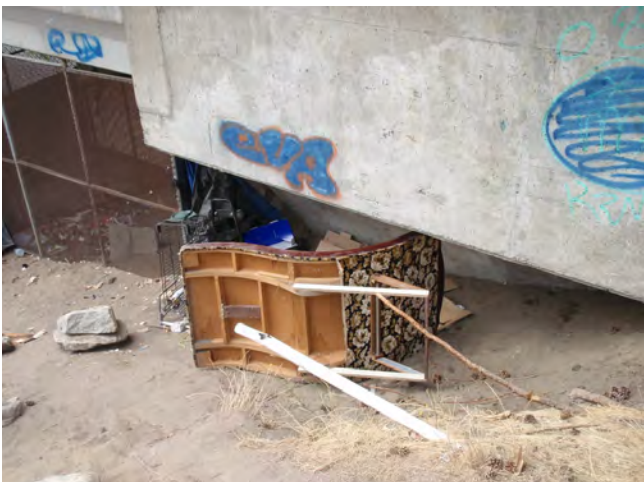
D-8 D-41.jpg

Typical encampment at east abutments.

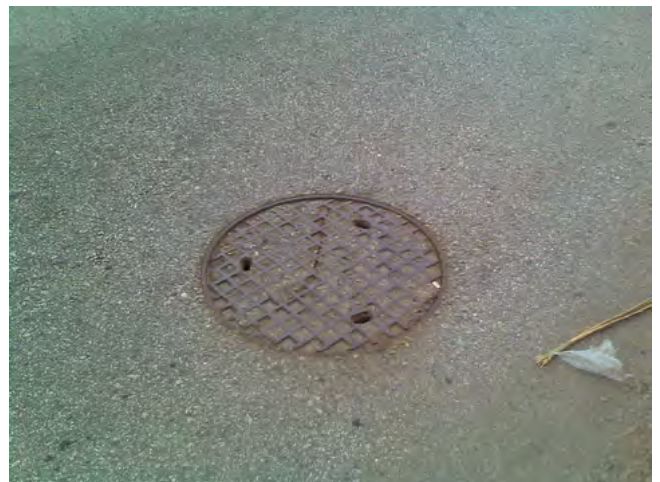
D-8 D-42.jpg

Crack in manhole cover in S11.
