**The report prepared by Glotman-Simpson for the City of Vancouver in 2012,
*Seismic Assessment and Upgrade Options in response to the Statement of Work
Outlined in the Request for Proposals PS11466.***

RE: Seismic Screening Review for Atira Women's Resource Society
101 East Cordova Street, Vancouver, BC

Read Jones Christoffersen Ltd. performed a seismic risk evaluation of Atira Women's Society located at 101 East Cordova Street, in Vancouver. This evaluation included a "rapid visual seismic screening", a review of drawings, and a walk-through site inspection. The "rapid visual seismic screening" was based on the second edition of the FEMA 154 Handbook, "Rapid Visual Screening of Buildings for Potential Seismic Hazards".

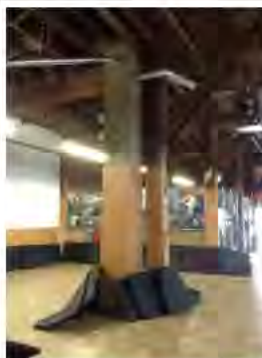
The chimney, stucco cladding, and north canopy structure on the building exterior represent potential fall hazards.

Pounding from the adjacent building, to the East, is a potential hazard.

Drawings were not made available during the review. Structure appeared to be wood post and beam framing with wood framed exterior walls. Exterior stucco cladding is in poor condition and represents a potential fall hazard. Unreinforced brick chimney, and unbraced north canopy structure also represent potential fall hazards. Pounding is a potential hazard from adjacent building (on East side).

Based on our screening we recommend a detailed, quantitative assessment of the seismic force resisting elements. The review thus far has indicated potential concerns with respect to the adequacy of the base structure seismic force resisting system.

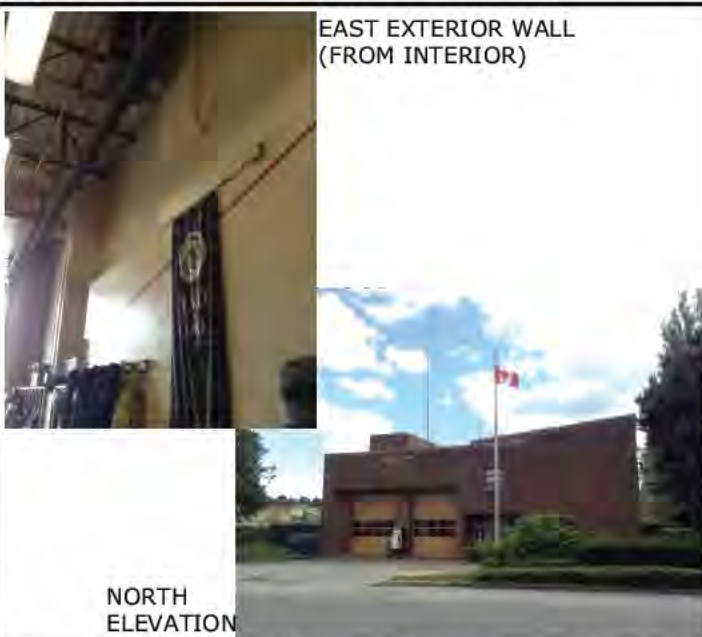
Building Name FIREHALL NO.14

Brick cladding and parapets are potential fall hazards.

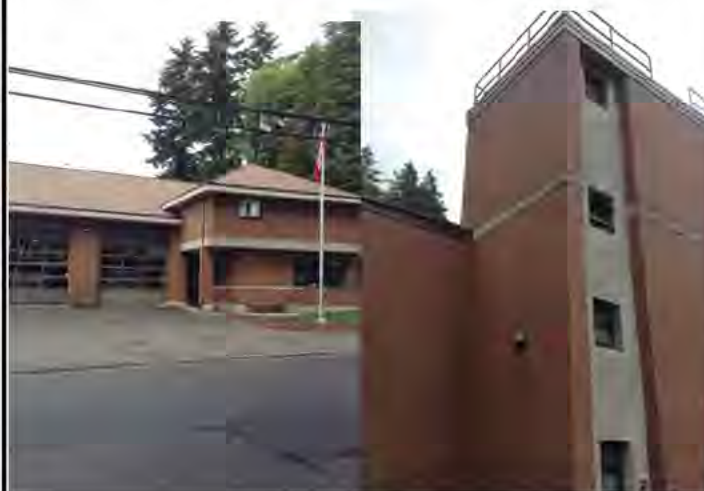
Building Name Firehall #21

The brick veneer cladding on the building exterior represents a potential fall hazard.

There were areas noted with suspended acoustical tile ceilings. The connection of the ceilings to the base structure was not reviewed during our site visit; these suspended structures may not be seismically restrained.

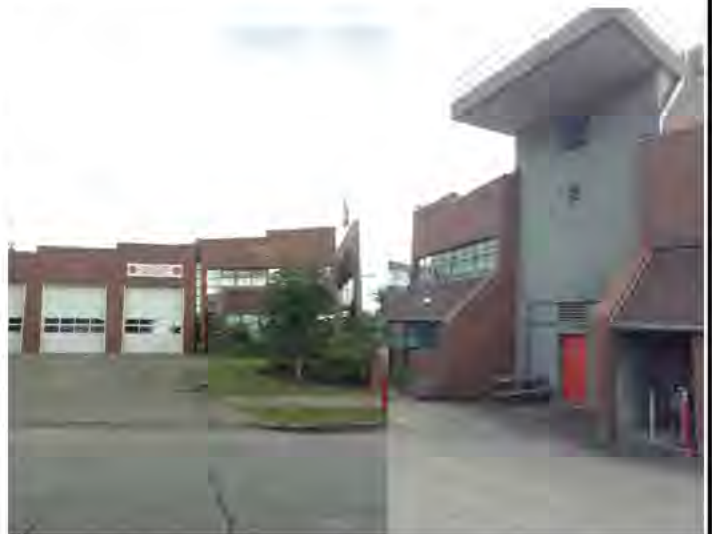
The brick veneer cladding on the building exterior represents a potential fall hazard.

There were areas noted with suspended acoustical tile ceilings. The connection of the ceilings to the base structure was not reviewed during our site visit; these suspended structures may not be seismically restrained.

Based on our screening we recommend a detailed, quantitative assessment of the seismic force resisting elements. The review thus far has indicated potential concerns with respect to the adequacy of the base structure seismic force resisting system.

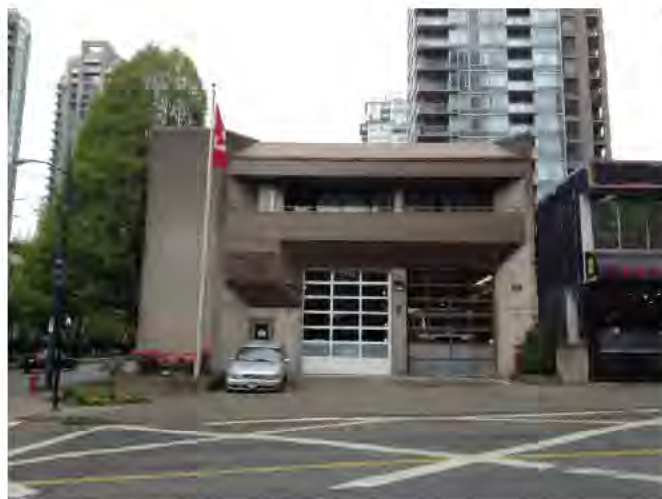
East Elevation

Pounding from the adjacent building, to the North, is a potential hazard.

Based on our screening we recommend a detailed, quantitative assessment of the seismic force resisting elements. The review thus far has indicated potential concerns with respect to the adequacy of the base structure seismic force resisting system.

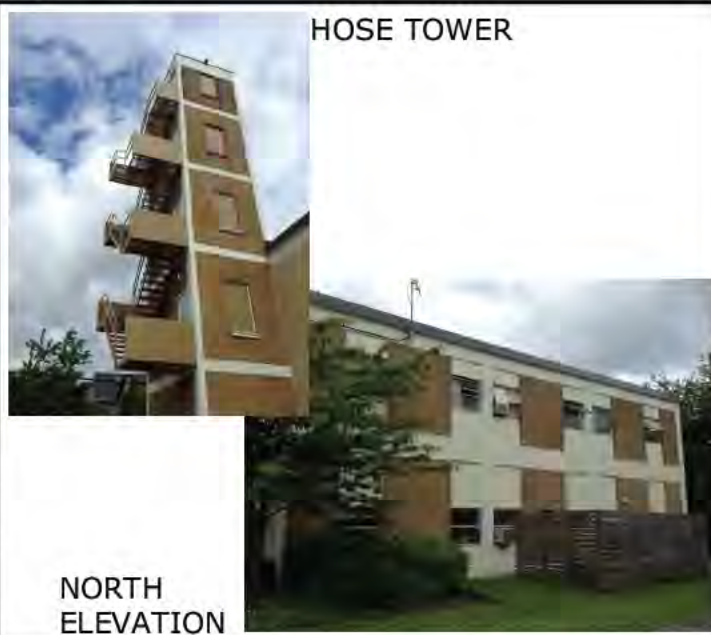
Building Name: FIREHALL NO.9

The brick cladding on the building exterior represents a potential fall hazard.

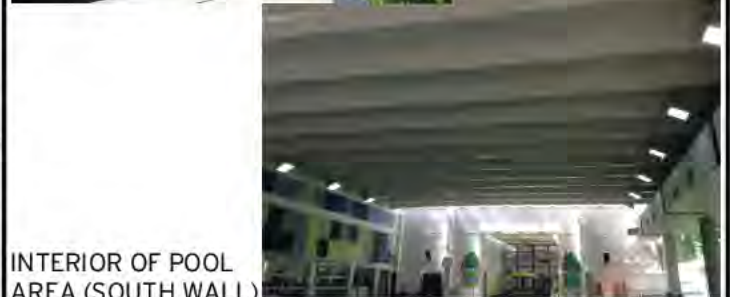
INTERIOR OF POOL AREA (SOUTH WALL)

Drawings were not made available during the review. Majority of the building appeared to be original; load-bearing block walls, with precast concrete single tee roof slabs for pool and gym, and cast-in-place concrete pan joist slabs typical elsewhere. FRP appears to have been installed on some of the pool block walls. Mechanical equipment observed appeared to be restrained. No cladding; just painted block.

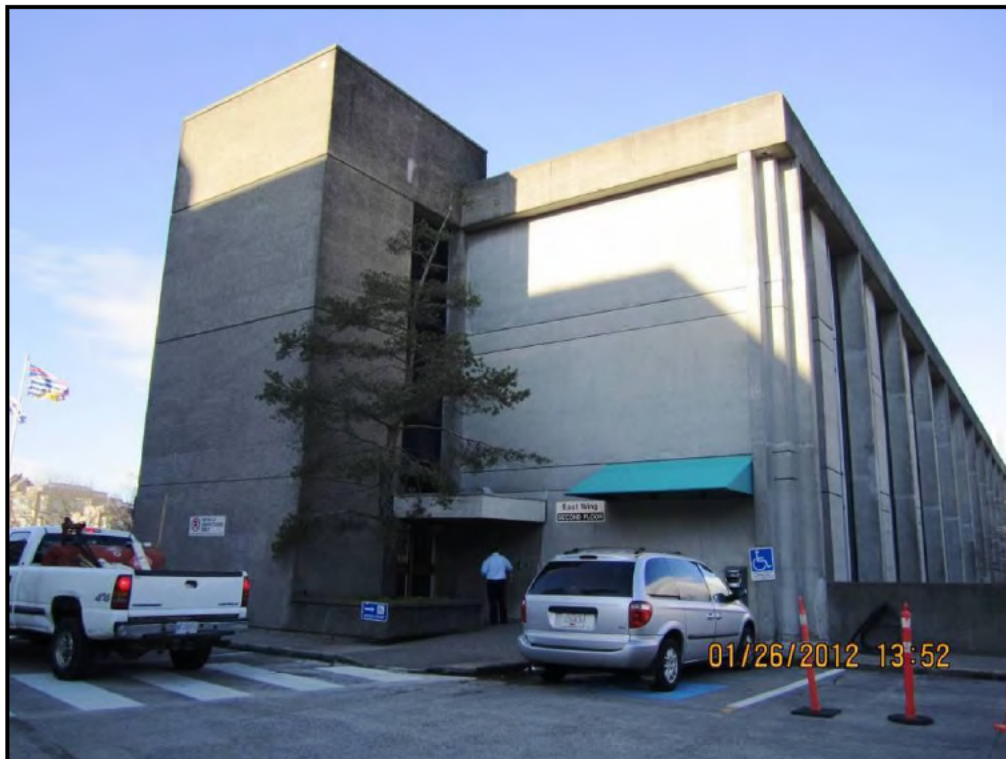
Photograph 4. East Wing and South Elevation

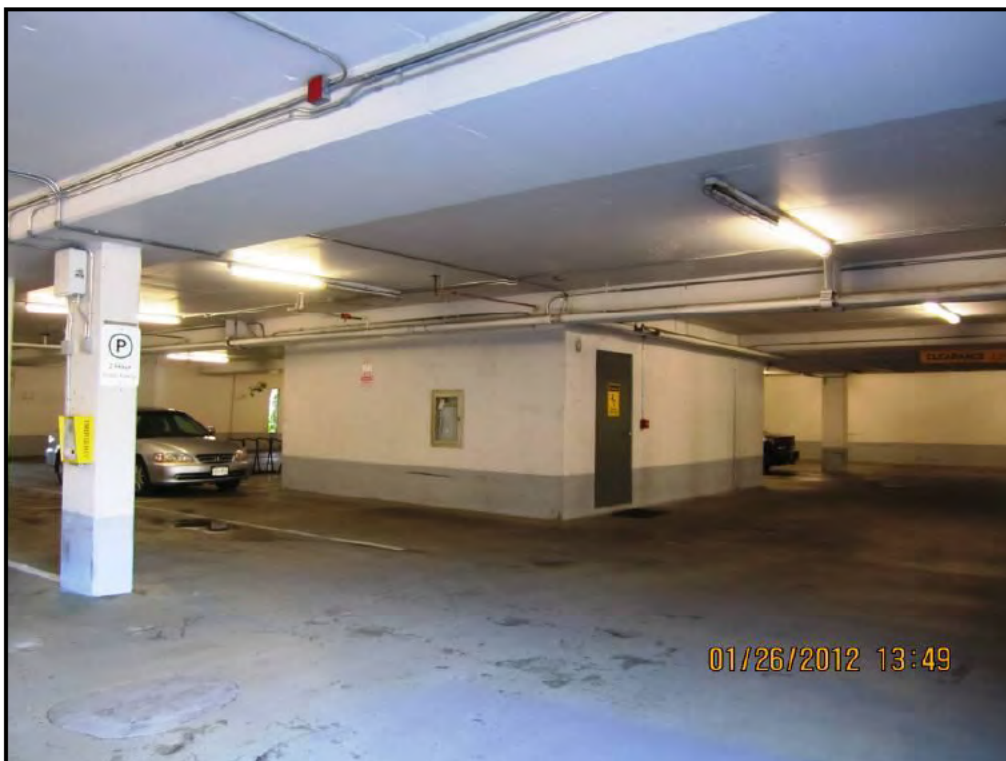
Photograph 5. East Wing and typical parkade structure

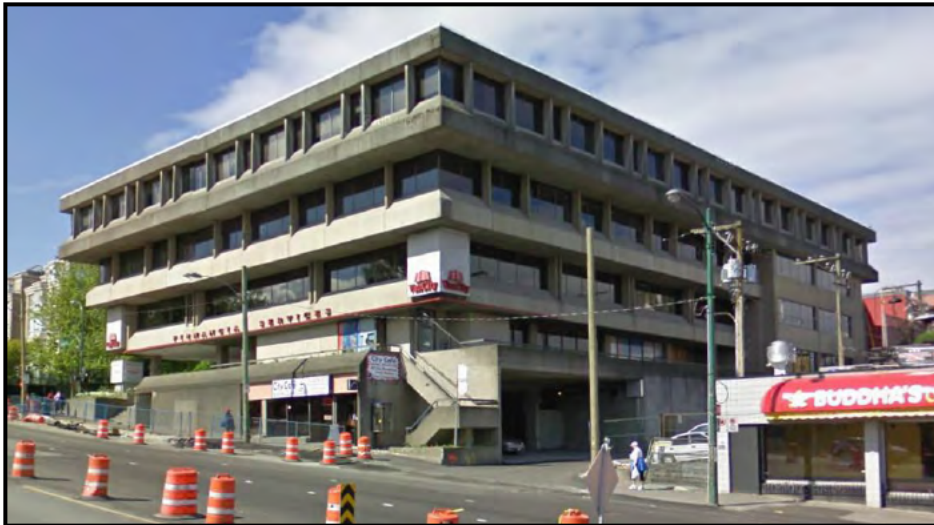
Photograph 6. West Annex South Elevation. The exterior of the building is clad with precast concrete sections.

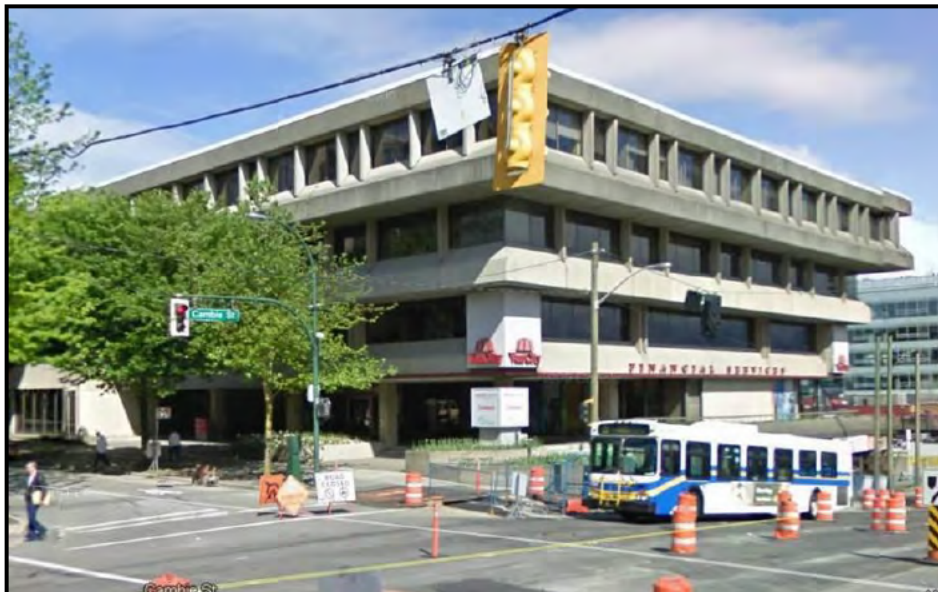
Photograph 7. West Annex North Elevation

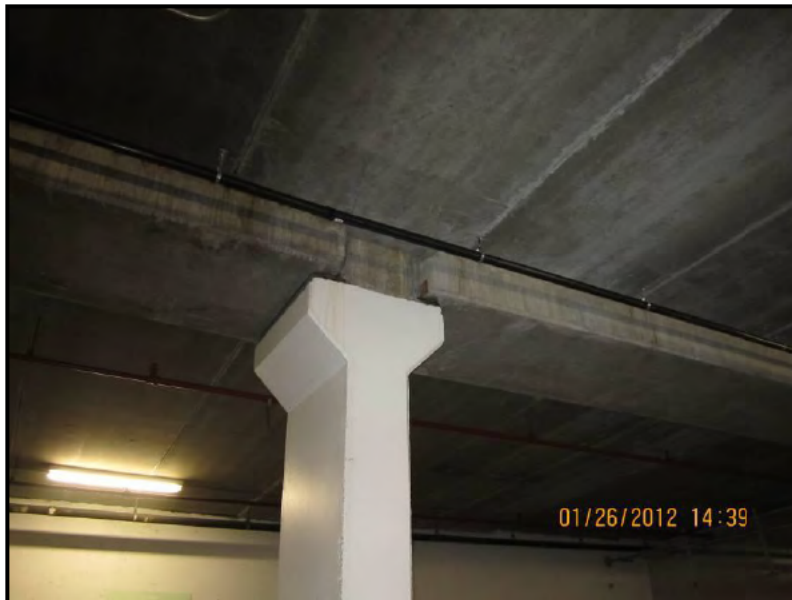
Photograph 8. West Annex and typical precast concrete construction of lower levels.

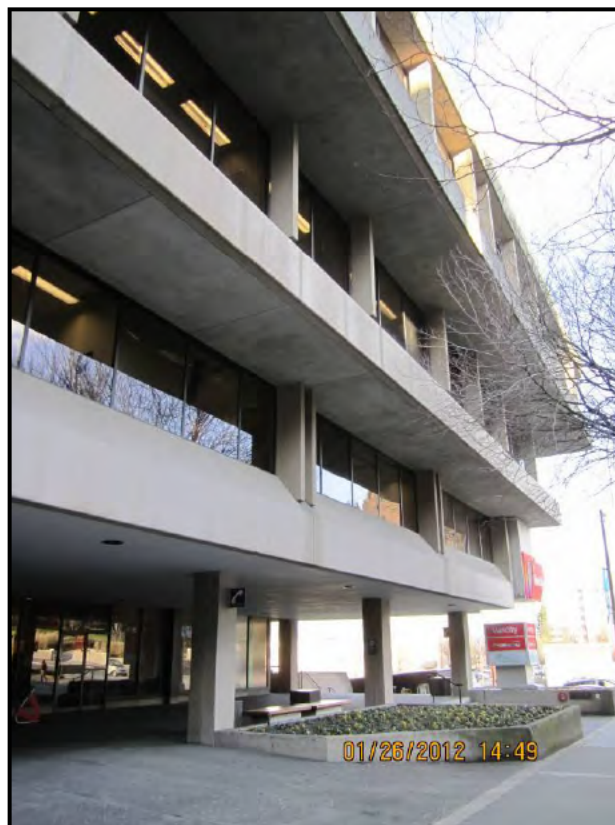
Photograph 9. West Annex and partial South Elevation and exterior precast concrete.

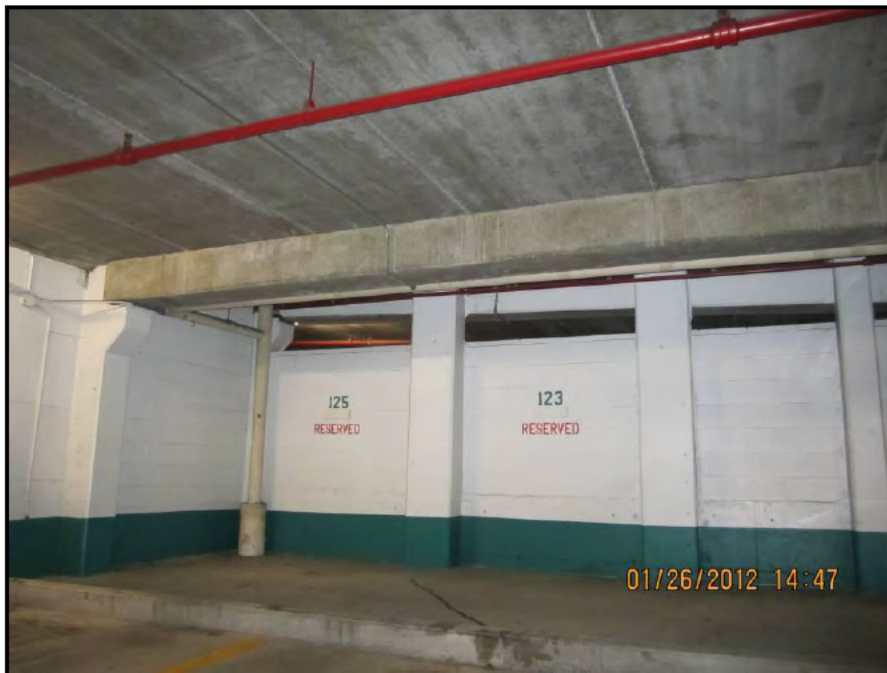
Figure 4.15 West Annex Precast framing and "short columns".

Precast in the ground floor and parking levels in the West Annex will require strengthening to maintain integrity during seismic shaking. Connections between beams and columns and collateral elements will be required to avoid pieces from slipping off their supports. One alternative is to remove and replace the diaphragm concrete topping with a reinforced concrete topping capable of distributing the loading to new wall elements dispersed throughout the parking areas.
