GEOTECHNICAL COMMENTS ON CAUSES AND FACTORS CONTRIBUTING TO COLLAPSE OF WEST EXCAVATION SHORING

Proposed Development
138 East 8th Avenue
Vancouver, BC

Our File: 120-4694

March 31, 2020

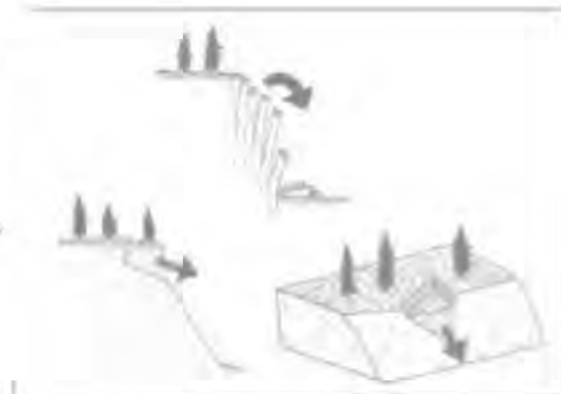
Figure 5: Rock slope failure mechanisms

Slope failures of bedrock or soil types acting in a similar manner to bedrock (e.g. fissured clays) are governed by jointing, with 'sliding block', 'wedge' or 'toppling' failures manifesting, depending on joint spacing and orientation. These failure types are indicated in Figure 5.

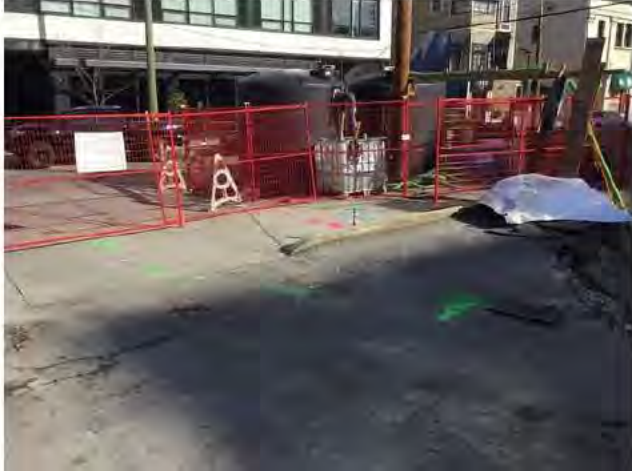
Storm Line(s) Located:	Yes
Equipment Used:	Ground Penetrating Radar
Signal Quality:	Average
General Depth:	0.5m
Other Notes:	Storm line running North out of site from catch basin. As per City of Vancouver, there is a storm connection to the South side of the building. Building owners previously had Storm lines snaked, exits to South end of property.

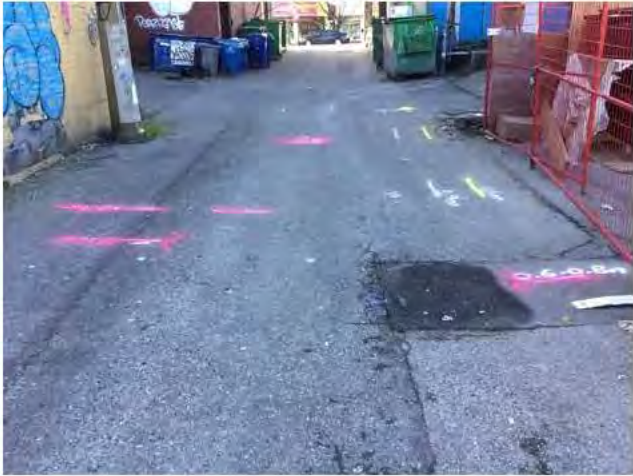
Site Images	
Image Annotation	Image
Unknowns in laneway

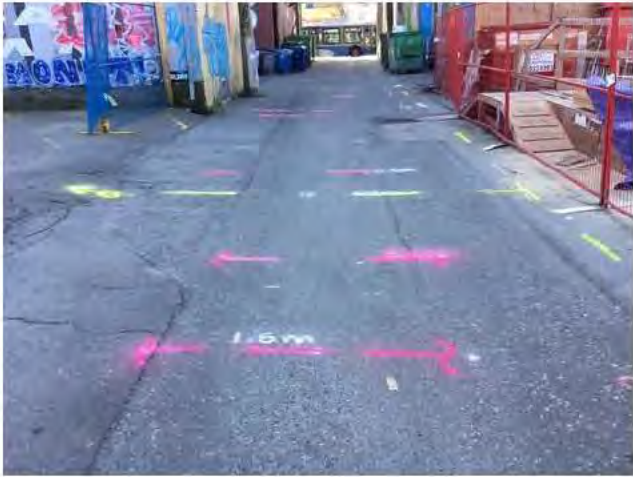
Unknowns and gas line in laneway

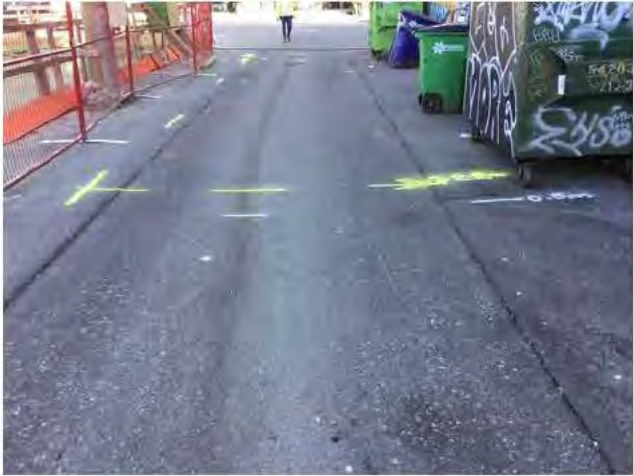
Site Images	
Image Annotation	Image
Gas line in laneway

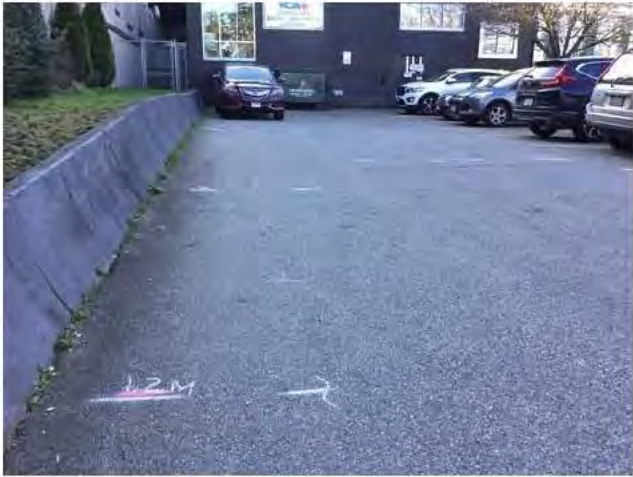
Unknowns in West parking lot

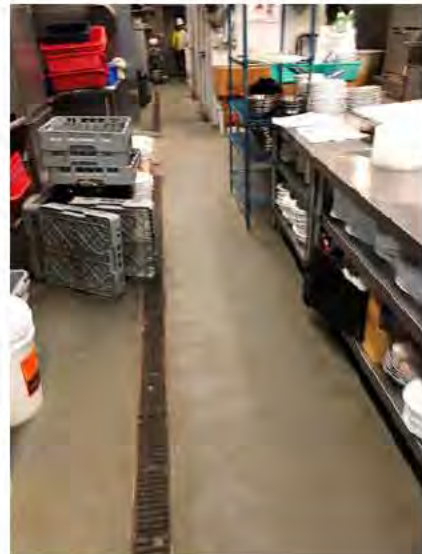
Photo 9

Slab on grade and trench drain in the kitchen on the west side of the building with no visible cracks.

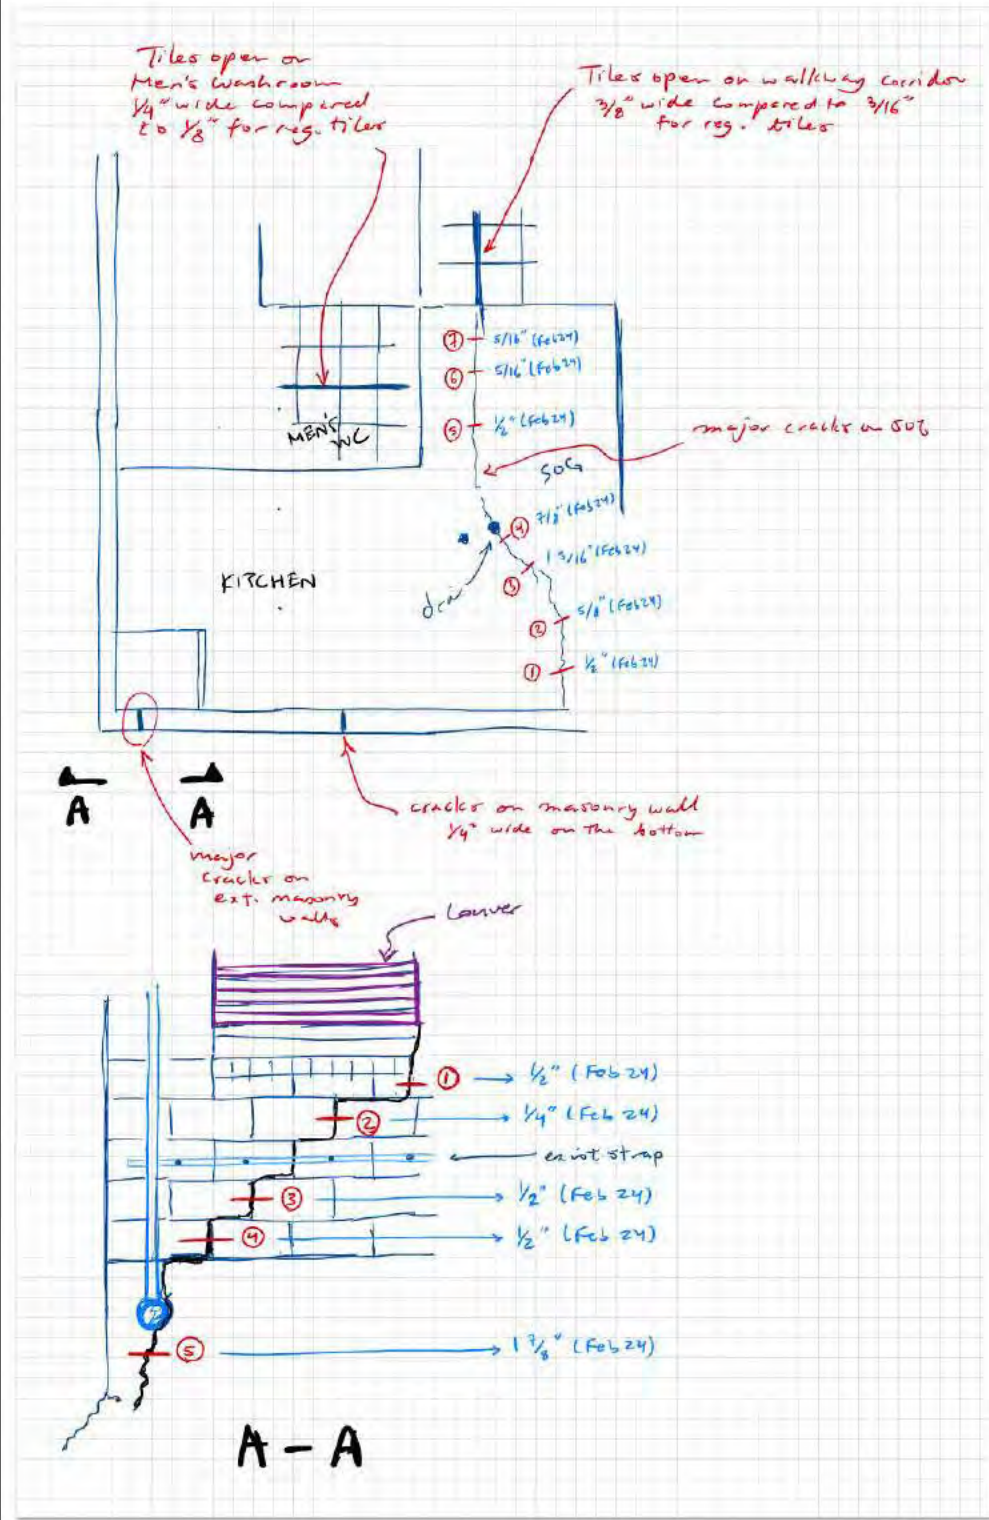
TABLE A2 – CRACK LOCATION SUMMARY

Plan outline of crack locations at the northeast corner with locations illustrated in table A1
